Appropriate Assessment

Forth Road Bridge Maintenance Works

JSF19-00013 / AA Revision 0

Project Name:	Forth Road Bridge Maintenance Works
Project Number:	JSF19-00013
Report Title:	Appropriate Assessment
Report Number:	AA

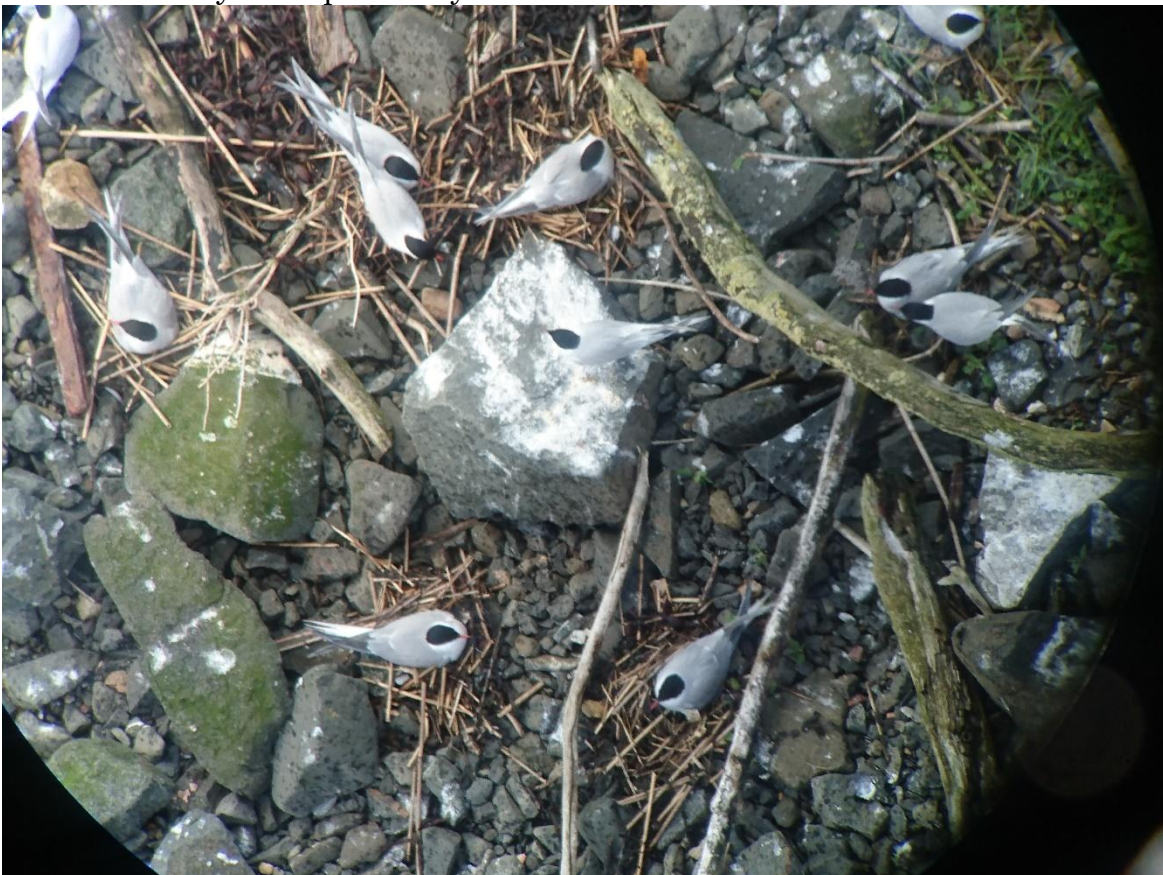
Figure 1. Common terns at eastern end of strand line create more complex nests than those near the centre.

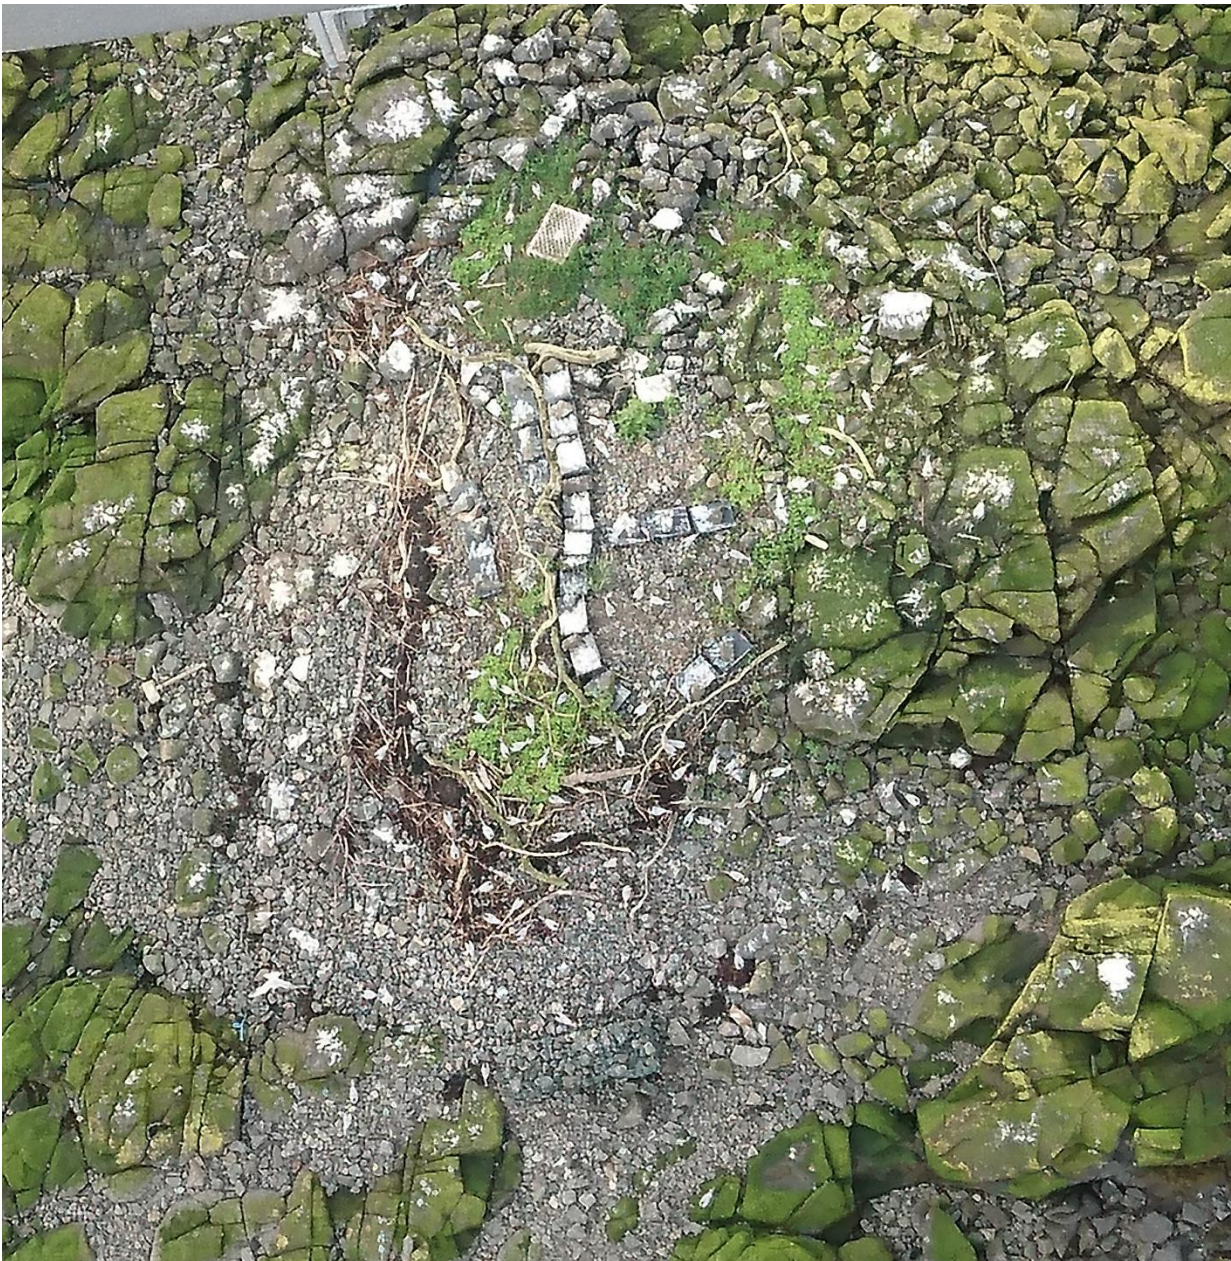
Figure 2. Showing almost all of nesting area, with visible strand line to the left (South).

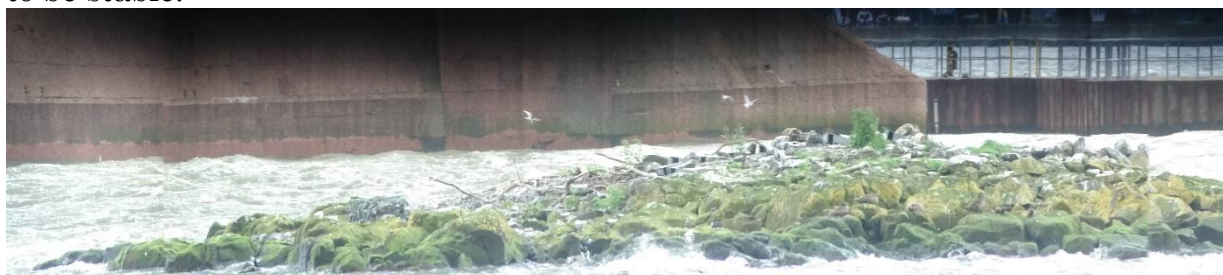
Figure 3. Extent of nesting area as viewed from North shore. Gabion cages visible to left.

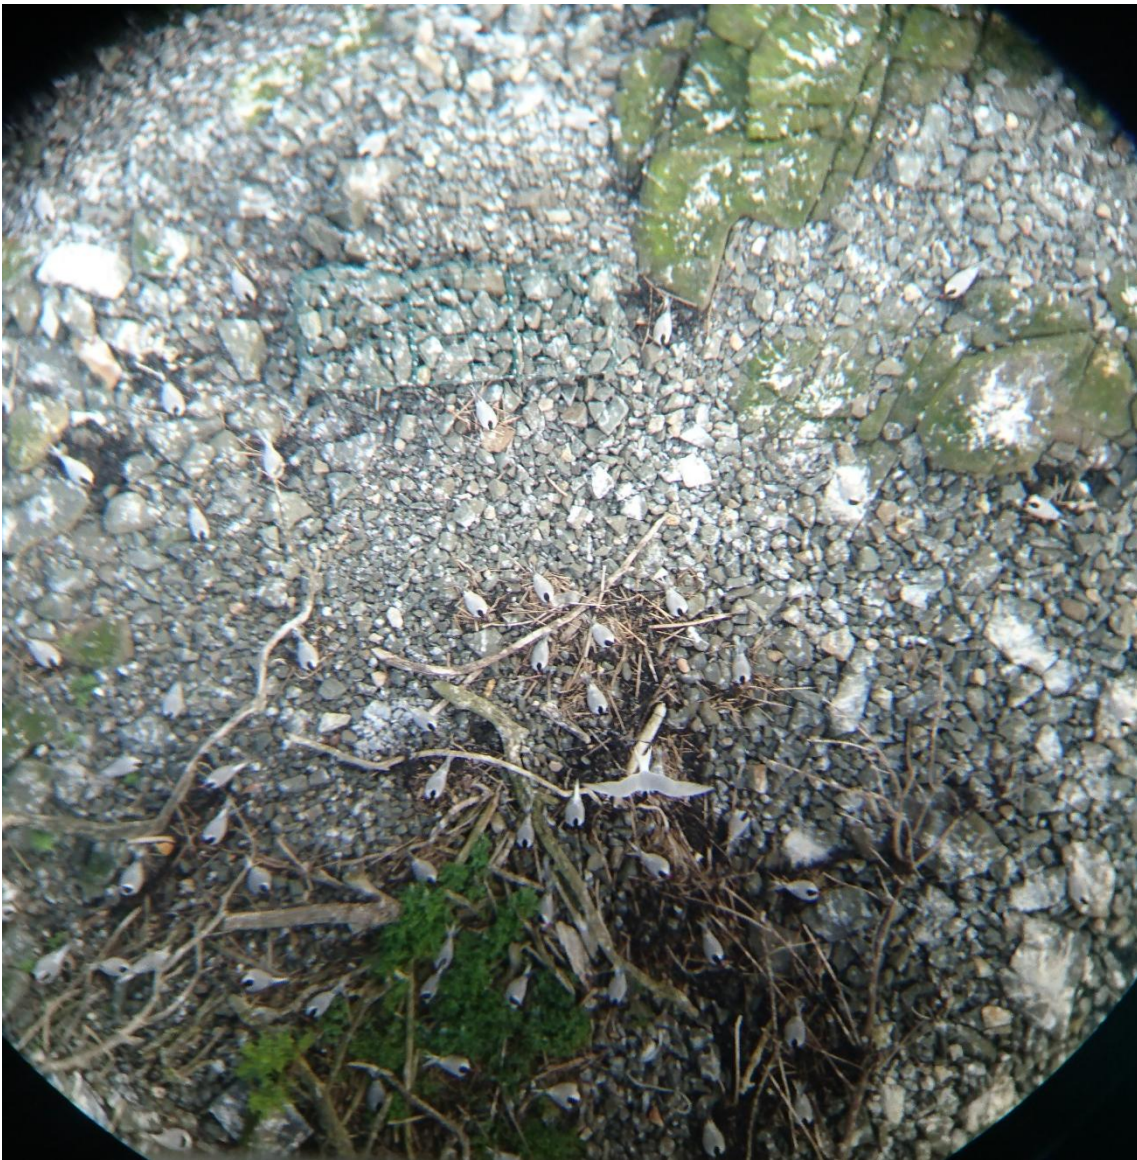
Figure 4. Common terns nesting from strand line down to gabion cages (near top of picture).
