Egilsay Harbour, Orkney Dredging Best Practicable Environmental Option Report

Client: Orkney Islands Council
 Project Title: Egilsay Harbour, Orkney
 Report Title: Dredging Best Practicable Environmental Option Report
 Document number: 15594
 Project number: 682766

Title
Sediment Sampling Stations Plan

Drawing No. 682766-GIS003	Revision A	Date 12 Aug 2025
Drawn MMF	Checked CCAS	Approved CCAS

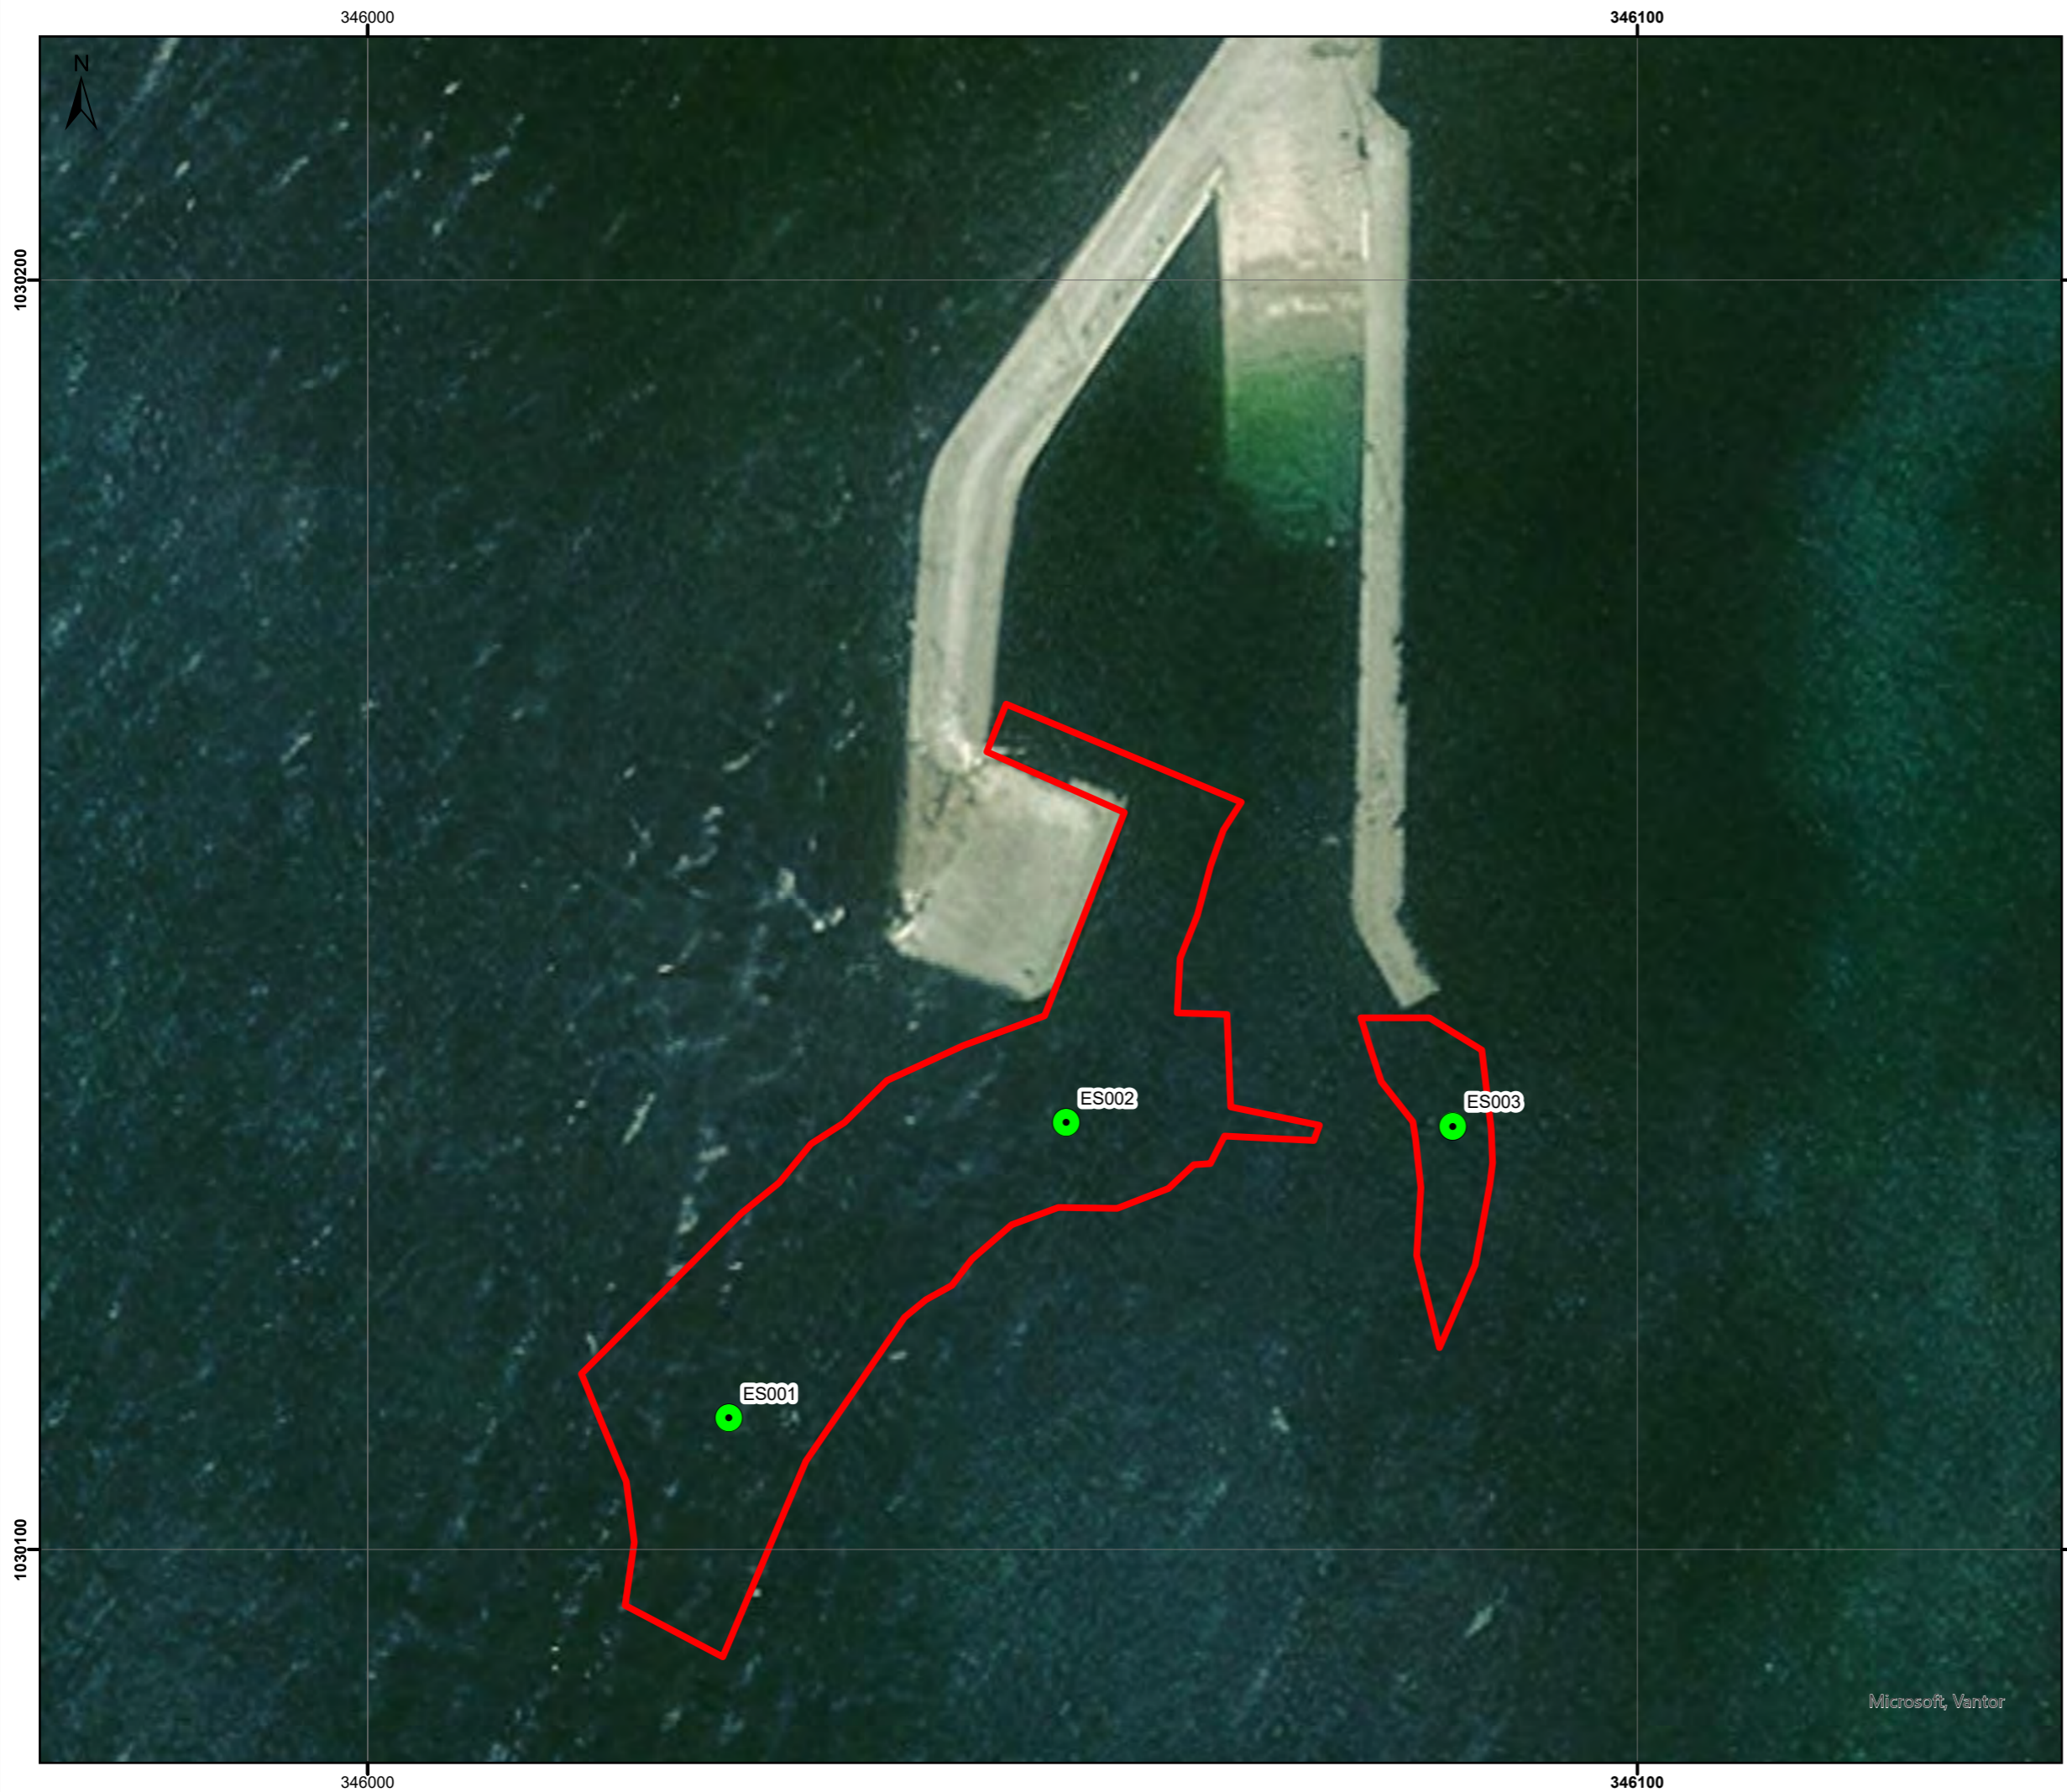
- Edilsay Dredge Area
- Egilsay Sampling Stations

The dredge area and sampling locations are detailed in within Drawing No. 682766-GIS003 and 682766-GIS004 provided in Appendix A.

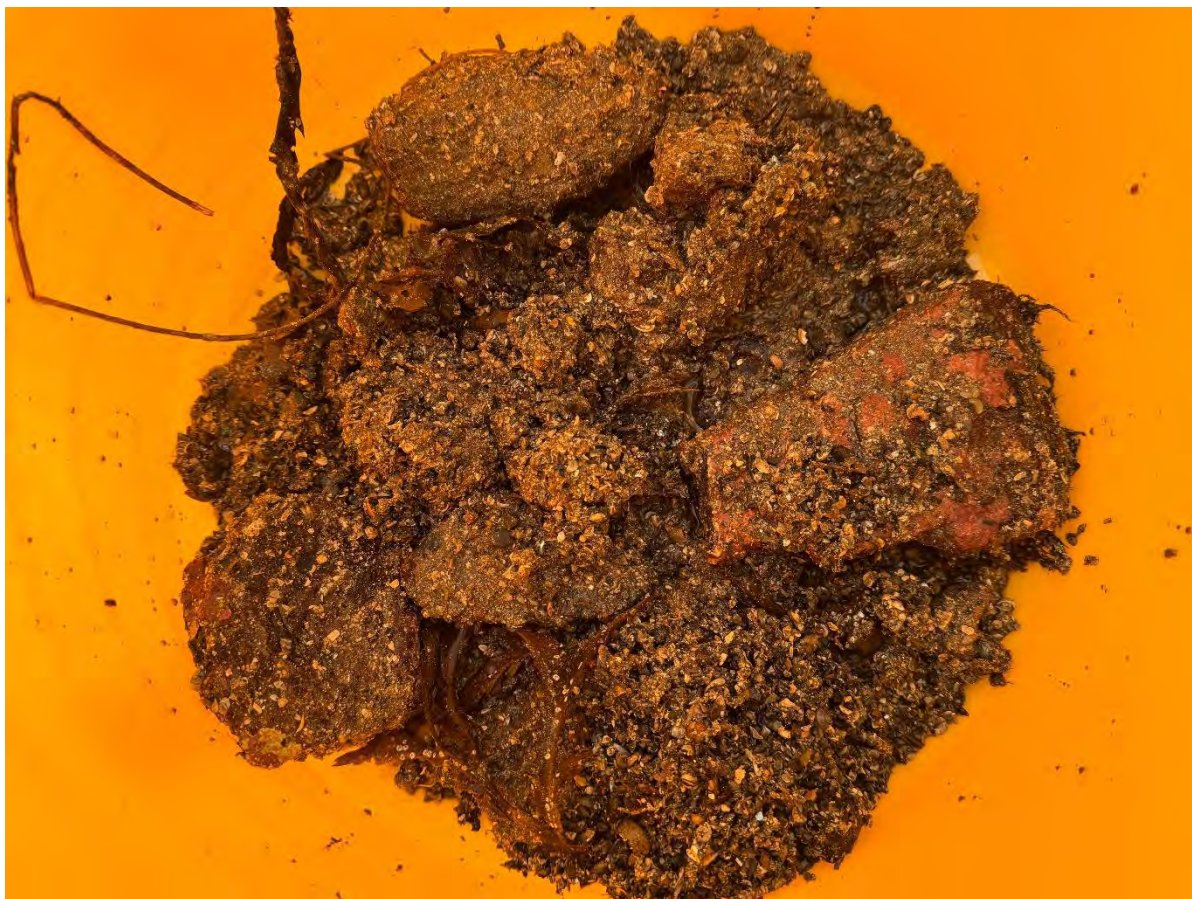
ES01

Remarks: Brown coarse sand with cobbles, shell fragments and seaweed.

Biota: Seaweed.

Notes: Grab sample obtained on 6th attempt.

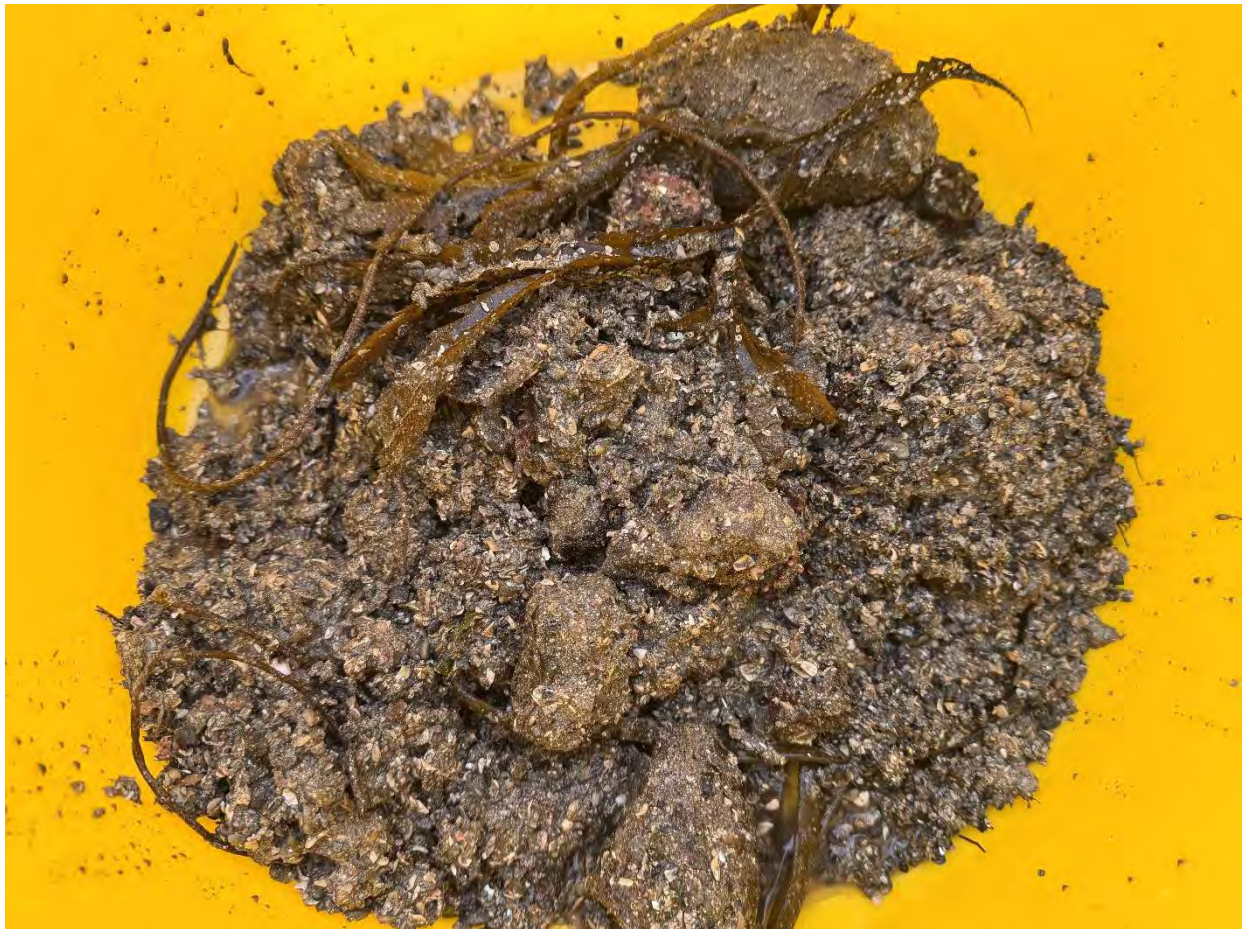
ES02

Remarks: Brown coarse sand with cobbles, shell fragments and seaweed.

Biota: Seaweed.

Notes: Grab sample obtained on 4th attempt.

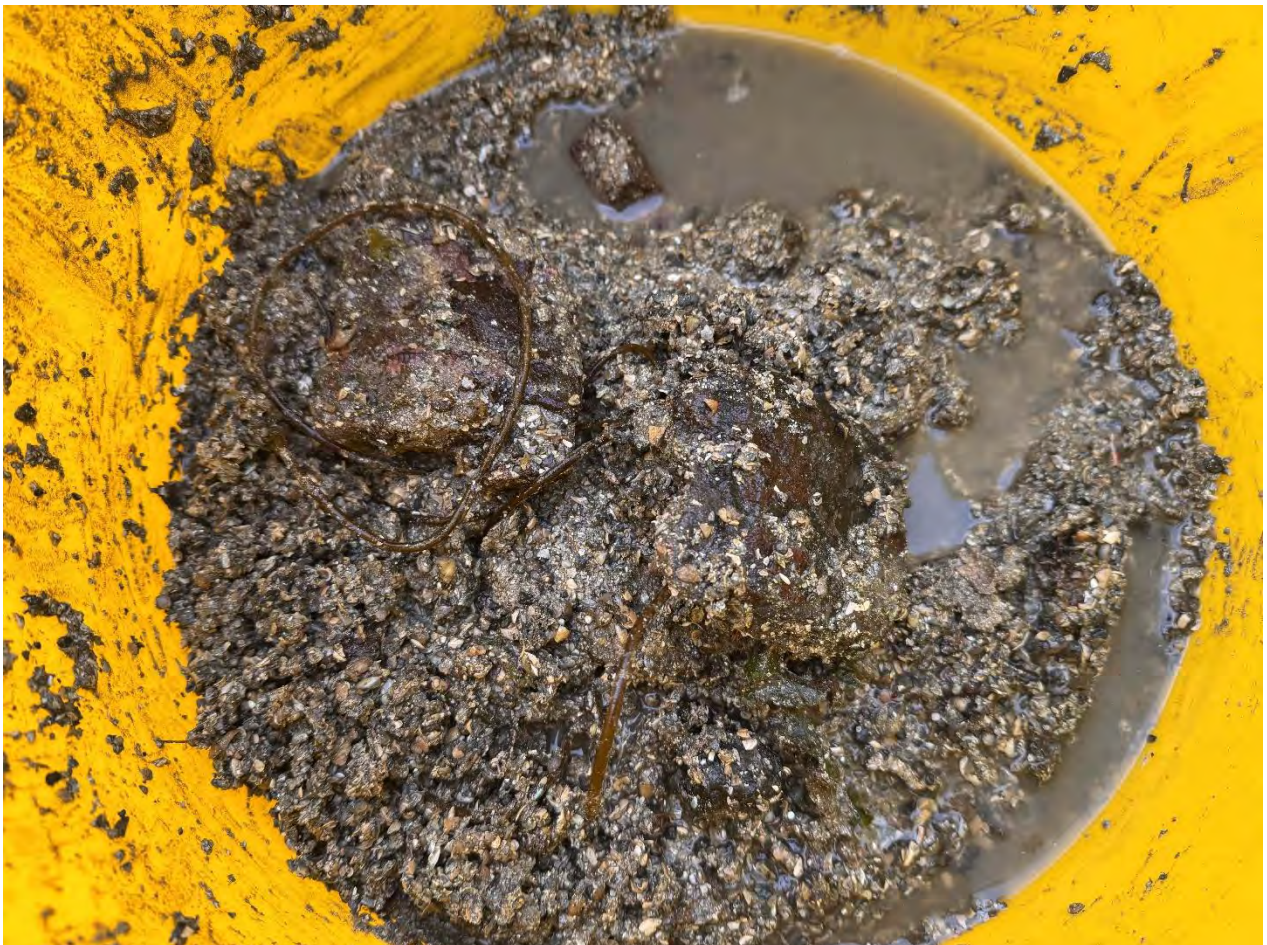
ES03

Remarks: Brown silty coarse sand with cobbles, shell fragments and seaweed.

Biota: Singular butterfish and seaweed.

Notes: Grab sample obtained on 5th attempt.
