# **Wyre, Orkney Dredging Best Practicable Environmental Option Report**

**August 2026**

Client: Orkney Islands Council  
 Project Title: Wyre, Orkney  
 Report Title: Dredging Best Practicable Environmental Option Report  
 Document number: 15596  
 Project number: 682766

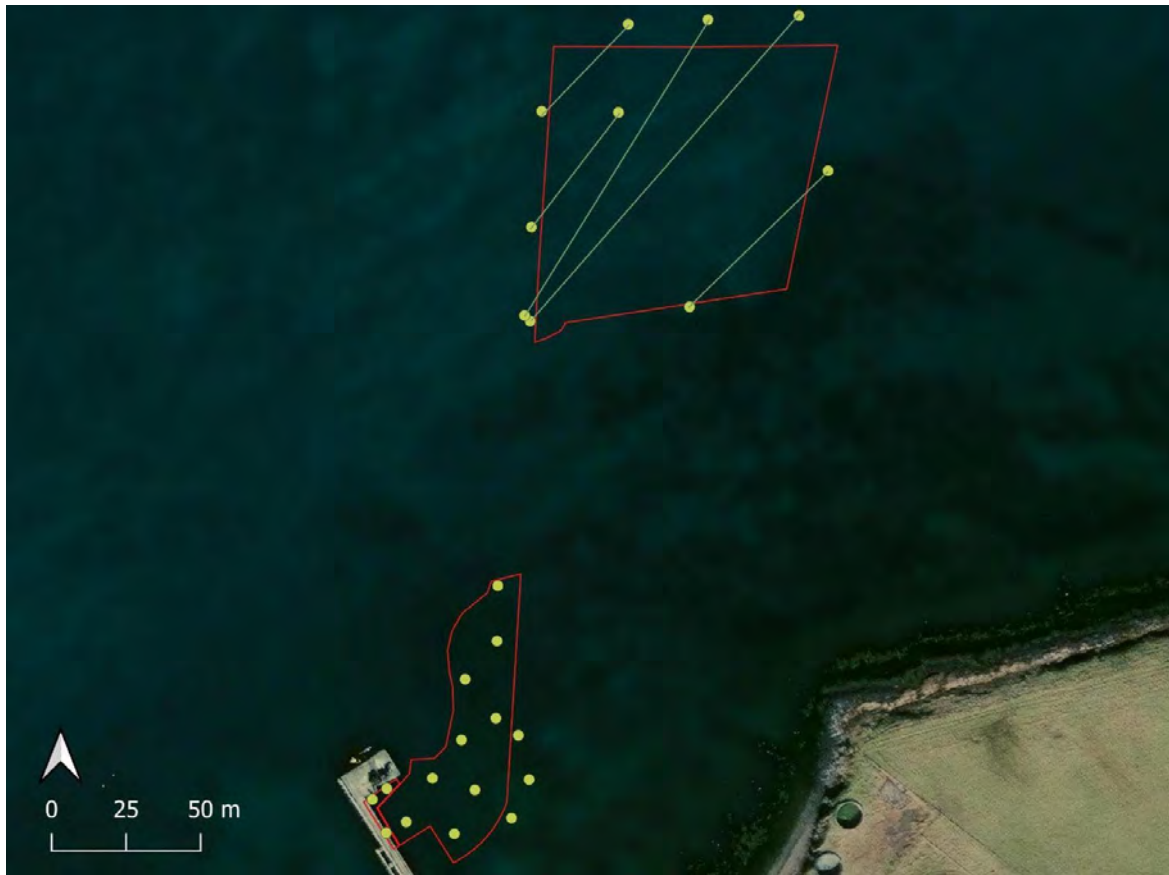
A total of 15 spot sites were surveyed, spread evenly through the dredge and slope areas. Five transect surveys were carried out to ensure coverage of the spoil area located north of the pier. The location of spot and transect sites are shown in Figure 2. A description of the dredge and spoil areas is provided below. Specific information for each site, including species and biotope data, are shown in Table 1.

Figure 2: Wyre survey area, showing dredge and spoil sites outlined by red polygons (top). Numbered dots show seabed survey locations with spot surveys in the dredge area (bottom left) and transects in the spoil area (bottom right). Numbers on transects indicate the starting location with the tracks showing the actual route of the survey vessel.

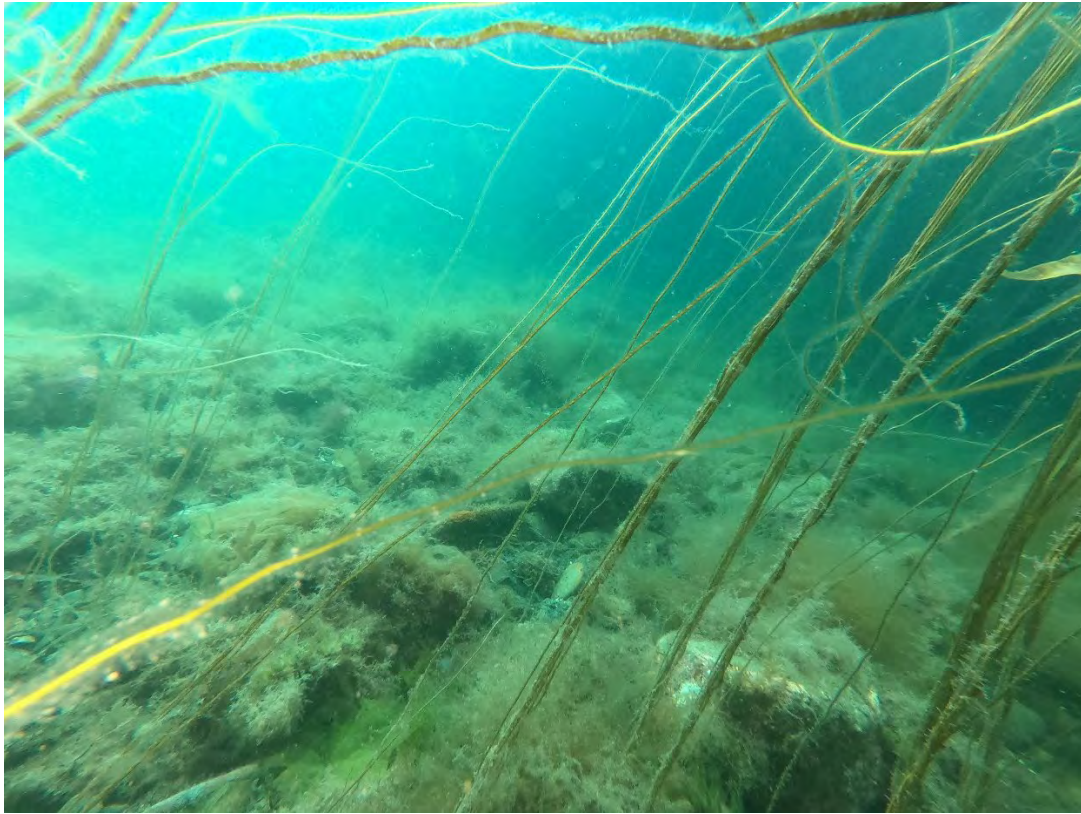
The dominant substrates in the dredge area were gravel, cobbles and boulders (Figure 3 & 4). The slope area to the east was composed mainly of sand and cobbles (Figure 5). The seaweed community in the dredge and slope areas was dominated by bootlace weed (*Chorda filum*), *Codium* sp., filamentous brown algae, *Ulva* sp. and sugar kelp (*Saccharina latissimi*) on cobbles. Sugar kelp increased in abundance further from the pier (Figure 6). Some evidence of maerl gravels was seen but was sparse in nature (Figure 7).

Figure 3: Boulder and cobble substrate at Spot site 2, Wyre dredge site.

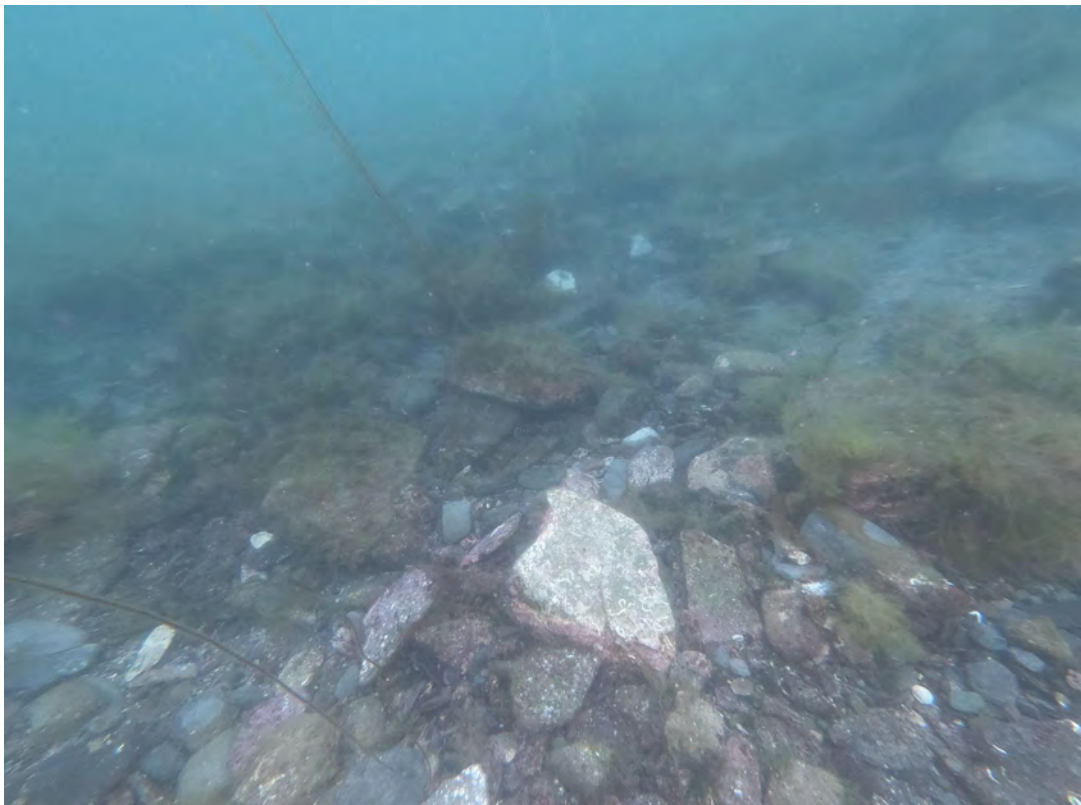
Figure 4: Boulder and cobble substrate at Spot site 6, Wyre dredge site.

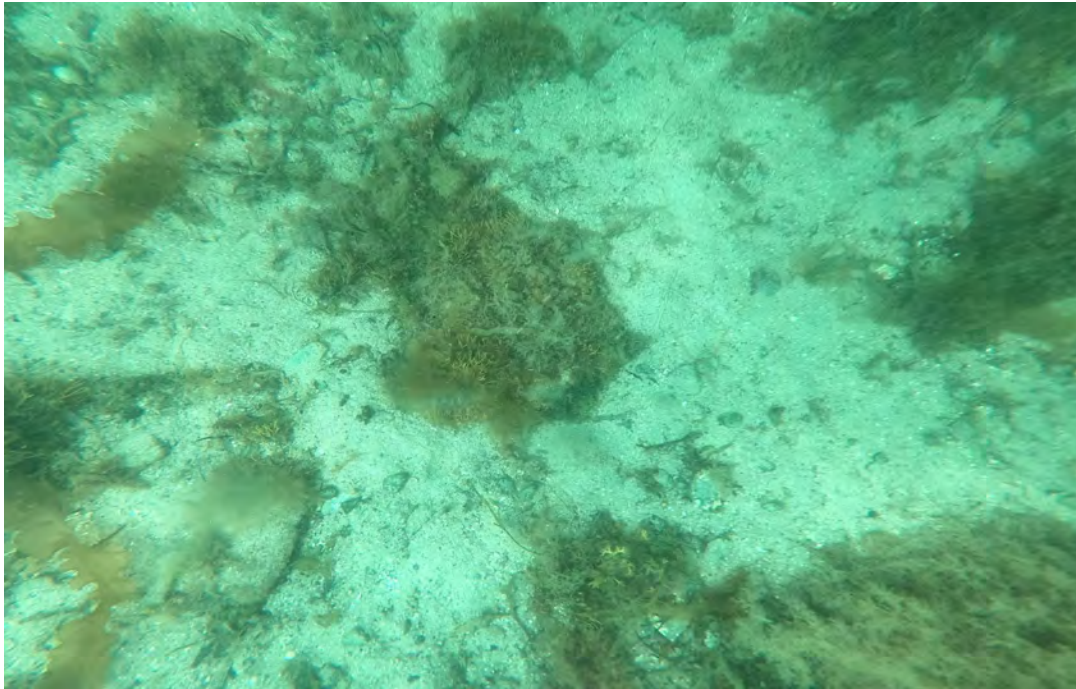
Figure 5. Sand and cobble mix substrate at Spot site 15, Wyre dredge site (slope area).

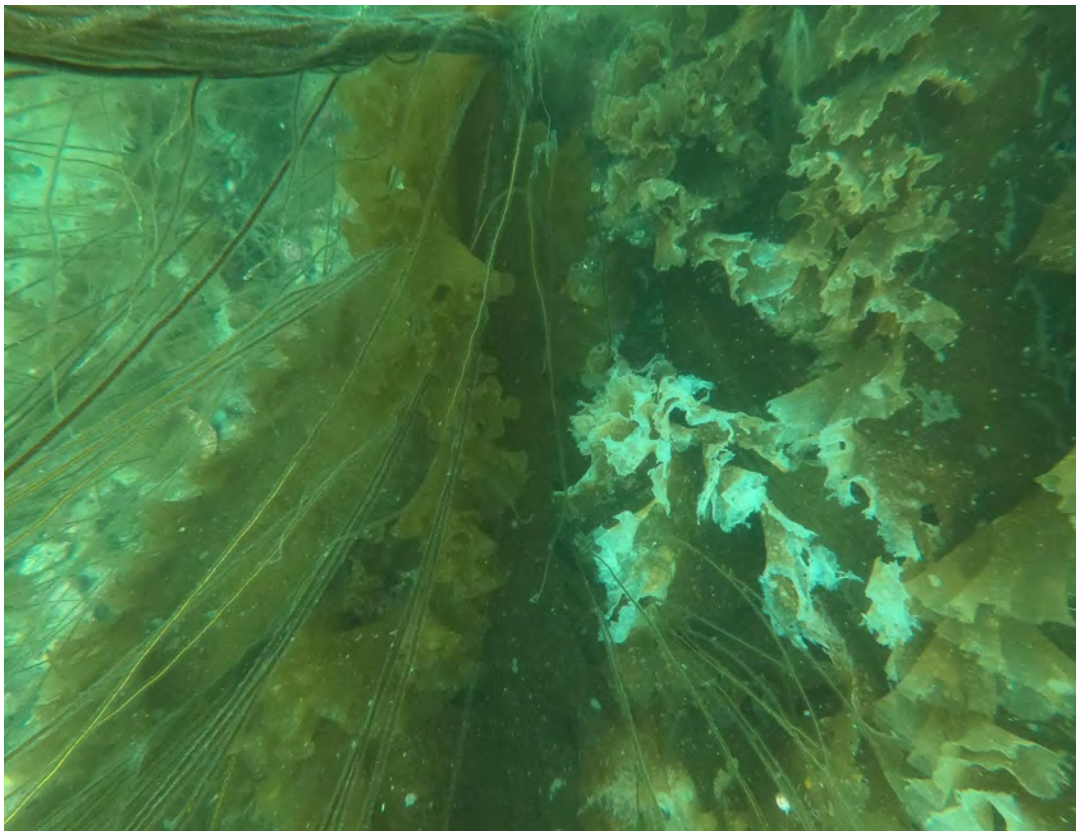
Figure 6. Sugar kelp increased in abundance further from the pier. Spot site 9, Wyre dredge site.

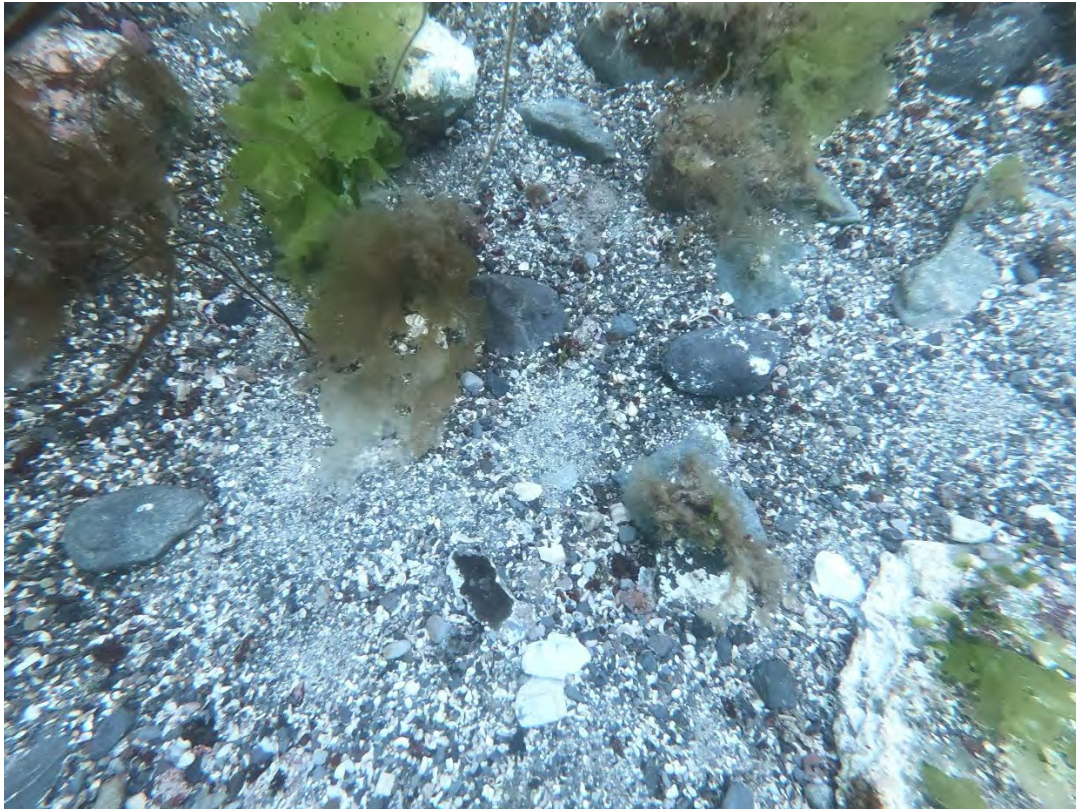
Figure 7: Some evidence of maerl gravel was present in the dredge area but this was sparse. Spot site 9, Wyre dredge site.

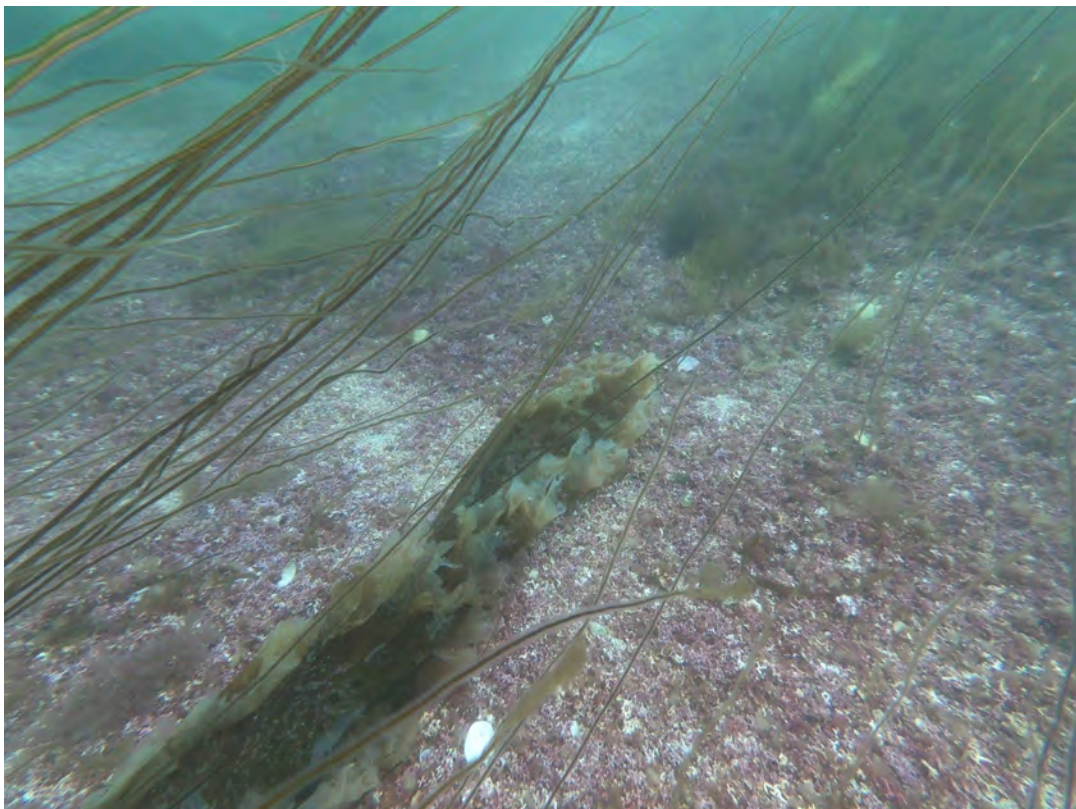
Figure 8. Maerl gravel substrate with abundant live maerl. Wyre spoil site, Transect 1.

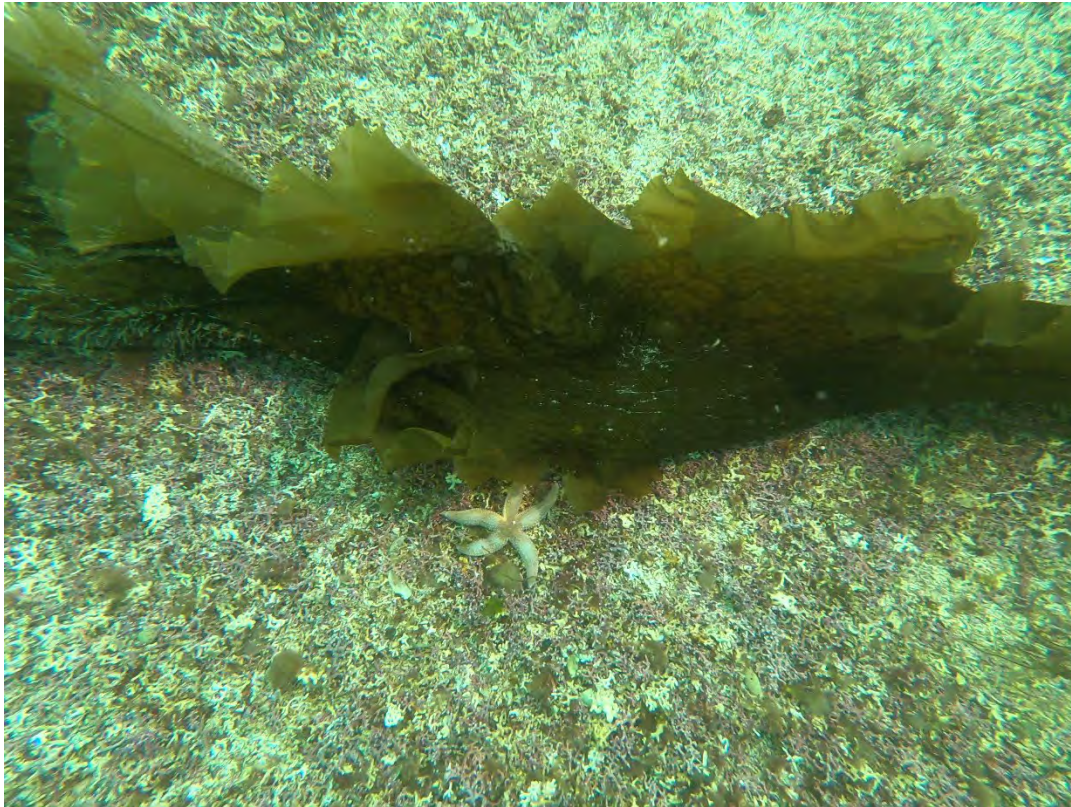
Figure 9: Maerl and sugar kelp (*Saccharina latissimi*). Wyre spoil site, Transect 2.

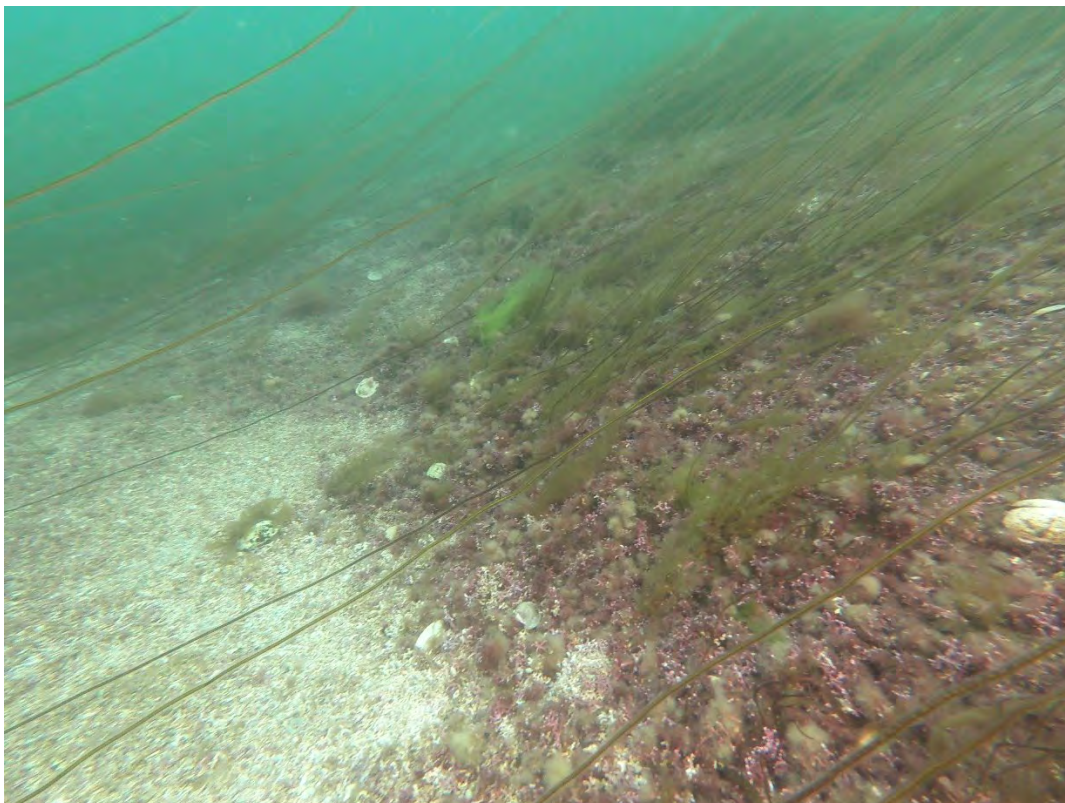
Figure 10: Boundary between areas of dead maerl (left) and pink living maerl gravel (right). Wyre spoil site, Transect 3.

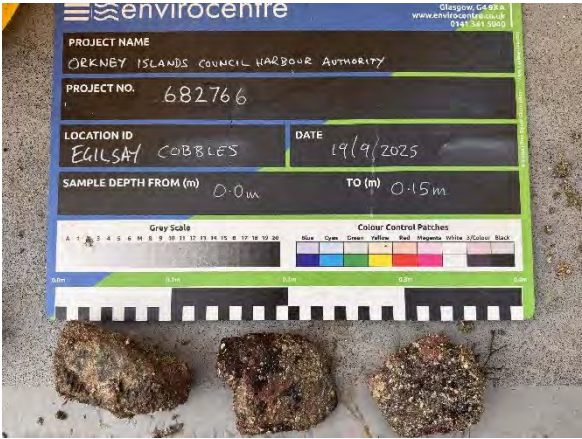
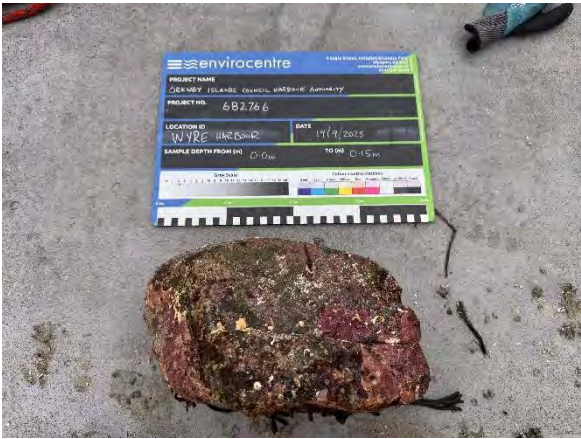
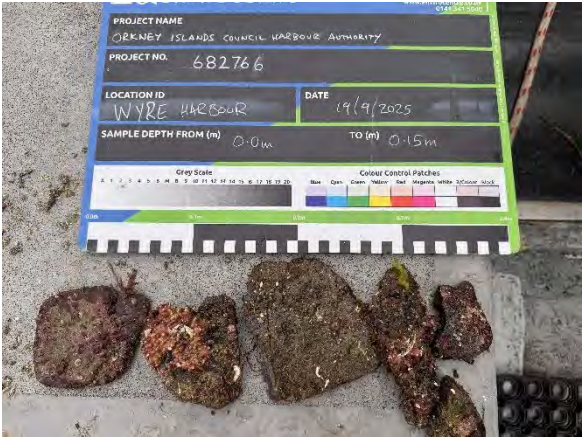
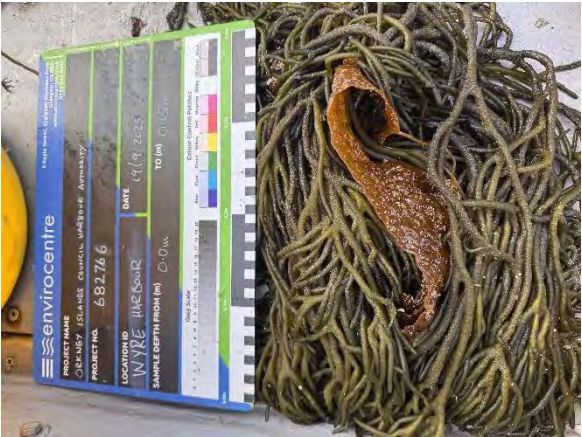
Notes:
Multiple attempts across the entire of the dredge area with no fine grained material recovered for analysis. Photos from each of samples locations provided below.
