| STIRLING OLD BRIDGE<br>SCOUR REPAIRS | | | |
| SITE LOCATION | | | |

**GENERAL ARRANGEMENT OF DEFECTS**

| SCOUR DEFECT IMAGES | | | |

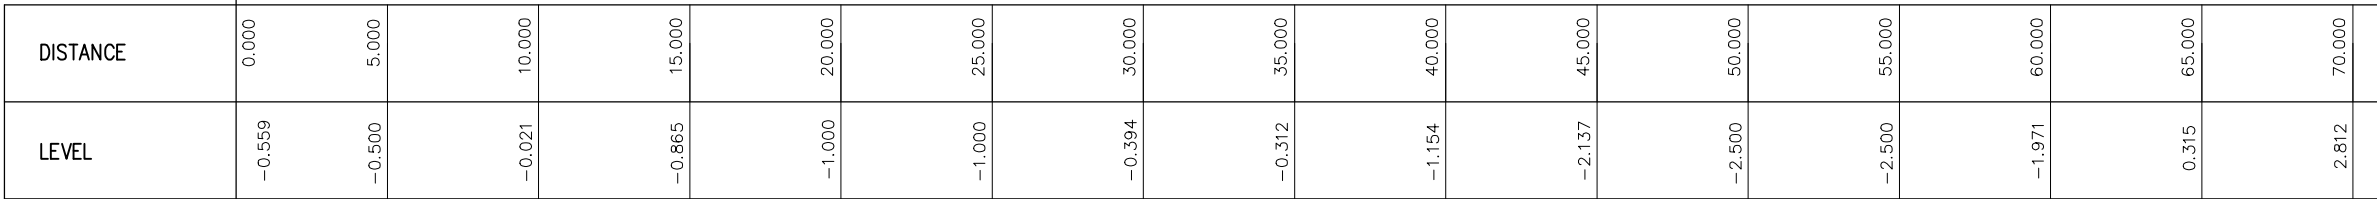
**SECTION D-D**  
(SCALE 1:250)

M.H.W.S. +3.200m  
M.H.W.N. +1.900m

M.L.W.S. +0.400m  
0.00mOD

DATUM  
-6.000mAOD

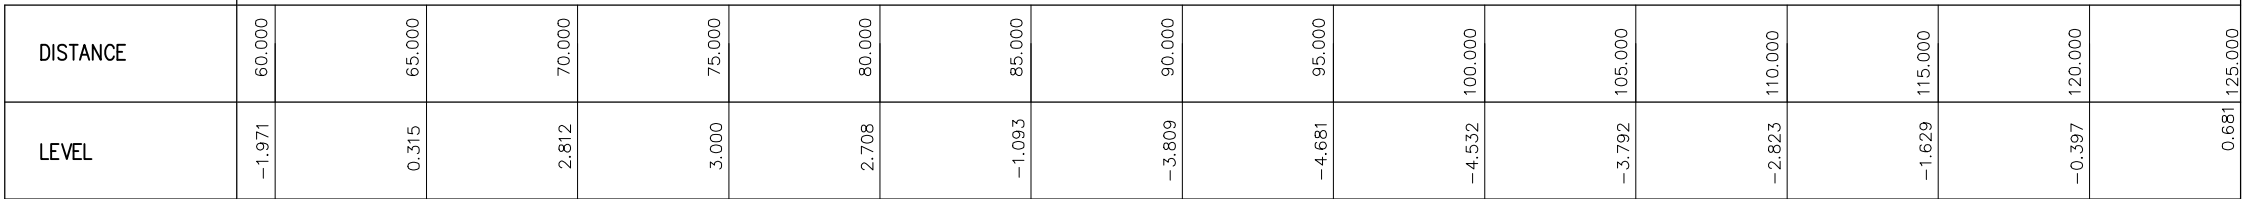
**SECTION D-D**  
(CONTINUED)  
(SCALE 1:250)

M.H.W.S. +3.200m  
M.H.W.N. +1.900m

M.L.W.S. +0.400m  
0.00mOD

DATUM  
-6.000mAOD

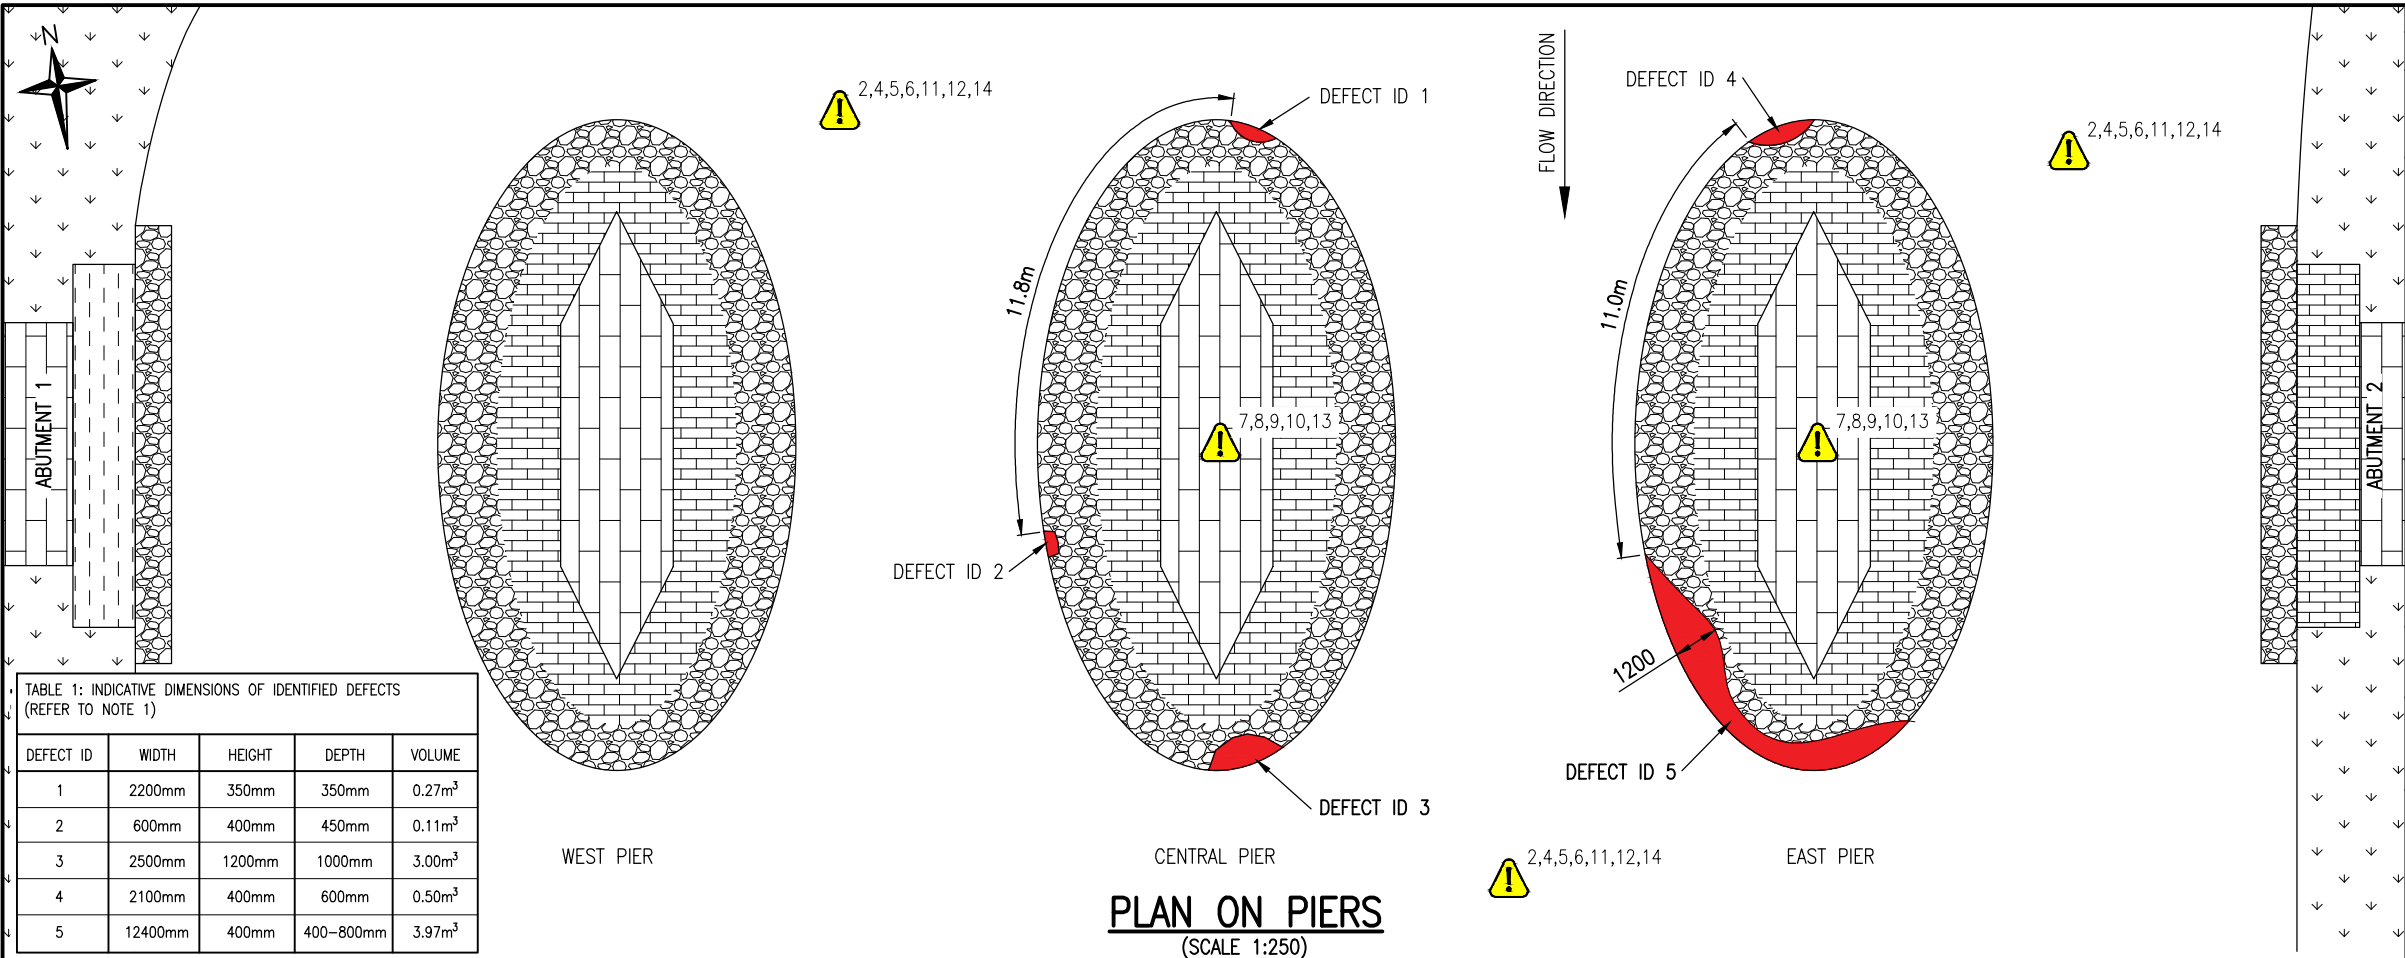
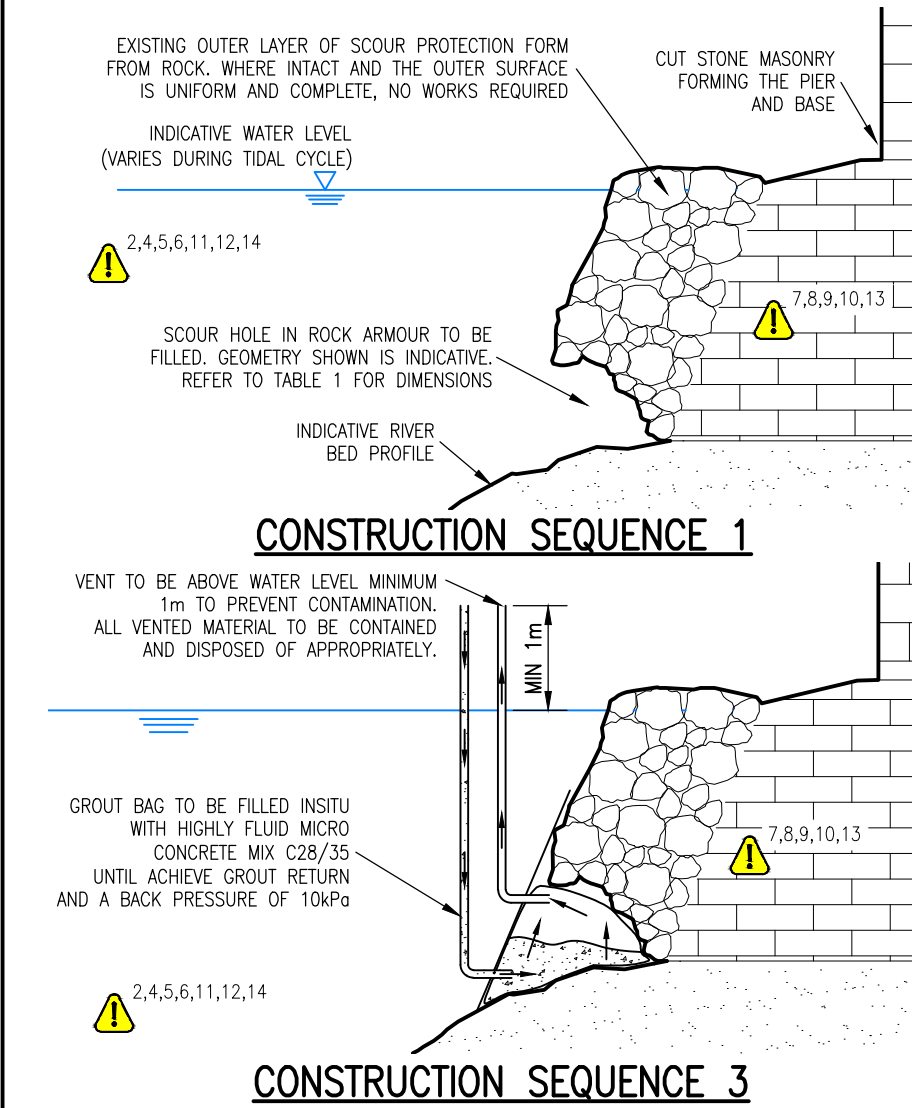
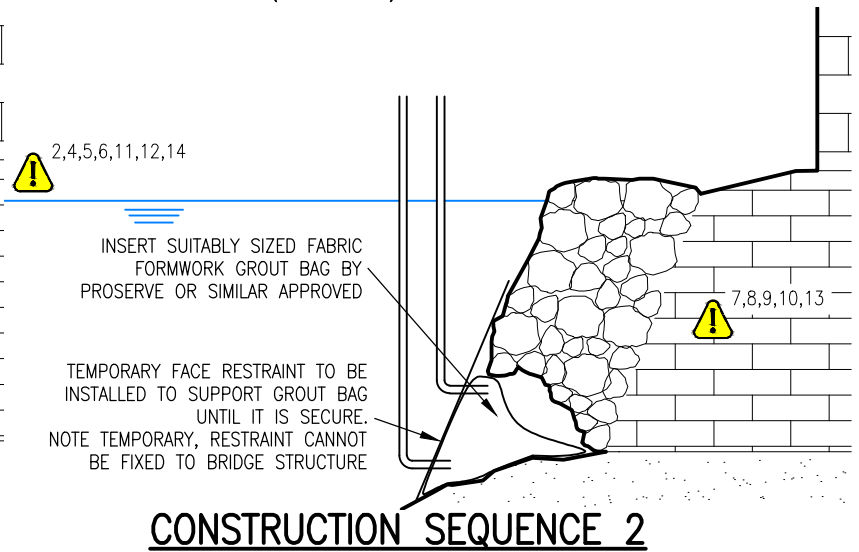
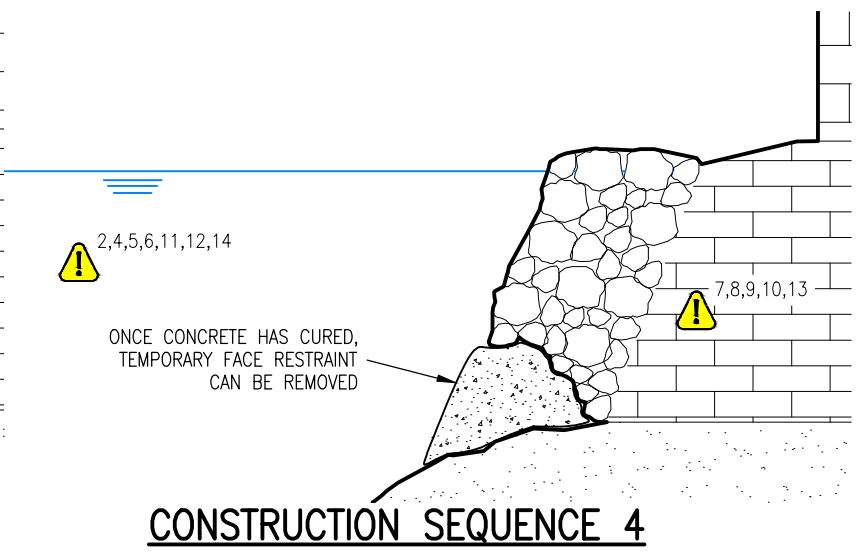
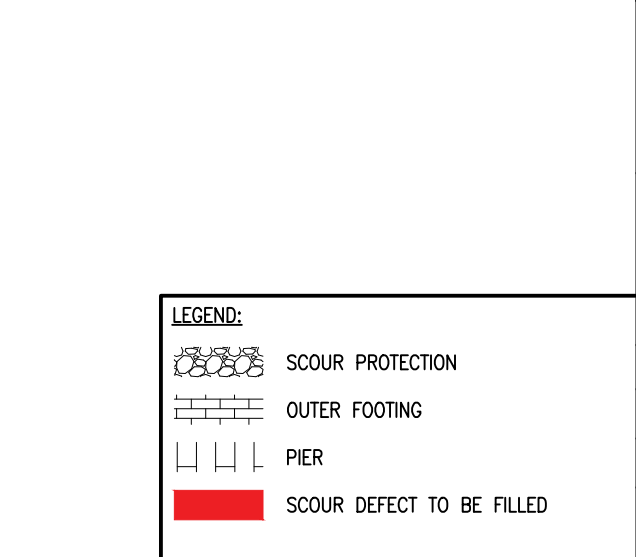
- SCOUR PROTECTION
- OUTER FOOTING
- PIER
- SCOUR DEFECT TO BE FILLED

- INDICATIVE VOID DIMENSIONS AND VOLUMES OBTAINED DURING PRELIMINARY SURVEY BY SHEARWATER MARINE SERVICES Ltd. IN JULY 2021. A MORE DETAILED SURVEY IS TO BE OBTAINED BY HES IN ADVANCE OF THE WORKS WITH RESULTS PROVIDED TO THE CONTRACTOR.
- NO PLANT OR MATERIALS TO UTILISE THE BRIDGE STRUCTURE. ALL ACCESS TO THE SCOUR DEFECTS IS TO BE VIA THE RIVER.
- IT IS ANTICIPATED THAT WORKS ARE ONLY ABLE TO BE UNDERTAKEN WHEN WATER VELOCITIES ARE BELOW 0.5m/s.
- CONTRACTOR TO TAKE UNCERTAINTY AND VARIATION IN WATER VELOCITIES AT DIFFERENT PARTS OF THE STRUCTURE AND WATERCOURSE INTO ACCOUNT DURING PROJECT PLANNING.
- THE CONTRACTOR IS RESPONSIBLE FOR MEASURING THE WATER VELOCITY DURING THE WORKS.

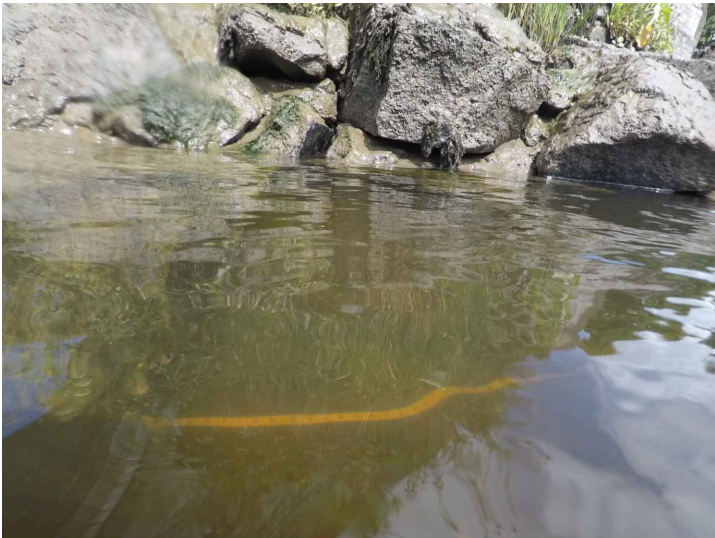
DEFECT 2: CENTRAL PIER – UNDERCUT TO THE OUTER FOOTING / SCOUR PROTECTION ON THE WEST SIDE OF THE PIER, 11.8m FROM THE TOE OF THE NORTHERN (UPSTREAM) SIDE

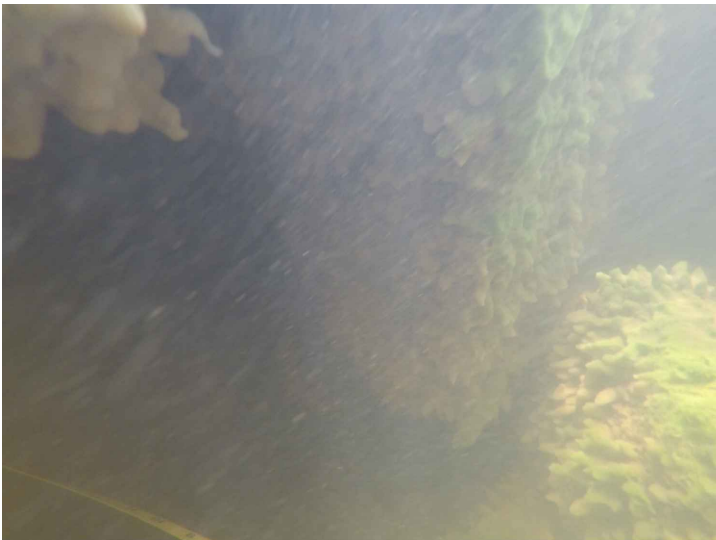
DEFECT 4: EAST PIER – UNDERCUT TO THE OUTER FOOTING / SCOUR PROTECTION AT THE TOE OF THE PIER ON THE NORTHERN (UPSTREAM) SIDE

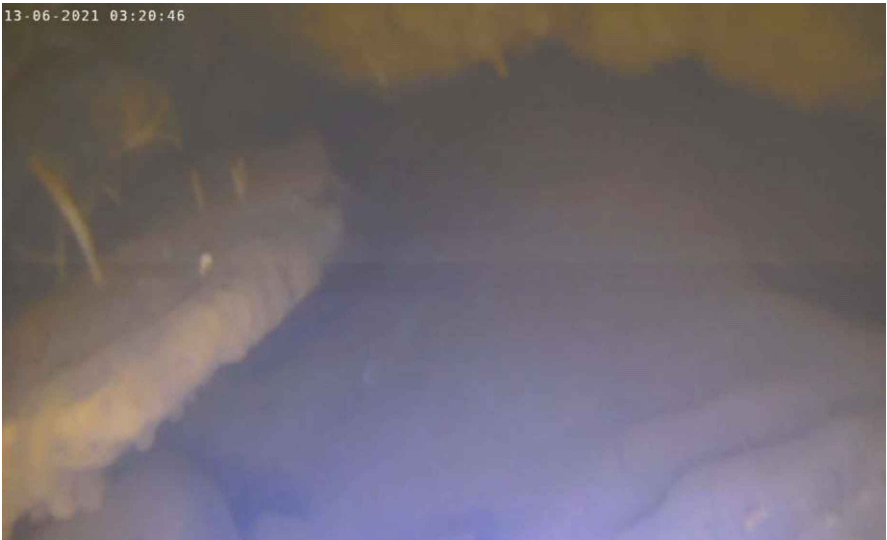
DEFECT 5: EAST PIER – UNDERCUT TO THE OUTER FOOTING / SCOUR PROTECTION, 11.0m FROM THE TOE OF THE NORTHERN (UPSTREAM) SIDE. THERE IS AN AREA 1200mm DEEP, 3m FROM THE START OF THE UNDERCUT
