# Peterhead - Smith Quay Extension

Benthic Characterisation Report

Peterhead Port Authority

Date: 03 June 2025

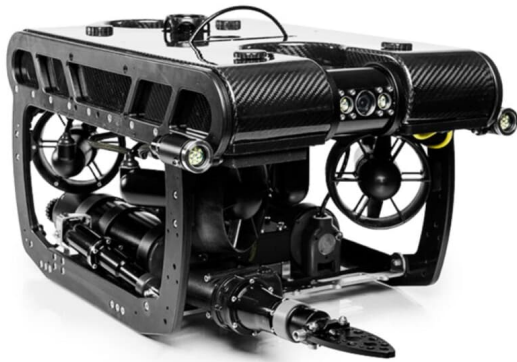
The ROV used in this survey was the DeepTrekker PIVOT Micro-ROV System (Figure 2.1). This system includes a vehicle, tether, and spares configurations. It was equipped with optional features such as an obstacle avoidance sonar and a gripper. The Micro-ROV is designed for underwater operations, providing high manoeuvrability and the ability to capture detailed visual data of the seabed.

*Figure 2.1 Micro-ROV*

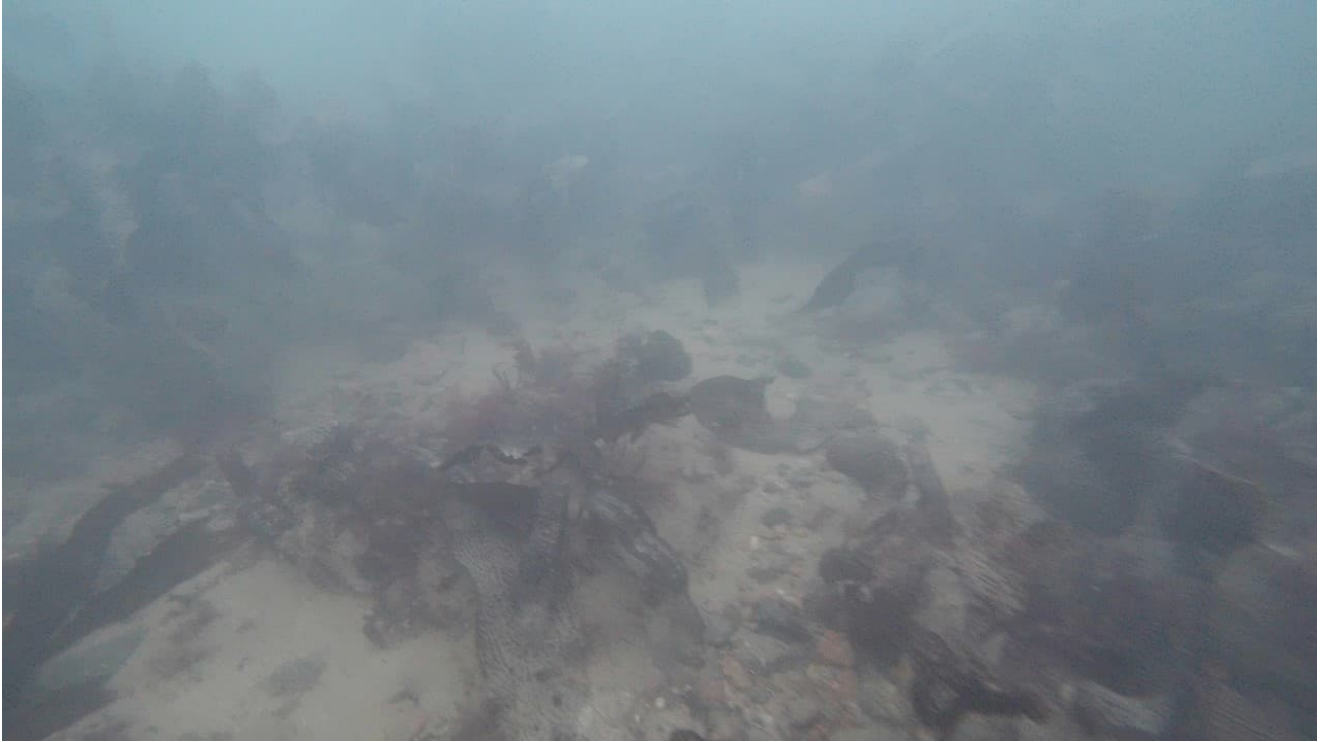
On transects 13 to 17 the habitats described above were occasionally seen but in addition, areas of variable sized large particles, from pebbles to large boulders, were seen in a matrix of fine sediment in some places. The size range of the boulders further away from the intertidal area was generally much smaller than those present around the rock armour/intertidal zone and there was a substantial separation between rock armour at the intertidal zone and stony ground areas, indicating that the habitat here may be natural.

The area of stony ground on transects 13 to 17 appears to meet the criteria for reef in terms of physical composition, and elevation, as there is significant coverage of cobbles and boulders appearing larger than 64 mm, at a distinct elevation from the seafloor. The area exceeds the minimum for reef; however, this habitat is biotically

depauperate with fauna and flora limited to some red algae and sugar kelp as well as occasional common starfish and sea urchin *Echinus esculentus*. This habitat (hard ground on transects 13 to 17) has been tentatively classified as low 'reefiness' stony reef as per the guidance provided in Irving (2009).

*Figure 3.2 Natural reef - Transect 15 (Image 7).*

The habitat of mixed-size large particles seen in transects 13 to 17, outside the proposed quay extension area, meets the description of stony reef with overall low 'reefiness' taking into account both the physical structure and biotic composition. This habitat does not appear to have been formed from dumped material as the size range is very different to the material deposited in the intertidal and shallow subtidal to protect the reclaimed land. Whether or not the reef has formed as a result of historic dredging of fine sediment, or may result from the presence of irregular stones originating from harbour wall construction, can only be speculated upon, but for current purposes this area is assumed to be low quality reef.

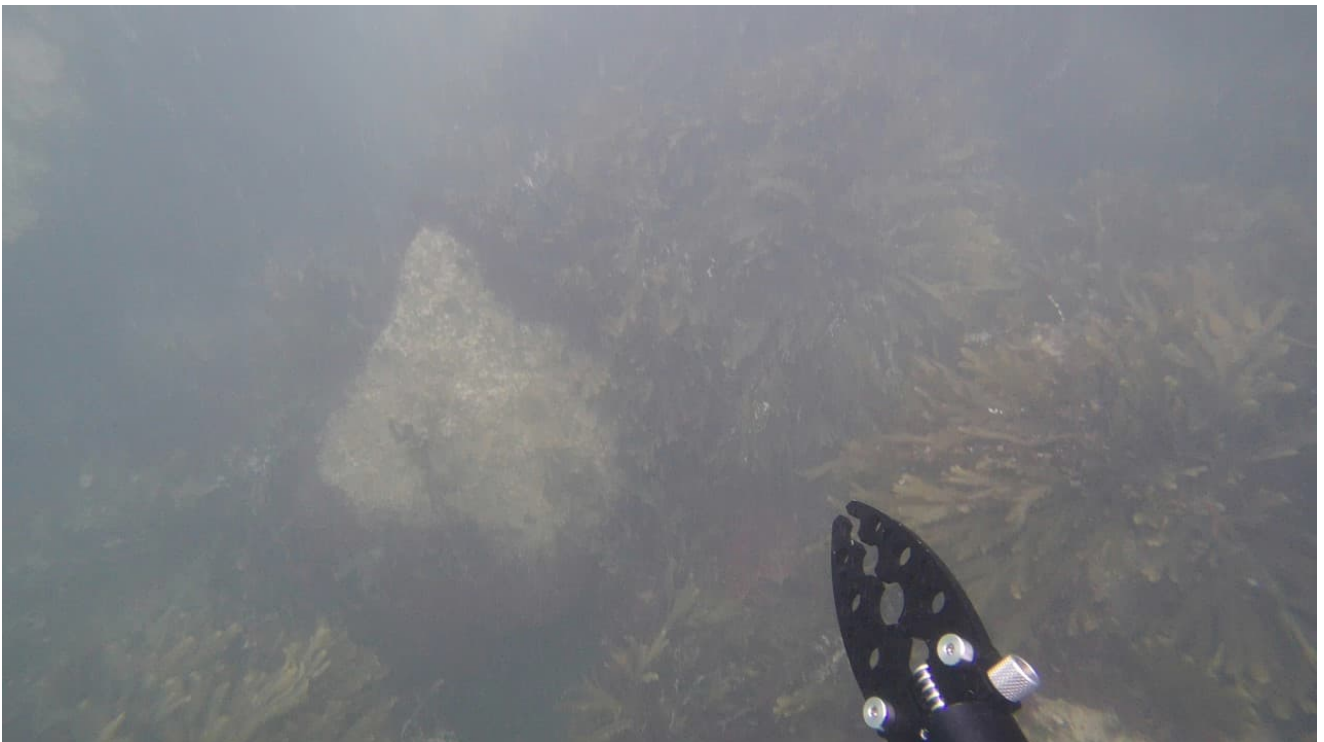
On transects 1 to 12, the habitats encountered were relatively consistent: in the deeper water the seabed was fine sandy sediment which was often rippled and in some areas evidence of infauna such as worm casts and burrow entrances could be seen. Once the rock armour protecting the reclaimed area was encountered, large boulders were seen which near the seabed were covered in silt and possibly supported some epifauna though the generally poor visibility prevented identification. Into shallower water, various types of red algae were observed as well as sugar kelp *Saccharina latissima* and sea lettuce *Ulva lactuca*. Near to the water's surface in what was most likely the intertidal zone, the surface of the boulders was covered with barnacles in amongst which limpets were occasionally seen. Above the barnacles was a canopy of fucoid algae most likely saw wrack *Fucus serratus* and spiral wrack *Fucus spiralis*, with a green alga likely gutweed *Ulva intestinalis* in places. Mobile epifauna observed on transects 1 to 12 included a squat lobster, a velvet swimming crab *Necora puber* and common starfish *Asterias rubens*.

*Figure 3.5 Artificial reef – Transect 6 (Image 19).*

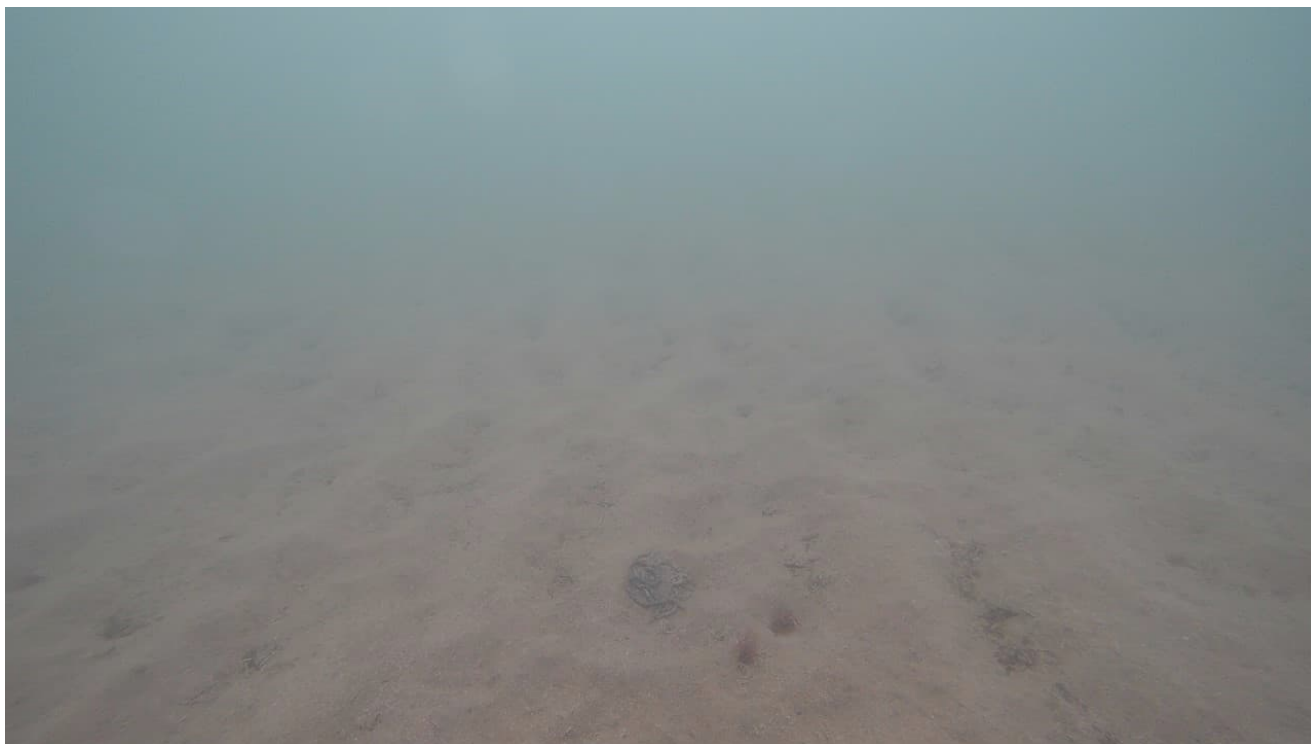
*Figure 3.6 Sediment – Transect 14 (Image 2).*

Seventeen images were taken on this line. Initially, the seabed is of fine sediment in which burrow entrances and worm casts can be seen. This then grades into an area of mixed size large sediment particles which supports growths of various red algae and kelp with common starfish and sea urchin *Echinus esculentus* seen. The transect line ends on this habitat, the rock armour recorded in previous lines was not present.

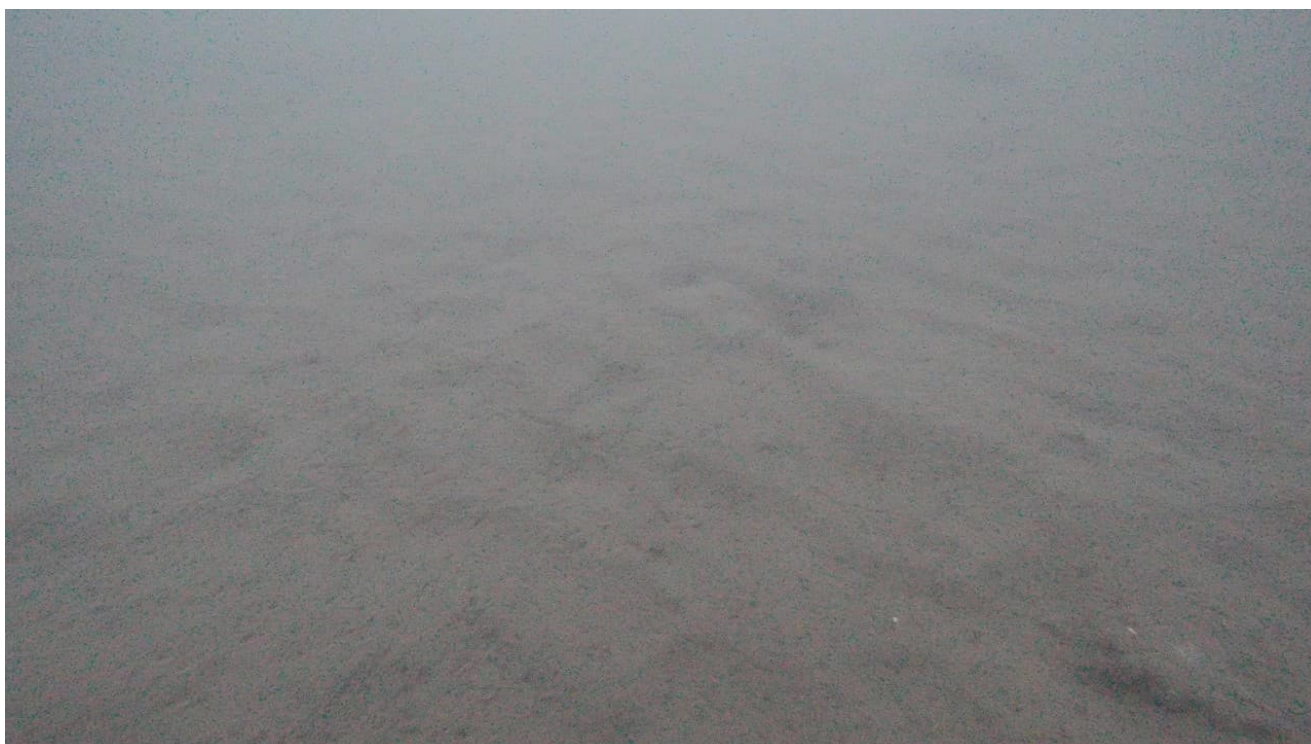
*Figure 3.7 Sediment - Transect 8 (Image 6)*

Twenty four images were taken on this line. The first images show a level seabed of rippled sediment on which casts produced by infaunal polychaetes can be seen. This habitat then morphs into a seabed of fine sediment with pebble, cobble and boulder with sparse red algae and sugar kelp as well as common starfish. At the base of the boulders there is clearly encrusting biotic growth on the boulder but the image is not clear enough to positively identify it. As the water depth decreases the boulders support a variety of algae including sea lettuce, sugar kelp and various red algae. Nearest to the water's surface, furoid algae and barnacles but with red and green algae in the darker crevices, with the exception of the last two images which have a green alga (possibly gutweed *Ulva enteromorpha*) on the upper surface of the boulders.
