Peterhead - Smith Quay Extension

Benthic Characterisation Report

Peterhead Port Authority
Date: 03 June 2025

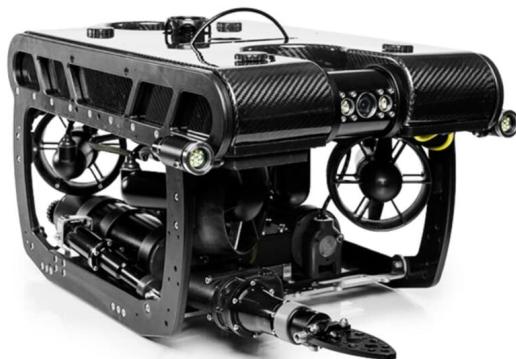
Figure 2.1 Micro-ROV

The ROV used in this survey was the DeepTrekker PIVOT Micro-ROV System (Figure 2.1). This system includes a vehicle, tether, and spares configurations. It was equipped with optional features such as an obstacle avoidance sonar and a gripper. The Micro-ROV is designed for underwater operations, providing high manoeuvrability and the ability to capture detailed visual data of the seabed.

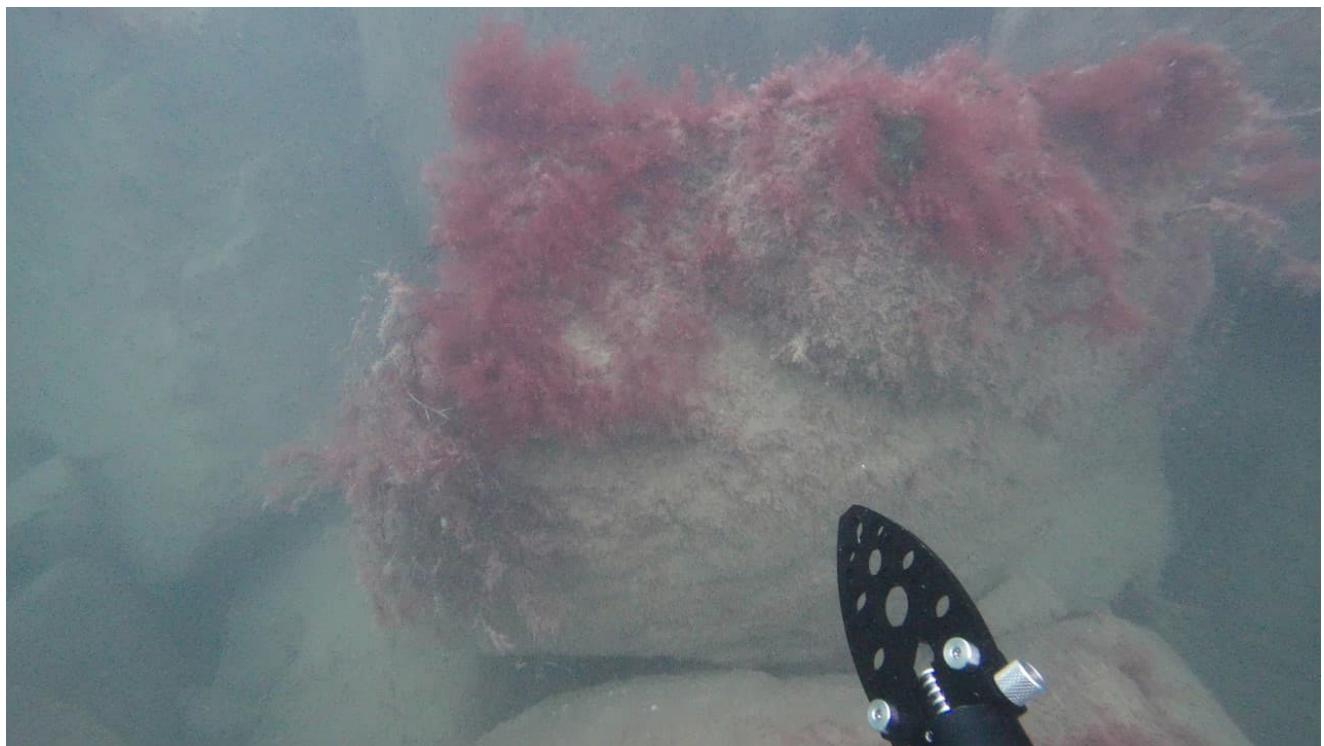
Figure 3.4 Artificial reef – Transect 6 (Image 12).

- Natural reef (Figure 3.2 and Figure 3.3Figure 3.3) – smaller, natural stones with epifaunal species and algal colonisation;
- Artificial reef (Figure 3.4 and Figure 3.5) – Rock armour with/without algal colonisation;
- Sediment (Figure 3.6 and Figure 3.7)– soft sediment (predominantly sandy); and
- NA – non-identifiable habitat type, e.g. poor quality image.

On transects 1 to 12, the habitats encountered were relatively consistent: in the deeper water the seabed was fine sandy sediment which was often rippled and in some areas evidence of infauna such as worm casts and burrow entrances could be seen. Once the rock armour protecting the reclaimed area was encountered, large boulders were seen which near the seabed were covered in silt and possibly supported some epifauna though the generally poor visibility prevented identification. Into shallower water, various types of red algae were observed as well as sugar kelp *Saccharina latissima* and sea lettuce *Ulva lactuca*. Near to the water's surface in what was most likely the intertidal zone, the surface of the boulders was covered with barnacles in amongst which limpets were occasionally seen. Above the barnacles was a canopy of fucoid algae most likely saw wrack *Fucus serratus* and spiral wrack *Fucus spiralis*, with a green alga likely gutweed *Ulva intestinalis* in places. Mobile epifauna observed on transects 1 to 12 included a squat lobster, a velvet swimming crab *Necora puber* and common starfish *Asterias rubens*.

Twenty-one images were taken on this line which started on a flat seabed of silt or fine sand which only showed evidence of burrows in one of the five images from this area. At the base of the boulders there was sparse growth of red algae and other erect biota though the poor visibility prevented a precise identification. As the water depth decreases the growth of red algae became thicker and a velvet swimming crab *Necora puber* was seen on one of the boulders, shallower still and the variety of red algae increased with filamentous and broad-fronded species present. Once again in the shallowest areas there was a predominance of fucoid algae and barnacles though there was less kelp coverage on this line than the previous lines.
