Detailed Unexploded Ordnance  
Risk Assessment

In Respect Of:  
Skye to Ornsay Underground Cable Route

For:  
Cnoclee Limited

Report Reference:  
9495 RA

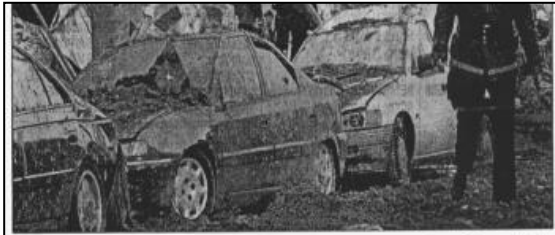
A WWII bomb killed 3 and injured 8 in Berlin - 1994

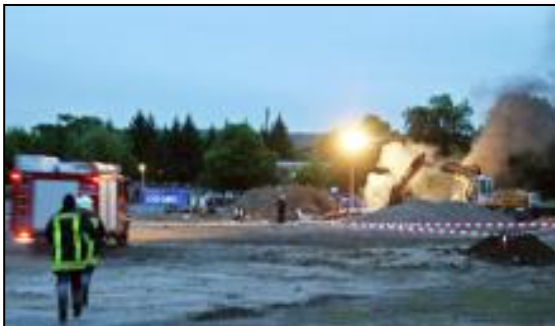
WWII bomb killed 3 in Goettingen, Germany – 2010.

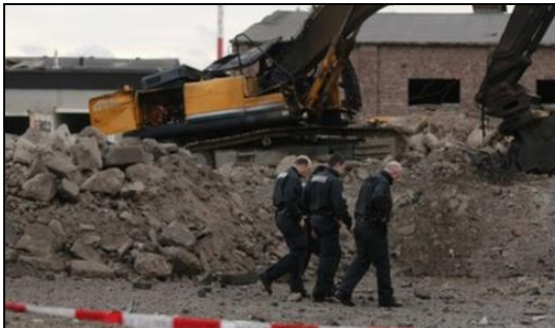
Excavator operator killed by WWII bomb in Euskirchen, Germany – 2014.

A WWII bomb exploded at a construction site near a west German town, killing a man and injuring 8 others. The explosion occurred with a digger accidentally struck the device during excavation works.

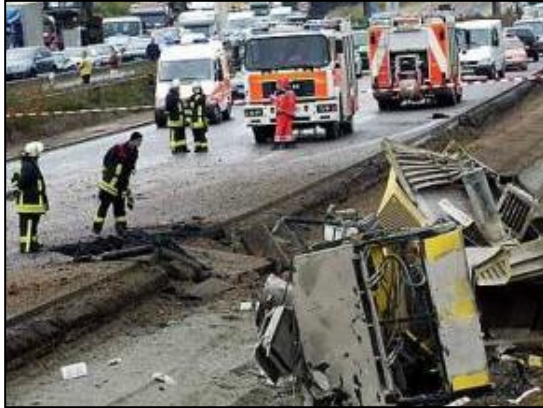
A highway construction worker in Germany accidentally struck a WWII bomb, killing himself and wrecking several passing cars – 2006.

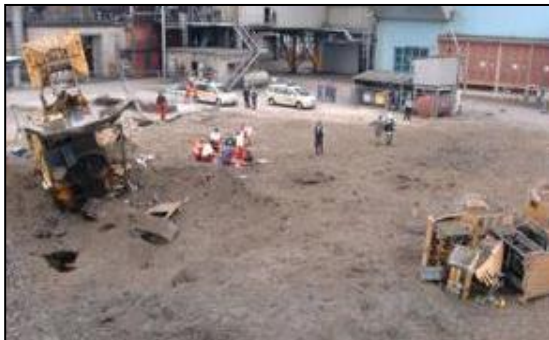
Destroyed piling rig and dump truck after detonation of WWII UXB in Austria – 2006.

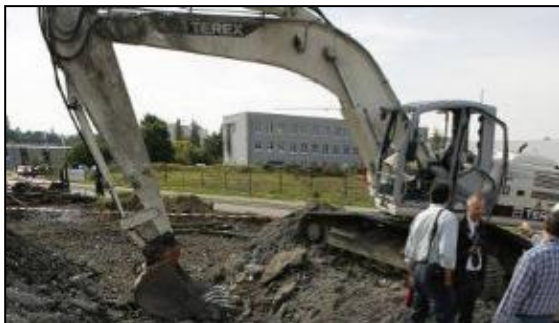
WWII bomb injures 17 at construction site in Hattingen, Germany – 2008.

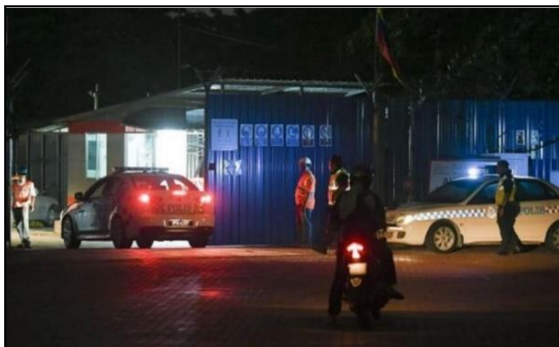
A buried WWII-era bomb exploded during construction works in Bandar Malaysia, Kuala Lumpur – 2017.

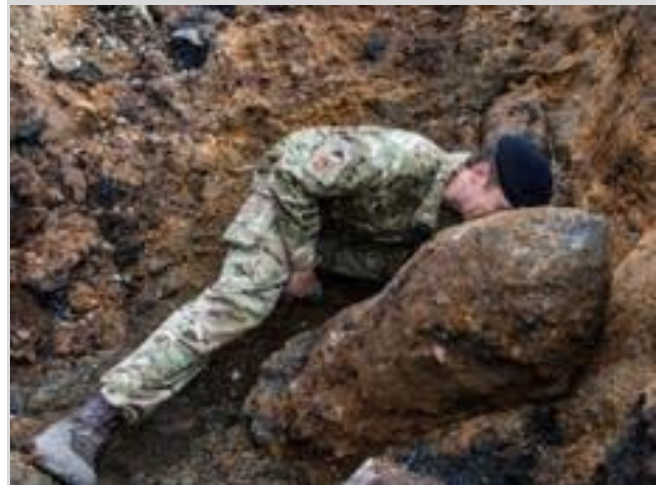
## SC50 found on site

In May 2015, an SC50 was found at a building site on Empire Way, Wembley, London. (*Image source: The Guardian*)

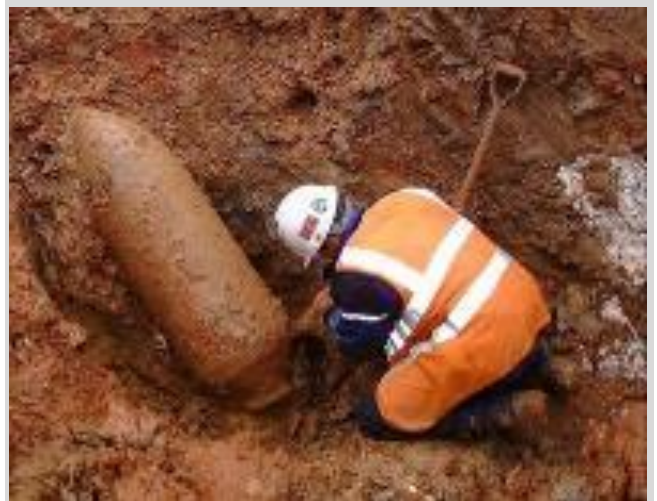
## SC250 found on site

In the year 2000, SafeLane  
Global discovered an SC250  
whilst supervising construction  
work at Hawkinge, Kent.

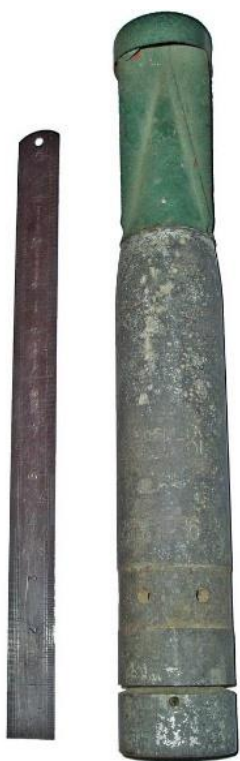
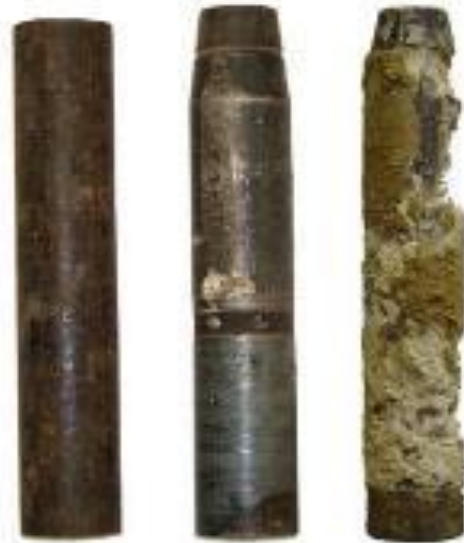
Above: Left - ordinary scaffold pipe, centre - 1kg incendiary bomb, right - incendiary bomb recently found on site in UK

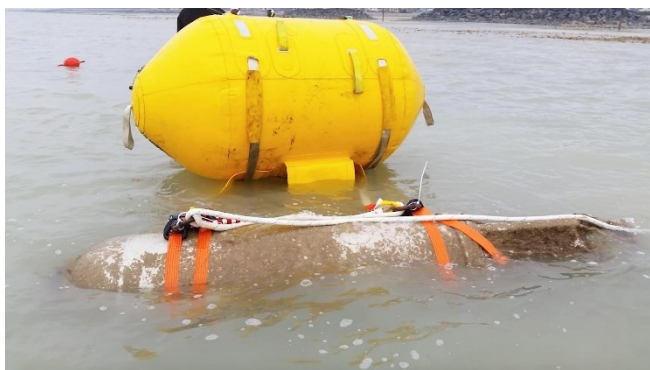
May 2018: a LMB parachute mine washed up on the shores of Bognor Regis (*The Sun*)

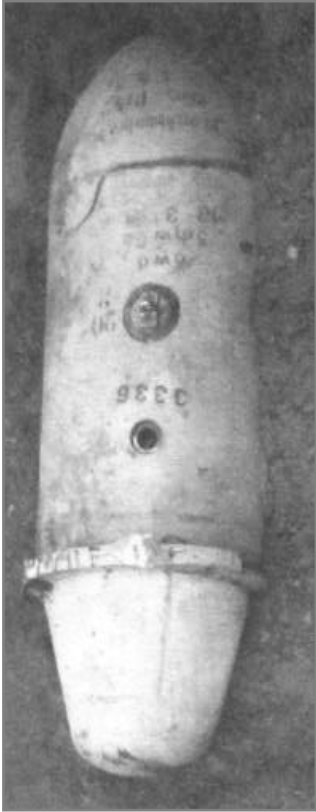
1: Lifting Lug, 2: Bomb Fuze, 3: Magnetic/acoustic tail, 4: Acoustic/magnetic tail

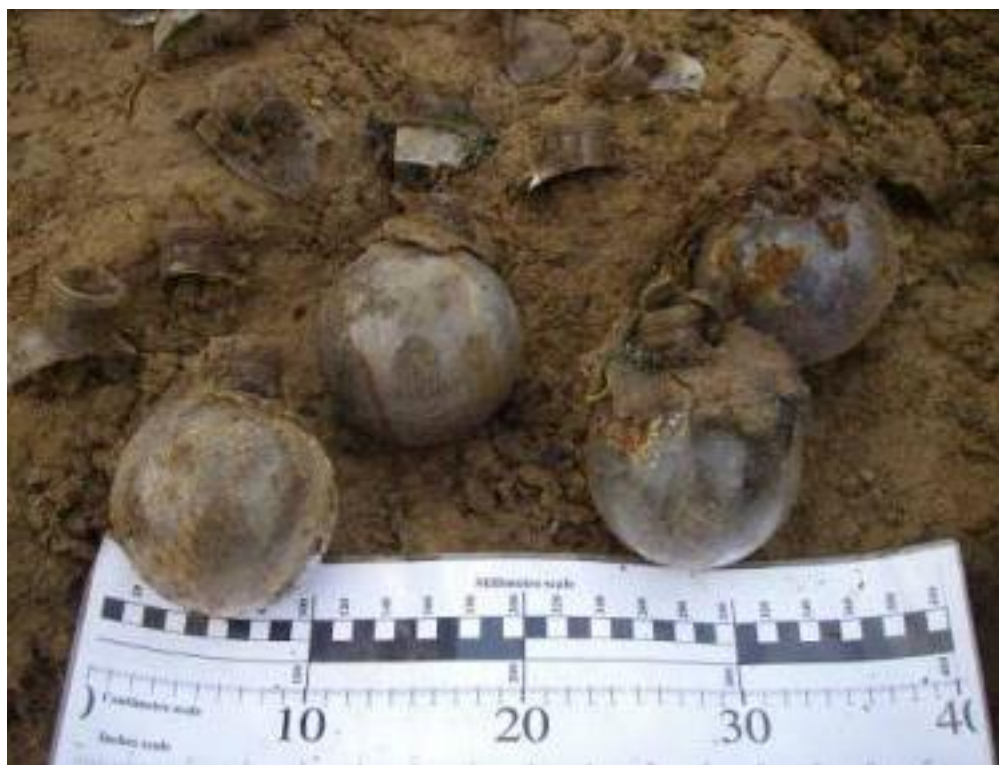
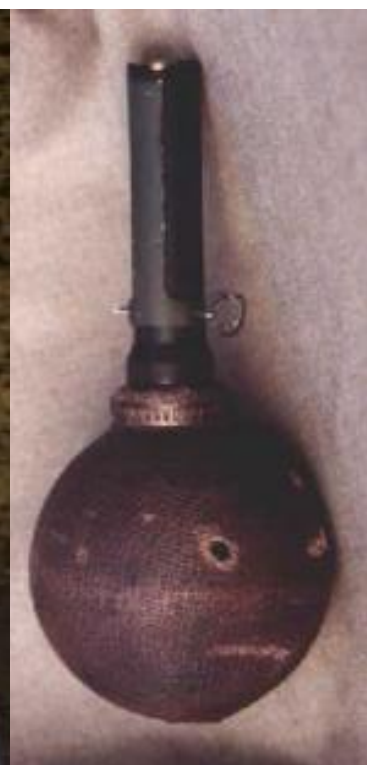
## No. 74 Grenade (Sticky Bomb)

Designed as an anti-tank grenade and used by the Home Guard. The grenade consisted of a glass ball on the end of a Bakelite (plastic) handle. Inside the glass ball was an explosive filling whilst on the outside was a very sticky adhesive covering. Until used, this adhesive covering was encased in a metal outer casing.

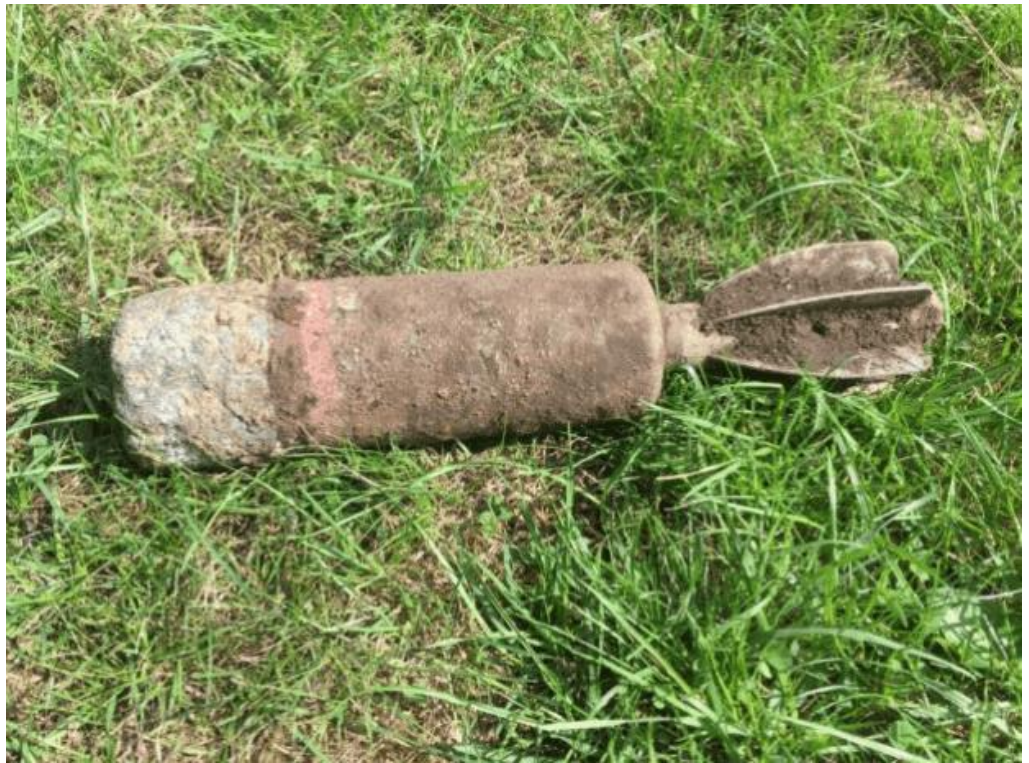
## Typical 2" High Explosive Mortar

**Remarks:** Fitted with an impact fuze which detonates the fuze booster charge (exploder) and, in turn, the high explosive charge. The main charge shatters the mortar bomb body, producing near optimum fragmentation and blast effect at the target.

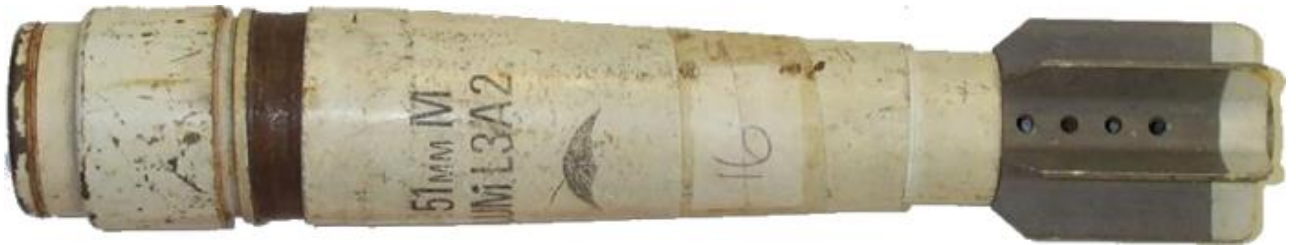
## Typical 2" Illuminating Mortar

**Remarks:** The expulsion charge ignites and ejects the candle assembly. A spring ejects the parachute from the tail cone. The parachute opens, slowing the descent of the burning candle which illuminates the target.

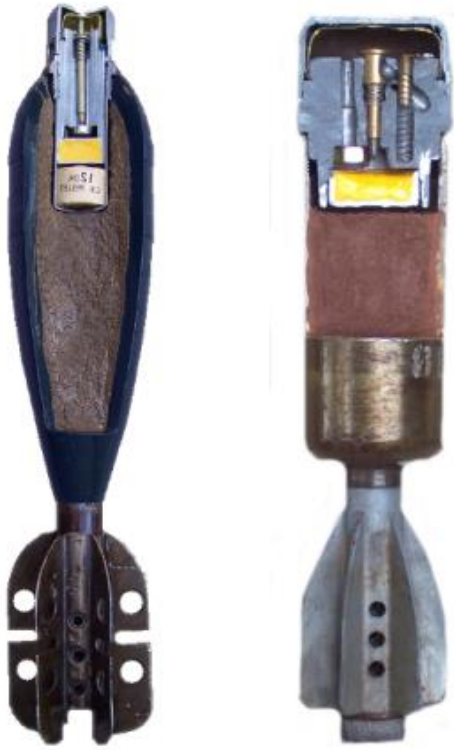
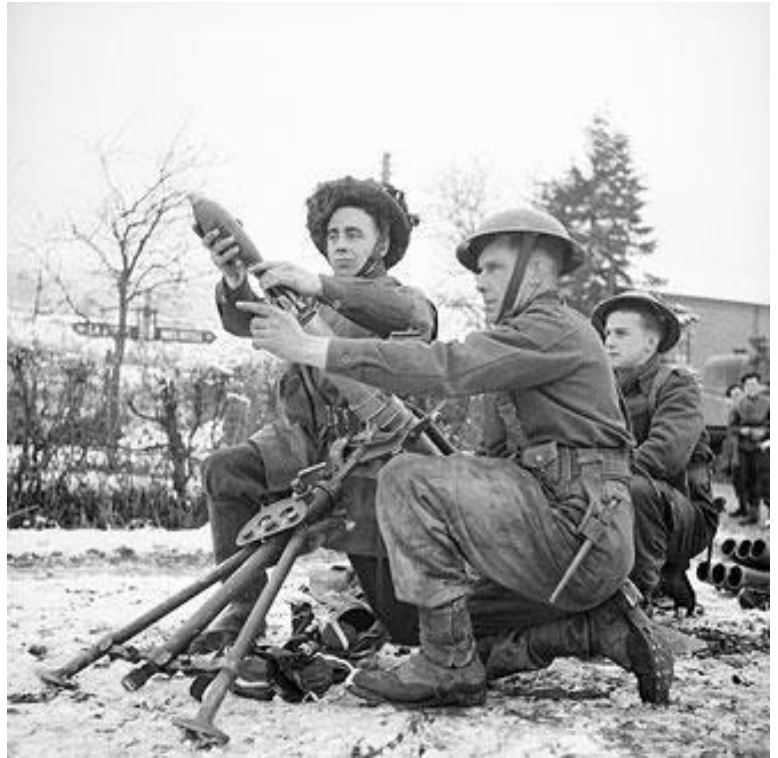
## Typical 3" Smoke Mortar

**Remarks:** On impact, the fuze functions and initiates the bursting charge. The bursting charge ruptures the mortar bomb body and disperses the white phosphorous filler. The white phosphorous produces smoke upon exposure to the air.

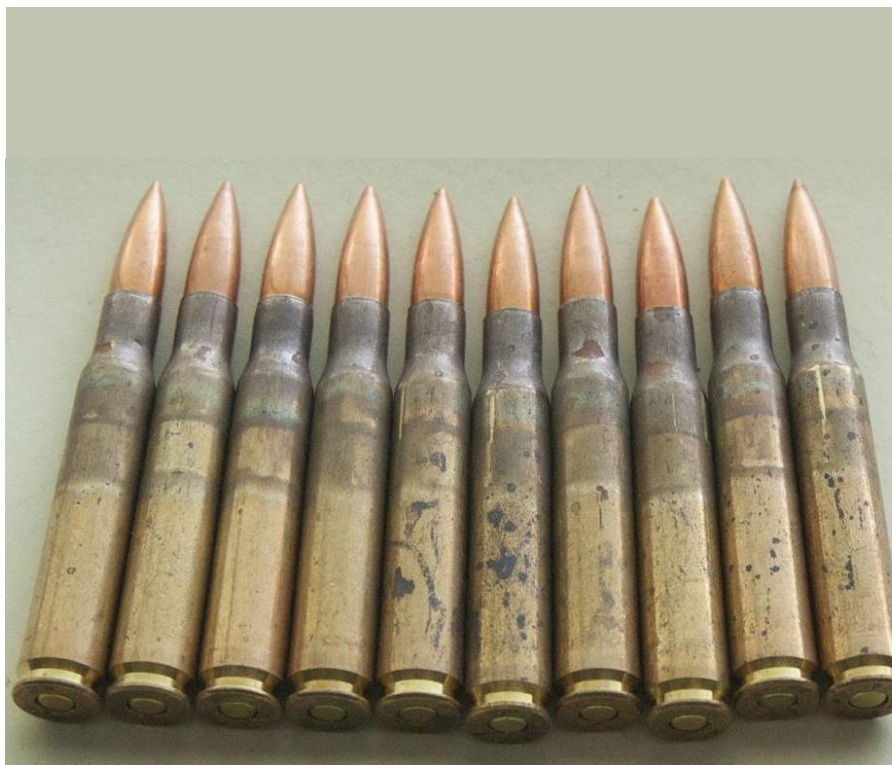
## .303" Ammunition

Fig. 1. Four types of ammunition used by modern infantry. 1 and 2 are ball cartridges, 3 is an armour-piercing bullet, and 4 a tracer bullet which burns and makes its flight visible.

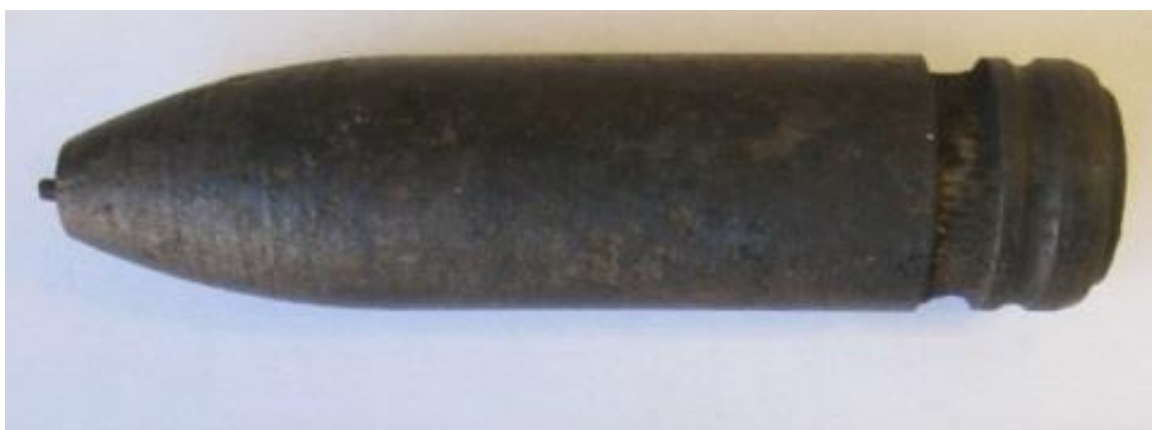
## 20mm Hispano HEI Ammunition

**Remarks:** Cartridges are belted or supplied loose in cartons.

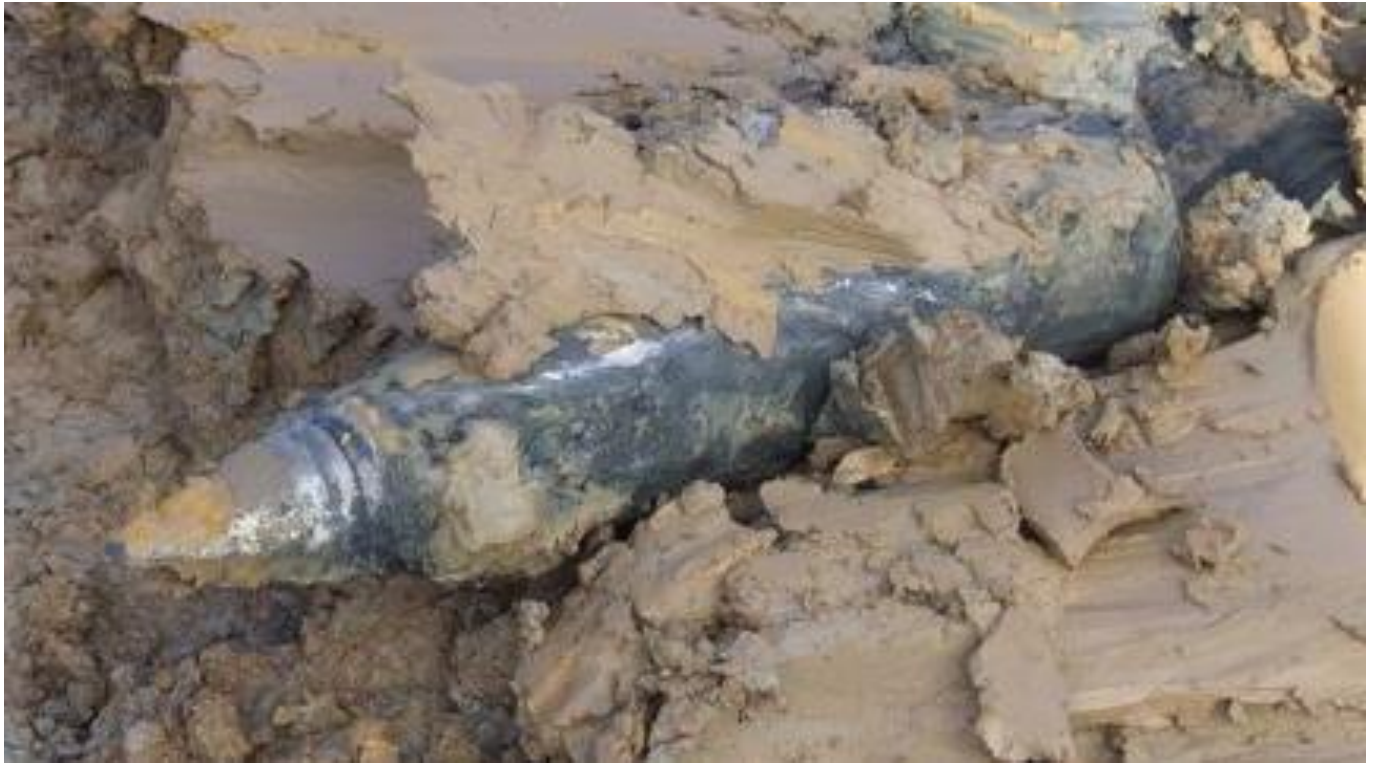
## 3.7" Anti-Aircraft Projectile

**Remarks:** 4.5" projectiles were also commonly utilized.

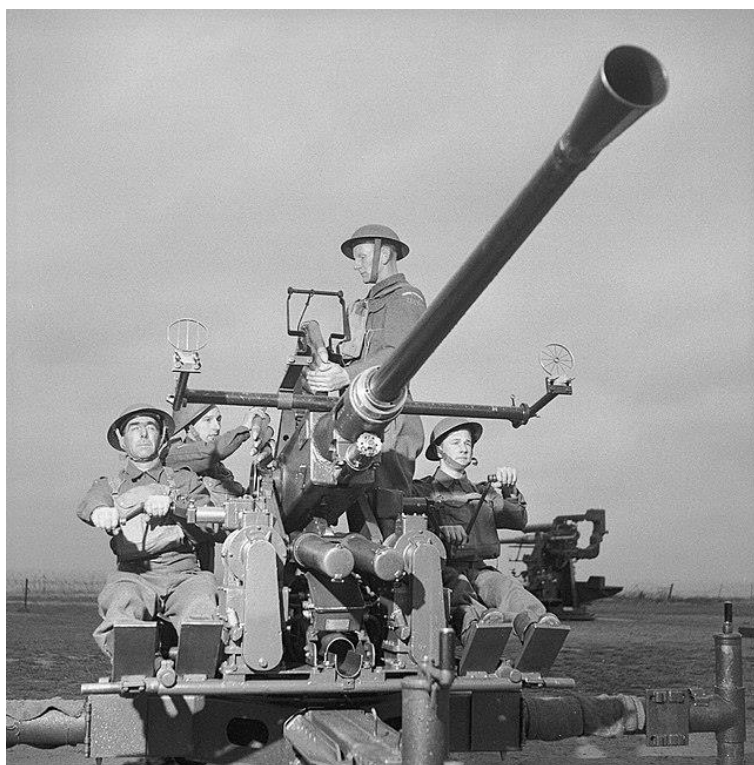
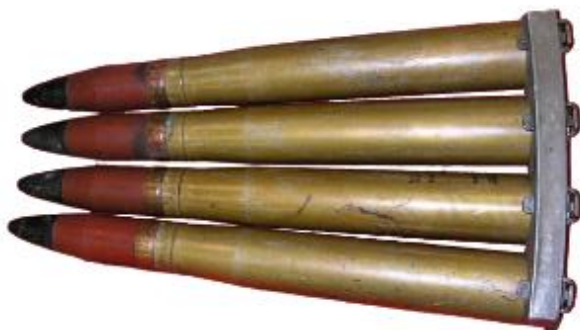
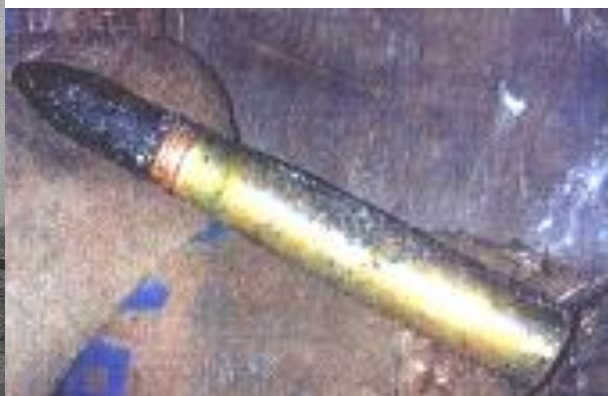
## 40mm Bofors Gun Projectile

SHELL, Q.F., HIGH EXPLOSIVE,  
40 MM.

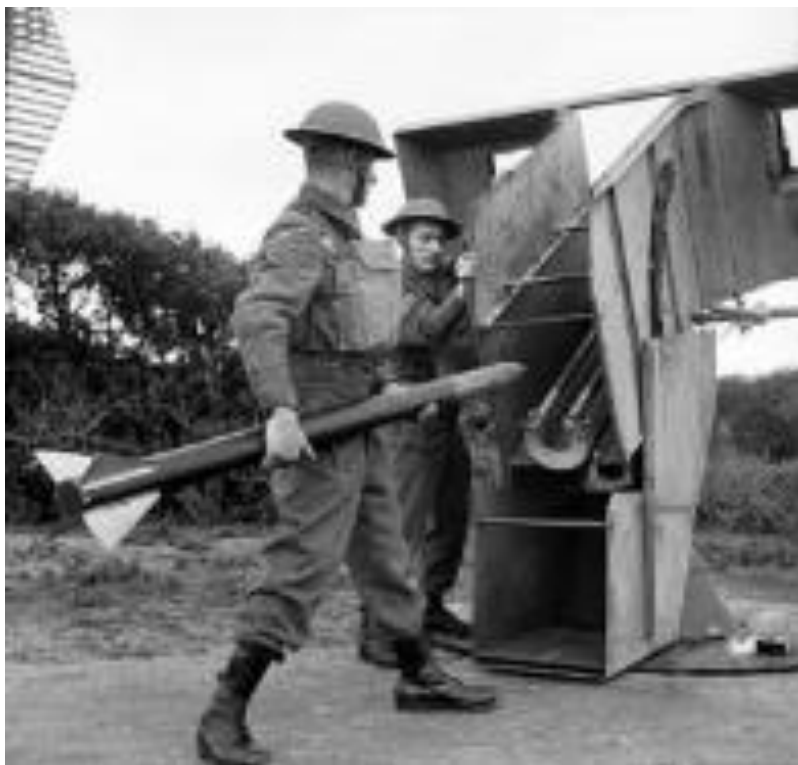
## Rockets / Un-rotating Projectiles

**Top-left image:** Home Guard soldiers load an anti-aircraft rocket at a 'Z' Battery

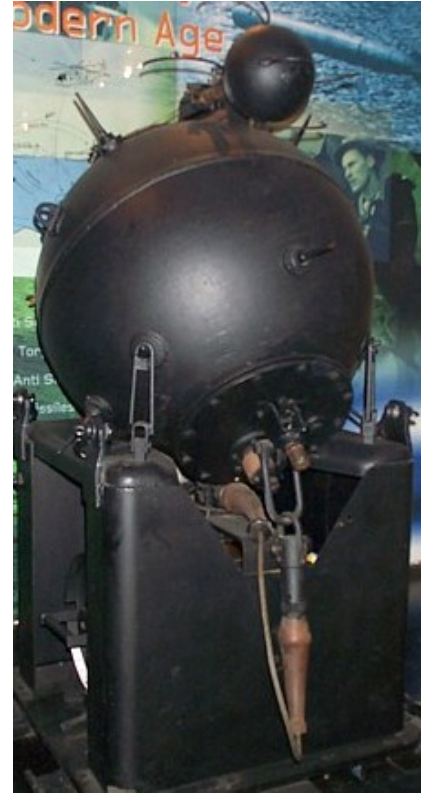
## Contact Mine Mk XIX & XIXS

**Remarks:** The standard British contact mine of WWII. Designed for laying in depths of 925m, there was also an influence (acoustic) version.
