VATERSAY SHELTERED BERTHING FACILITY

# PRELIMINARY ECOLOGICAL APPRAISAL REPORT

| Client | Vatersay Pier Users Association |
| Date | 26 March 2026 |

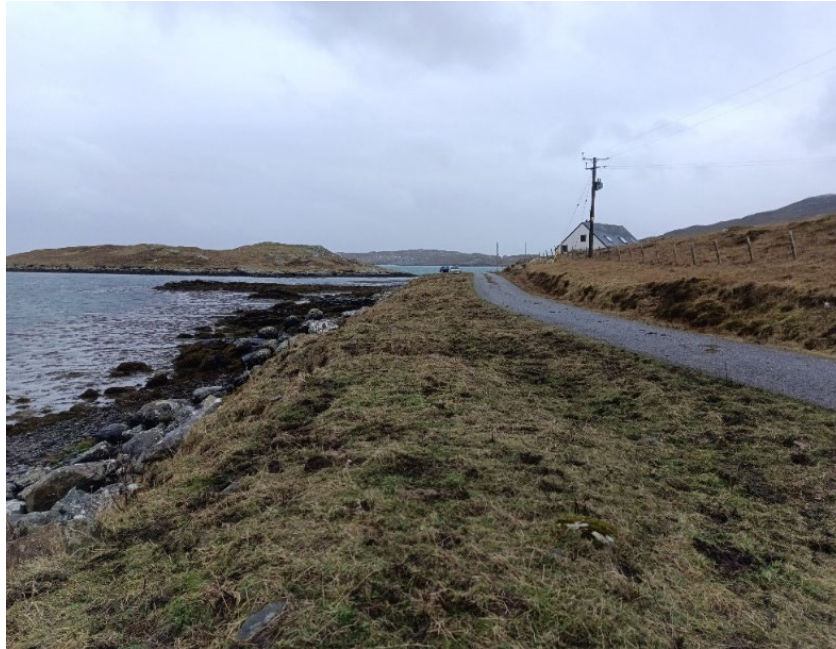
*Image 1. Photograph taken in Vatersay, pointing towards the east, featuring a small road and verge composed of B1.2 Acid grassland – semi-improved. The uninhabited island, Orasaigh is visible to the left.*

4.2.2.2 This habitat is common in the southern side of the survey area, within an area of common grazing, as well as on roadside verges grassland classed as semi-improved is generally species poor due to modification and found in open areas on acid soils (Appendix 3 - Image gallery, Image 1).

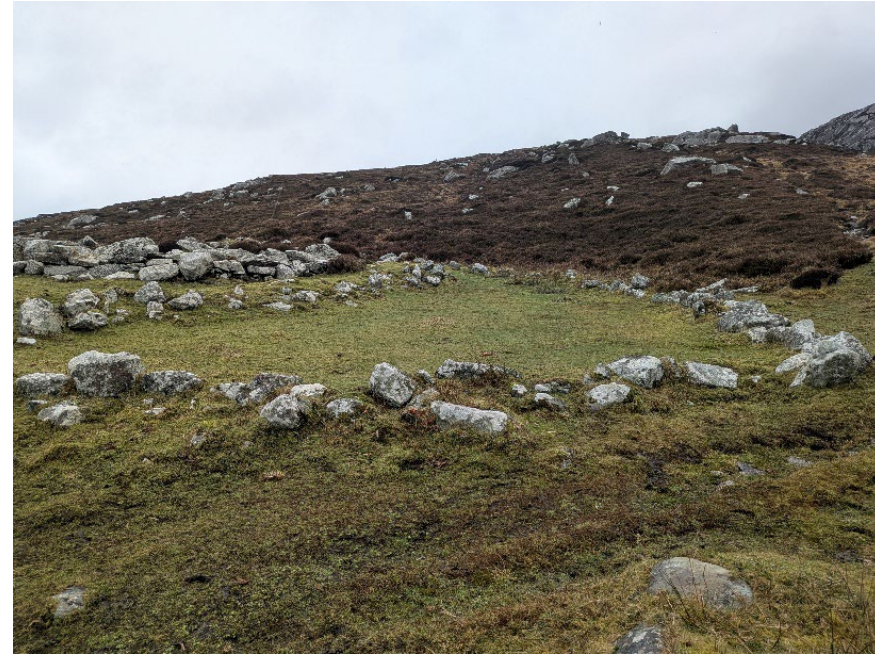
*Image 2. B4 Improved grassland and the scheduled monument.*

4.2.2.6 Improved grassland is limited to a small area surrounding the scheduled monument (VE06) in the northeast of the survey area (Appendix 3 - Image gallery, Image 2). Improved grassland is typically species poor and dominated by grasses which give it a characteristic bright green colour. This habitat type is formed through intensive modification, favouring plant species which prefer nutrient rich conditions and are tolerant of high grazing pressure.

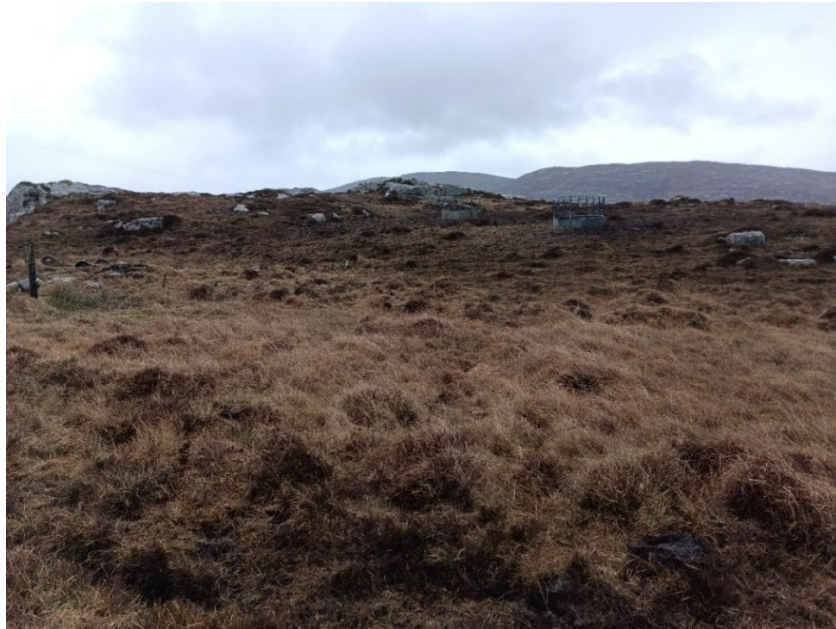
*Image 3. A patch of B5 marshy grassland, dominated by tussocks of purple moor grass, surrounded by heathland in the south of the survey area.*

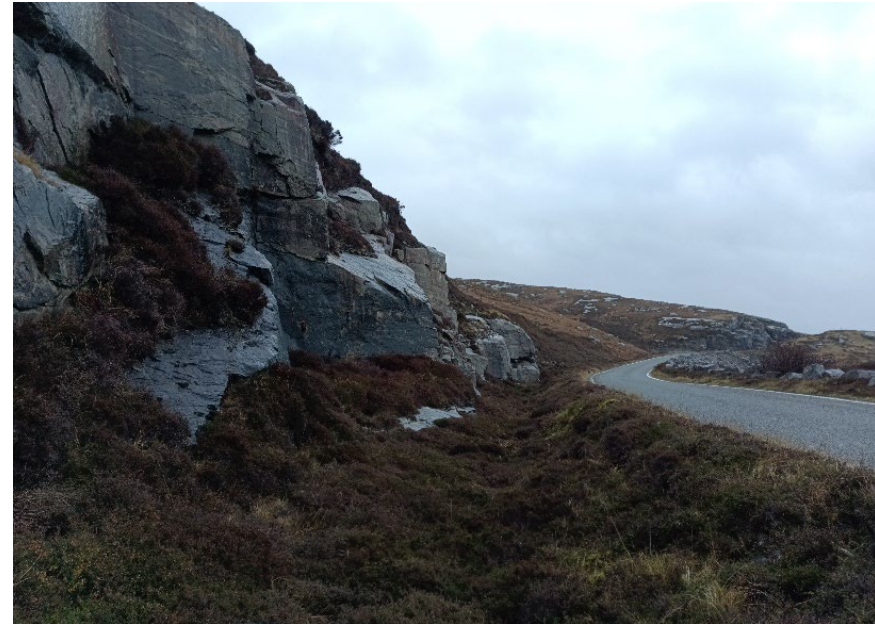
*Image 4. D1 dry dwarf shrub heath at the roadside and growing upon rocks in the north of the survey area.*

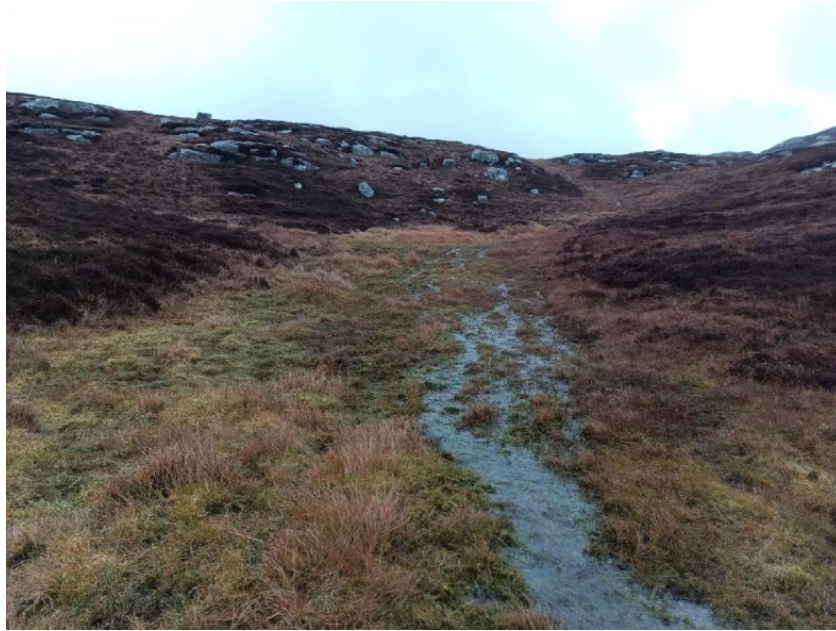
*Image 5. An acidic flush (E2.1) dominated by Sphagnum mosses and cotton grass with running water in the foreground. In the background, heather-dominated D2 dwarf shrub wet heath is present alongside rocks from the Lewisian Complex – Gneiss.*

4.2.2.16 The hillside in the north has peaty soils with no more than 30cm depth, sitting upon the Lewisian Complex – Gneiss bedrock, which frequently protrudes above the surface (Appendix 3 - Image gallery, Image 5). The ground was found to be wet during the fieldwork, with small patches of standing water, not large enough to be considered pools. Grazing influences the vegetation here, with evidence of rabbits and sheep found.

- 4.2.2.24 *Sphagnum fallax*, is most dominant species, forming lawns and *Sphagnum cuspidatum* is frequent where there are small pools of water. (Appendix 3 - Image gallery, Image 5) Other bryophyte species present include *Sphagnum subnitens*, *Sphagnum rubellum*, *Sphagnum papillosum* and *Sphagnum palustre*. Vascular plants which coexist with these mosses include deergrass, cross-leaved heath, common heather, bog asphodel, common cotton grass and hare's tail cotton grass (*Eriophorum vaginatum*). In some cases, flushes were dominated by tussocks of purple moor grass instead of *Sphagnum* mosses.

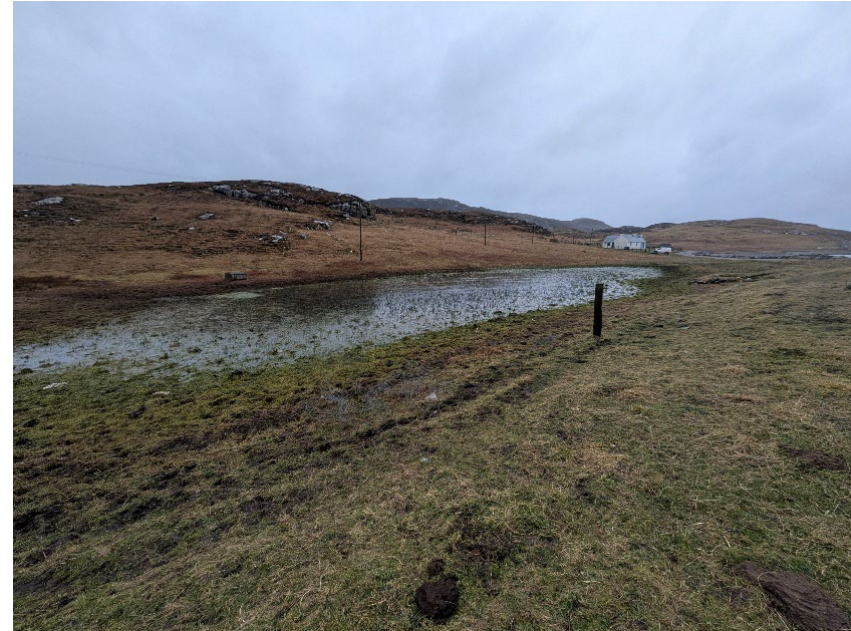
*Image 6. Seasonally inundated pond, classified as a swamp.*

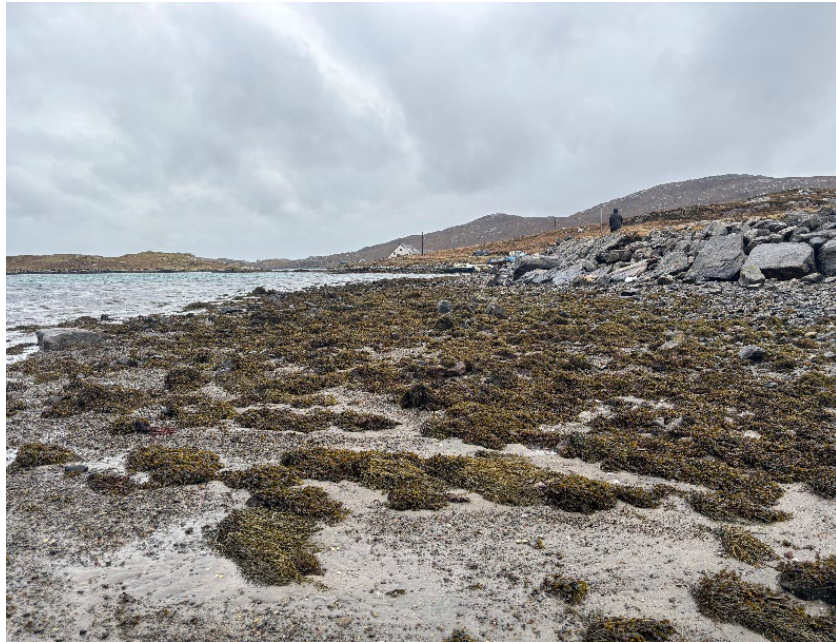
*Image 7. Intertidal mud/sand with patches of egg wrack (foreground) and fucoids (background).*

- 4.2.2.32 On the eastern shore, the upper intertidal comprises stones and rocks, grading downslope into sand and then mud towards the lower shore (Appendix 3 - Image gallery, Image 7). Within the more transitional upper-shore areas towards the causeway, rocks and shingle are dominated by egg wrack (*Ascophyllum nodosum*). Empty shells of common cockle (*Cerastoderma edule*), common periwinkle (*Littorina littorea*), common limpet (*Patella vulgata*) and dog whelk (*Nucella lapillus*) were also recorded frequently. Individual fronds of seagrass (likely to be *Zostera* sp.) were noted as beach-cast material. Beyond the

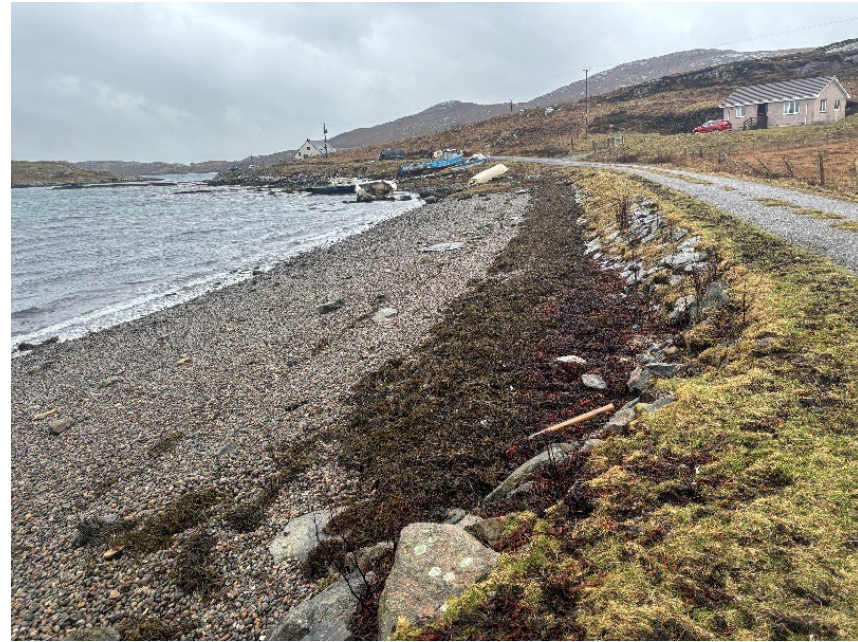
*Image 8. Shingle beach with seaweed deposited at the top.*

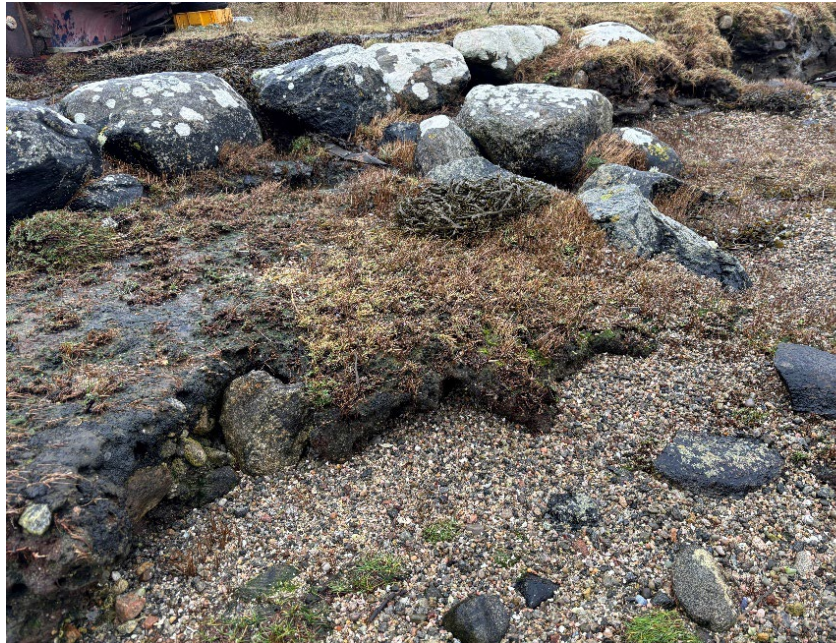
*Image 9. Eroding patch of salt marsh-like halophytic vegetation community upon shingle beach.*

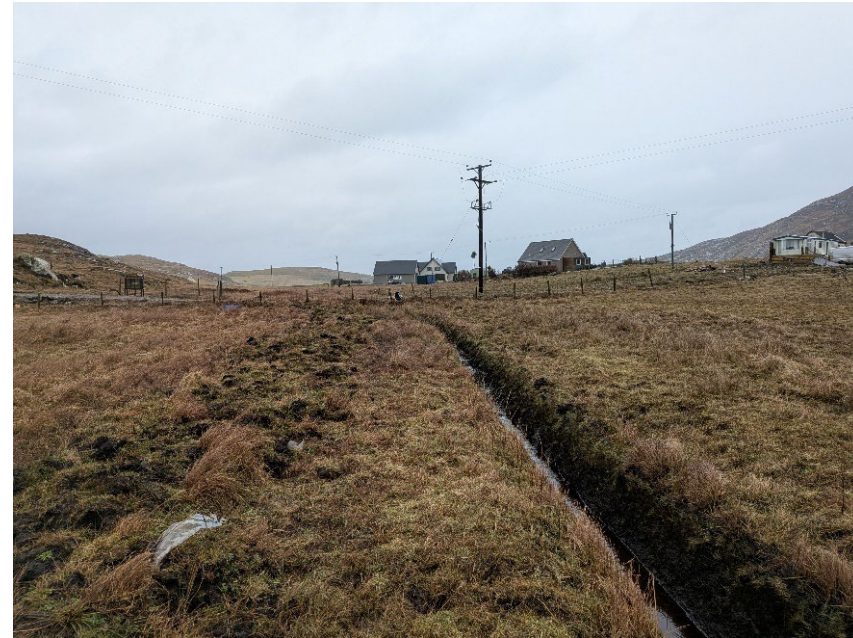
*Image 10. Drainage ditch running through marshy grassland towards seasonally inundated pool.*

4.2.3.2 Standing water is found in drainage ditches within the southern side of the survey area in Vatersay. The most significant feature being a drainage ditch spanning an area of marshy grassland and connecting with the seasonally inundated pond (described as a swamp, F1). This drain had an unvegetated peaty substrate and had standing water during the site visit. It is possible that the water may flow slowly at some times of year as could alternatively be classed G2 running water. (Appendix 3 - Image gallery, Image 10) The other drain observed were generally more vegetated and shallower.

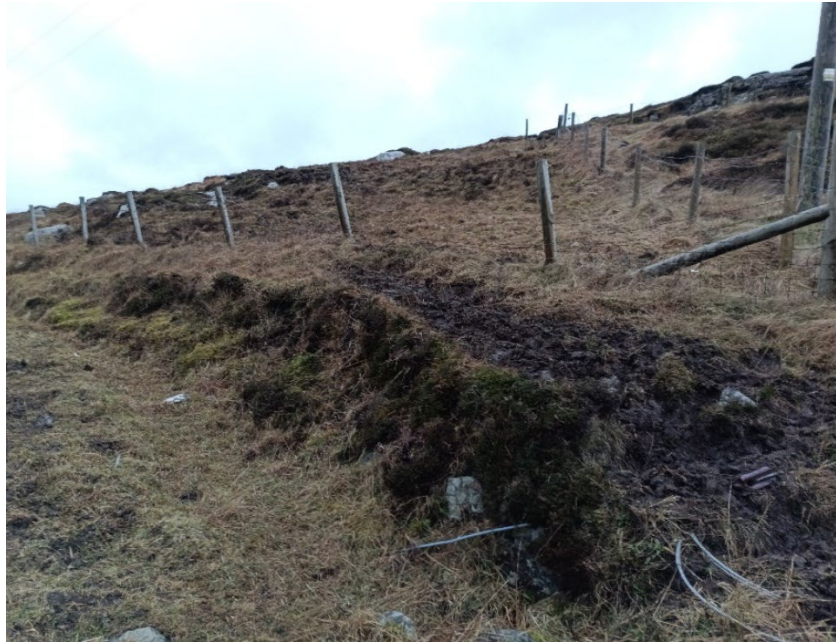
| VE27 | Fence broken and trampled by cows. (Appendix 3 - Image gallery, Image 11) |

*Image 11. Trampling of vegetation by cattle, and damage to the fencing in the south of the survey area.*

4.2.3.11 Fencing is generally rylock fencing. The majority of the fences appeared in good condition during the survey, with the exception of a few points where the fence was trampled by cattle. (Appendix 2 – Phase 1 Habitat Survey Target notes, VE27, Appendix 3 - Image gallery, Image 11).

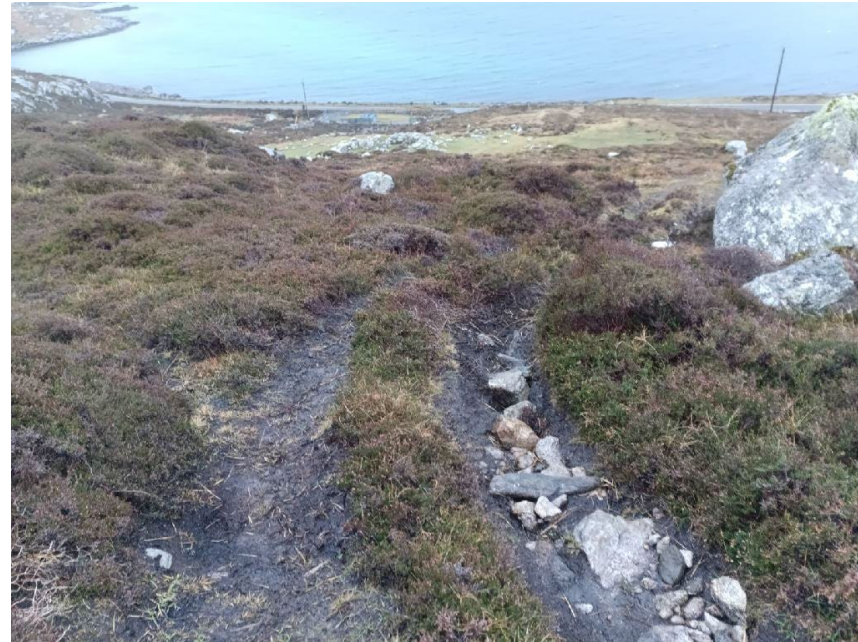
*Image 12. Heavily eroded track in the north of the survey area (Appendix 3, Table 8, VE09).*

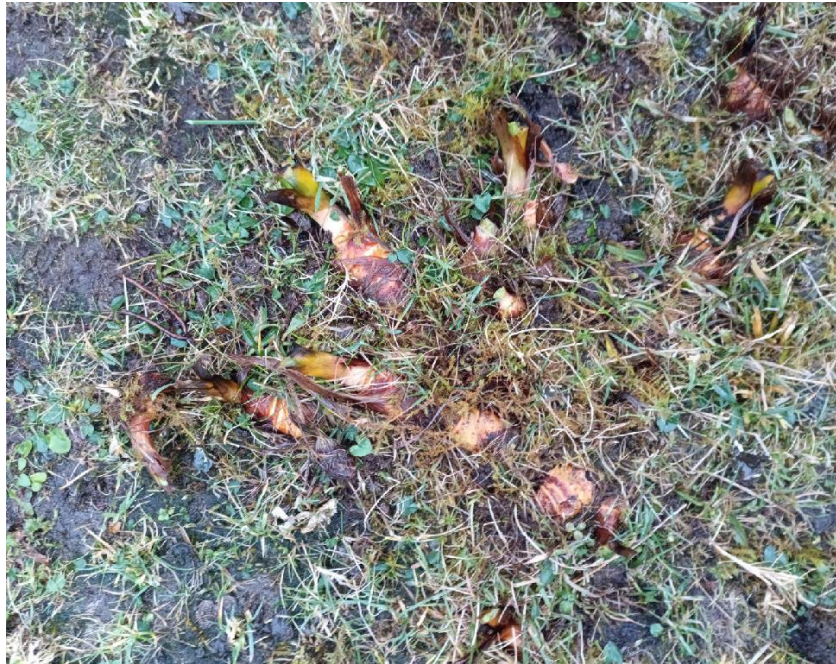
*Image 13. Corms from an unidentified plant (Appendix 2 – Phase 1 Habitat Survey Target notes VE05).*

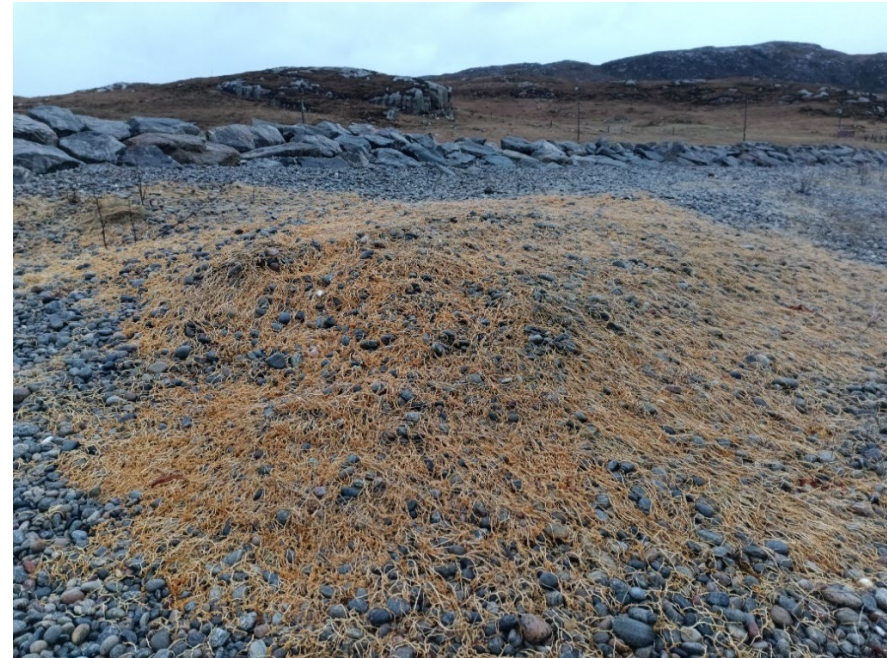
| VE38 | Patch of sea sandwort upon shingle beach (Appendix 3 - Image gallery |

*Image 14. Sea sandwort (*Honkenya peploides*) (Appendix 2 – Phase 1 Habitat Survey Target notes, VE38).*

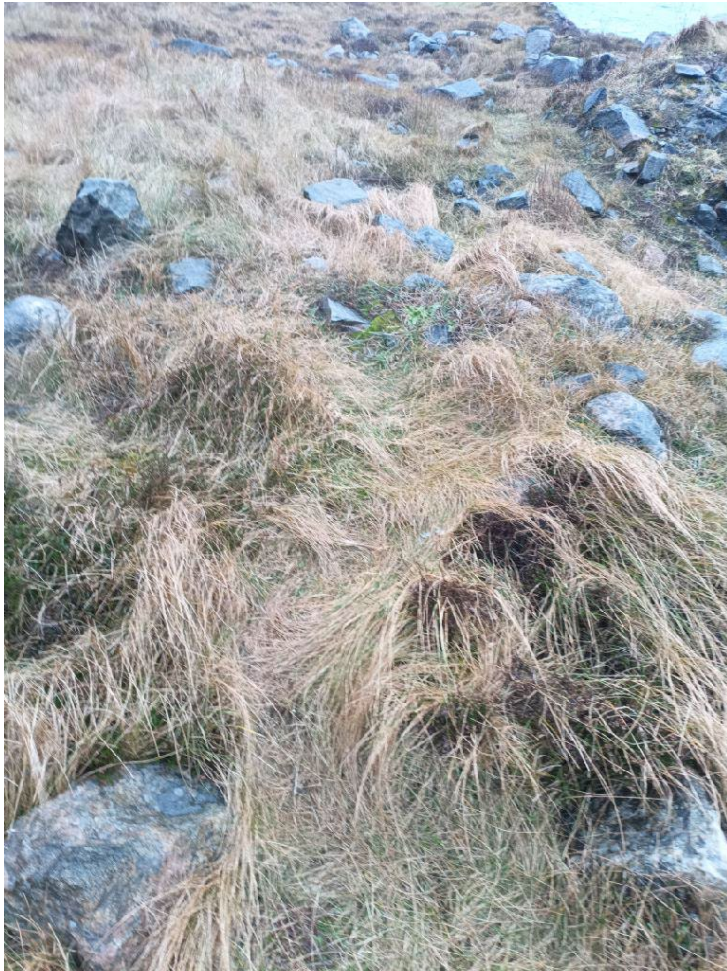
| ID | Otter Sign | Notes |
|---|---|---|
| FS02 | Path | Path running from top of seawall adjacent to the sea running east away from the causeway. |

*Image 15. Otter pathway running from top of seawall adjacent to the sea running east away from the causeway (FS02).*

- 4.2.2.38 Boulders/rocks above the high-tide mark comprise artificial boulder sea defence forming the base of the causeway and coastal protection along its eastern flank (Appendix 3 - Image gallery, Image 15), where rock armour also protects and locally raises the road. Conspicuous flora and fauna are sparse and comprise mainly maritime lichens and cast seaweed. Marine litter, including creels, ropes and polystyrene, was recorded trapped within crevices between boulders. A surface water outfall was also noted in one location, with no visible evidence of pollution at the time of survey.
- 4.2.2.39 The corresponding UKHab classification is (t1e 701) splash zone with lichens, sea wall.

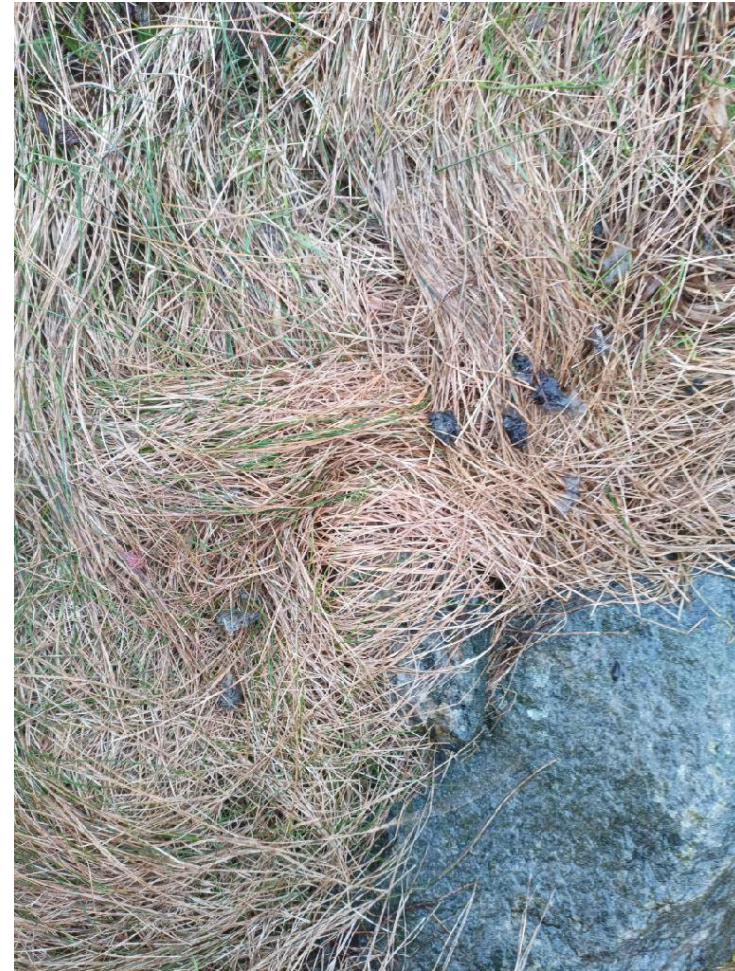
*Image 16. Otter spraints of varying freshness / degradation (FS04).*

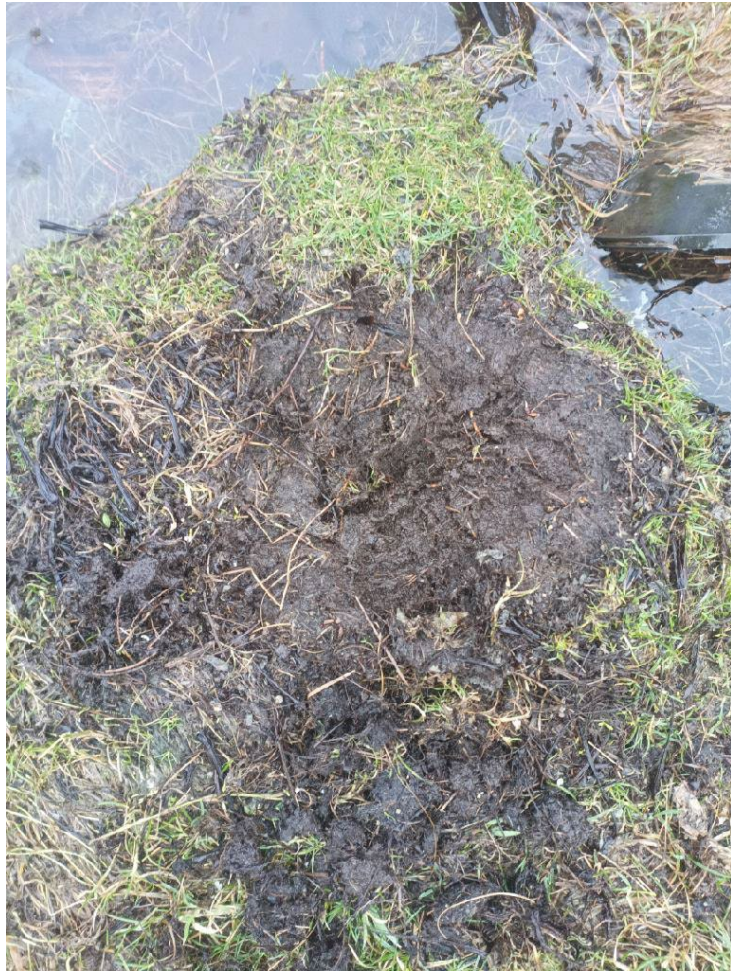
*Image 17. Otter pawprints in mud by edge of water. at northeastern edge of survey boundary (FS15).*

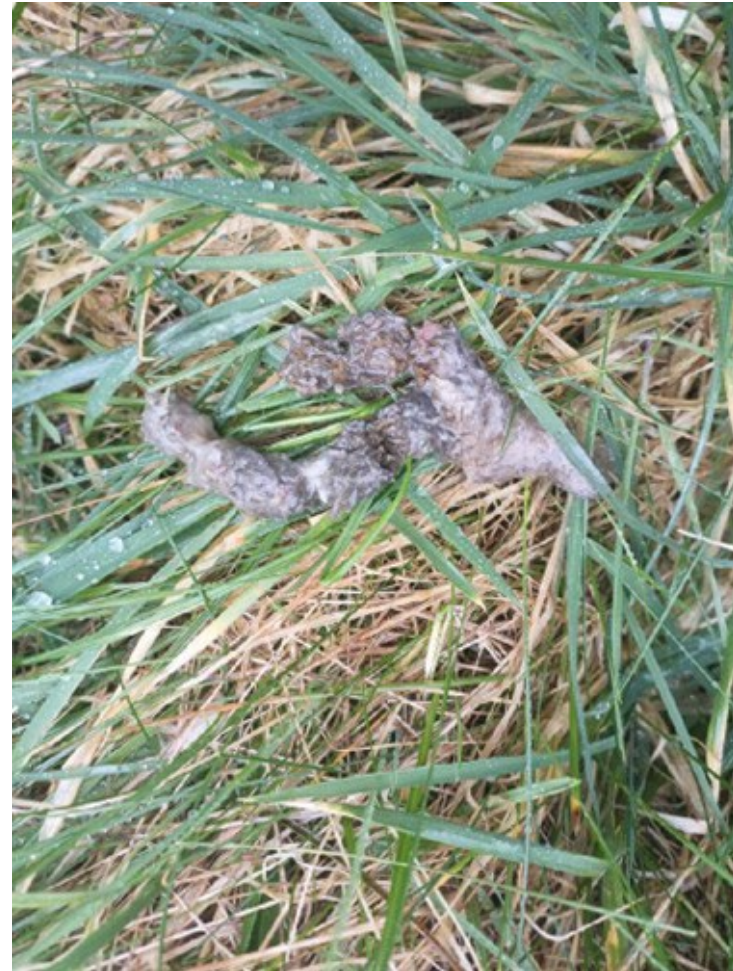
*Image 18. Potential Mink Scat recorded at northeastern edge of survey boundary.*

- 5.7.1.1 Although no vegetative INNS were recorded during the survey, the site is vulnerable to colonisation from INNS brought in by machinery or materials from elsewhere. Therefore, strict biosecurity measures should be put in place to minimise the chance of spreading vegetative INNS.
- 5.7.1.2 A potential mink spraint was found during the site walkover (Appendix 3 - Image gallery, Image 18). Mink are an INNS that can have an impact on native bird and mammal populations.
