Pentland Firth East EPS Risk and Protected Sites and Species Assessment

Scottish and Southern Energy plc

Document Number: A-302428-S01-REPT-001

Scottish Hydro Electric Power Distribution Pre-application Consultation Report Pentland Firth East Cable Replacement

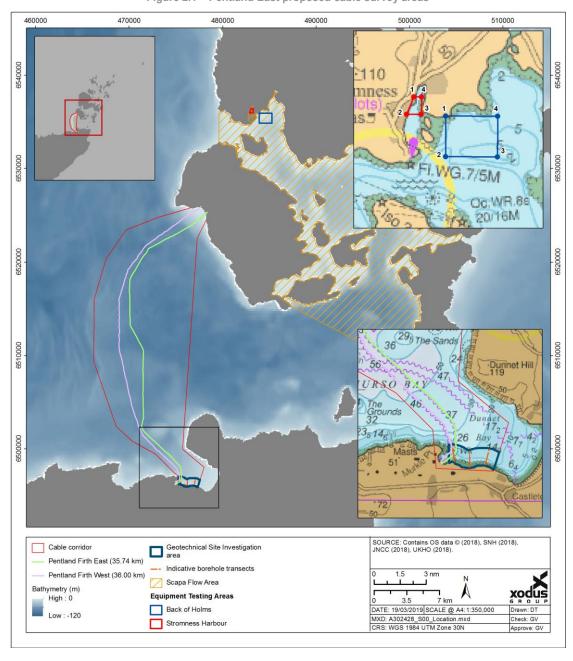
Figure 2.1 Pentland East proposed cable survey areas

The location of the existing Pentland East cable route is shown in Figure 2.1. A list of co-ordinates, and the area in which the cable surveys will take place is provided in Table 2-1. Prior to surveys commencing it will be necessary to undertake calibration/testing of USBL, MBES and SSS equipment. It is proposed that equipment calibration would be undertaken at dedicated test sites located at Back of Holms or Stromness Harbour or within the wider Scapa Flow area. Test sites will be selected based upon the weather, other activities occurring in the vicinity on the day and whether they cover small or large boat calibrations.

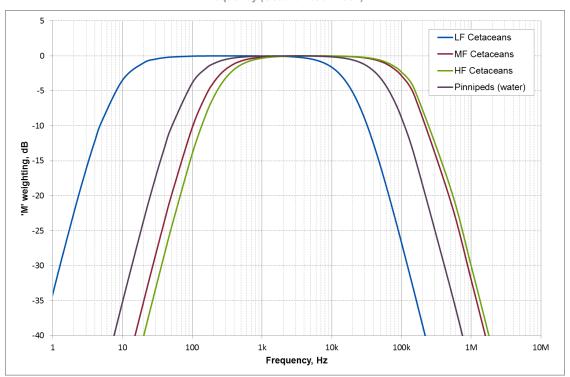
Figure 3.1 M-weighting functions for pinnipeds and cetaceans in water (LF = low-frequency, MF = mid-frequency, HF = high-frequency (Southall et al. 2007)

To determine the potential for noise to impact cetaceans, perceived sound levels are compared to available estimated thresholds for injury or disturbance. Several threshold criteria and methods for determining how sound levels are perceived by marine mammals are available (e.g. the dBht method and other hearing weighted and linear measures) and each has its own advantages and disadvantages. JNCC (2010) guidance recommends using the injury criteria proposed by Southall et al. (2007) based on a combination of linear (unweighted) peak pressure levels and mammal hearing weighted (M-weighted) sound exposure levels (SEL). The M-weighting function represents the hearing sensitivity frequency bandwidth for marine mammal groups (see Figure 3.1 below).

If a sound emission is composed of frequencies which lie outside the estimated auditory bandwidth for a given species, then disturbance is unlikely. However, noise sources which are sufficiently high can still cause physical damage, including damage to hearing and other organs, even when the frequencies lie outside an animal's auditory range. To understand the potential for noise-related impacts, the likely hearing sensitivities of different cetacean hearing groups has been summarised below in Table 3-3. Section 3.4 assesses the potential for injury to be incurred for each hearing group, given the estimated auditory bandwidth.

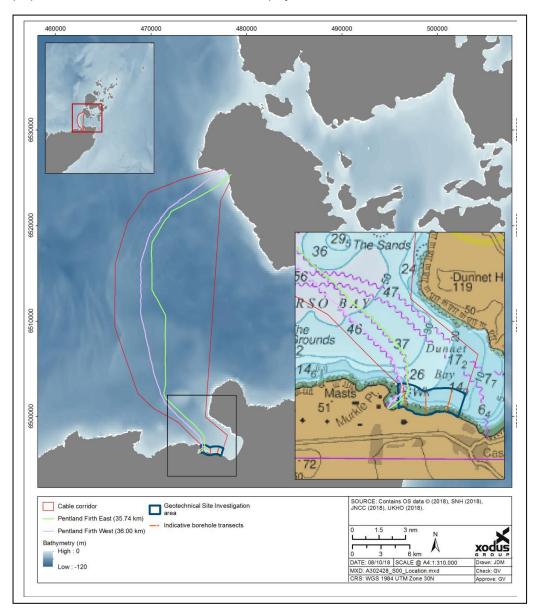
Figure 1: Proposed Cable Corridor

A five nautical mile (nm) buffer is considered around the proposed corridor of the replacement cable for the purposes of hazard identification relevant to the project.

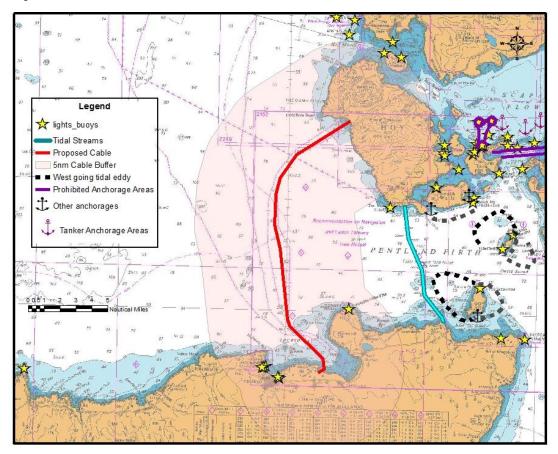
Figure 2: Navigational features

The principal navigational features relative to proposed corridor of the replacement cable are presented in Figure 2. This figure displays charted anchorage areas and navigational aids. The buoy and anchorage positions are taken from the Admiralty Charts of the area, with supplementary information taken from previous NRAs compiled for the Pentland Firth, informed by Admiralty Sailing Directions and Clyde Cruising Club Sailing Directions and Anchorages.

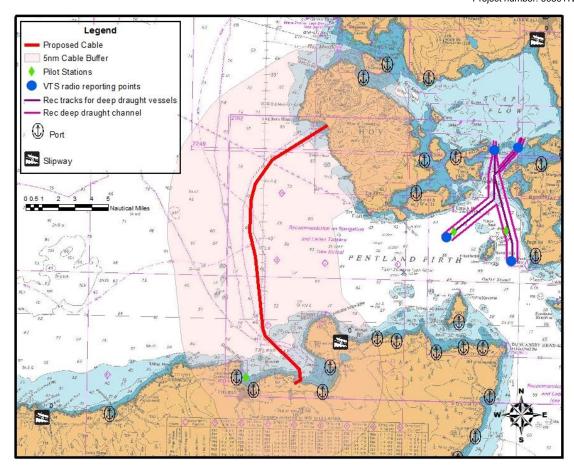
Figure 3: Ports, Harbour Limits and Recommended Tracks

OIC Marine Services administers 29 Orkney Harbour Areas for which it is the Competent Harbour Authority. The Council exercises its jurisdiction through a Director of Marine Services. The Duty Holder for the Authority is now the Harbour Authority Sub-committee, established in July 2016. Proposed corridor of the replacement cable is at no point in the vicinity of the Limits of Orkney Harbours. However, berthing and overnighting of survey vessels may be required at anchorages within these Limits.

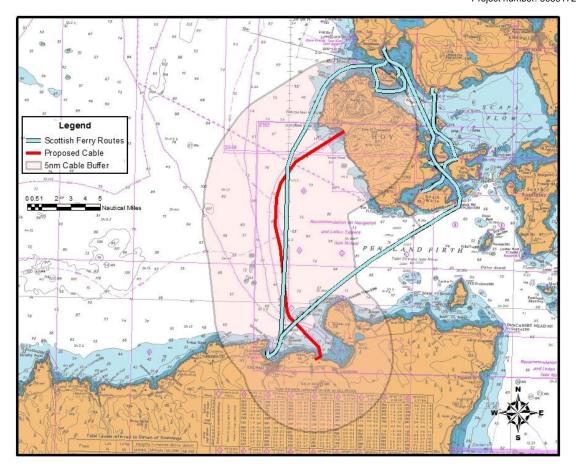
Figure 4: Ferry Routes from Scrabster

The harbour at Scrabster is the setting off point for the Northlink Ferries Scrabster-Stromness ferry service which runs twice at weekends during off-peak season (September to April) and three times daily in the peak season. As can be seen in Figure 3, the principal route to the west of Hoy crosses over the proposed cable route twice and is entirely within the 5nm buffer. Consultation with Northlink Ferries will be required to assess the risk to the proposed cable due to falling objects from the Ro-Ro service and dropped anchors during adverse weather, as well as impacts on the ferry service of survey vessels traversing the Pentland Firth at the same time as ferry sailings.

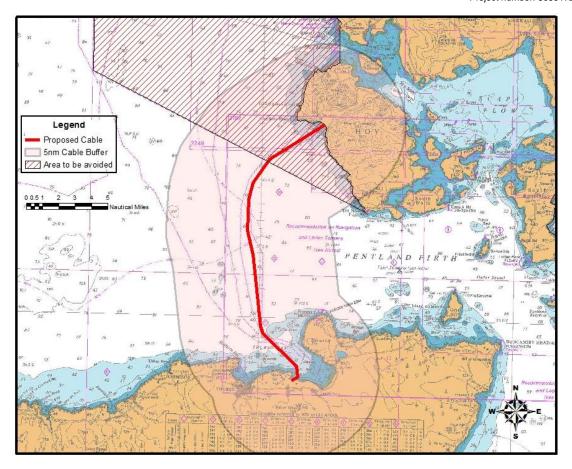
Figure 5: ATBA in the vicinity of the proposed cable

The statutory regulations surrounding the burial of pipelines and cables within this region should be checked to ensure no regulatory obstacles exist to both surveying and cable laying operations.

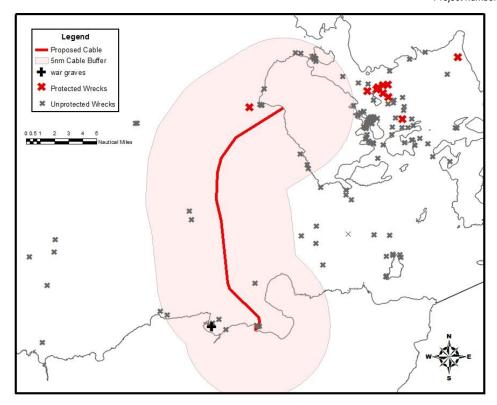
Figure 6: Identified Wrecks

There are 24 reported unprotected wrecks within 5nm of proposed corridor of the replacement cable. Of particular interest are two wrecks identified in Murkle Bay where the proposed cable will land on the Scottish North coast. The condition of these wrecks is not known and the effect they may have on survey and cable laying operations is unknown.

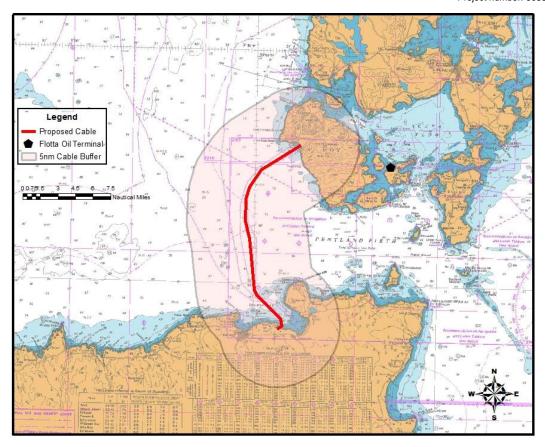
Figure 7: Oil and Gas Infrastructure

There are no oil and gas installations or licence blocks in the immediate vicinity of the proposed cable, however there are installations to the east of the project, in Scapa Flow, associated with Flotta Oil Terminal, which is approximately 10nm east of the area. Installations here include a tank farm, pumping station, power station and burn- off flare.

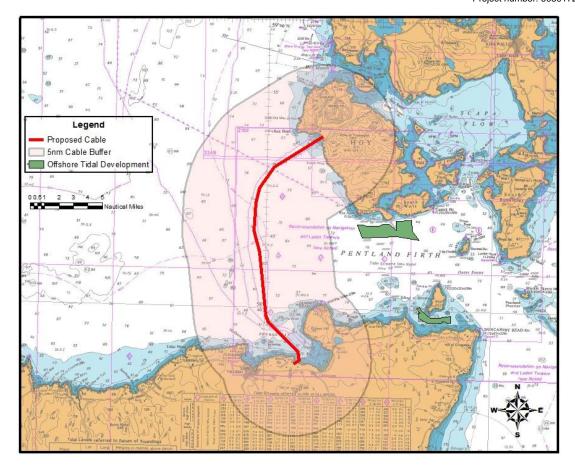
Figure 9: Tidal Power Projects in the Pentland Firth

MeyGen is currently running monitor and reporting phases of their tidal power project in the Inner Sound to the south of the Isle of Stroma. This currently comprises a single turbine on a gravity foundation and is not anticipated to impact cable laying operations directly. Vessel traffic to and from the site from local ports by maintenance, reporting and installation vessels my impact on available berths in the area as the project is reported to enter into a second phase of installation in 2019, with further turbines being put in place.

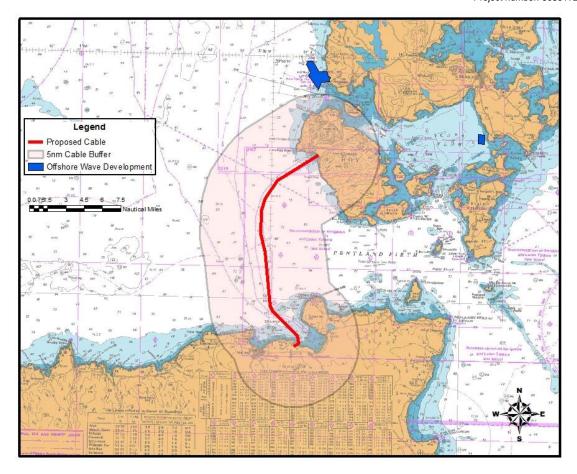
Figure 10: Wave Energy Projects

No impact is predicted on surveying or cable laying operations however, the area should be avoided to prevent collision with floating wave energy generators.

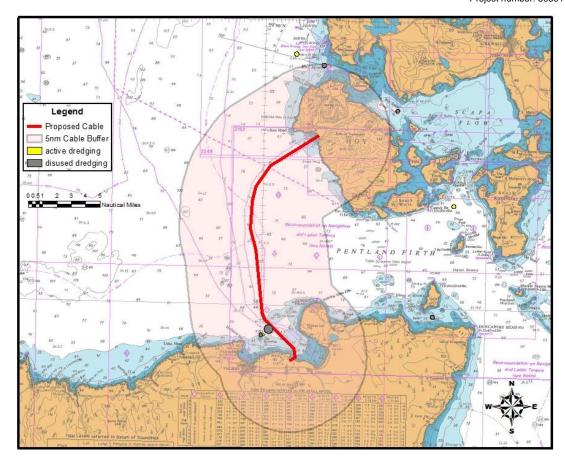
Figure 11: Dredge Disposal sites

Within 5nm of proposed corridor of the replacement cable there are 3 disused and a single operational dredge arising's disposal site (as of the most up to date charts in December 2018). The most significant is the larger disused dredge disposal site which lies over the proposed cable route at its southern extent and could impact on the ease of cable burial. The active site will require further monitoring to determine the effects of dredge disposal during project operations, however it lies around 1nm to the south-west of the proposed cable route.

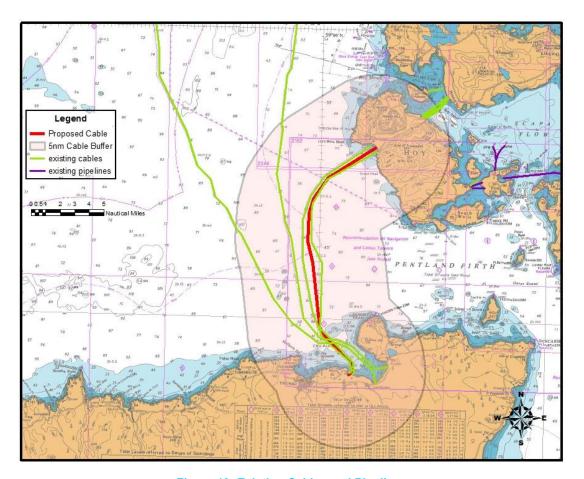
Figure 13: Existing Cables and Pipelines

Of particular interest are the two existing cables which this project aims to replace. They run to either side of proposed corridor of the replacement cable typically at a distance of 0.5nm from each other. They make landfall within Murkle Bay on the Scottish north coast and at Rackwick on Hoy. Care will be required where trenches are required to bury the new cables that the existing cables are not damaged. The combined capacity of these cables is 40MW.

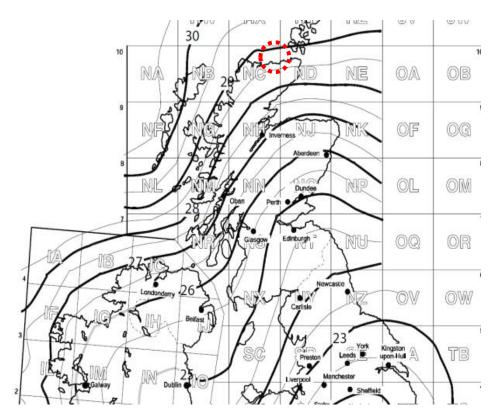
Figure 1: Value of fundamental basic wind velocity vb, map (m/s) 50 years return period. Source: NA to BS EN 1991-1-4:2005+A1:2010.

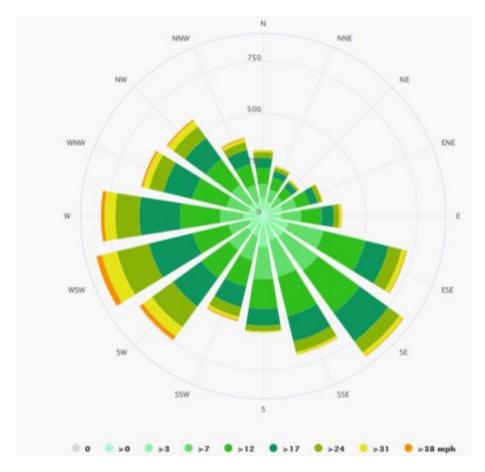
The wind rose for Thurso, Figure 17 below, shows on how many hours per year the wind blows from the indicated direction.

Figure 17: Thurso wind rose. Source: Meteoblue website: https://www.meteoblue.com/en/weather/forecast/modelclimate/thurso_united-kingdom_2635881

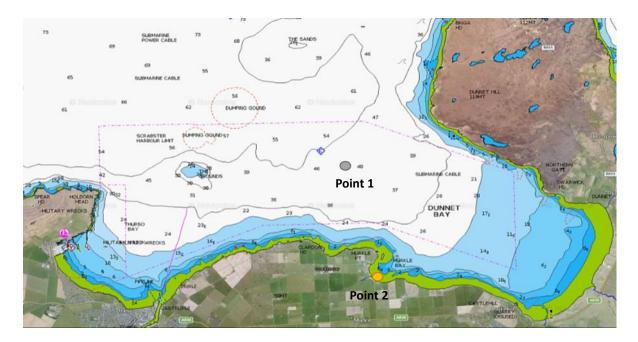
Hindcast analysis has been undertaken for several locations to get a better understanding of the estimated waves near the area of study.

Figure 18: Hindcast analysis - Point 1 and 2 locations. Source basemap: navionics.

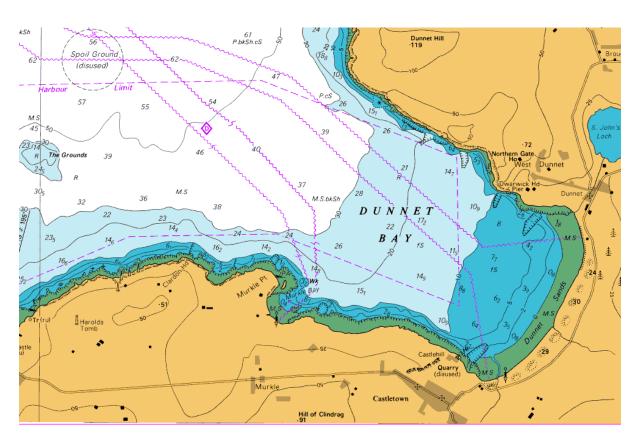
Currents at the site have been taken from Admiralty Chart BA2162 Pentland Firth and Approaches, 2012.

Figure 20: Tidal Streams Points. Source: Admiralty Chart BA2162 Pentland Firth and Approaches, 2012.

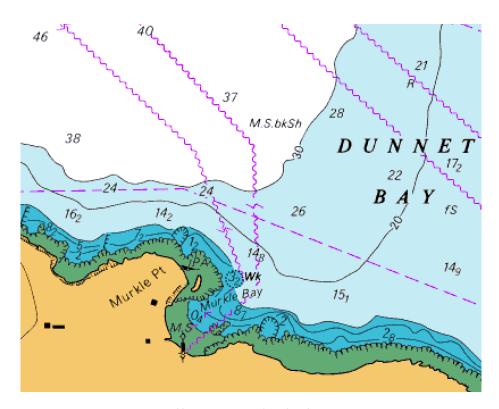
AECOM do not hold any detailed bathymetric survey for the site. For the purpose of this report, regional bathymetry was based on the Admiralty Chart BA2162 Pentland Firth and Approaches, 2012.

Figure 23: Murkle Bay. Source: Admiralty Chart BA2162, 2012.

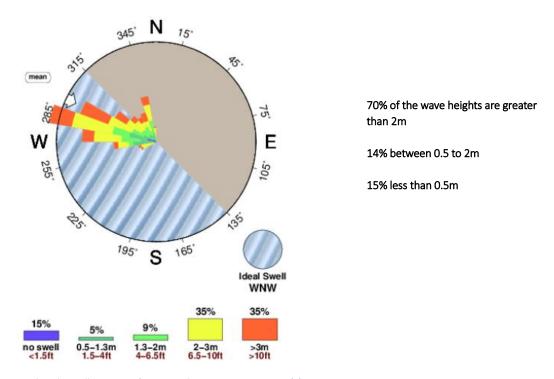
Figure 26 below shows the range of swells directed at Rackwick through an average December and is based on 2953 NWW3 model predictions since 2006 (values every 3 hours). The wave model does not forecast surf and wind right at the shore. Therefore, this information has been used only for information as estimation on the possible wave height reaching Rackwick coast and to be compared with other results obtained.

Figure 26: Rackwick Swell Statistics for December. Source: www.surf-forecast.com

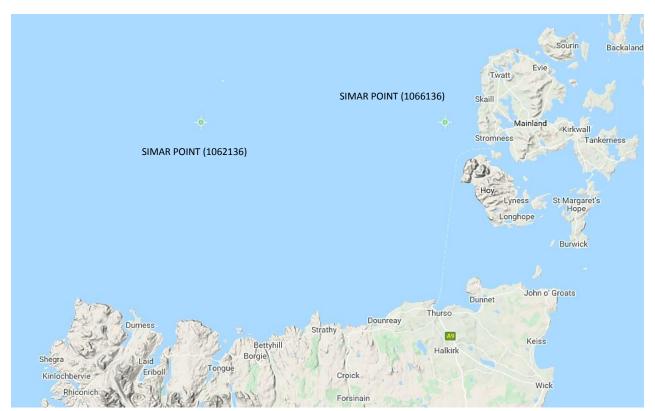
Longitude:	3.50° W
Latitude:	59.00° N
Data sampling:	1 h
Code:	1066136
First record date:	04-01-1958
Data Set:	SIMAR point

Figure 32: SIMAR Point. Source: www.Puertos.es
