ESSO Petroleum Company, Ltd

BOWLING MARINE STRUCTURES MAKING SAFE WORKS

Habitat Regulations Appraisal

DATE: JULY 2023

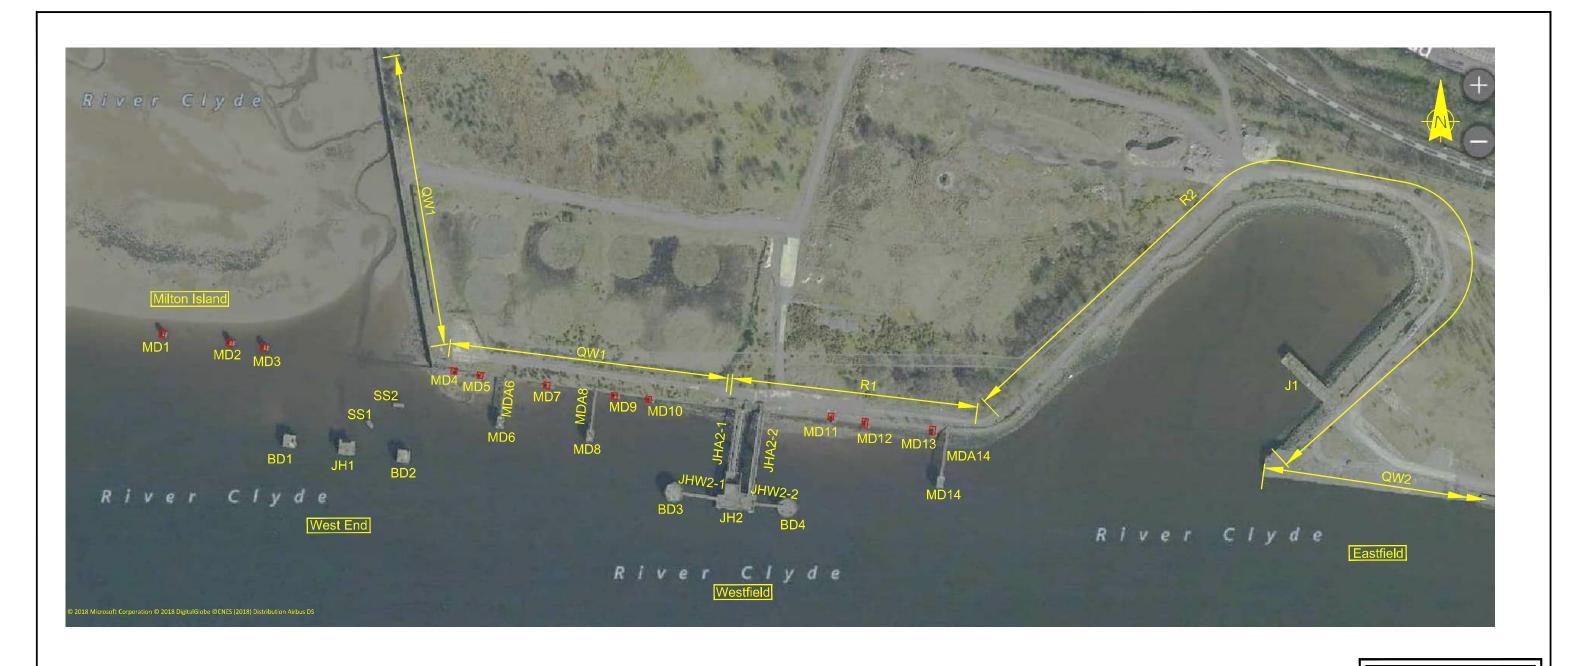
SITE PLANS AND OUTLINE WORKS METHODOLOGY

Bertning Dolphins	
Item	Reference
Westfield Berthing Dolphins	BD4
Westfield Jetty Head	JH2
West End Berthing Dolphins	BD1, BD2
West End Jetty Head	JH1

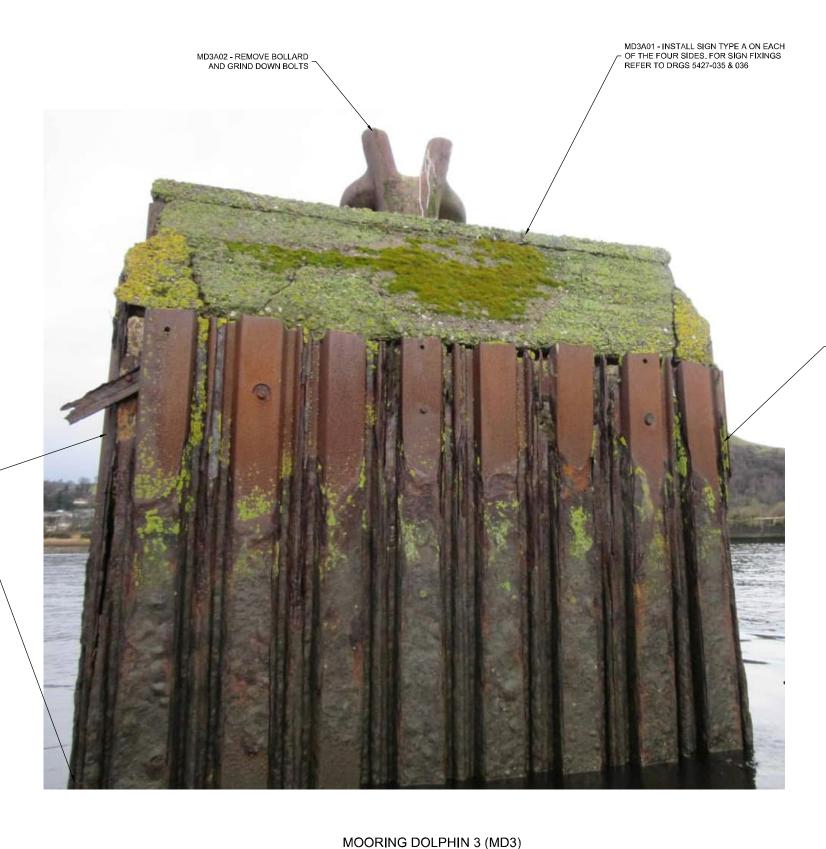
MD3A03 - INSTALL STRAPPING SYSTEM REFER TO DRG 5427-032 SAFETY, HEALTH AND ENVIRONMENTAL INFORMATION

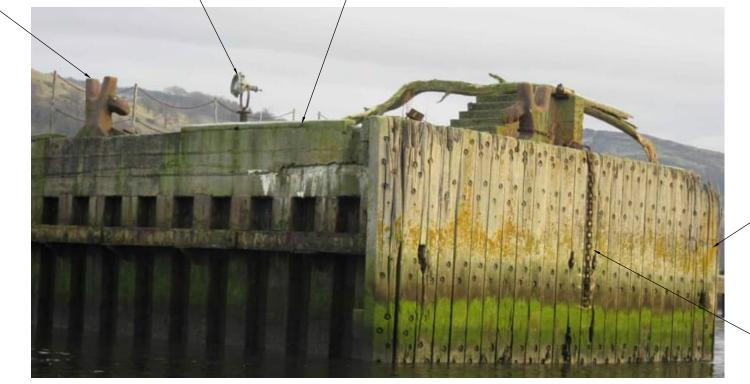
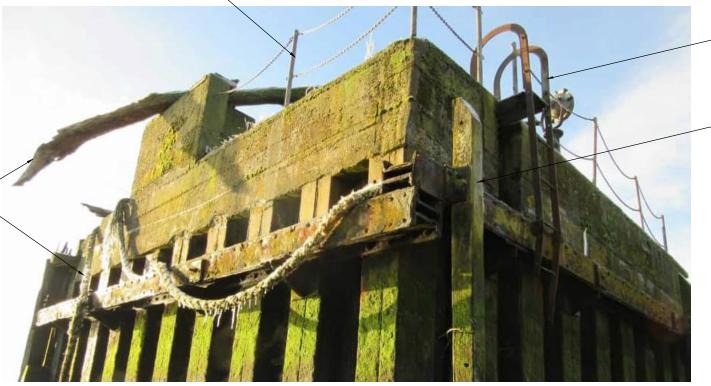
BERTHING DOLPHIN 1 (BD1)

BD1A02 - REMOVE BOLLARDS (2No.) AND GRIND DOWN BOLTS

BD1A04 - REMOVE TIMBER FENDER FACING ON FRONT FACE

BD1A05 - REMOVE ALL CHAINS

BD1A09 - REMOVE ROPE, DRIFTWOOD AND ANY OTHER LOOSE ITEMS/DEBRIS

BD1A06 - REMOVE LADDER

Infill material type with in structure below water level is not known. There are heavily corroded tie rods that may be structurely connecting the structure together. Contractor to take precautionary measures in their demolition methodology to account for this. For further information on the condition of the structure refer to Appendix A the Pre-construction

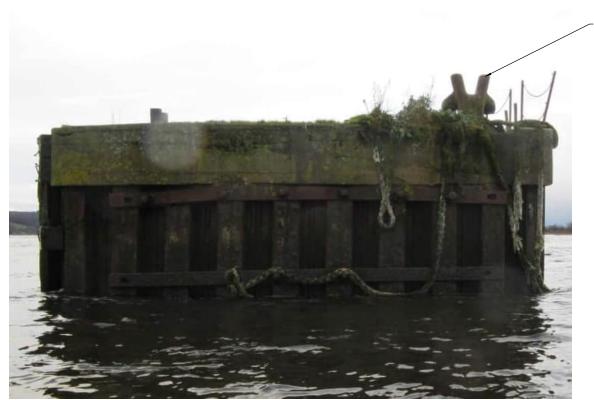
Drg No: 5427-005

BD2A01 - INSTALL SIGN TYPE B ON EACH OF THE FOUR SIDES, BOLT SIGNS INTO CONCRETE, THE FRONT FACE WHERE THE TIMBER FENDERS ARE IN THE WAY INSTALL -SIGN ON DECK USING BRACKETS BOLTED TO CONCRETE DECK. FOR SIGN FIXINGS REFER TO DRGS 5427-035 & 036

BD2A07 - REMOVE ROPE AND ANY OTHER LOOSE ITEMS/DEBRIS BD2A05 - REMOVE LADDER BD2A06 - REMOVE HANDRAIL POLES AND CHAINS

BD2A03 - REMOVE TIMBER FENDER

BD2A02 - REMOVE BOLLARDS (2No.) AND GRIND DOWN BOLTS

- BD2A04 - REMOVE ALL CHAINS

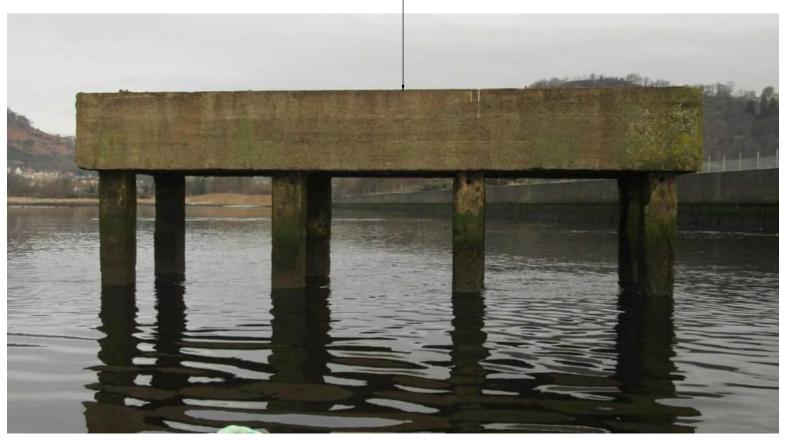
SUPPORT STRUCTURE 2 (SS2)

SS2A01 - INSTALL A SIGN TYPE A ON EACH OF THE FOUR SIDES. BOLT SIGNS INTO CONCRETE. FOR SIGN FIXINGS REFER TO DRGS 5427-035 & 036.

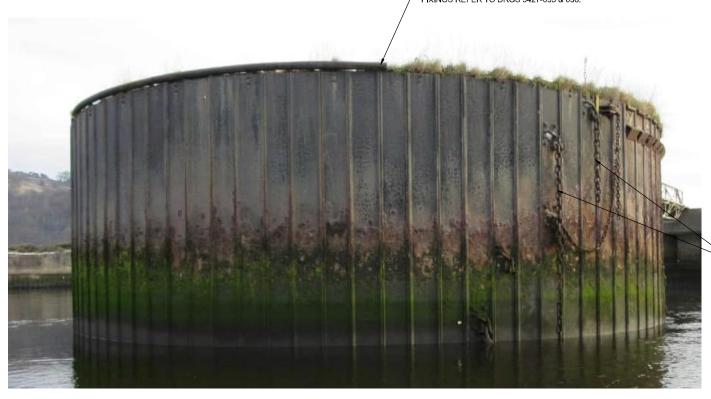
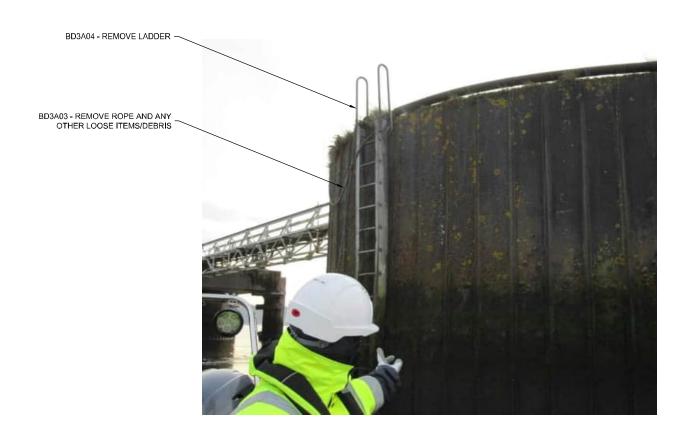
BERTHING DOLPHIN 3 (BD3)

BD3A01 - INSTALL 8 SIGNS TYPE B AT EQUAL
DISTANCE FROM EACH OTHER, FOR SIGN
FIXINGS REFER TO DRGS 5427-035 & 036.

➤ BD3A02 - REMOVE CHAINS

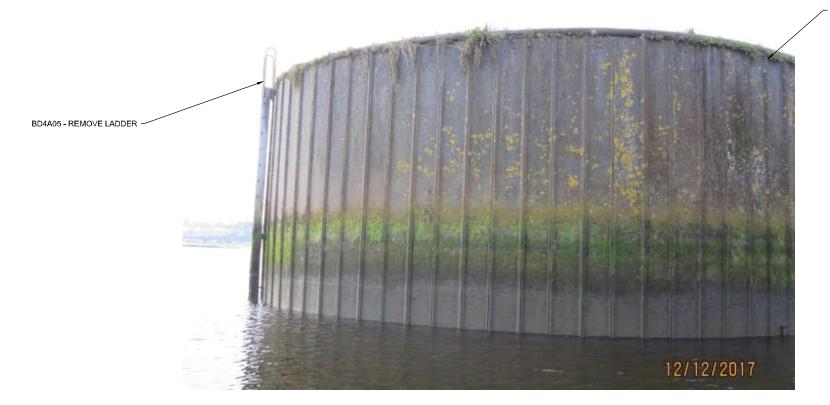
BERTHING DOLPHIN 4 (BD4)

BD4A04 - REMOVE ANY LOOSE ITEMS/DEBRIS (IF PRESENT)

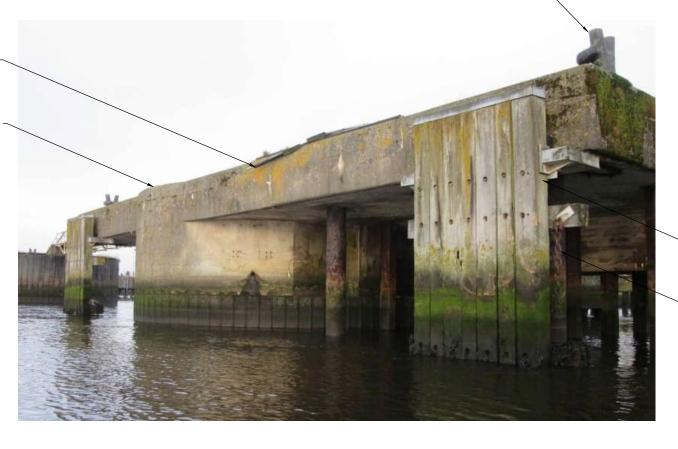
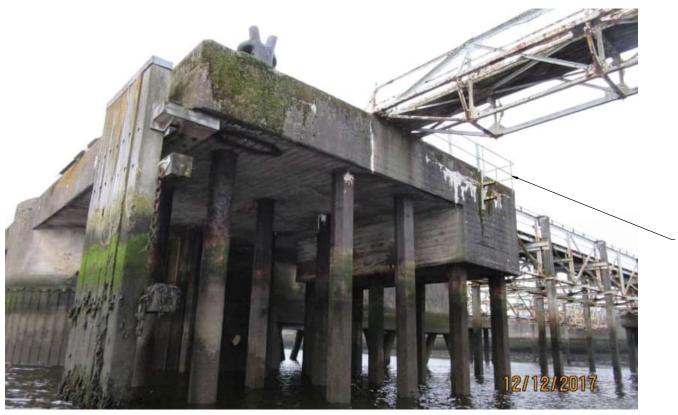
JETTY HEAD 2 (JH2)

JH2A05 - REMOVE ROPES AND ANY LOOSES ITEMS/DEBRIS

JH2A02 - REMOVE TIMBER FENDERS ON THE SOUTH FACE

- JH2A04 - REMOVE CHAINS

JH2A06 - REMOVE HANDRAIL

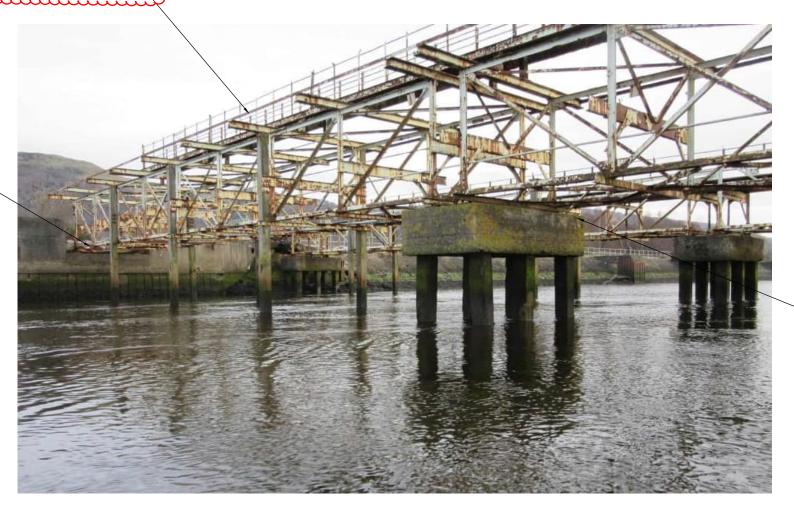
JETTY HEAD ACCESS 2-1 (JHA 2-1) OPTIONS 1& 2

Option 2 is no longer required. Physical access to the structure to be fully restricted through installation of palisade fencing with a lockable gate. Gates shall be 3.0m wide and 1.8m high, with suitable fencing, and installed as per manufacturer's recommendations with suitable foundations.

(OPTION 2) JHA2-1A03-2 DEMOLISH/REMOVE ENTIRE ACCESS TRESTLE AND CUT TIMBER PILES 1m BELOW RIVERBED

(OPTION 1) JHA2-1A01 - DEMOLISH/REMOVE FIRST SECTION OF ACCESS TRESTLE TO THE SUPPORT STRUCTURE AND CUT TIMBER PILES 1m BELOW RIVERBED

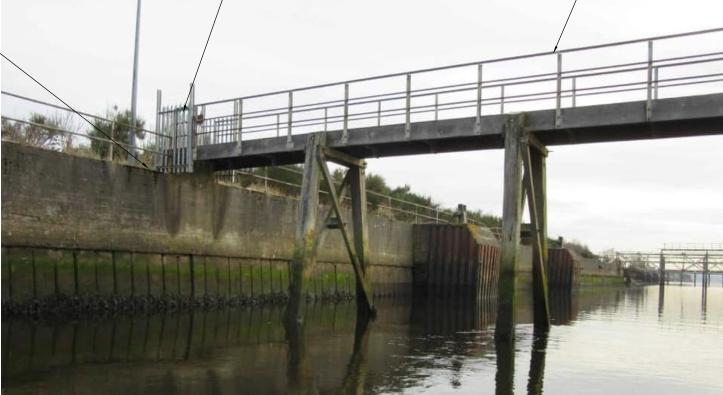
MOORING DOLPHIN ACCESS 8 (MDA8) OPTIONS 1 & 2

Option 2 is no longer required. Physical access to the structure to be fully restricted through installation of palisade fencing with a lockable gate. Gates shall be 3.0m wide and 1.8m high, with suitable fencing, and installed as per manufacturer's recommendations with suitable foundations.

(OPTION 1) MD8A06 - REMOVE FIRST LANDSIDE SECTION OF WALKWAY

(OPTION 1) MD8A07 INSTALL ONE SIGN TYPE C ON LANDSIDE. FOR SING -FIXINGS REFER TO DRGS 5427-035 & 036

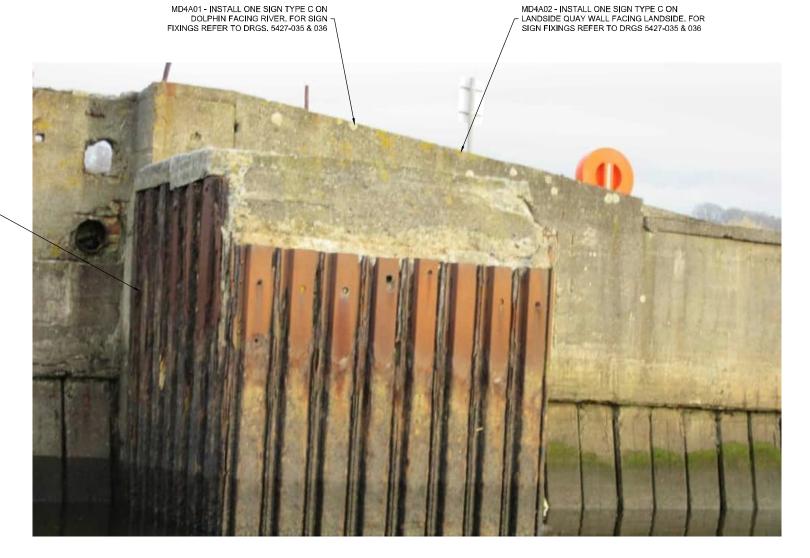
MOORING DOLPHIN 4 (MD4)

MD4A03 - INSTALL STRAPPING SYSTEM. FOR STRAPPING DETAILS REFER TO DRG 5427-032 TO 34

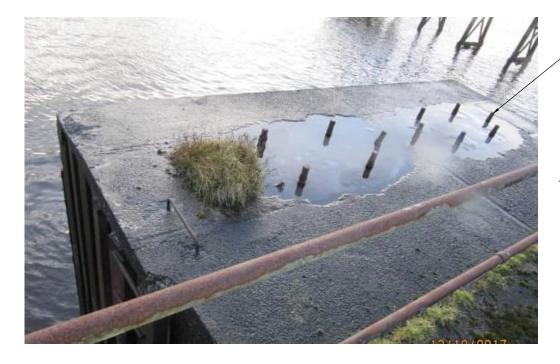
MOORING DOLPHIN 7 (MD7)

MD7A02 - INSTALL ONE SIGN TYPE C ON - DOLPHIN FACING RIVER. FOR SIGN FIXINGS REFER TO DRGS 5427-035 & 036.

MD7A04 - GRIND DOWN BOLTS

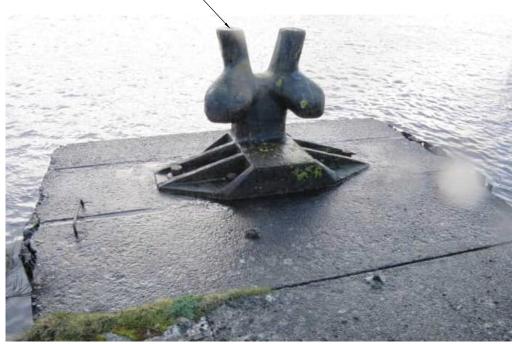
MD9A03- INSTALL STRAPPING - SYSTEM. FOR STRAPPING DETAILS REFER TO DRG 5427-032 TO 034.

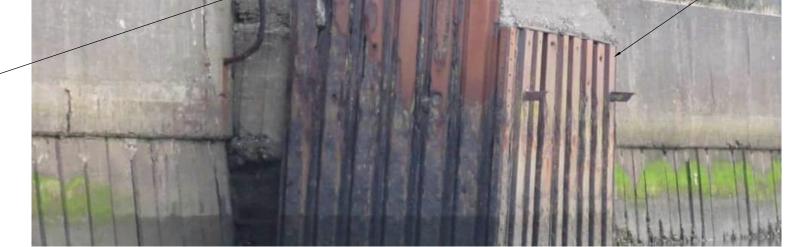
MOORING DOLPHIN 10 (MD10)

MD10A04 - REMOVE BROKEN TIE ROD

MD10A01 - INSTALL ONE SIGN TYPE C ON

LANDSIDE FACING LANDSIDE. FOR SIGN FIXINGS REFER TO DRGS 5427-035 & 036.

MD10A05 - REMOVE BOLLARD AND GRIND DOWN BOLTS

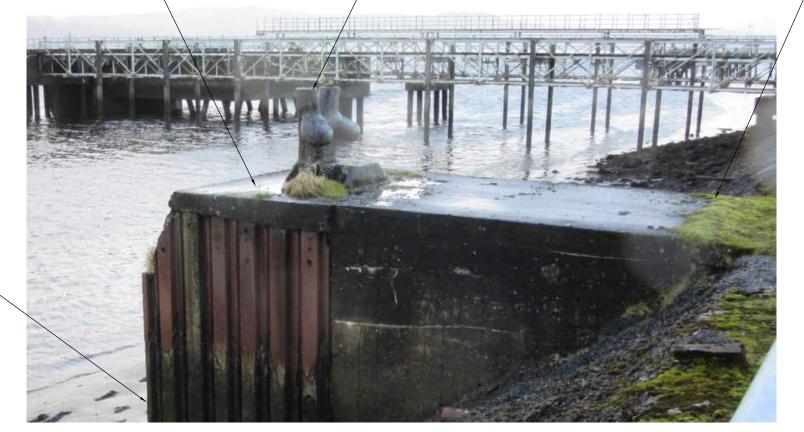
MOORING DOLPHIN 11 (MD11)

MD11A02 - INSTALL ONE SIGN TYPE C ON DOLPHIN FACING RIVER. FOR SIGN FIXINGS REFER TO DRGS 5427-035 & 036. MD11A04 - REMOVE BOLLARD AND GRIND DOWN BOLTS

MD11A03 - INSTALL STRAPPING SYSTEM. FOR STRAPPING DETAILS -REFER TO DRG 5427-032 TO 034.

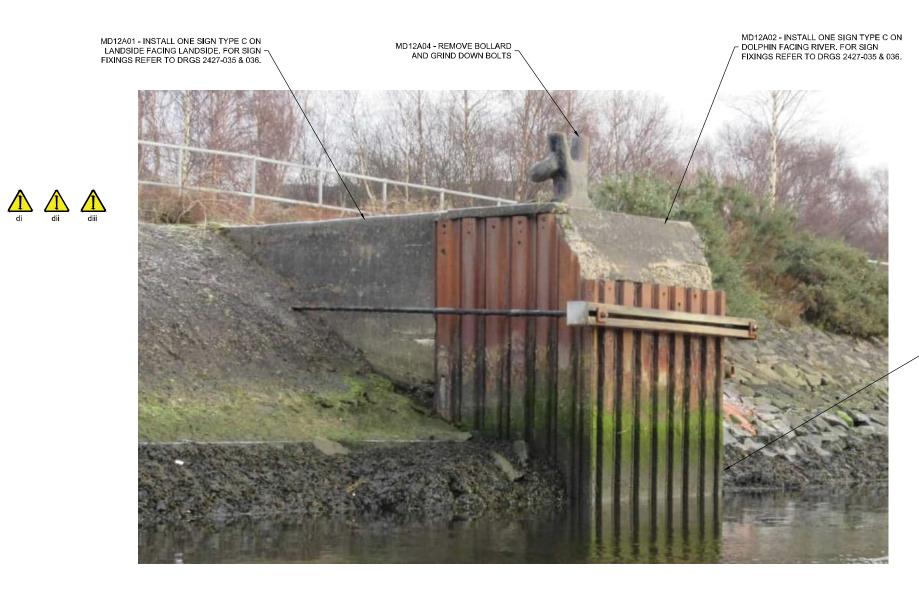
MD12A03 - INSTALL STRAPPING SYSTEM - (ONLY BOTTOM). FOR STRAPPING DETAILS REFER TO DRG 5427-032 TO 034.

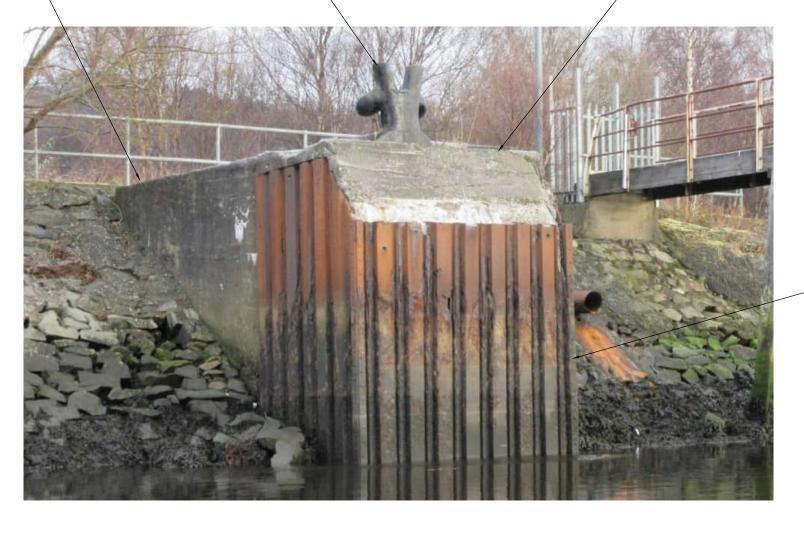
MD13A03 - INSTALL STRAPPING - SYSTEM. FOR STRAPPING DETAILS REFER TO DRG 5427-032 TO 034

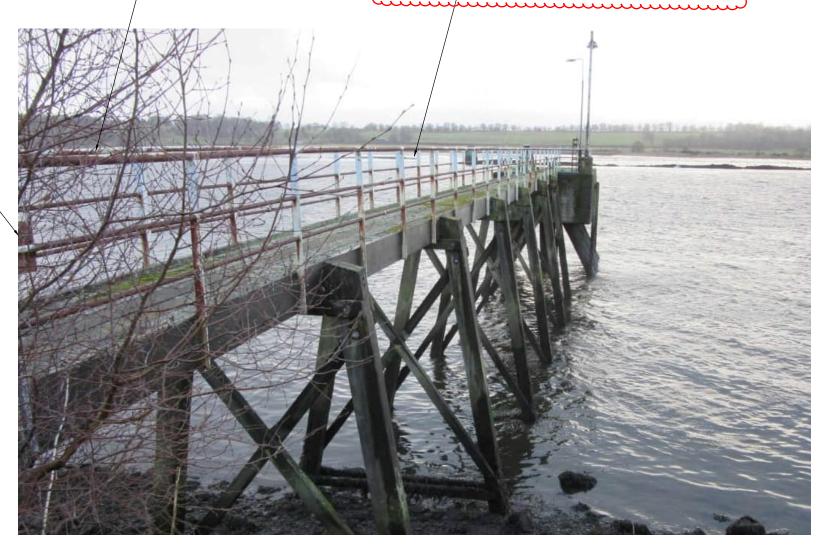
MOORING DOLPHIN ACCESS 14 (MDA14)

mOption 2 is no longer required. Physical access to the structure to be fully restricted through installation of palisade fencing with a lockable gate. Gates shall be 3.0m wide and 1.8m high, with suitable fencing, and installed as per manufacturer's recommendations with suitable foundations.

> (OPTION 2) MDA14A08 - REMOVE ENTIRE WALKWAY ACCESS STRUCTURE AND CUT TIMBER PILES 1m BELOW RIVERBED.

M14A07 - INSTALL ONE SIGN TYPE C ON LANDSIDE, FOR SIGN FIXINGS -REFER TO DRGS 5427-035 & 036

MDA14A06 - REMOVE FIRST SECTION OF WALKWAY

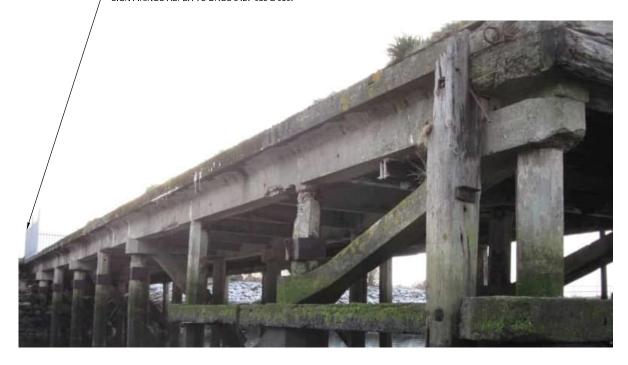
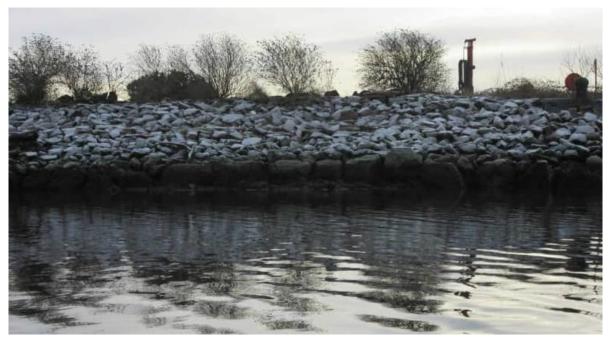
JETTY 1 (J1) OPTIONS 1 & 2

J1A02 - INSTALL ONE SIGN TYPE A ON THE PALISADE FENCE FACING THE ROADSIDE. FOR SIGN FIXINGS REFER TO DRGS 5427-035 & 036.
