# MULTIBEAM AND GEOPHYSICAL SURVEY

# STORNOWAY HARBOUR

**SURVEY REPORT**

A5006

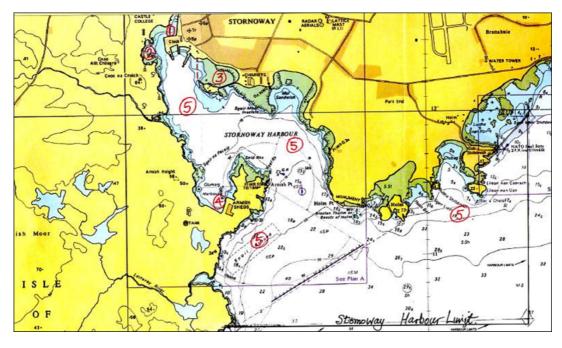
Area 5 was the remainder of Stornoway Harbour limits of responsibility. This was further subdivided by a line running east-west through Arnish Point, giving an inner and outer area.

Figure 1 - Overview of the survey area, with sub-areas marked in red

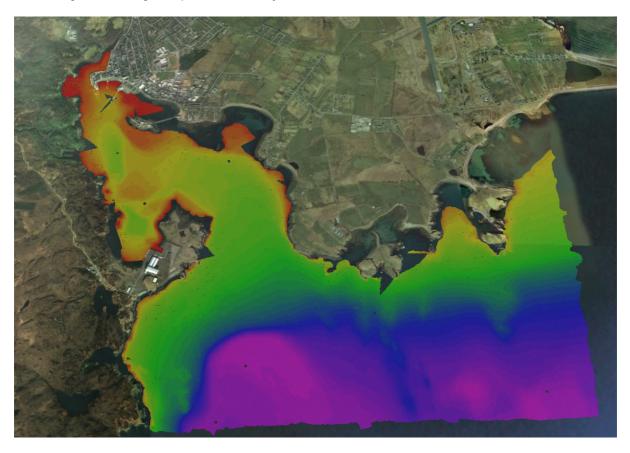
Figure 2 - Overview of the bathymetry in Stornoway Harbour (depths coloured 0 to 40m, red to magenta)

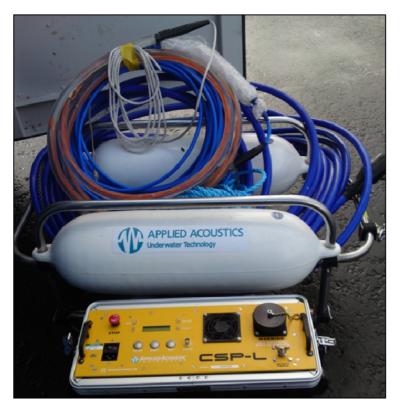
Figure 4 - Applied Acoustics boomer system utilised for the sub-bottom profiler surveys

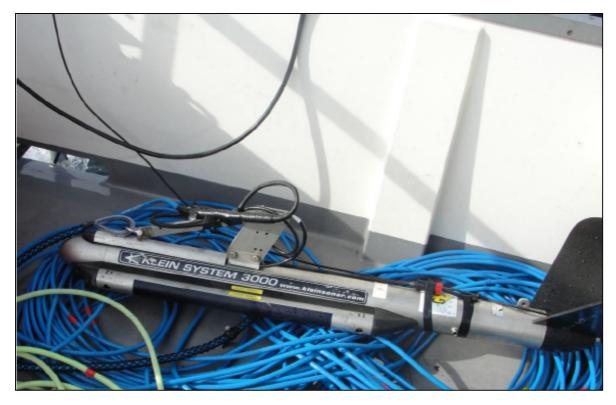
Figure 5 - Klein 3000 500kHz side-scan sonar system, used for the side-scan sonar survey in Glumaig Harbour, Area 4

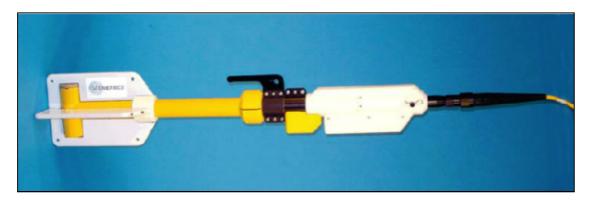
The magnetometer survey was carried out with a Geometrics G882 Caesium Vapour magnetometer which can measure total field strength to a precision of 0.02nT.

Figure 6 - Geometrics G882 Caesium Vapour magnetometer as used for the magnetometer survey

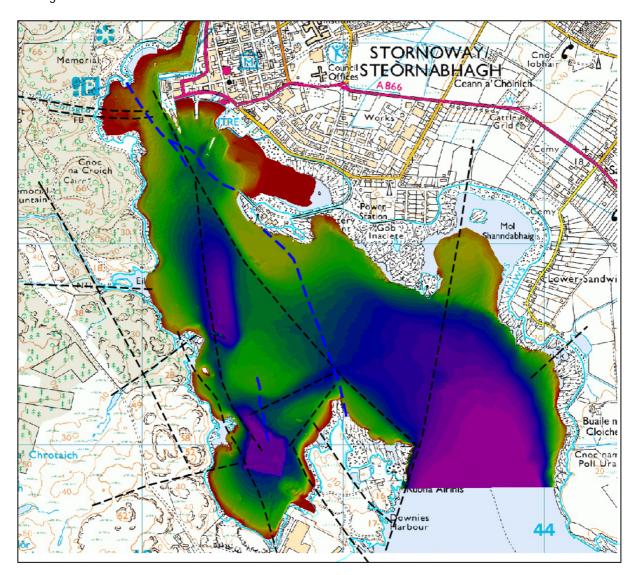
Figure 7 - Bathymetric map superimposed on the Ordnance Survey 1:25k map with a number of linear features interpreted (black pecked lines) and the axes of the longer magnetic anomalies shown as blue pecked lines.

A pronounced, continuous magnetic anomaly passes axially through the harbour: NNW-trending from the north tip of Arnish point towards Goat Island then turning more north-westerly to pass close south west of Goat Island towards the small headland south of Lews Castle. This is likely to be the anomaly shown in Annex F Figure 7, from the regional aeromagnetic data and probably caused by a significant basaltic dyke within the bedrock.

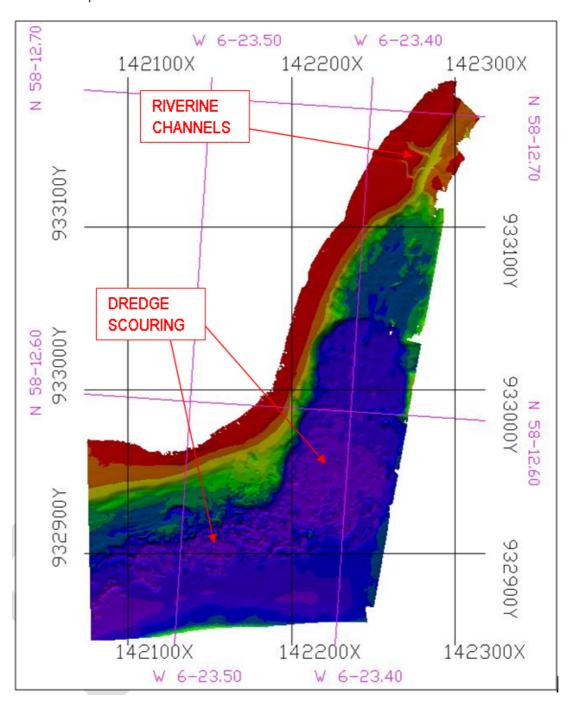
The bathymetric survey of Area 1 covered a depth range of 2.49m above Chart Datum to 4.33m below Chart Datum. This area contained pontoons and moored vessels, and was limited on the east and south sides by Cromwell Street Quay and North Beach Quay. In the north-east corner seabed channels characteristic of the riverine input can be seen in Figure 8. Evidence of dredging activity can be seen in the deeper areas, with the semi-circular scour patterns indicative of this.

Figure 8 - 0.5m gridded soundings showing the extents of Area 1, riverine channels and dredge scouring

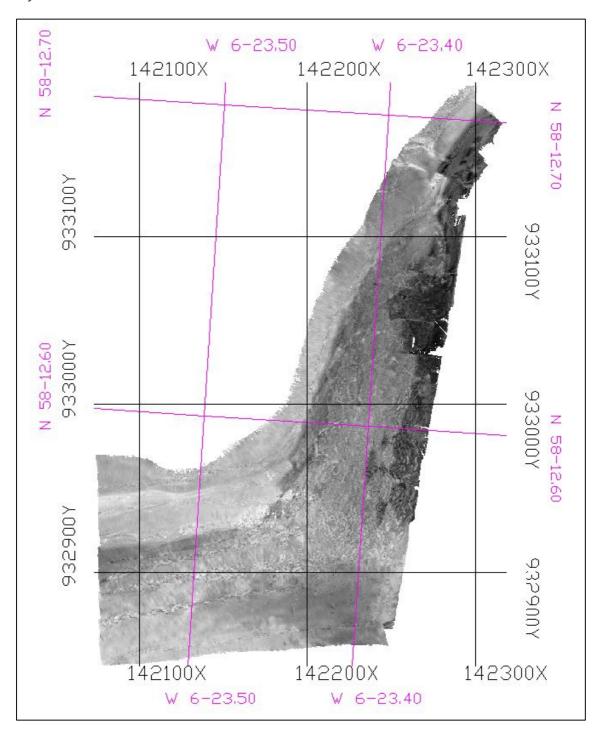
The numerous bright, linear features that can be seen along Cromwell Street Quay can be identified as the mooring ropes holding the pontoons in place and not as seabed features. The dredge scours are also shown clearly in the backscatter data.

Figure 9 - Backscatter data from the multibeam system for Area 1, showing areas of differing sediment type (brighter colour corresponds with higher backscatter)

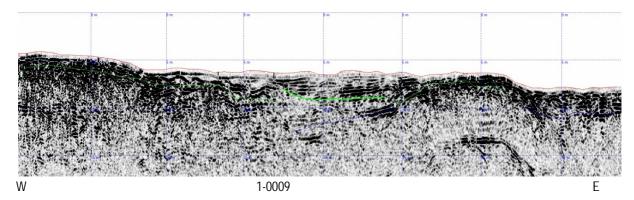
The seismic data in this area appear to indicate that the substrate is mainly rock (Permo-Triassic conglomerate) at or near surface, possibly even within the main N-S channel towards the east of the area. The bedrock may have a thin drape of modern marine or intertidal silty mud overlying pockets of sediment with inclined stratification (perhaps glacial sand and gravel) up to 6-8 m thick (e.g. line 1-0009). Thicker sub-seabed sediment sequences with parallel or low angle cross-stratification occur locally, for example filling an elongate hollow (traversed by 1-0009, Fig. A2) to the west of a south-trending bedrock promontory.

Figure 10 - Line 1-0009 crossing a sediment-filled feature.

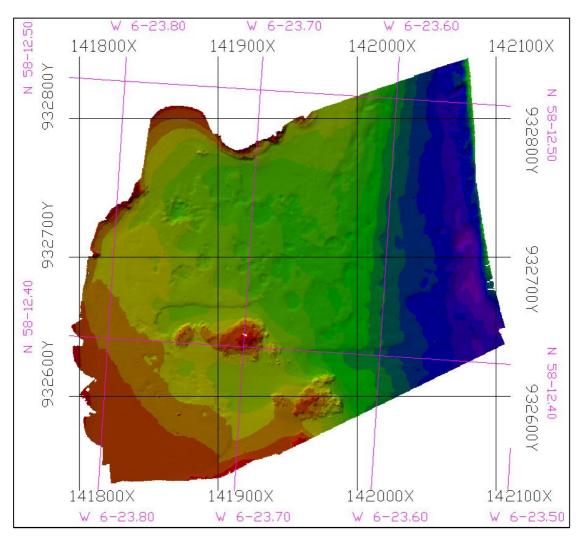
Area 2, a basin to the west of Esplanade Quay, contained a large concentration of moorings, which can be seen as shallow, round depressions in Figure 11, a rendered image of the bathymetric data. The depth range of this area was from 2.46m above Chart Datum to 6.28m below it. Bounded on the west side by a rocky shore and the east by the Esplanade quay wall, there are also two prominent areas of rock outcropping in the south-west quadrant of Area 2.

Figure 11 - TIN image generated from 0.5m gridded soundings showing the extents of Area 2

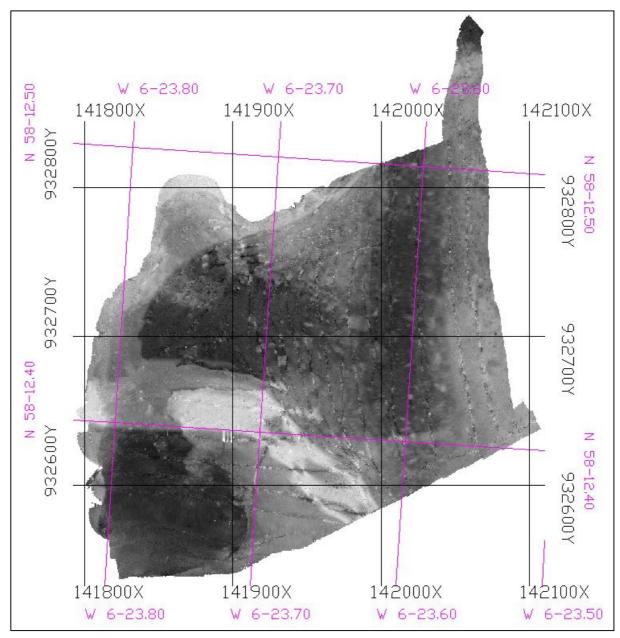
Figure 12 - Backscatter data from the multibeam system for Area 2, showing areas of differing sediment type (brighter colour corresponds with higher backscatter)

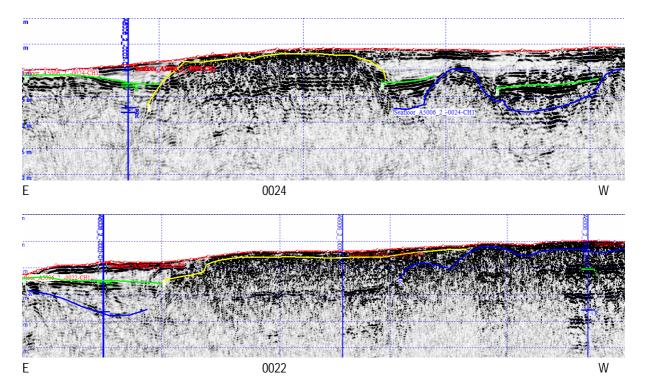
The bathymetric data show a very gently east-shelving seafloor 'platform' broken by bedrock outcrops in the southern part, passing over a steeper slope into the deeper channel to the east of the area. In the vicinity of the outcrops, the surface is offset by E-trending features that appear to be a continuation of features evident on land to the west.

Figure 13 - Two lines showing the different elements of the sub-seabed structure and composition of Area 2 with stratified sediments overlying the rugged rockhead topography and the more enigmatic smoother-topped bodies that may be till or morainic deposits or gas within the substrate.

It is difficult to rule out bedrock but the smoother form lead to an alternative explanation as relict bodies of glacial till or moraine deposits sculpted by meltwater prior to inundation and burial by the sand and gravel. If not bedrock, the acoustic energy generally fails to penetrate sufficiently to give a clear response from the underlying bedrock.

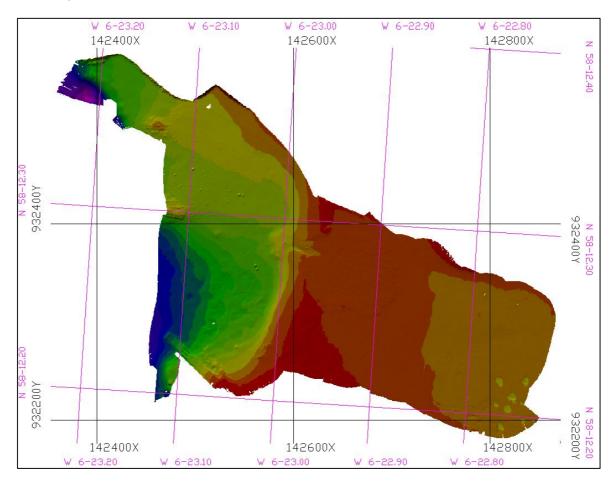
Area 3, Newtown Basin, had a depth range of 2.26m above Chart Datum to 7.39m below it. Similarly to Area 2, there were multiple moorings observed, which can be seen as shallow, round depressions in the multibeam bathymetric data Figure 14. Many of these moorings are connected to the shore with fixed mooring lines preventing a complete survey of the area in particular with the boomer system. The slipway structure of the boat yard located on the south side of this area can clearly be seen in the bathymetric data, and the armour stone around the piers can be seen in the north-west section.

Figure 14 - TIN image generated from 0.5m gridded soundings showing the extents of Area 3, Newton Basin

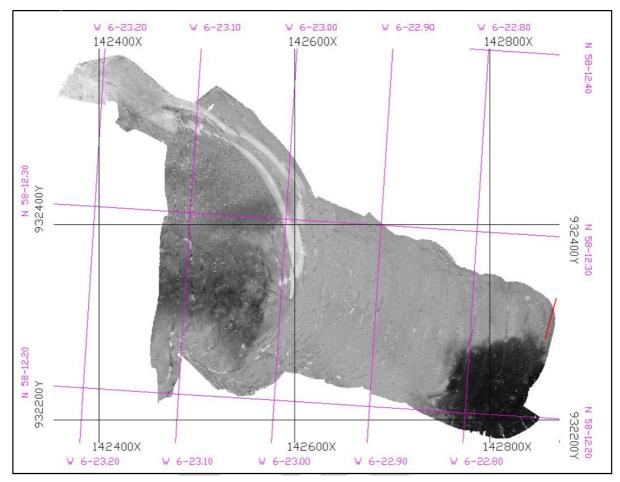
Figure 15 - Backscatter data from the multibeam system for Area 3, Newton Basin, showing areas of differing sediment type (brighter colour corresponds with higher backscatter) and linear object (red line highlighted)

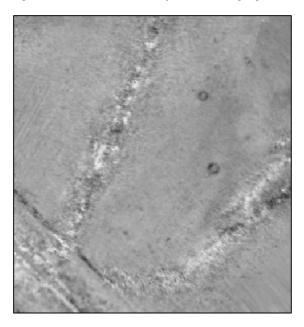
Figure 16 - An extract of the backscatter data for Area 3 showing two tyres on the seabed, close to the slipway (seen on the bottom left of the image)

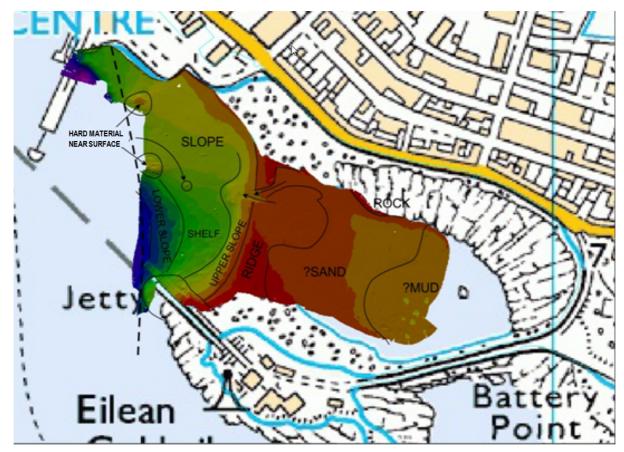
Figure 18 - Bathymetric data for Area 3 superimposed on the Ordnance Survey 1:25 k scale topographical map

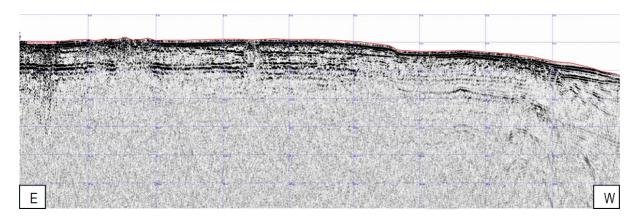
within the inner bay (e.g. line 3-0010), possibly coring the northern part of the 'beach' ridge (line 3-0008) and underlying much of the gently sloping area of the northern outer bay (lines 3-0011 to 3-0019).

Figure 19 – Line 3-0008: bedrock crops out at seabed near the eastern (left) end and lies close to seabed near the western end of the data but is otherwise buried beneath a cover (up to c. 3 m thick) of seismically layered deposits unconformably overlain by a drape of sea bed sediment. A marked thickening of the layered sedimentary sequence is evident at the west end of the section (Mouth of the bay)

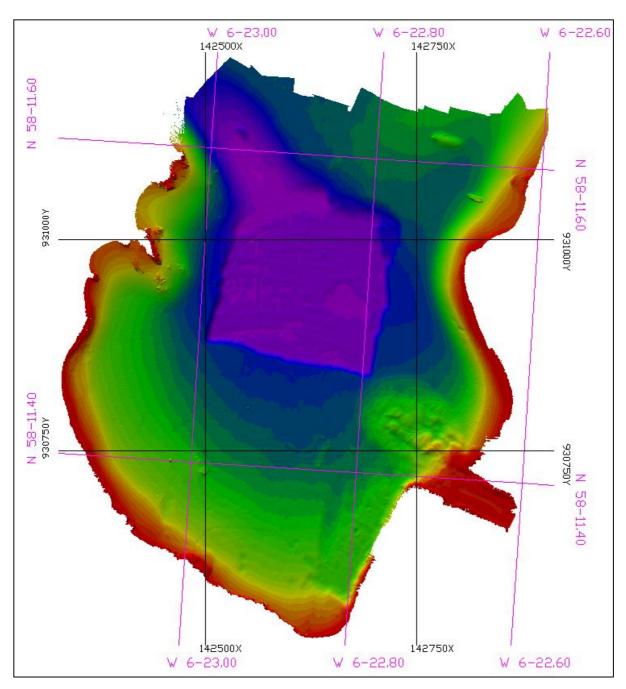
Area 4, Glumaig Harbour, had depths ranging from 2.27m above Chart Datum to 14.55m below Chart Datum. Long, linear markings can be seen on the seabed, which are likely to be anchor scour marks. One well defined wreck and 2 largely covered and dispersed wrecks can be seen in the north of the area, Figure 20 and detailed as Sonar Contacts. On the east side of Glumaig Harbour, in the vicinity of 142750 930750, an area of higher seabed can be seen protruding from the side. This is likely to be dredging spoils which have spread out over time, as the pattern shown is characteristic of this. Areas of rock outcropping can be seen around the edges of the area.

Figure 20 - TIN image generated from 0.5m gridded soundings showing the extents of Area 4

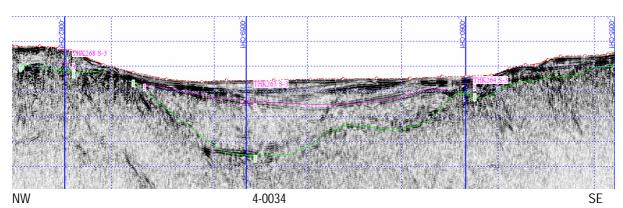
The subsurface data from Area 4 suggest a very similar scenario to that in Area 2. A very irregular rockhead topography on Lewisian gneiss, locally exposed at the sea bed, is largely buried by seismically laminated, moreor less-transparent sediments up to 15 m thick with subhorizontal to gently inclined layering and internal thickness variations 21, suggesting prograding glaciofluvial or glaciomarine clastic (sand and gravel) deposits.

Figure 21 - One of a groups of lines across a relatively deep, asymmetrical, erosional bedrock feature, feature filled with glacial deposits, the upper part of the sequence showing large-scale cross-bedding in glaciofluvial or glaciomarine sediment prograding from the east

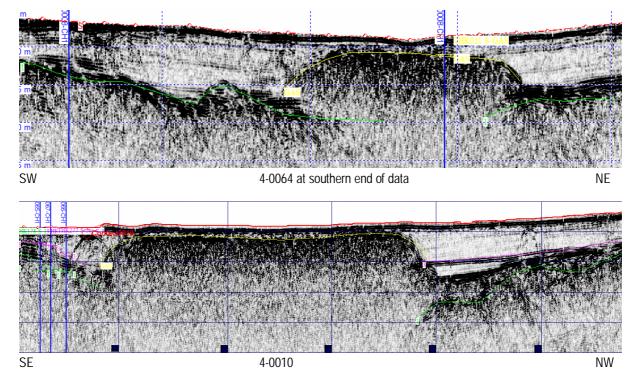
Also as in Area 2, rounded or flat topped bodies of seismically opaque material Figure 22 (Horizon 2 yellow digitised line below and blue on the rendered drawing) occur within the layered sedimentary succession; these may be bedrock but are more likely to consist of till / moraine or gas as discussed previously.

Figure 22 - Undulating bedrock surface with rounded to flat topped body of till/moraine buried by 'dished'? glaciomarine or glaciofluvial sediments, possibly sand and gravel, that show slight ponding against the steep flanks of the bedrock and till features

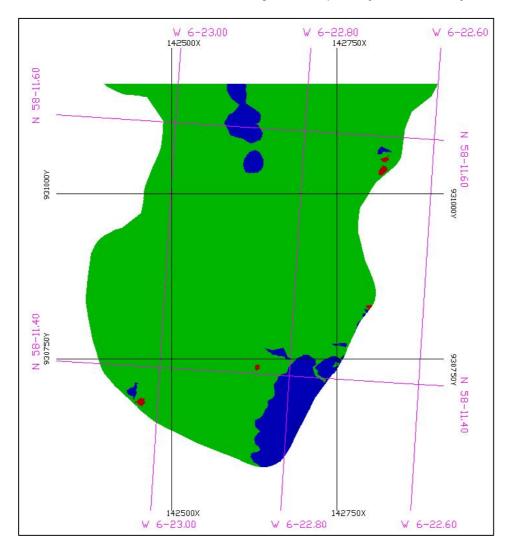
The magnetometer data for Area 4 shows several anomalies. The large anomaly in the south-east corner of the survey Figure 23 is likely to be as a result of the proximity of the pier and dock wall. Other small anomalies may be attributed to wrecks and other debris related to Glumaig Harbour's proximity to a fabrication yard.

Figure 23 - TIN image of Area 4 generated from 2m sorted data showing background magnetic field strength, with anomalies in blue (negative) and red (positive)

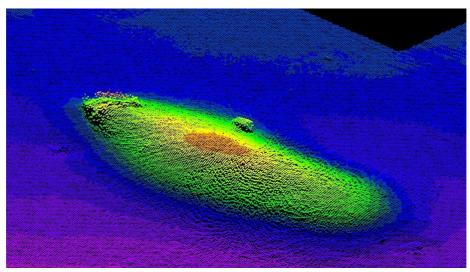
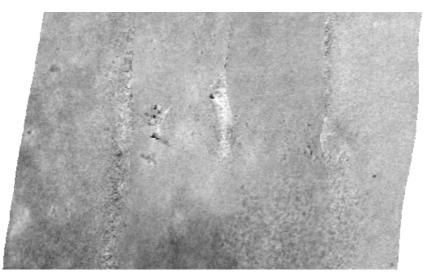
A5006_SSS_11							
A5006_SSS_11 Position (E/N) 142785 931116	Position (WGS84) 58 11 38.26N 006 22 39.10 W	Dimensions (Length x Breadth x Height above seabed) 35.5 x 10.7 x 1.6m	Surrounding Depth (Chart Datum) 8-9m	Least Depth (Chart Datum) 5.49m	Suspected remains of the known wreck Andalina. Last divers report detailed a boiler as the		
					last remains. This may be		
					the visible object in the		
					images below.

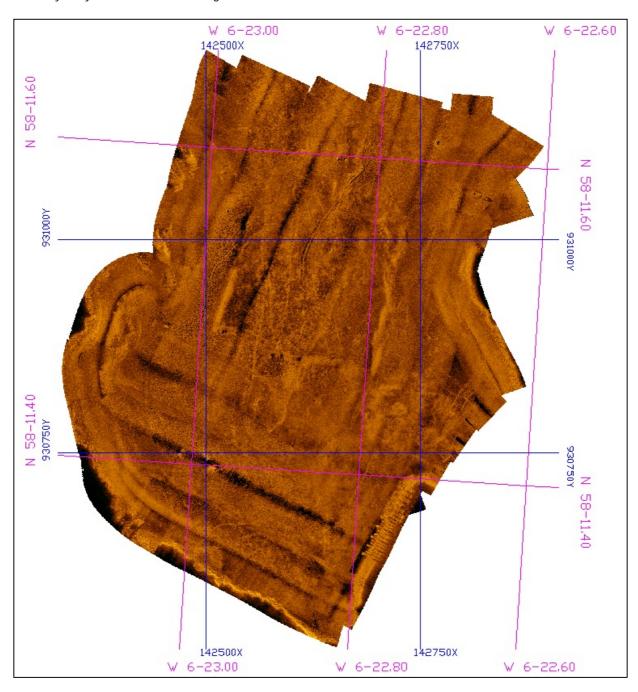
Mosaicked as a whole, the side-scan sonar survey of area 4 shows the dredged box in the centre of the harbour clearly, and highlights outcroppings of rock around the edges. The long, linear scour marks which can be seen in the bathymetry are also shown well Figure 24.

Figure 24 - Mosaicked side-scan sonar data for Area 4, Glumaig Harbour

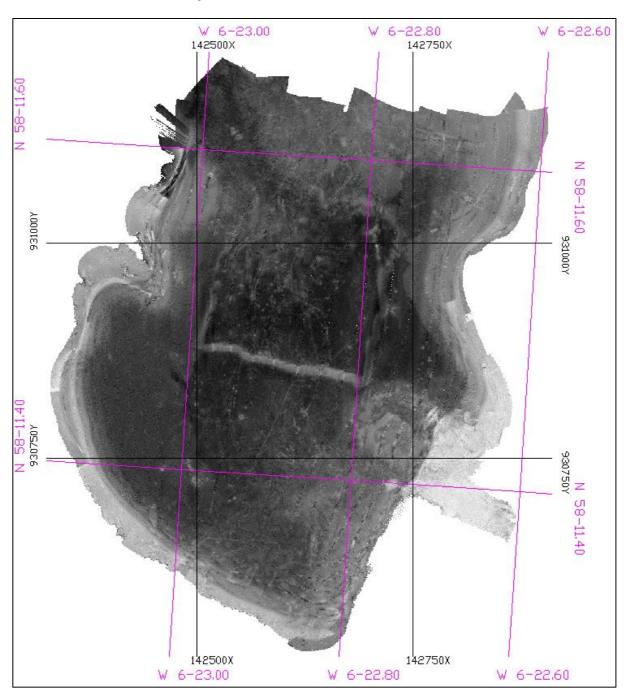
The edges of the dredged box in the centre of Glumaig Harbour show up as bright lines on the backscatter data as a result of their steep sloping sides. The backscatter around the edges of the harbour is generally higher than in the centre, with numerous patches of rock outcropping seen and again steeply sloping edges. This data ties in well with the side-scan sonar survey.

Figure 25 - Backscatter data from the multibeam system for Area 4, Glumaig, showing areas of differing sediment type (brighter colour corresponds with higher backscatter)

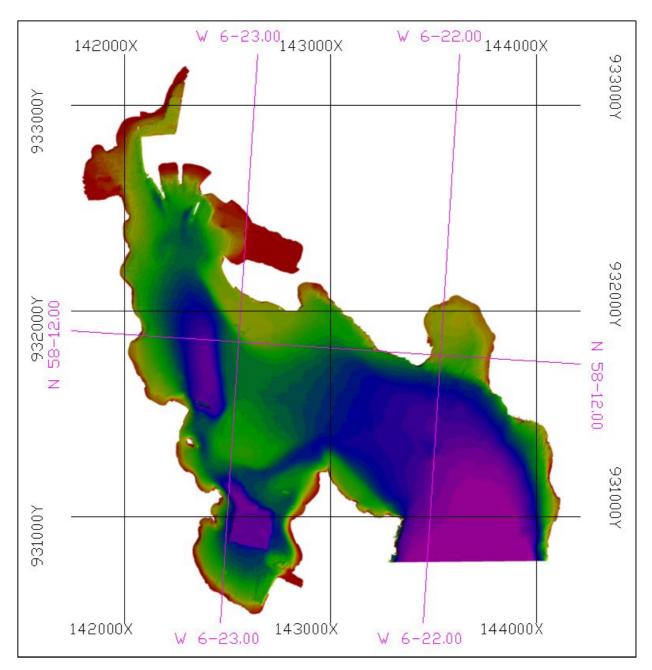
The inner section of Area 5, including all the previously described areas, had a depth range of 2.62m above Chart Datum to 16.90m below Chart Datum.

Figure 26 - TIN image generated from 1m gridded soundings showing the extents of Area 5 Inner

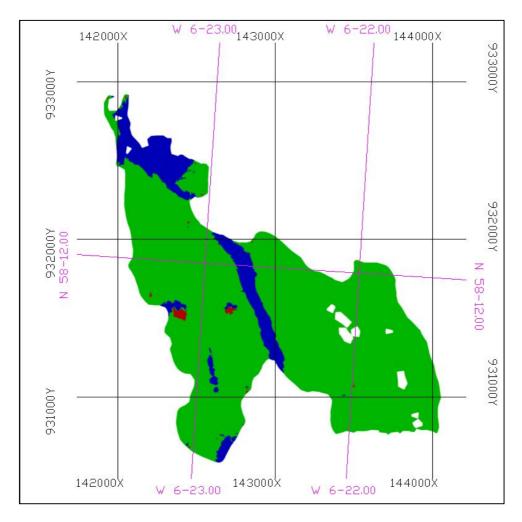
To the west of Arnish Point, another magnetic anomaly was detected that can be attributed to an object on the seabed. This has been included in Wreck Report A5006\_SSS\_13 as it represents that detected wreck, the shape and size being similar to that of the boiler of a steamship, several of which are reported to have been wrecked in the area.

Figure 27 - TIN image generated from 2m sorted data showing background magnetic field strength with anomalies in blue (negative) and red (positive), showing the extents of the magnetometer survey

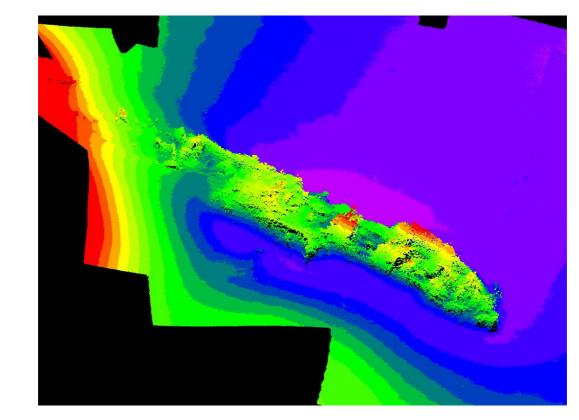
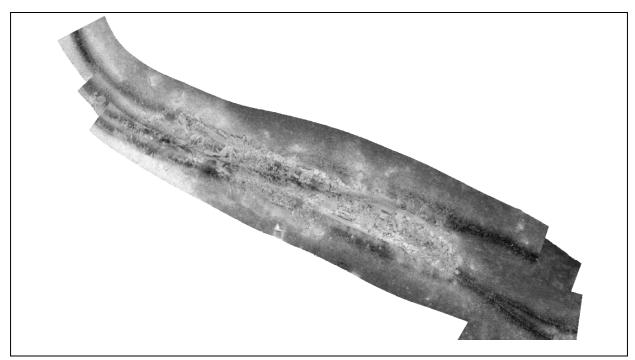
Position (E/N)	Position (WGS84)	Dimensions (Length x Breadth x Height above seabed)	Surrounding Depth (Chart Datum)	Least Depth (Chart Datum)	Remarks
142369 931549	58 11 51.38N 006 23 6.22W	112.5 x 15.2 x 5.0	13-14m	3.25m	Thought to be the wreck of the Alabama. Very broken but still a substantial wreck with significant height.

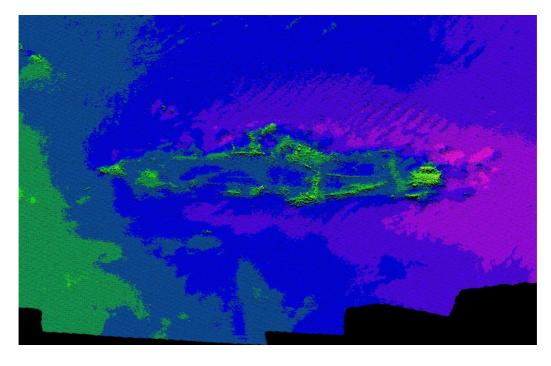
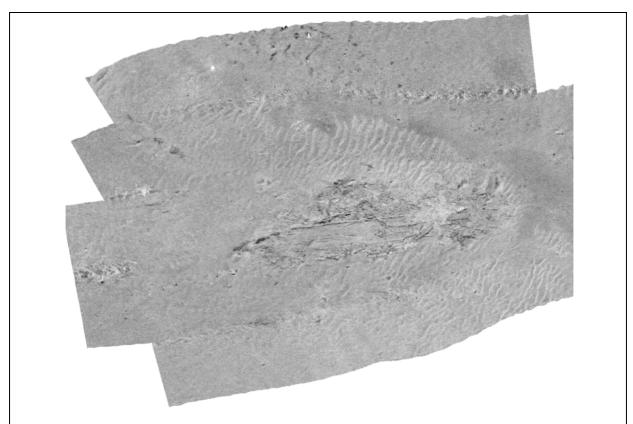
Position (E/N)	Position (WGS84)	Dimensions (Length x Breadth x Height above seabed)	Surrounding Depth (Chart Datum)	Least Depth (Chart Datum)	Remarks
142712 931566	58 11 52.63N 006 22 45.32W	71.5 x 12.7 x 0.5m	8-9m	7.46m	A very dispersed wreck debris field thought to be related to the known wreck Portugal (Charted)

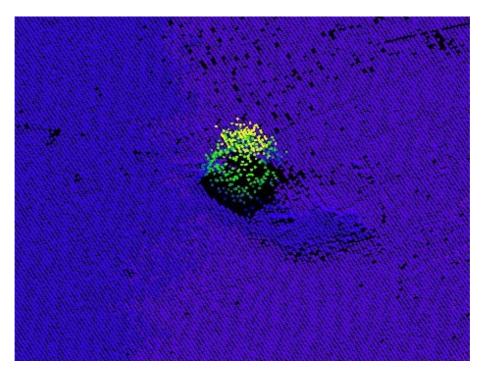
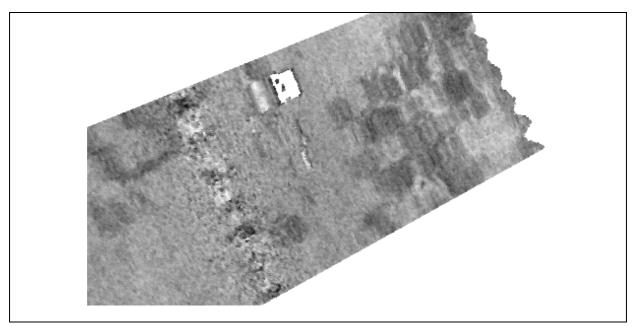
Position (E/N)	Position (WGS84)	Dimensions (Length x Breadth x Height above seabed)	Surrounding Depth (Chart Datum)	Least Depth (Chart Datum)	Remarks
143494 931080	58 11 38.59N 006 21 55.64W	4.4 x 3.9 x 3.1m	14-15m	10.64m	This magnetic contact correlates with this block feature detected on the seafloor East of Arnish Point. There is a charted Foul close north of this location. The block could possibly be associated with the ruined tower on Arnish Point.

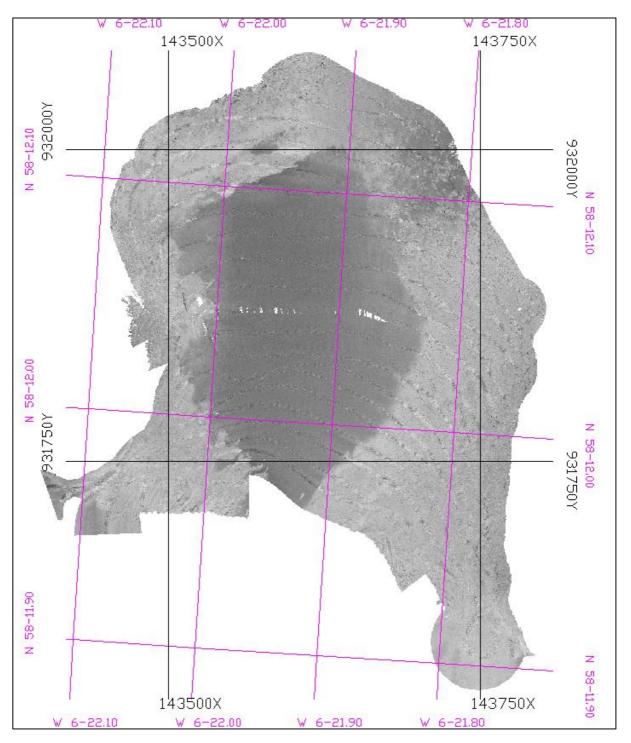
The backscatter data in Area 5 outwith the 4 sub-areas already described was split into sections by day for processing and presentation, with sections from this shown below. In Mol Sandwick, a central area of reduced backscatter was seen to be present, suggesting that the sediment around the edges of the bay is coarser and harder Figure 28. A number of small objects can be seen in the area of higher backscatter, which are likely to be boulders or moorings / fish keeps.

Figure 28 - Backscatter data from the multibeam system for Mol Sandwick, within Area 5 Inner, showing areas of differing sediment type (brighter colour corresponds with higher backscatter)

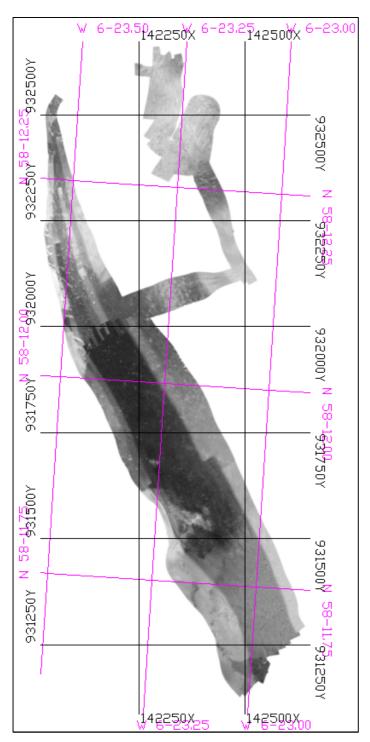
Backscatter data from along the western side of the harbour shows the shipwreck at 142369 931549 (59 11 51.38N 006 23 6.22W) clearly within a large patch of sediment with reduced backscatter. This suggests that the shipwreck rests within an area of finer sediment. Channels can be seen along the north-west edge of the area, showing as areas of higher backscatter.

Figure 29 - Backscatter data from the multibeam system for 22<sup>nd</sup> February (western side of harbour from end of No. 1 Pier in the north to the entrance of Glumaig Harbour in the south) within Area 5 Inside, showing areas of differing sediment type (brighter colour corresponds with higher backscatter)

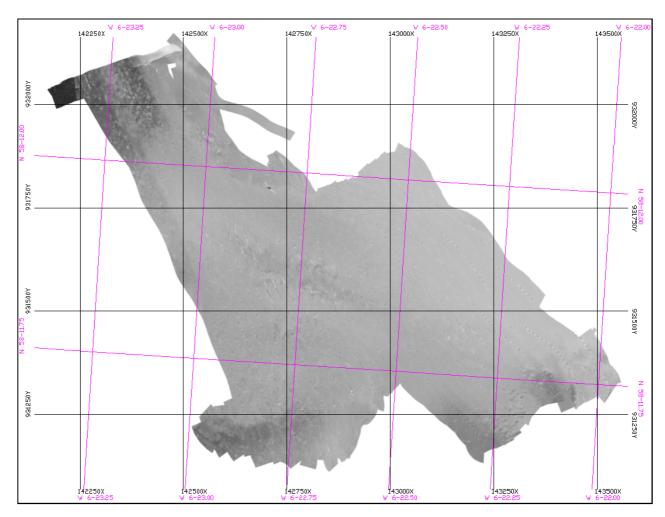
The central portion of the harbour shows a largely uniform sediment type across much of the southern part of the area Figure 30. A patch of what appears to be finer sediment can be seen in the north-west corner. Running along a line orientated north-west south-east through the site of the wreck at 142712 931566 (58 11 52.63N 006 22 45.32W) there is a patch of ripples which measure around 2.5m in wavelength from peak to peak, indicating a mobile substrate.

Figure 30 - Backscatter data from the multibeam system for 25<sup>th</sup> February (centre of the harbour from Goat Island in the north down to Glumaig Harbour in the south) within Area 5 Inside, showing areas of differing sediment type (brighter colour corresponds with higher backscatter)

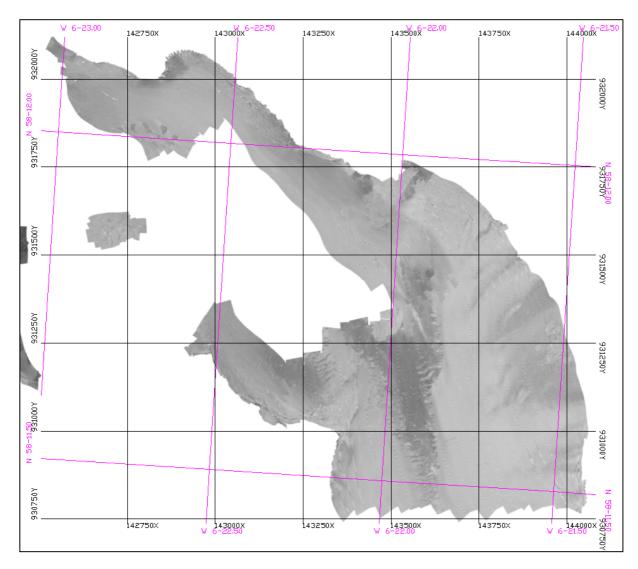
The area running along the western side of the harbour from Goat Island down to Arnish Point shows several patches of finer sediment interspersed throughout the area. A patch of possible outcropping rock can be seen just north of 143500 931250 in Figure 31, with a large area of sediment finer than the surroundings to the south of this. Another area of finer sediment can be seen at the entrance to Mol Sandwick.

Figure 31 - Backscatter data from the multibeam system for 26<sup>th</sup> February (eastern side of the harbour from Goat Island in the north to Arnish Point in the south) within Area 5 Inside, showing areas of differing sediment type (brighter colour corresponds with higher backscatter)

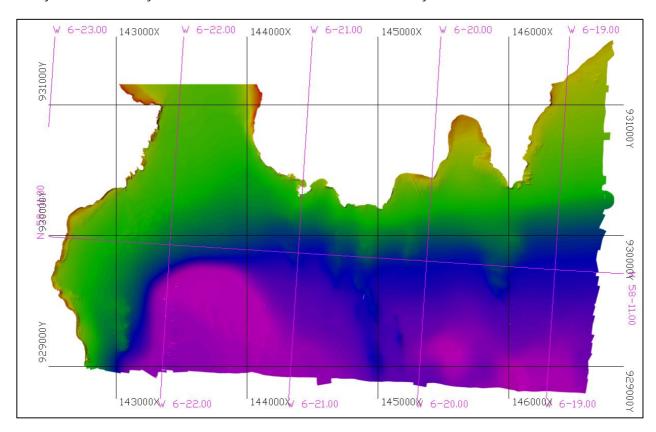
The depths in the outer section of Area 5 extended from 2.20m above Chart Datum to 45.78m below Chart Datum, the greatest depths experienced in the survey. In the deepest areas to the south of the survey, several pock marks can be seen on the seabed, measuring up to 30m across. These may be as a result of escaping gas from under the seabed. The geological report of the surrounding area states that gas blanking was seen in seismic data outside Stornoway Harbour<sup>8</sup>, supporting the idea that gas could be escaping in this part of the survey area. Alternatively, this could be evidence of historical wartime activity.

Figure 32 - TIN image generated from 1m gridded data showing the extents of Area 5 Outer

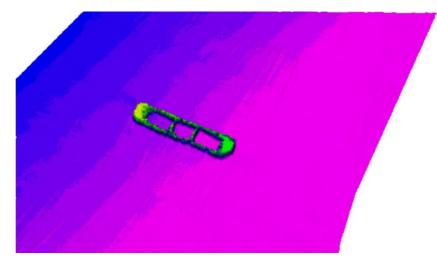
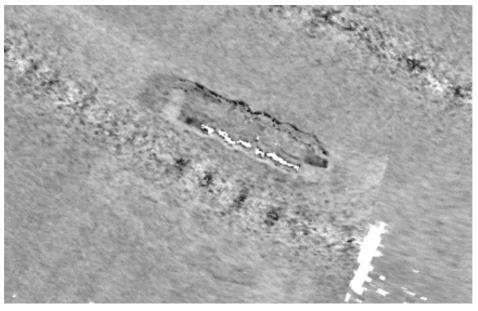
Position (E/N)	Position (WGS84)	Dimensions (Length x Breadth x Height above seabed)	Surrounding Depth (Chart Datum)	Least Depth (Chart Datum)	Remarks
142871 930027	58 11 3.33N 006 22 29.51 W	25.5 x 5.3 x 1.8m	16-17m	13.54m	Medium sized barge like structure with significant height above the seabed.

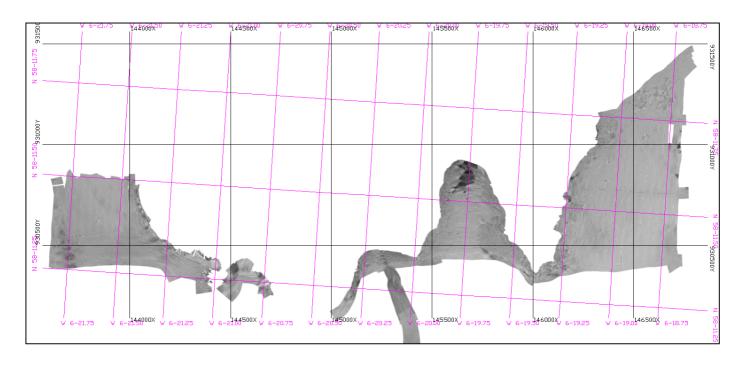
Figure 33 - Backscatter data from the multibeam system for the north-east part of the outer part of Area 5, showing areas of differing sediment type (brighter colour corresponds with higher backscatter)

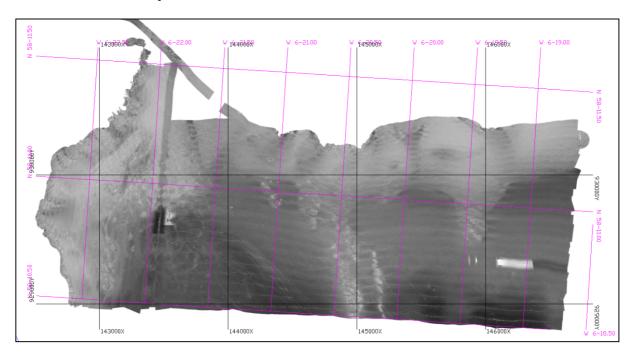
Figure 34 - Backscatter data from the multibeam system for the southern section of the outer part of Area 5, showing areas of differing sediment type (brighter colour corresponds with higher backscatter)

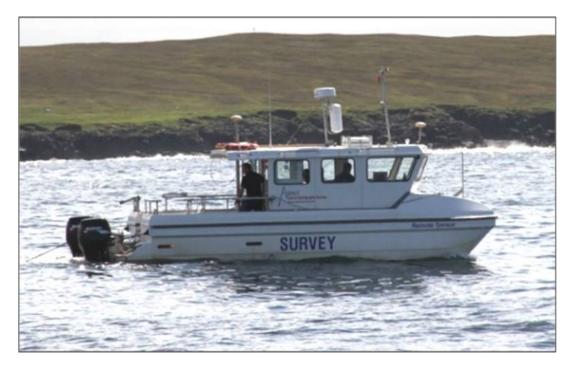
Figure 35 - Survey vessel Remote Sensor with multibeam sonar and towed sensors deployed

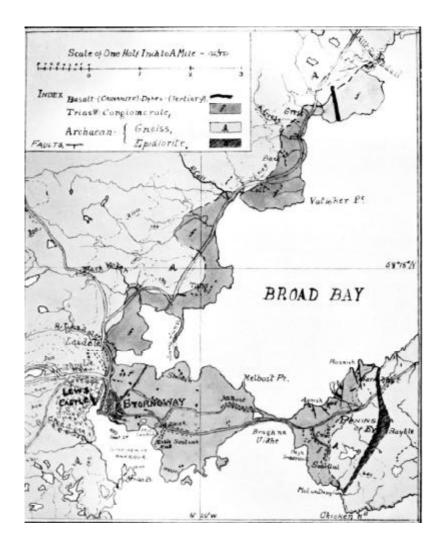
Figure 6: Sketch map of the Stornoway area from Stevens (1914)
