Banff Harbour Best Practicable Environmental Option (BPEO) Report

Client: Aberdeenshire Council
 Project Title: Banff Harbour
 Report Title: Best Practicable Environmental Option (BPEO) Report
 Document number: 13883
 Project number: 374702

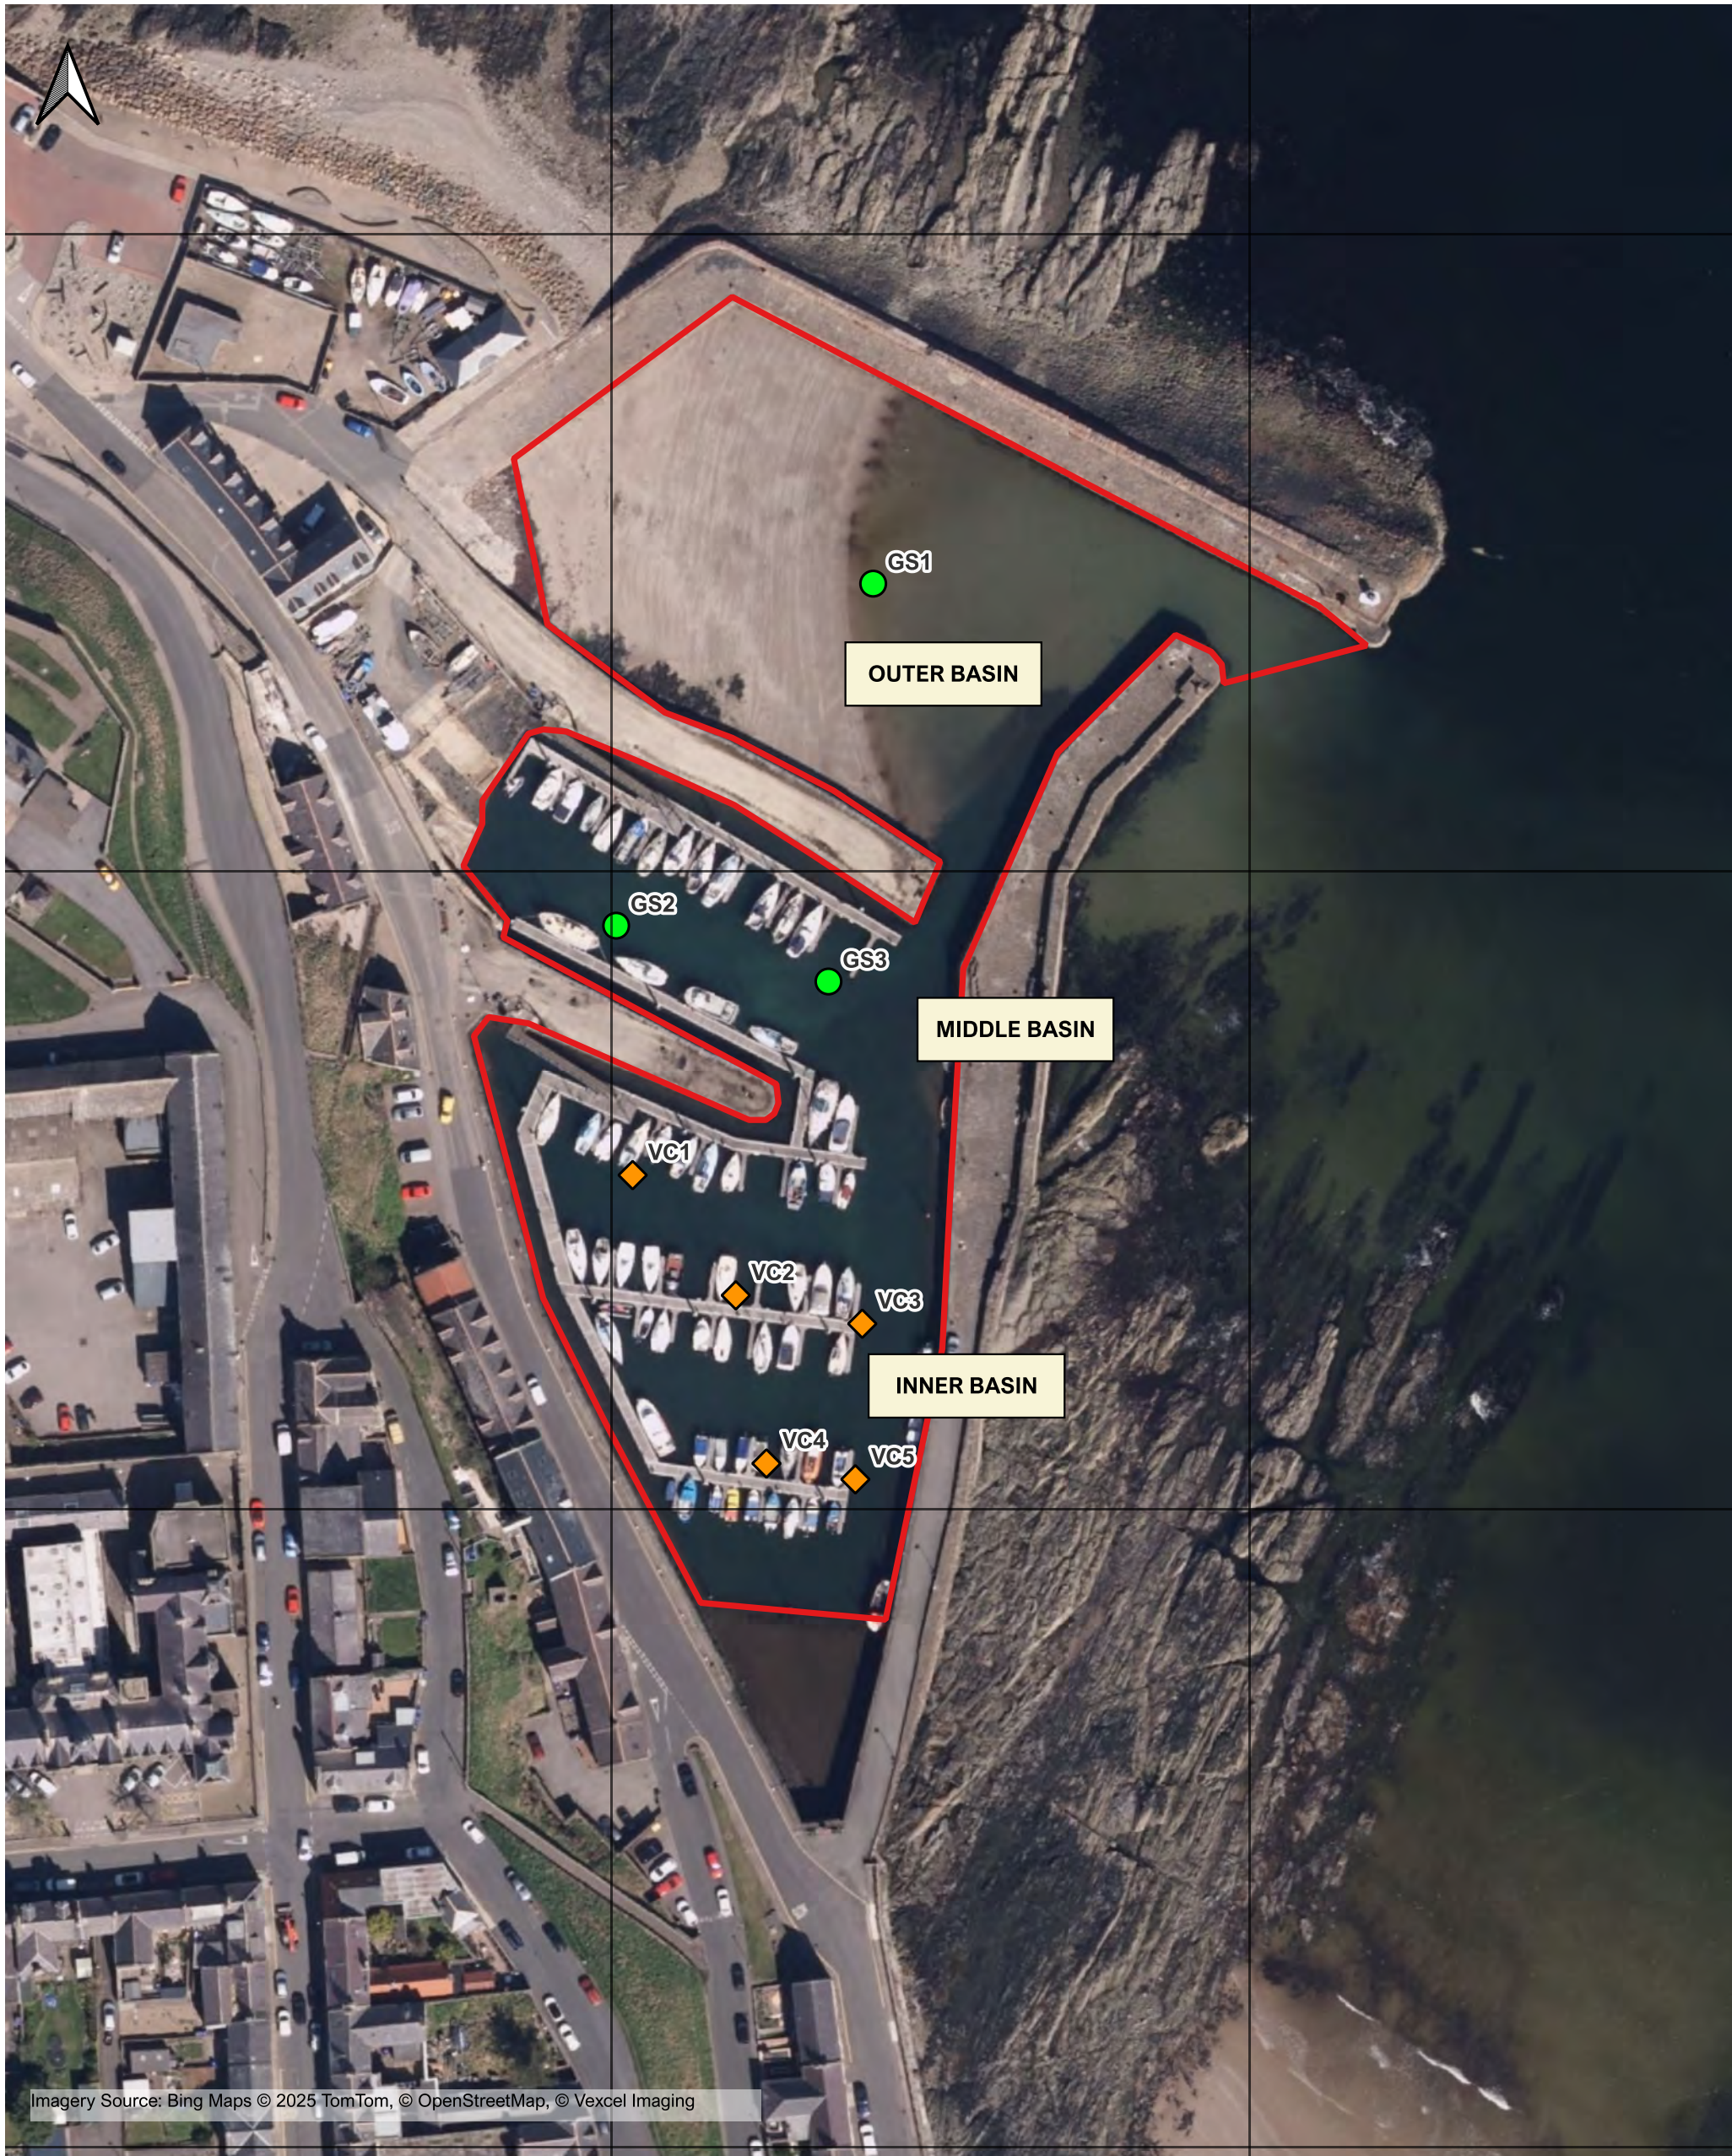
| 374702-QGIS012 | Banff Harbour Sample Stations |

Sample locations are shown in Drawing No. 374702-QGIS-012, included in Appendix A.

Sediment cores (VC) were collected from five locations, with grab samples (GS) collected from three locations. Sample station locations are outlined in Table 2-1.

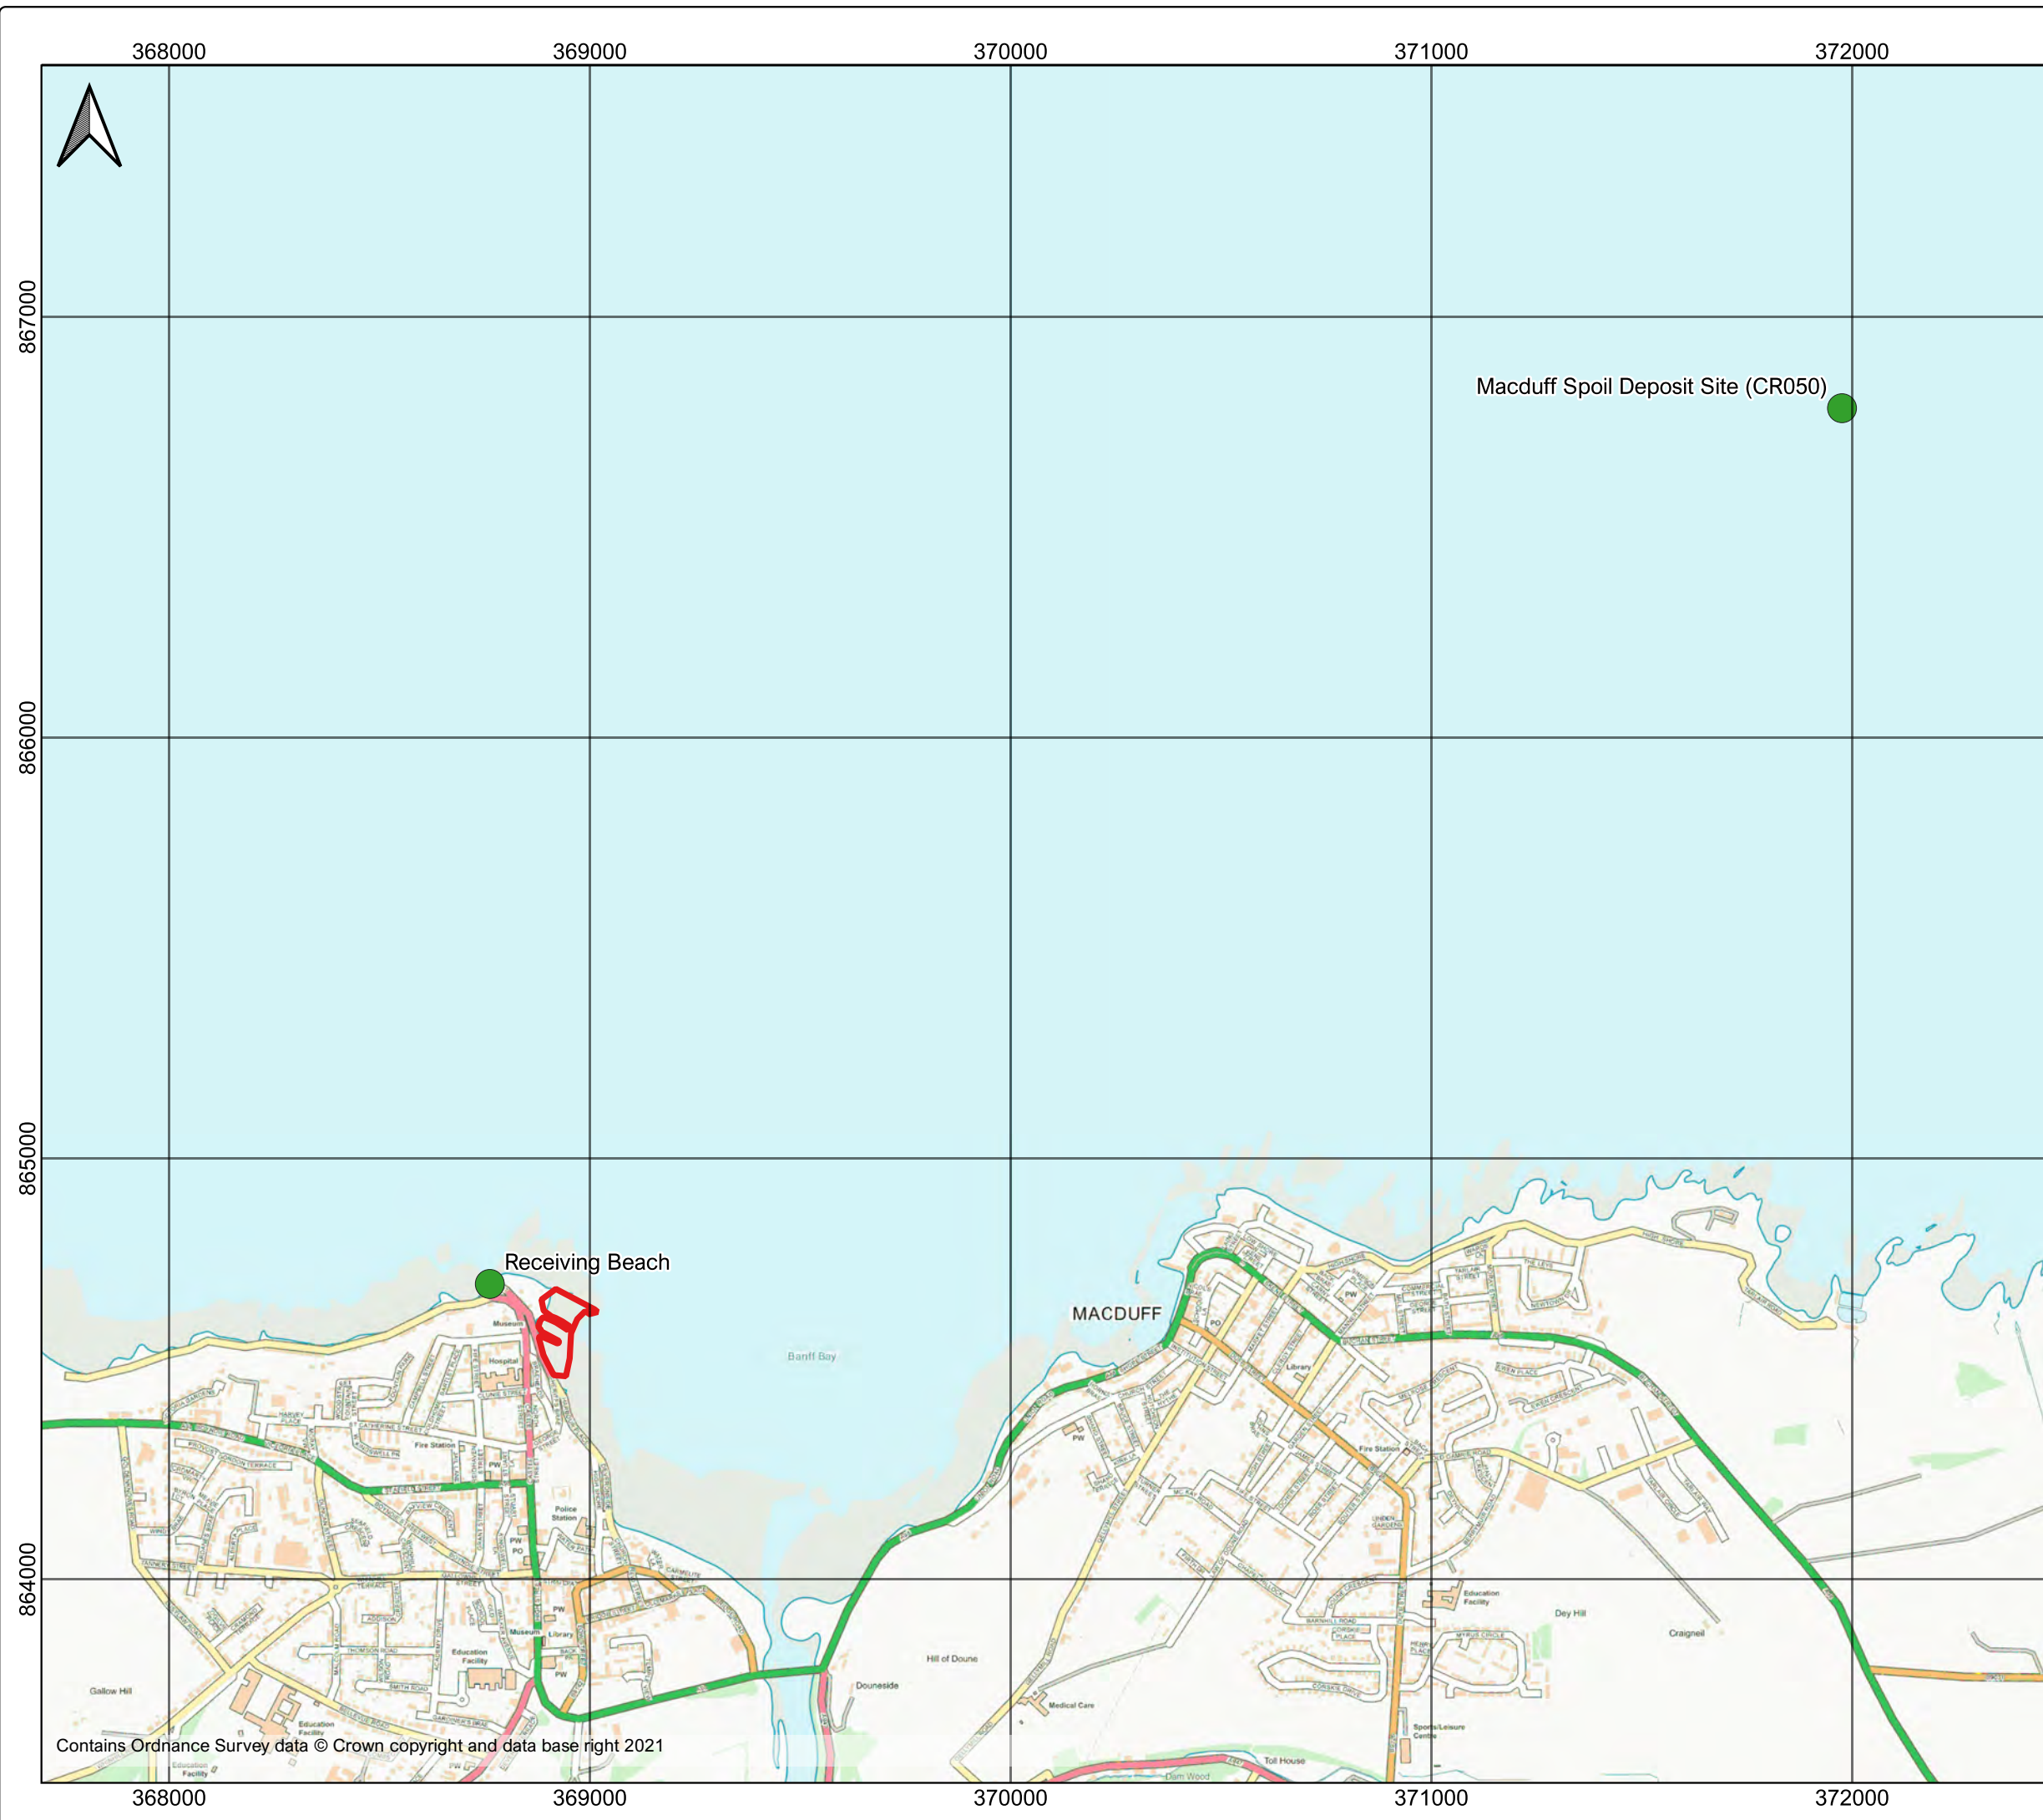
| 374655-QGIS003 | Proposed Dredged Material Deposit Sites |

Material to be disposed of at sea is deposited at the Macduff disposal site (CR050). The proposed receiving beach for the sand material from the outer basin is 150 metres west of the harbour. Proposed disposal locations are shown on Drawing No. 374655-QGIS003 in Appendix A. It should be noted that depending on available marine plant and the finalised dredging method, then it may be proposed that all material is destined for sea disposal.

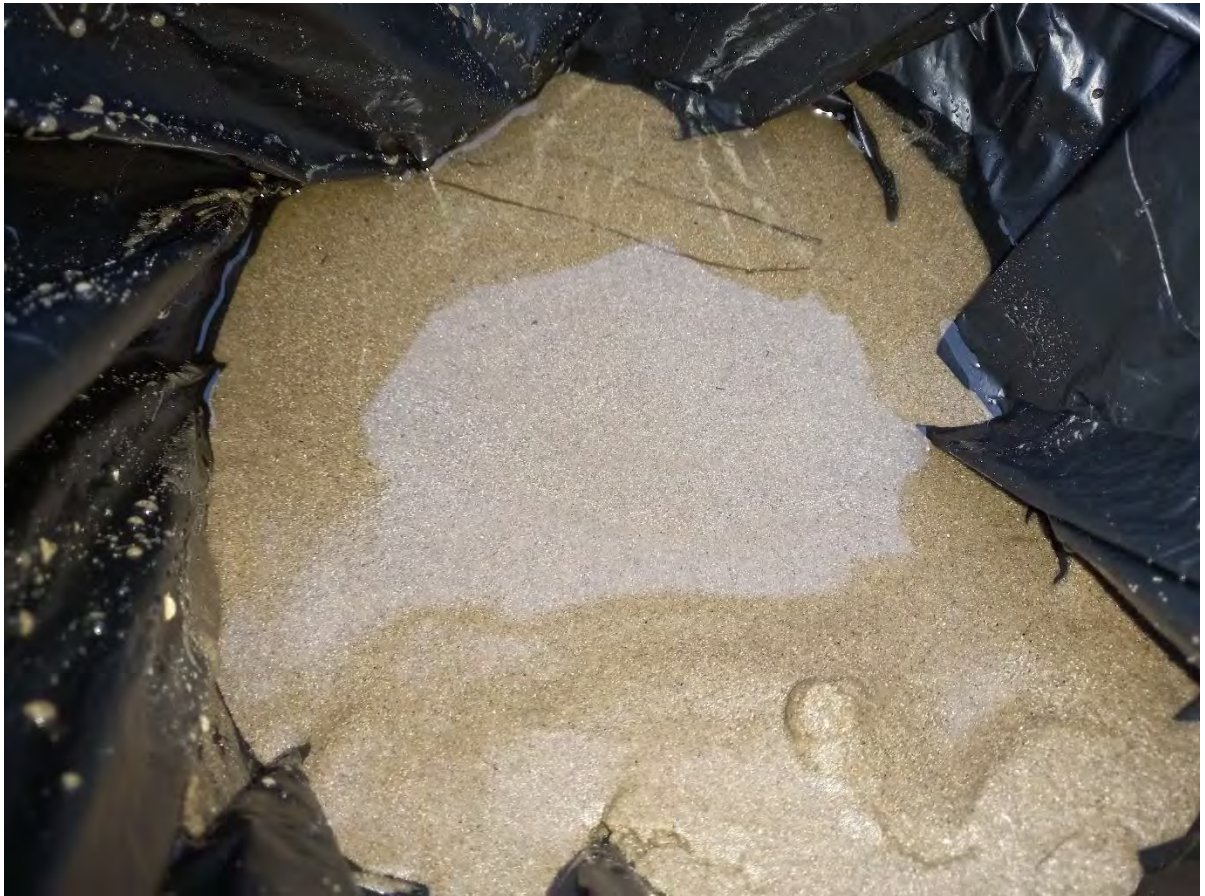
GS2

Notes: Several attempts made from the south pontoon in the middle basin. Very little sediment obtained.

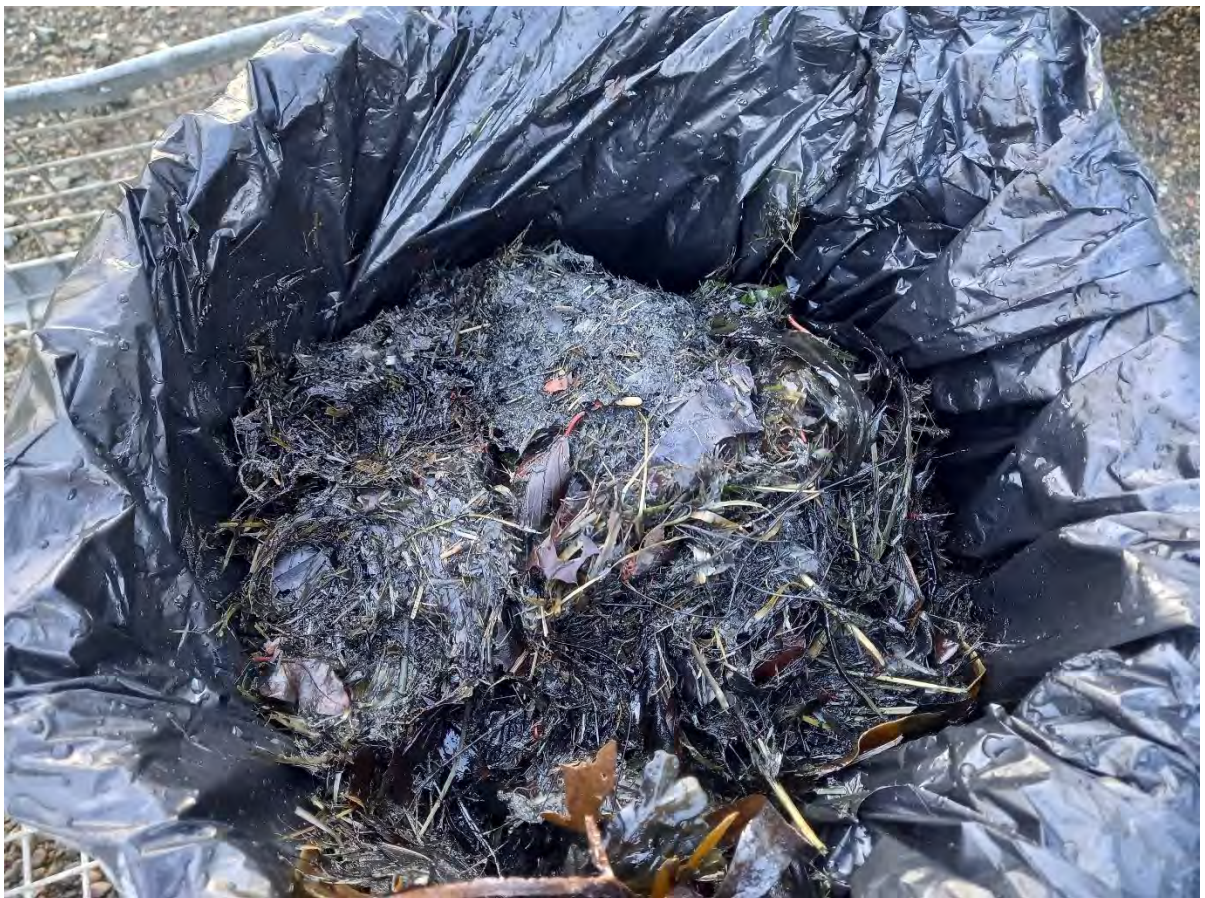
GS3

Anthropogenic Inputs: Singular small fragment of hard plastic.

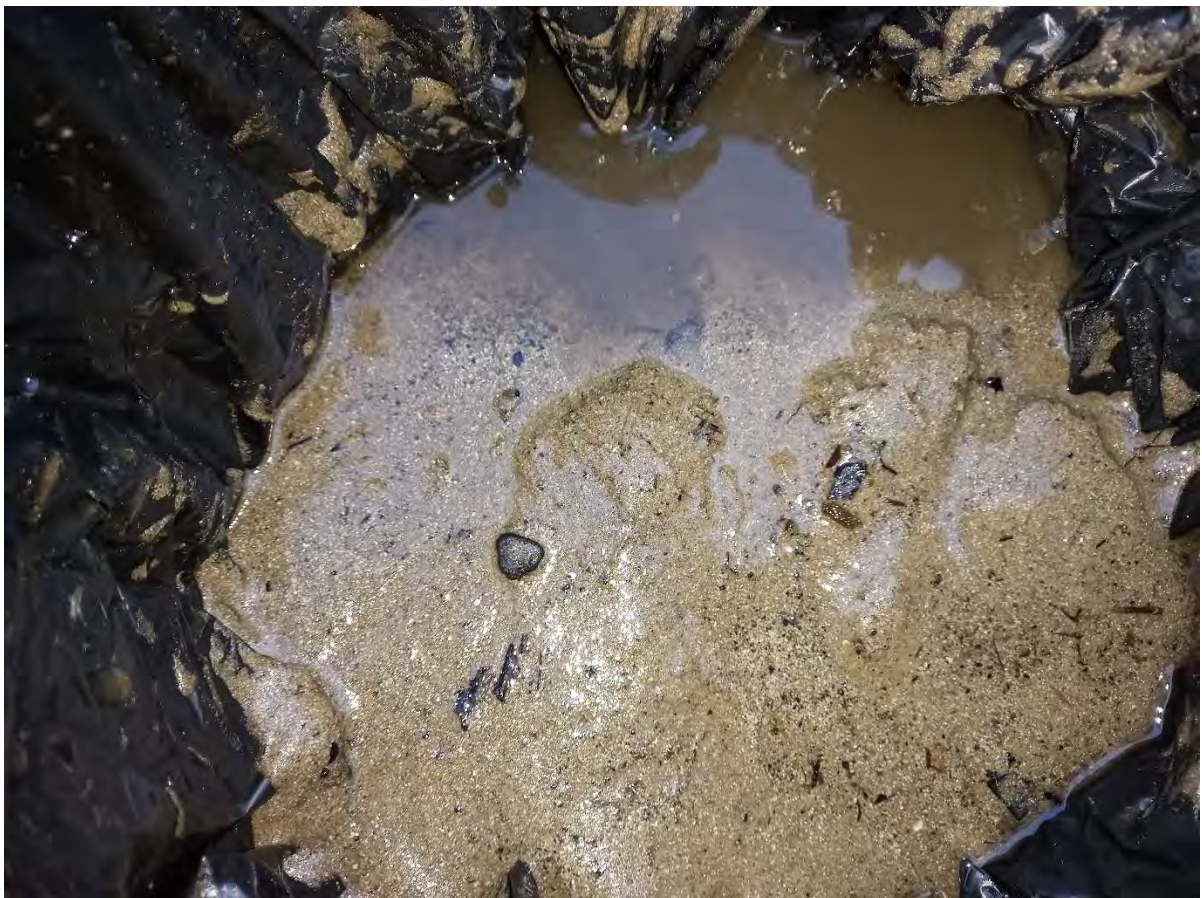
Project Name	Banff Harbour, Aberdeenshire	Location ID VC1
Project No.	374702	
Client	Aberdeenshire Council

SEDIMENT CORE LOG

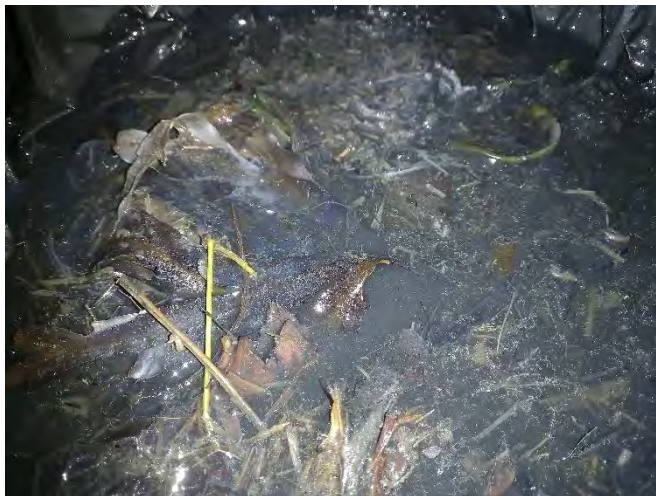
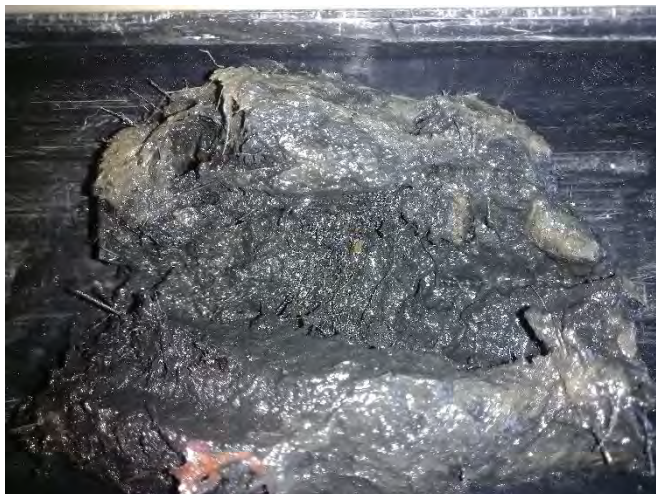
Notes: Maximum depth achieved with vibrocore was 0.25m, with two attempts and micro-siting undertaken. Probable bedrock obstructing further sampling depth.

As discussed in Section 2.3, organic parameters were noted to be deviating within core samples VC1 (0.0-0.25m) and VC5 (0.0-0.2m). This was due to very limited recovery of sediment and depth of these cores, meaning that only one container could be filled. The plastic tub was prioritised to allow the metals suite to be analysed without deviation. This was considered the most appropriate course of action given the historical elevated concentrations of copper and zinc at Banff Harbour. Analysis of the organic parameters was undertaken regardless to provide as much information as possible.

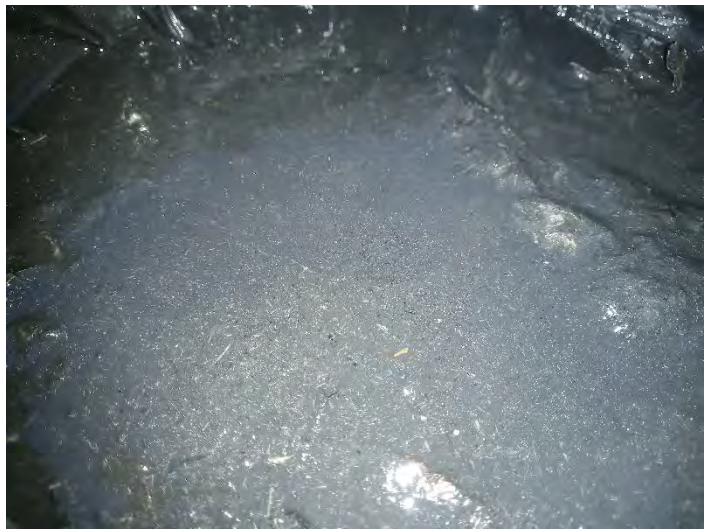
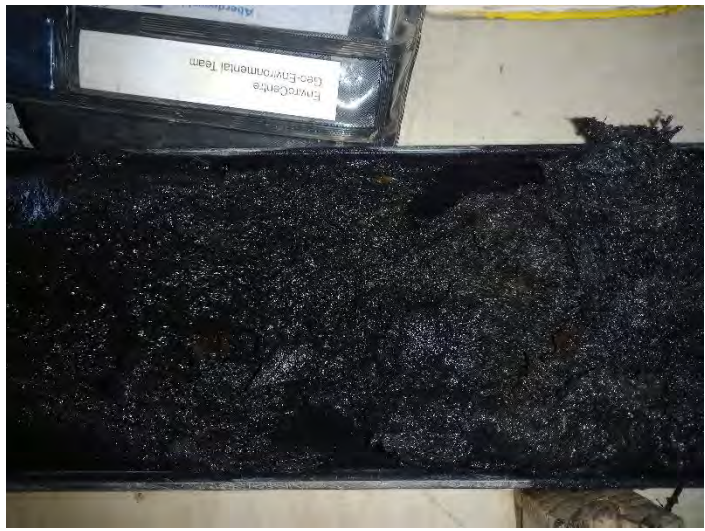
Project Name	Banff Harbour, Aberdeenshire	Location ID VC2
Project No.	374702	
Client	Aberdeenshire Council

0.0 – 0.7m (Vibrocore) Soft dark grey/black silt (very soft at surface) with occasional vegetation and leaf litter. Mussel shell noted at 0.2m.

Biota: One crab noted within grab sample.

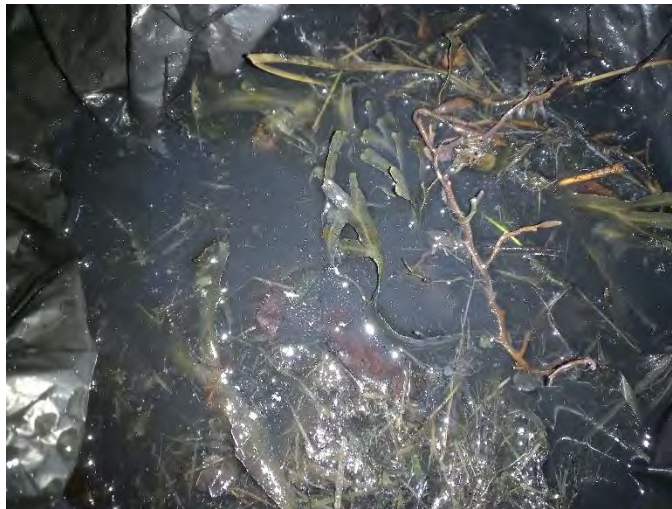
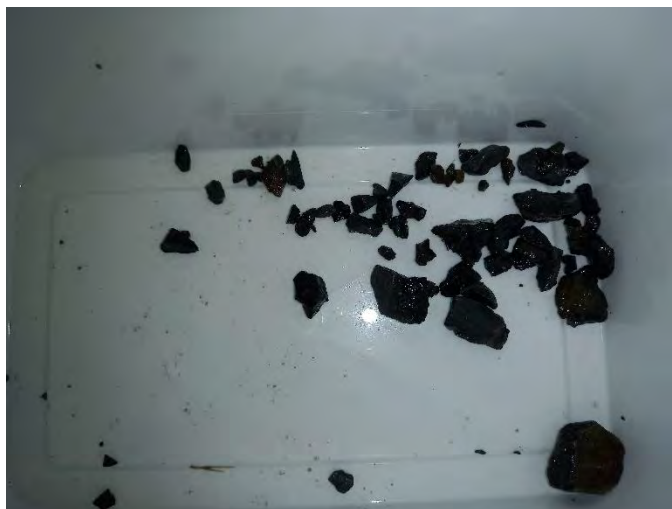
Project Name	Banff Harbour, Aberdeenshire	Location ID VC3
Project No.	374702	
Client	Aberdeenshire Council

Notes: Vibrocore sampling provided no recovery of sampleable material other than a few dark grey pieces of fine gravel.

No core sample was obtained at proposed location VC3, despite several attempts in the vicinity. The vibrocore recovered only a few dark grey pieces of fine gravel, suggesting that the core barrel was hitting bedrock. A grab sample was however able to be obtained.

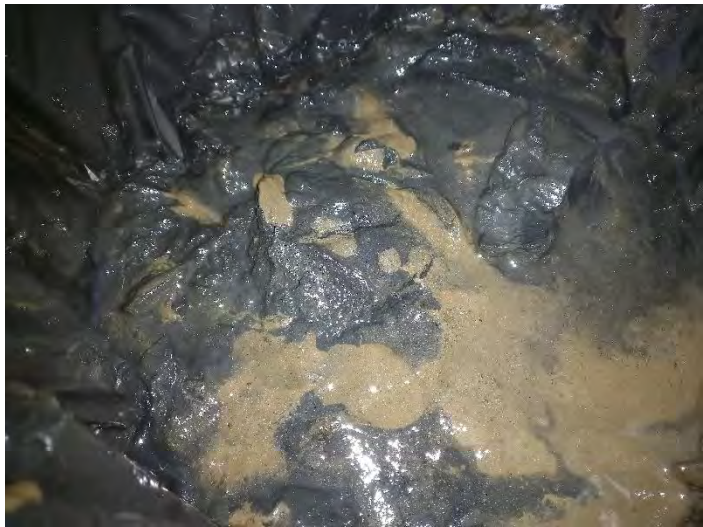
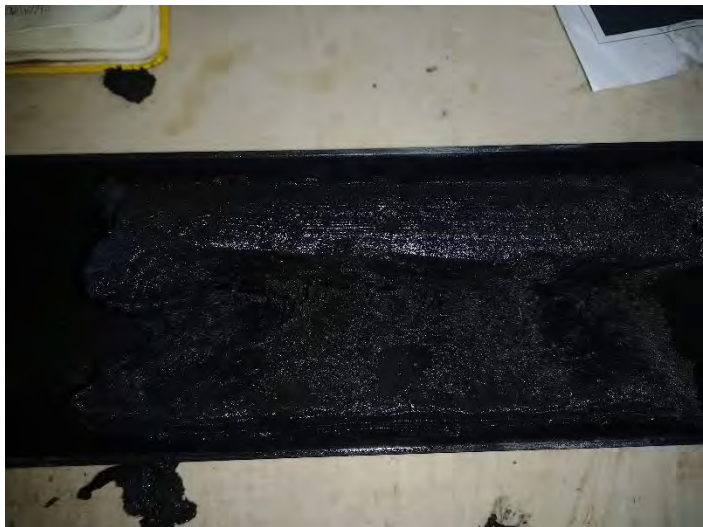
Project Name	Banff Harbour, Aberdeenshire	Location ID VC4
Project No.	374702	
Client	Aberdeenshire Council

Notes: Maximum depth achieved with vibrocore was 0.85m. Probable bedrock obstructing further sampling depth.

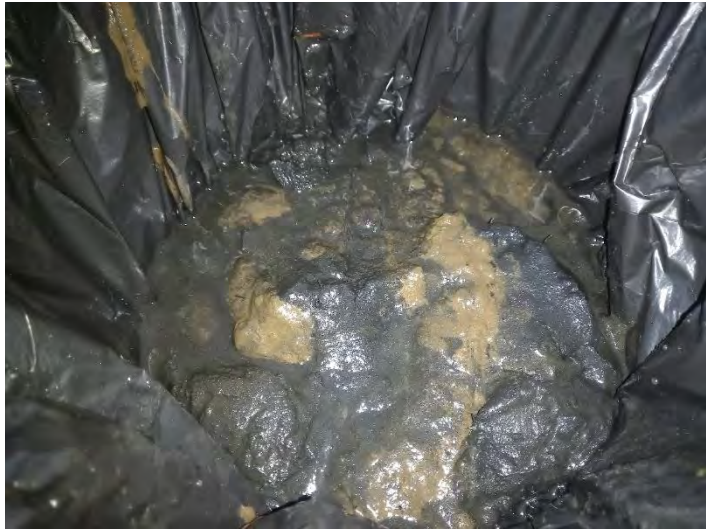
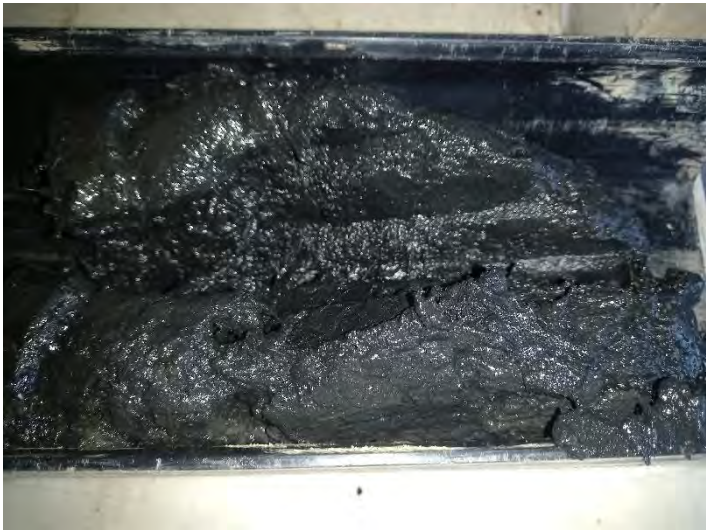
Project Name	Banff Harbour, Aberdeenshire	Location ID VC5
Project No.	374702	
Client	Aberdeenshire Council

Notes: Maximum depth achieved with vibrocore was 0.2m. Probable bedrock obstructing further sampling depth.
