XD Route_Kincardine Tower XD130

**Shadow Habitat Regulations Appraisal
Statement**

Document:	BOWS17_66 XD Route_Kincardine Tower XD130			
Version	Date	Prepared by	Technical Reviewer	Approved by
<i>DRAFT</i>	10/12/2024	Alice Helyar, <i>Principal Ecologist</i>	Emma Robson <i>Principal Ecologist</i>	Emma Robson <i>Principal Ecologist</i>
<i>FINAL</i>				
<i>V1</i>				
<i>V2</i>				
<i>V3</i>

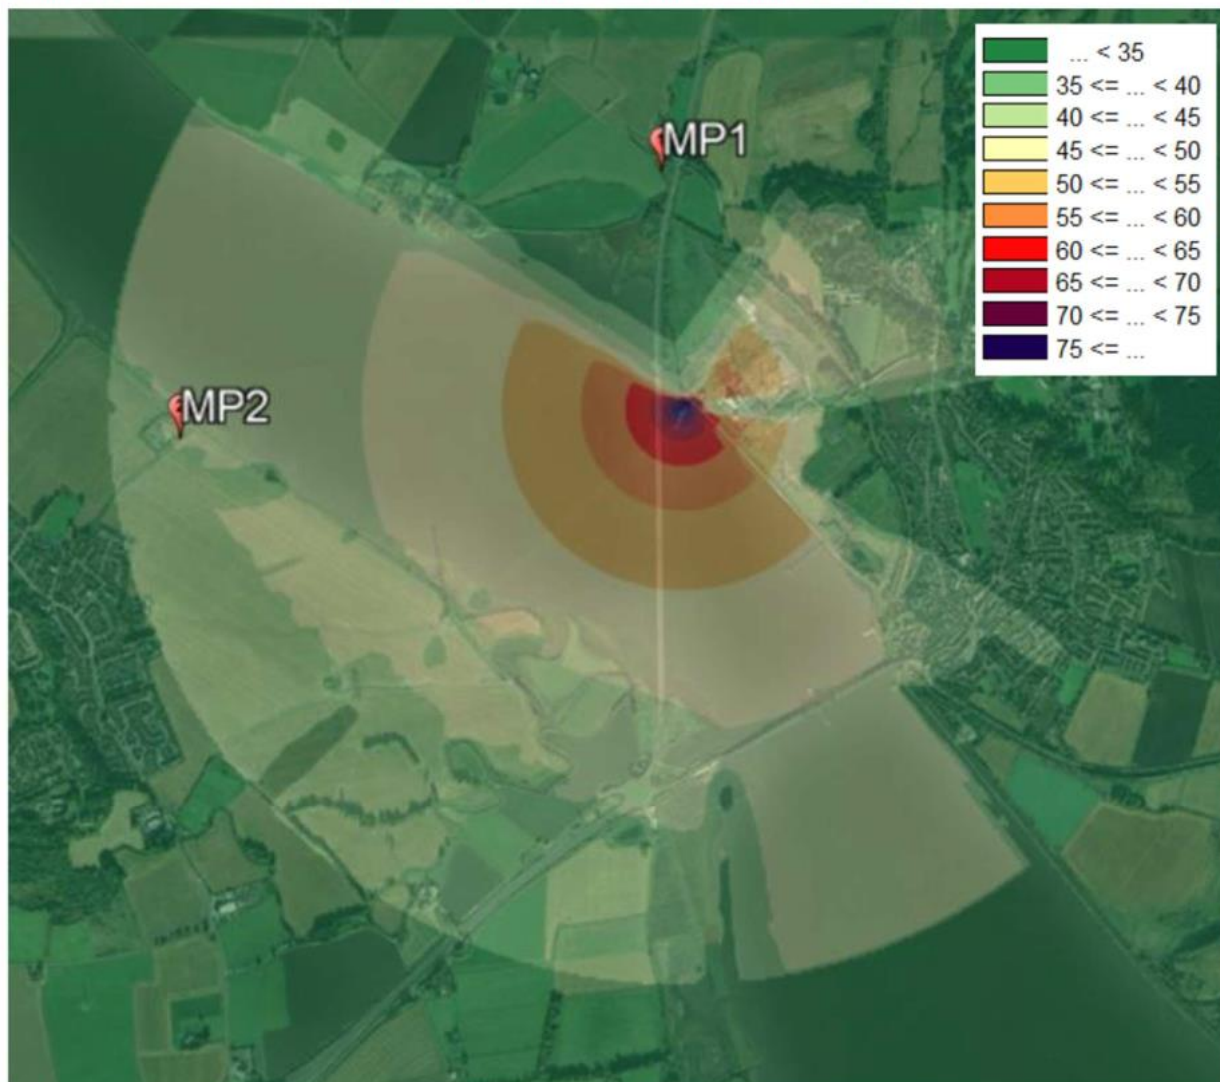
Figure 2: Predicted noise levels for the proposed remedial works of the Kincardine Tower XD130

- 2.11 The specific sound level (the sound level produced by a source, without corrections for acoustic features) at the source, emitted by the remedial works, considered to be worst case scenario is predicted to be 114 dB (overall corrected sound power level). It is assumed that the Firth of Forth is an acoustically reflective ground surface and the remaining surfaces are acoustically soft ground cover between the noise source and receptor. At a distance of approximately 350 m from the source (as shown in Appendix E), the predicted noise levels for typical construction activities associated with the proposed works, the noise levels fall below 55 dB $L_{Aeq,T}$. Therefore, noise levels at the designated sites, which are located >350 m from the source, are anticipated to be below 55 dB $L_{Aeq,T}$. It should be noted that as a worst case, the modelling assumed maximum noise levels generated by the hydrodemolition plant operating at full power. In practice, emissions are likely to be lower. No works will occur at night.

winter walkover surveys, therefore they may experience some limited disturbance due to noise levels up to 60 dB be disturbed by elevated noise levels. However, only the area within approximately 10 m of the tower will experience noise levels (>70 dB) that might cause a response in the ecological receptors.
