Ardrossan Harbour Best Practicable Environmental Options Report

Best Practicable Environmental Options Report

Client: Peel Ports Group/Clydeport Operations

Sediment Sampling Report

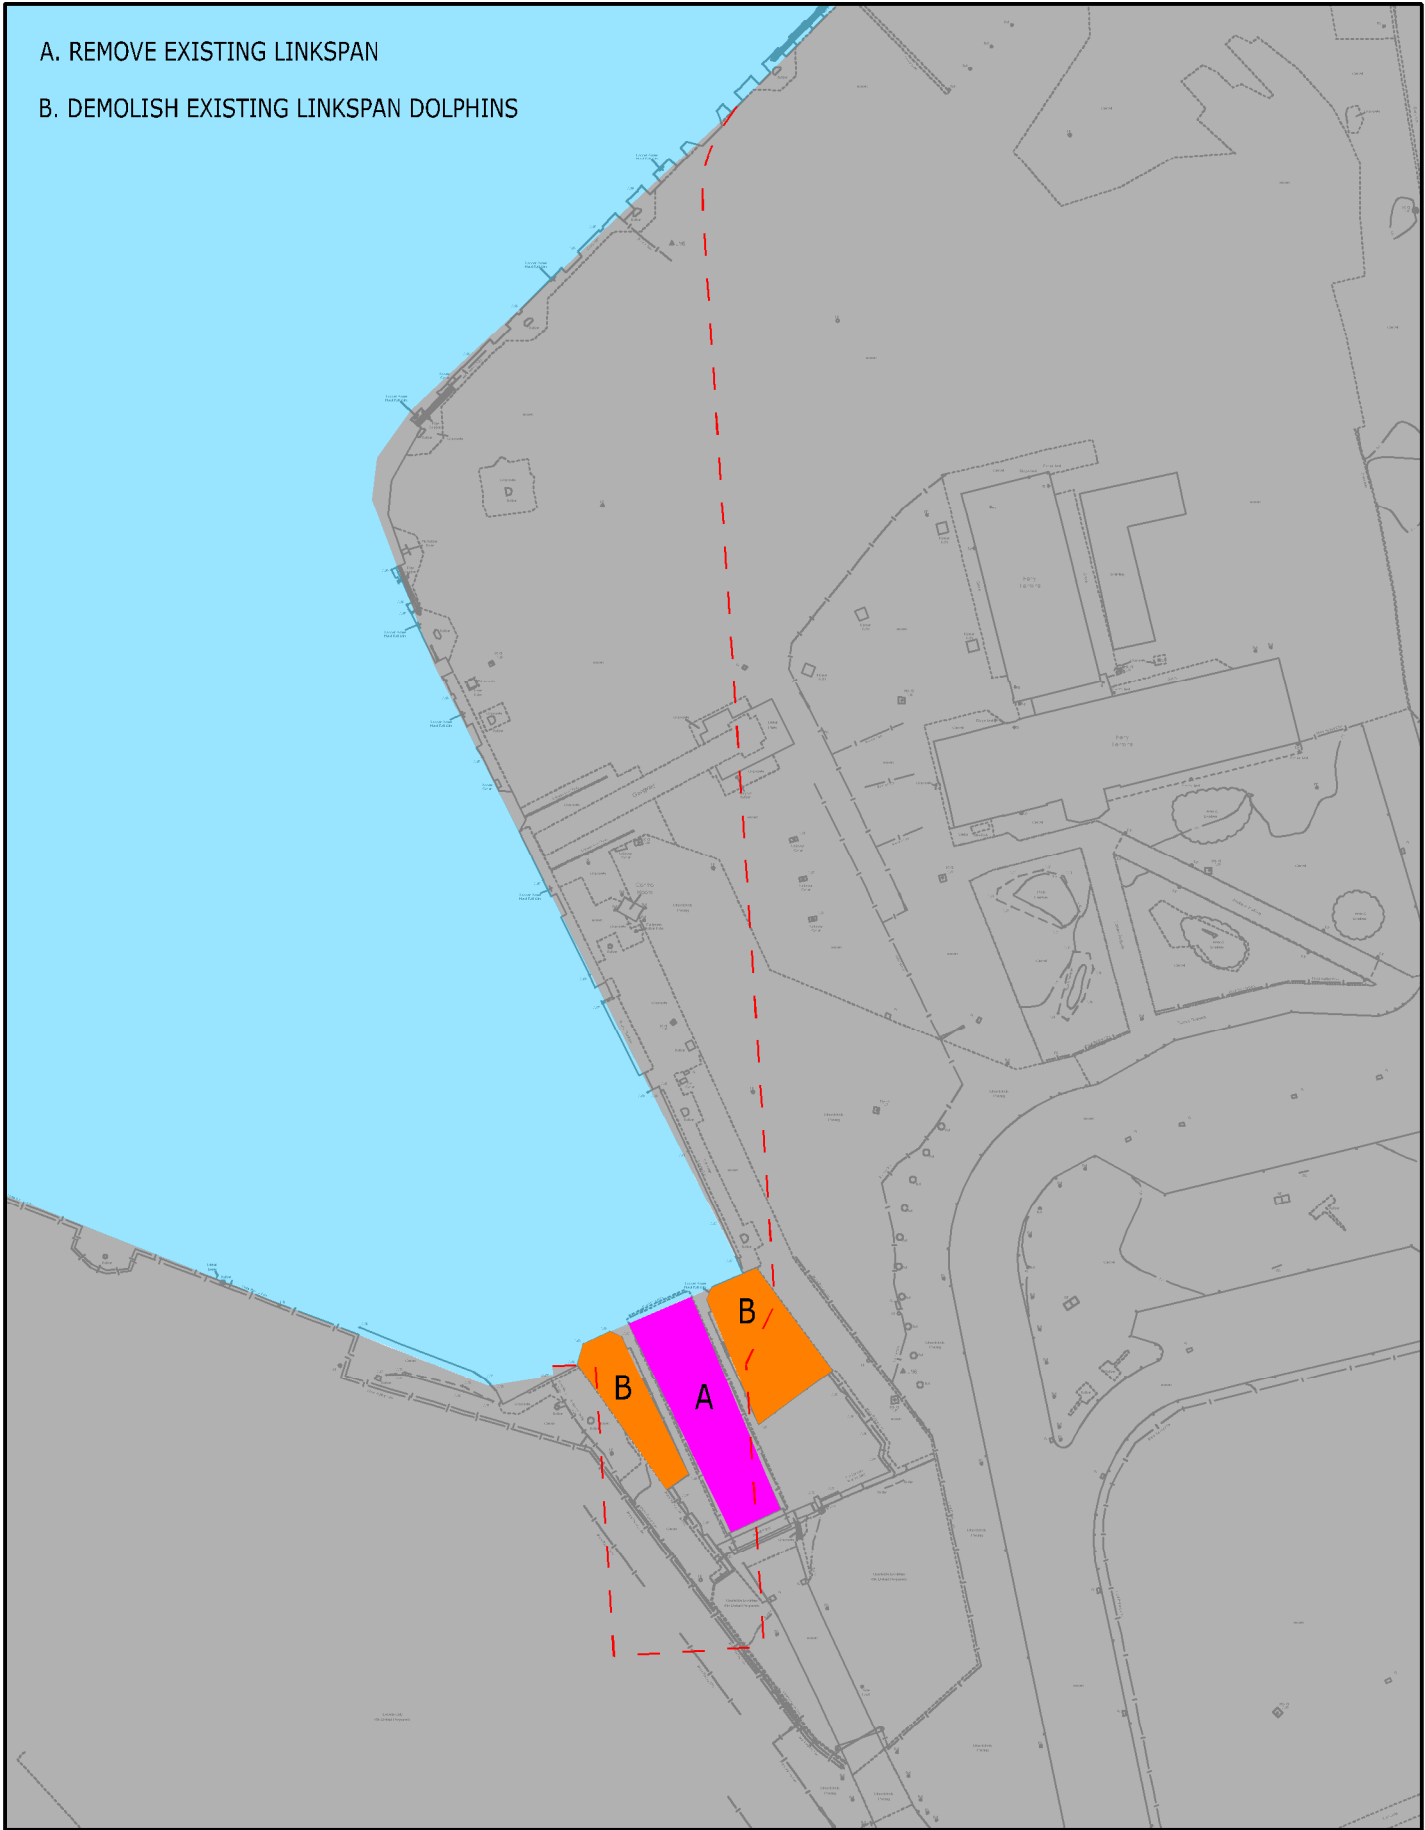
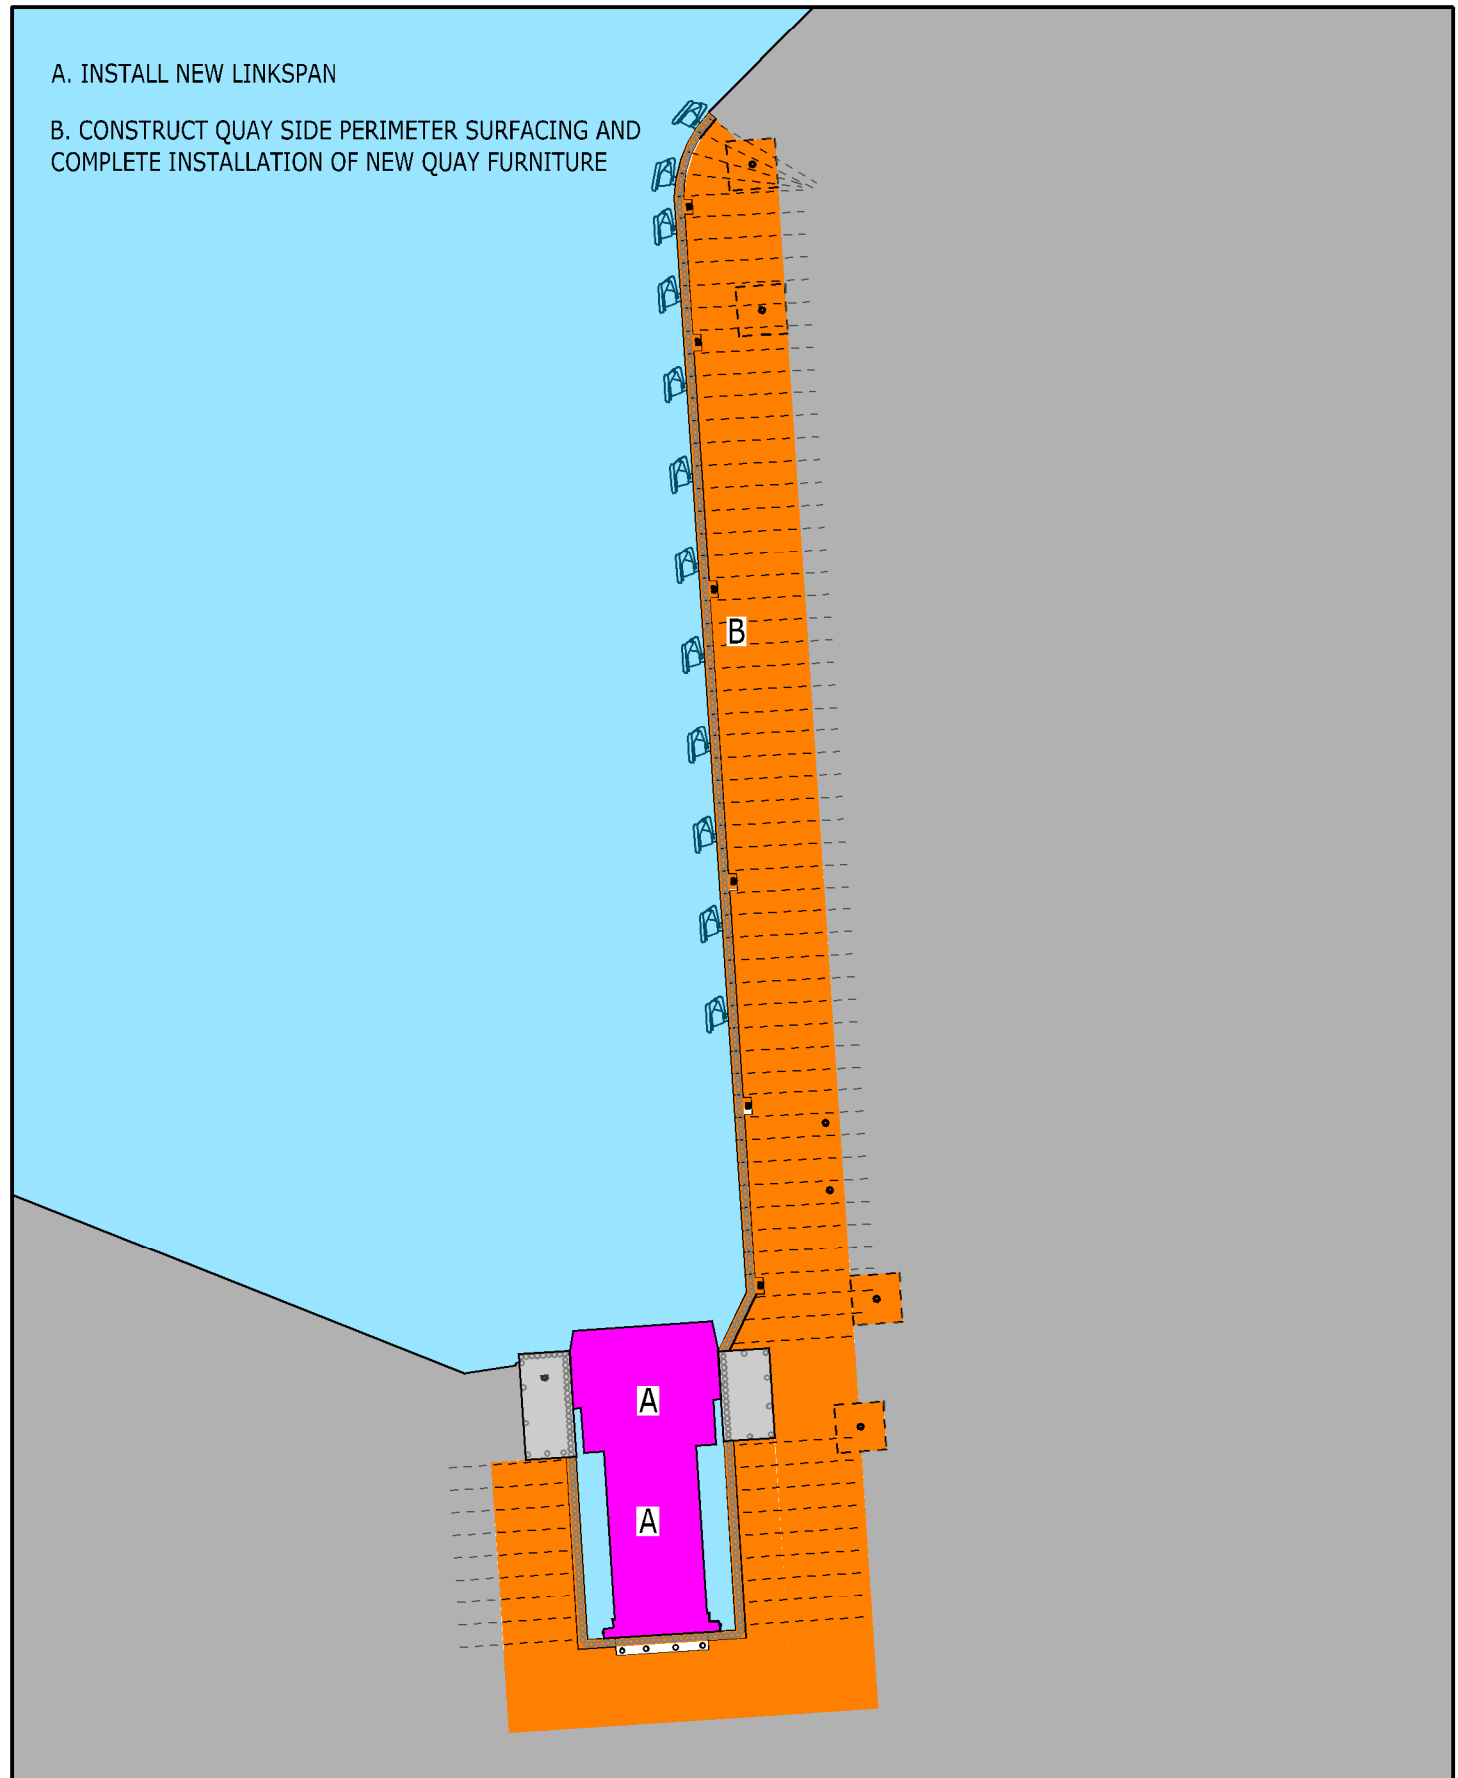
**ARDROSSAN HARBOUR
REDEVELOPMENT
ARRAN BERTH
CONSTRUCTION SEQUENCE**

- Begin demolition of the existing berth, working using long reach excavators operating from the quayside surface. The excavator will work backwards from the outer perimeter towards the new quay wall line while excavating the quayside in benches to form the new berth. The contractor may choose to leave the perimeter sheet piles in place for as long as he can to protect the works before breaking these down. The excavation may be on a single work front (likely to be progressing south to north) or multiple work fronts.
- On completion the existing perimeter piles will either be cut off at bed level or removed completely by the excavation of the shallow trench that the toe of the piles are concreted into.
- Finally, the excavators will trim the excavation to the face of the new quay wall and within the linkspan recess.

In addition to the traditional marine sediment dredging described above, approximately 27,000m³ of material is to be removed which currently forms the Arran Berth. This area is identified in Ramboll Drawing 1620005121-RAM-ARN-00-DR-CW-1001 as Stage 5 within Appendix A. The exact details of how this will be removed will be provided when there is an appointed Contractor. However, it is expected that in principle this area will be removed as follows:

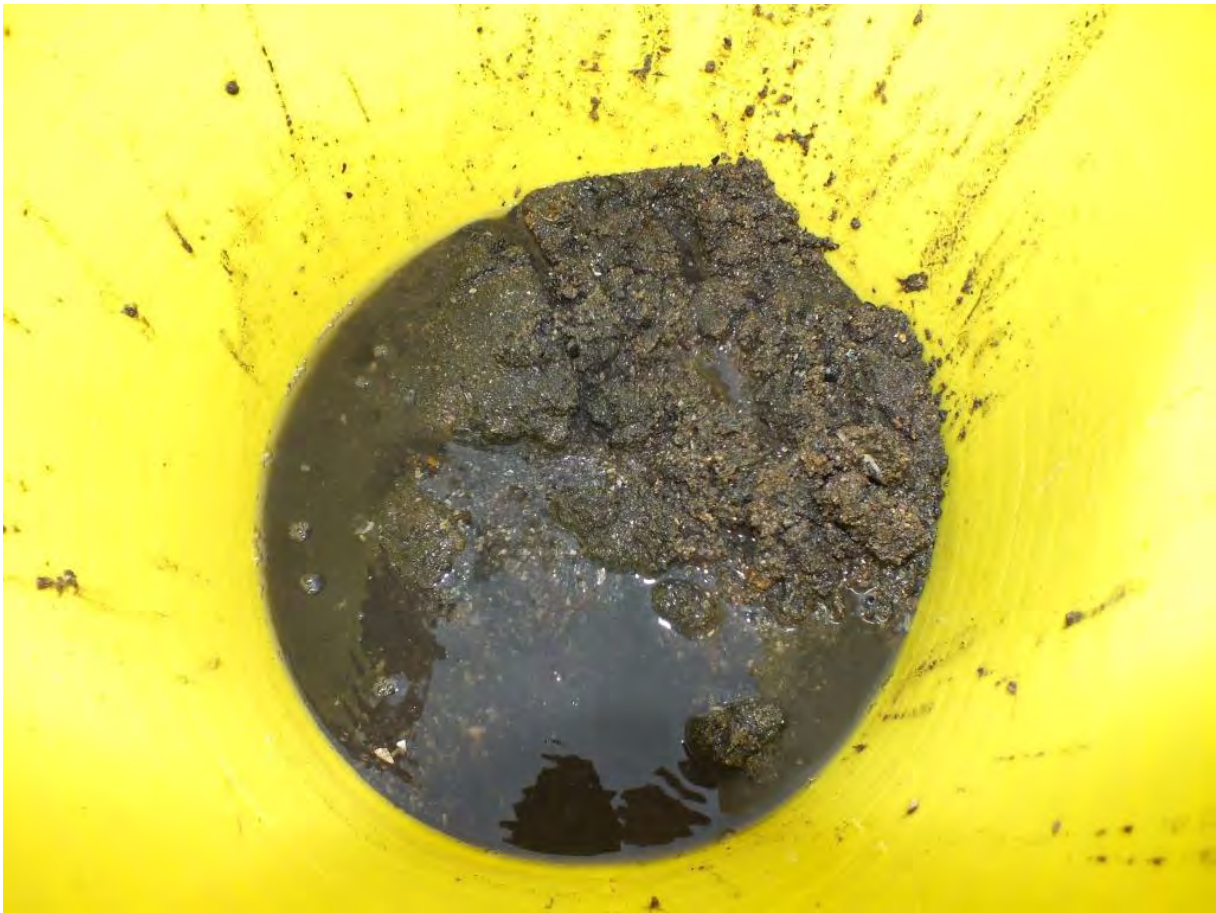
8 Eagle Street, Craighall Business Park, Glasgow, G4 9XA	Project Name	Ardrossan Harbour	Location ID SS3
		Project No.	169719	
		Client	Clydeport Operations Ltd

Anthropogenic Inputs: None noted.

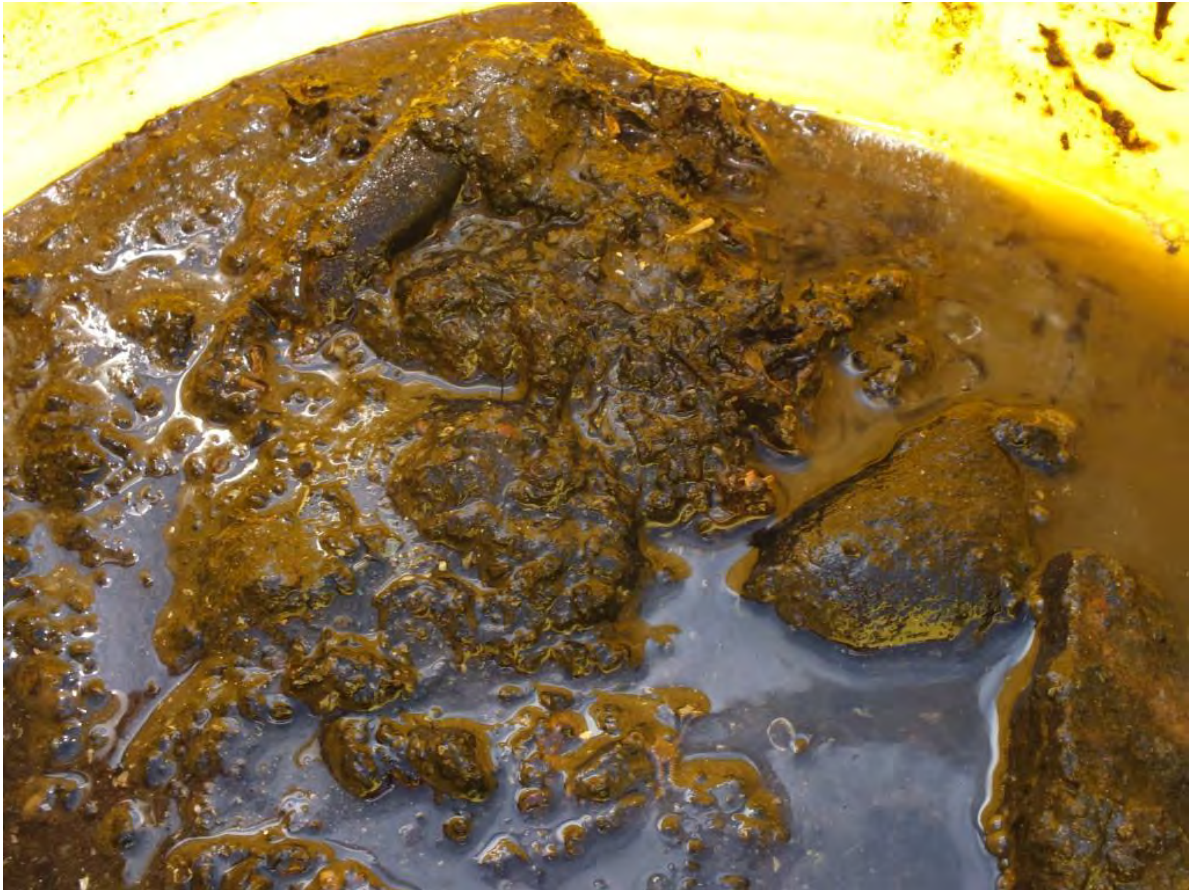
8 Eagle Street, Craighall Business Park, Glasgow, G4 9XA	Project Name	Ardrossan Harbour	Location ID SS5
		Project No.	169719	
		Client	Clydeport Operations Ltd

Anthropogenic Inputs: Fragments of roofing slate.

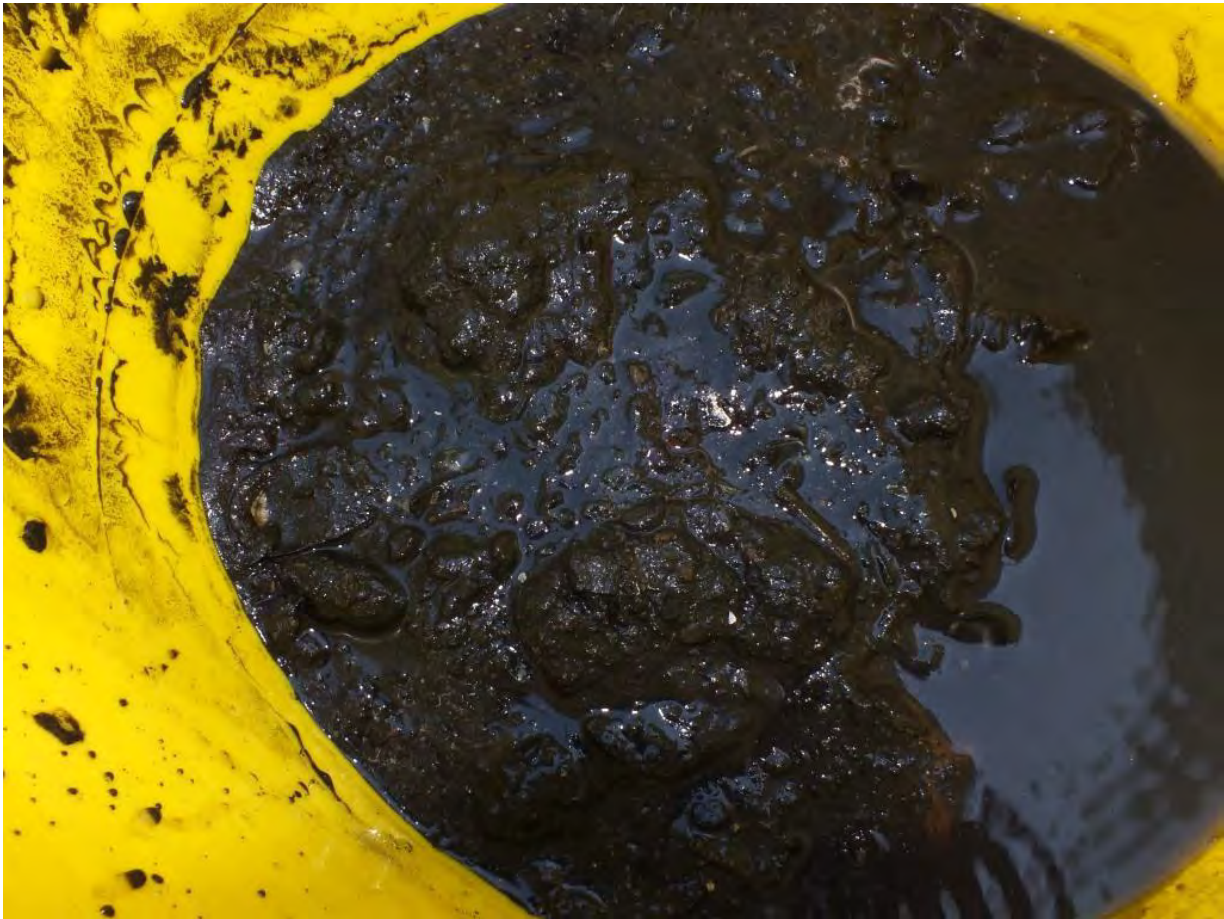
8 Eagle Street, Craighall Business Park, Glasgow, G4 9XA	Project Name	Ardrossan Harbour	Location ID SS6
		Project No.	169719	
		Client	Clydeport Operations Ltd

Anthropogenic Inputs: Fragments of slag noted.
