Port Edgar Marina

Dredging Licence Best Practical Environmental Option Report

PROJECT TITLE: Dredging Licence Application

REPORT TITLE: Best Practical Environmental Option Report

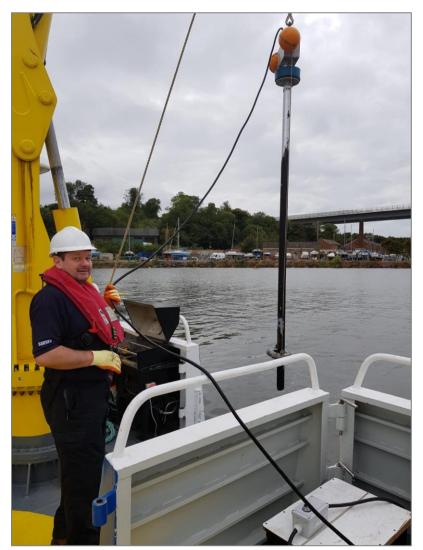
FIGURE 3 - SDI D-4 VIBROCORER AND CORE BEING RECOVERED TO DECK OFSHORE SENSOR

A Speciality Devices Incorporated D-4 vibrocorer was used for all samples. A 76mm diameter, 3m long core was fitted for all sample attempts and each core tube was constructed of aluminium.

The sediment was pushed out of the core tube and carefully sampled to prevent taking material that had come into contact with the tube wall.

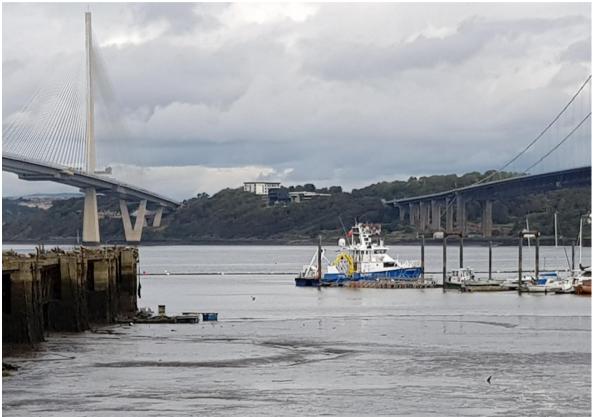
FIGURE 5 - SURVEY VESSEL: OFFSHORE SENSOR

Offshore Sensor is a 22m aluminium hulled catamaran with a deck crane suitable for vibrocore operations.

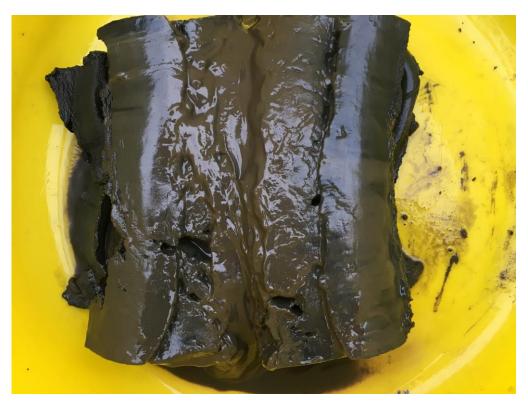
Grab 1: Soft brown silt

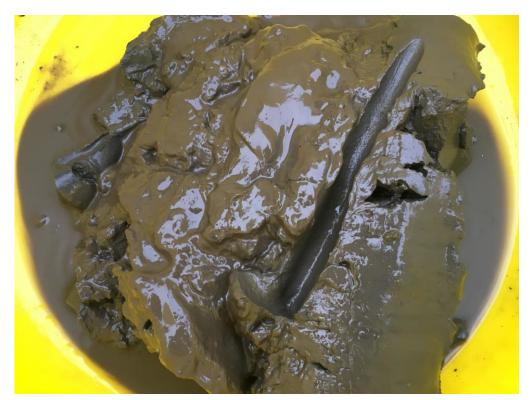
Grab 2: Soft brown silt

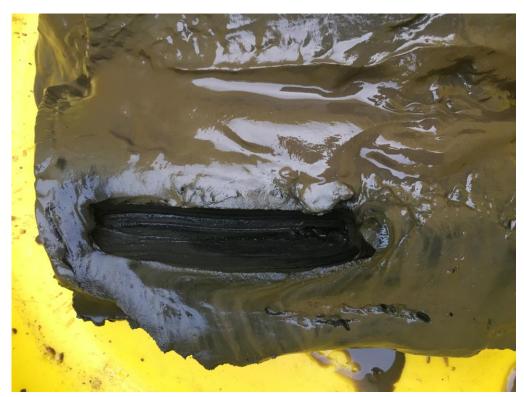
Grab 3: Soft brown silt

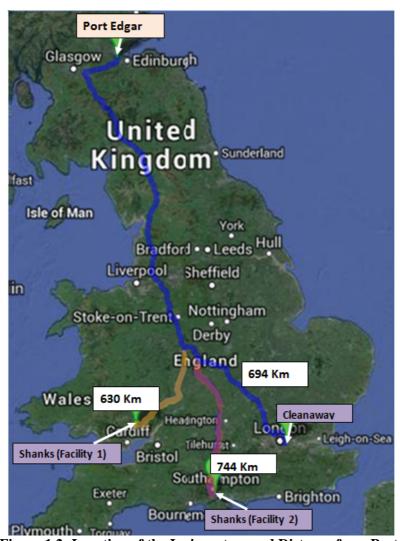
Figure 1.2: Location of the Incinerators and Distance from Port Edgar

Figure 3.2 shows the locations of the facilities, and the routes and distances to transport the material from the port to each of the facilities. Figure 3.2 shows that the nearest Incinerator from Port Edgar is Shanks (Facility 1) and the furthest would be Shanks (Facility 2).

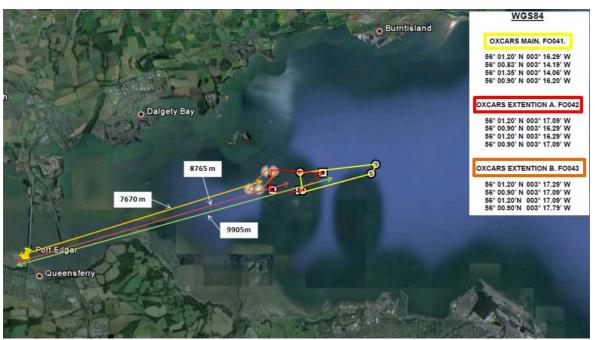
Figure 3.3: Location of the Oxcars Spoilground and the Distance from Port Edgar

Figure 3.3 shows the location of the Oxcars Spoilground and the distance from Port Edgar.

A site that has been identified as the nearest acceptable site for sea disposal is the Oxcars Spoil Ground which is less than 10km east of Port Edgar. Early consultation with Marine Scotland suggests that the material should be suitable for disposal at sea. A copy of the correspondence with Marine Scotland is included in Appendix B.

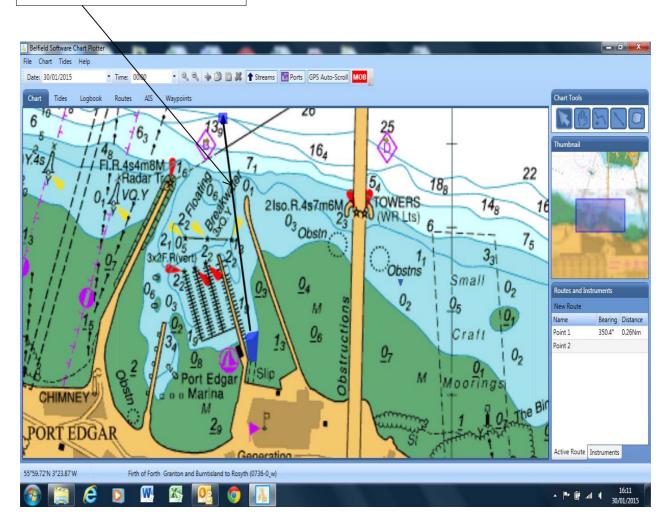
SKETCH PLAN OF PLOUGH DREDGING PROPOSAL

Approximate Route to dispersal area (Approx position 55°59.93'N 003°24.65'W)

Co-ordinates of Dredge Box 55°59.639N 003°24.559W 55°59.663N 003°24.569W 55°59.666N 003°24.549W 55°59.639N 003°24.545W

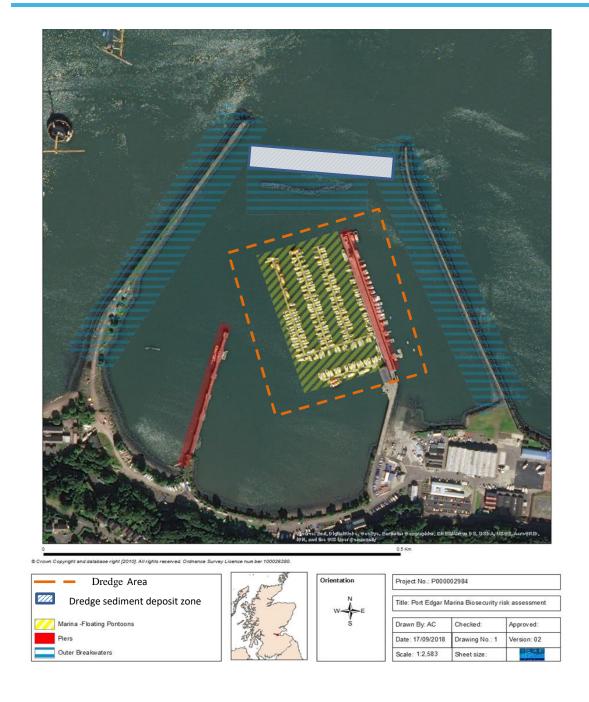
Figure 1 Plan view of Port Edgar indicating the location of the outer breakwaters, marina, piers and dredge area.

The marina at Port Edgar consists of three main structural components (the outer breakwaters, floating pontoons and the piers) and each should be considered separately (see Figure 1). Each structural component is subjected to similar environmental conditions, however, the habitats associated with them and the physical characteristics of the structures are different. Therefore, each of the three structures will have different risk factors and control measures associated with them specific to their physical characteristics.

The proposed dredging operation will take place within the marina, between the pontoons and piers within the confines of the breakwaters Figure 1. The actual dredged extent will likely be a smaller section within the dredge area outlined in Figure 1 which will be informed by depth conditions at the site and the needs of the marina berth holders. The seabed within the marina is predominantly soft sediment and described as SS.SMu.CSaMu 'Circalittoral sandy mud' under the EUNIS classification system (EmodNET)⁴. The mud habitats are not considered to provide suitable substrate for colonisation by the NNS currently found in Port Edgar Marina (see Section 3.2.4). However, debris and other hard substrate amongst the mud could provide potential settlement habitats and a precautionary approach requires the assumption that NNS could be present in the sediment.
