**BAE Systems
Best Practicable Environmental Options (BPEO)
Report -Scotstoun and Govan**

September 2020

Document number: 9278

Project number: 173920

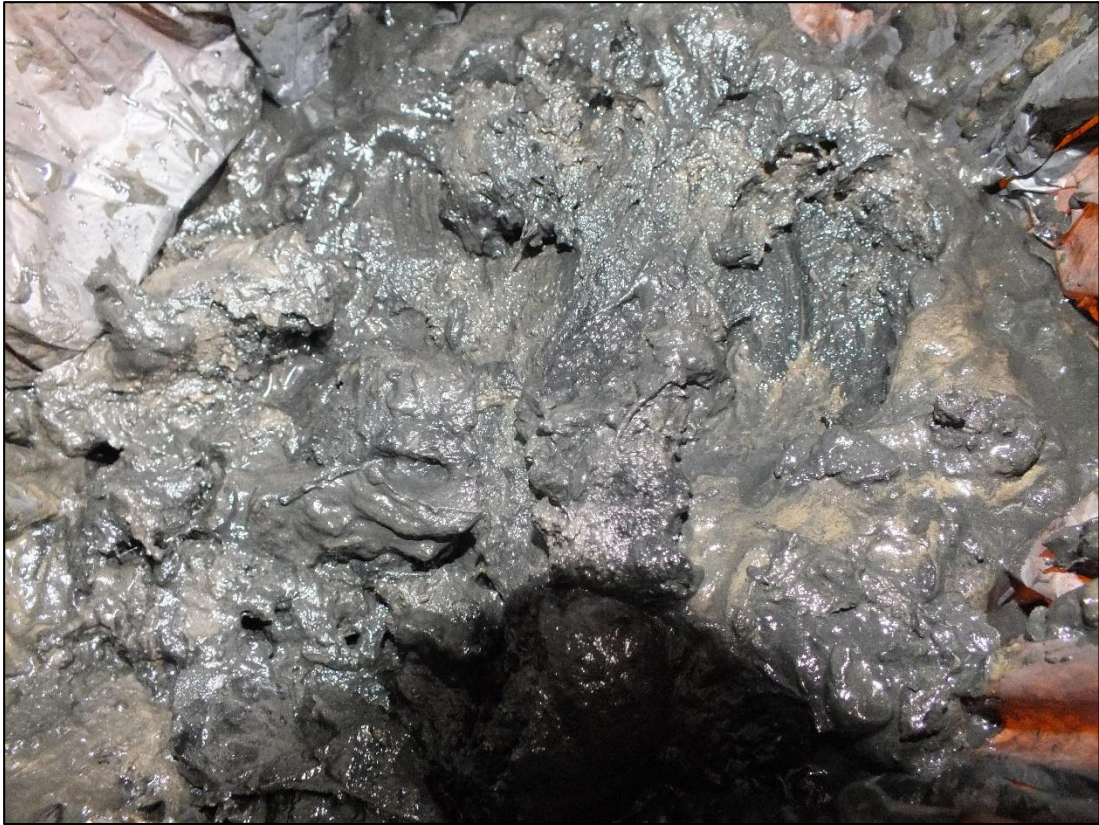
8 Eagle Street, Craighall Business Park, Glasgow, G4 9XA	Project Name	BAE Systems – Scotstoun & Govan	Location ID S2.2
	Project No.	173920	
	Client	BAE Systems

Remarks: Soft black silt. One thumb-sized rusty metal fragment.

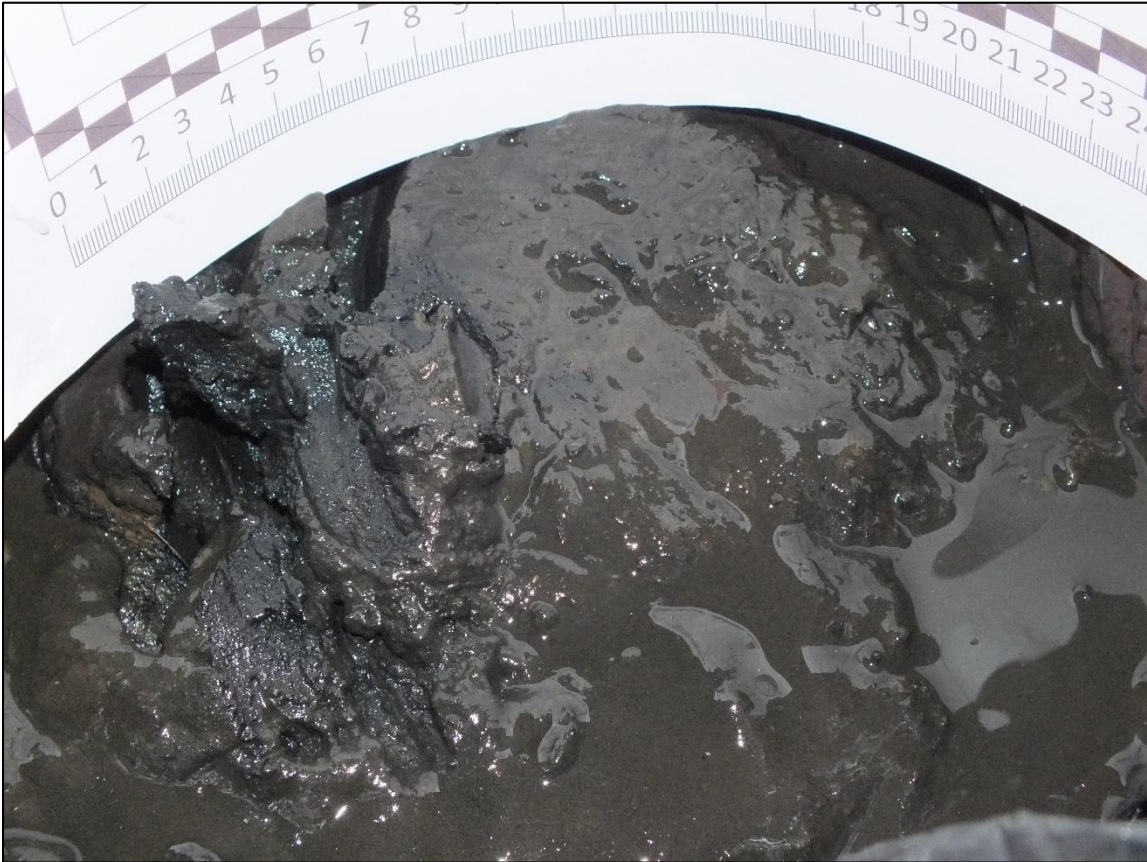
8 Eagle Street, Craighall Business Park, Glasgow, G4 9XA	Project Name	BAE Systems – Scotstoun & Govan	Location ID
	Project No.	173920	S4
	Client	BAE Systems

Remarks: Soft black silt with rare decomposing vegetation and paint and rusty metal chips.

Anthropogenic Inputs: Paint and rusty metal chips

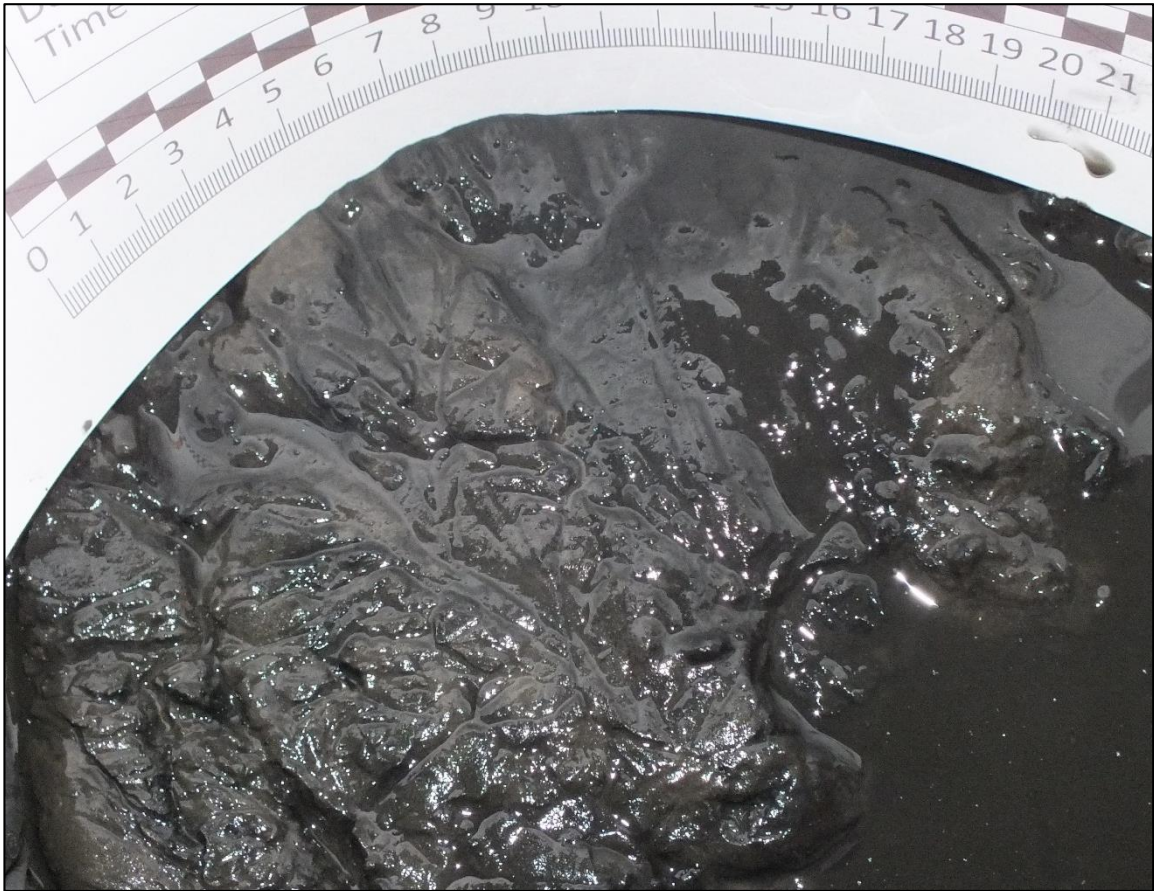
8 Eagle Street, Craighall Business Park, Glasgow, G4 9XA	Project Name	BAE Systems – Scotstoun & Govan	Location ID
	Project No.	173920	S8
	Client	BAE Systems

Soft black silt with one thumbnail-sized rusty metal fragment.

Rusty metal fragment.

Noted to be drier and more cohesive than other similar samples.

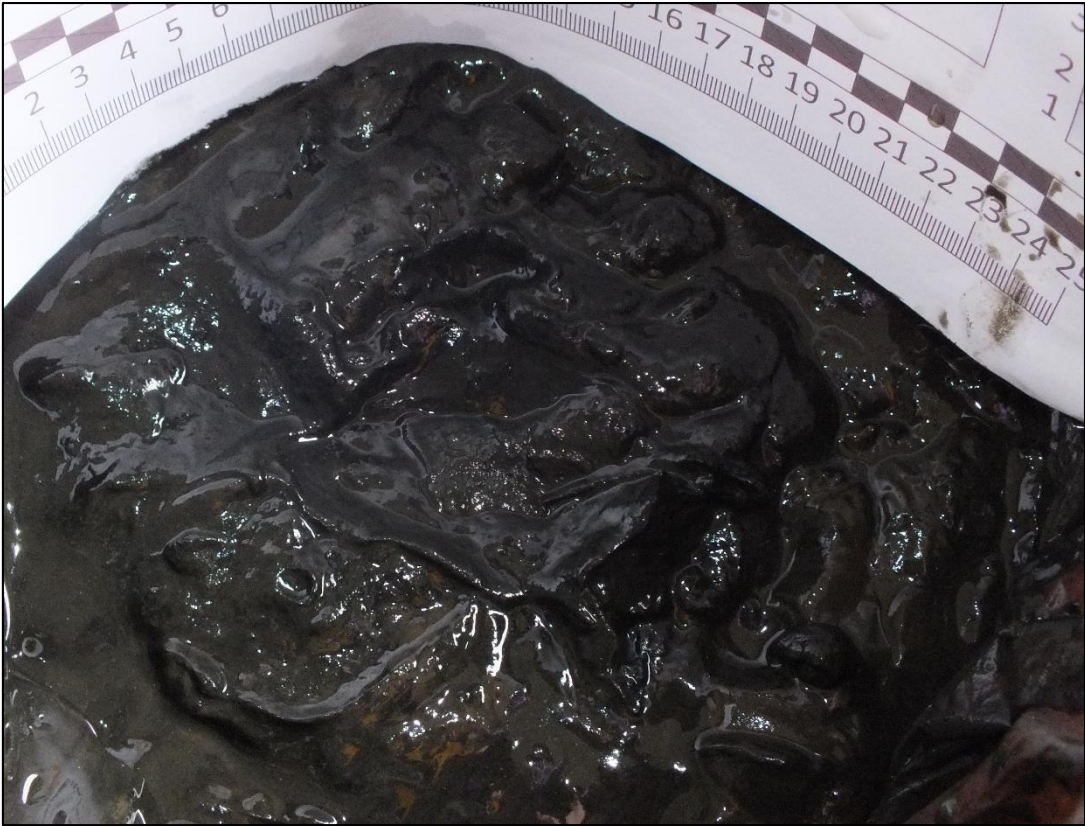
8 Eagle Street, Craighall Business Park, Glasgow, G4 9XA	Project Name	BAE Systems – Scotstoun & Govan	Location ID S13
	Project No.	173920	
	Client	BAE Systems

Anthropogenic Inputs: Clinker.
