River Clyde Maintenance Dredge - July 2023 Best Practicable Environmental Options (BPEO) Report

Client: Peel Ports Group
 Project Title: River Clyde Maintenance Dredge - July 2023
 Report Title: Best Practicable Environmental Options (BPEO) Report
 Document number: 13542
 Project number: 178303

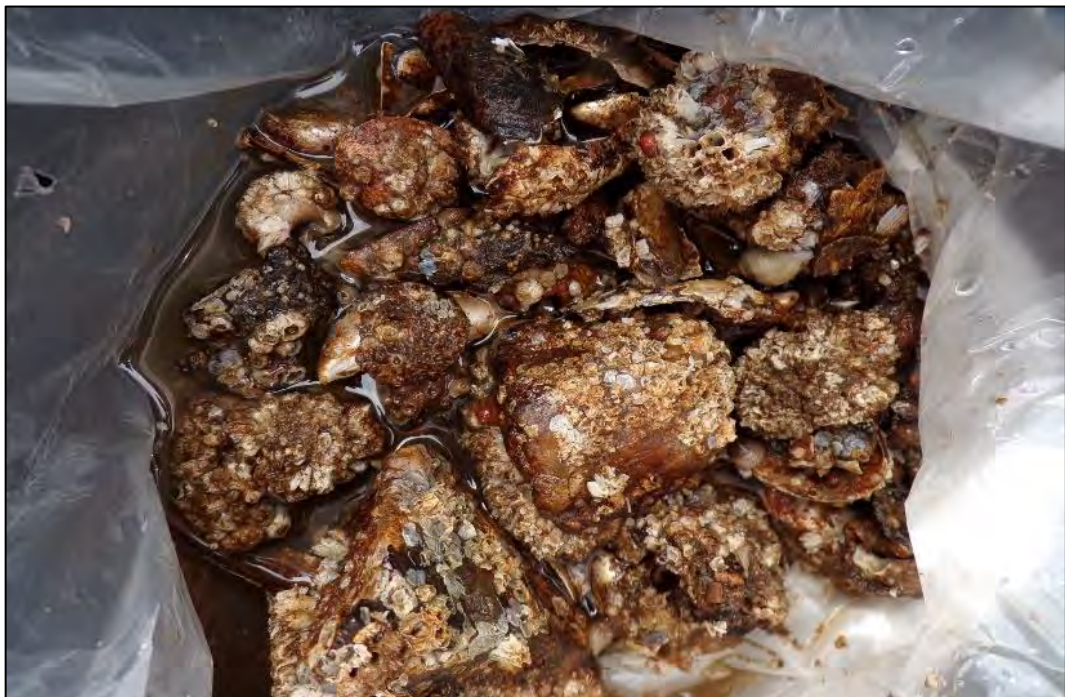
Project Name	River Clyde Maintenance Sampling July 2023	Location ID SL04
Project No.	178303	
Client	Peel Ports Group Ltd.

Notes: Several unsuccessful attempts with several attempts made at micro-siting. Eventual recovery of some material but was not suitable for analysis.

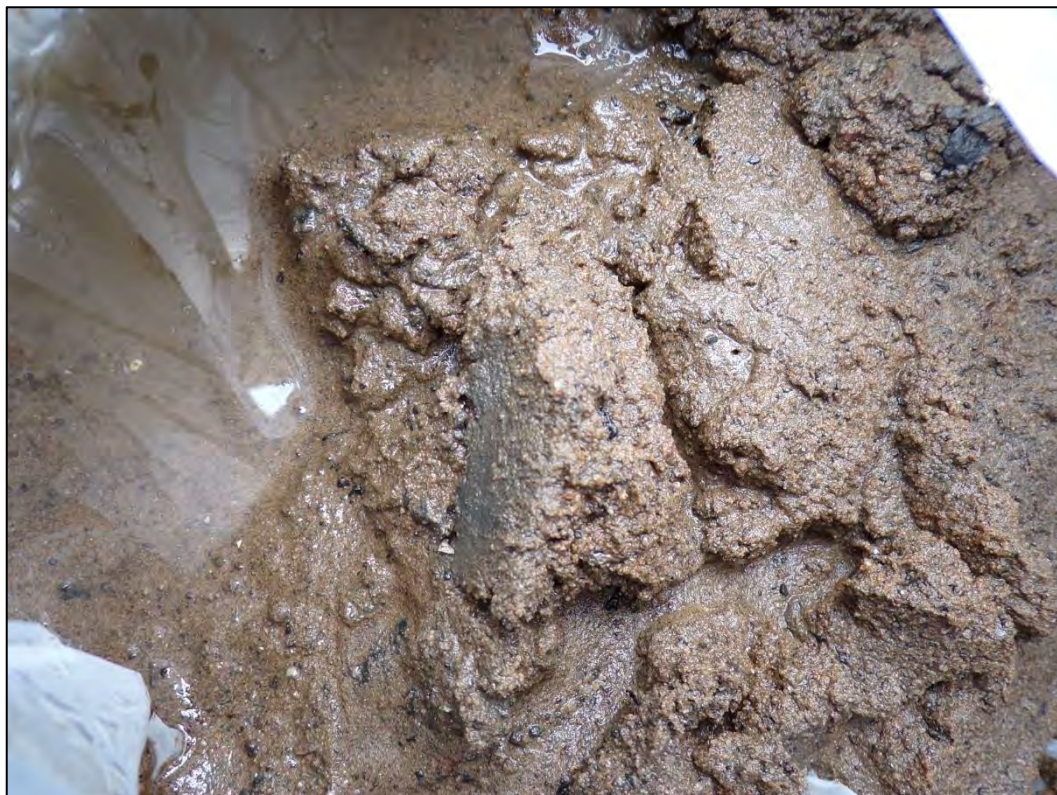
Project Name	River Clyde Maintenance Sampling July 2023	Location ID SL19
Project No.	178303	
Client	Peel Ports Group Ltd.

Anthropogenic Inputs: One glass fragment.

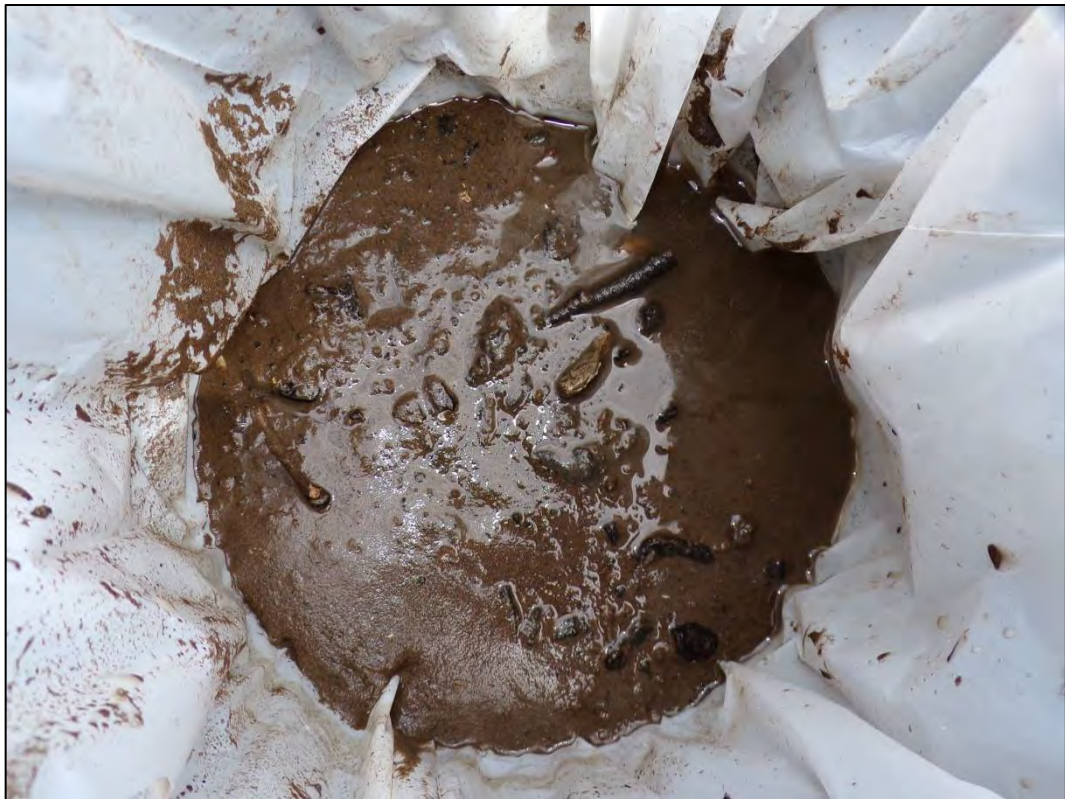
Project Name	River Clyde Maintenance Sampling July 2023	Location ID SL25
Project No.	178303	
Client	Peel Ports Group Ltd.

Notes: Multiple attempts made at obtaining material. Strong pull from flooding tide. Limited sample volume.

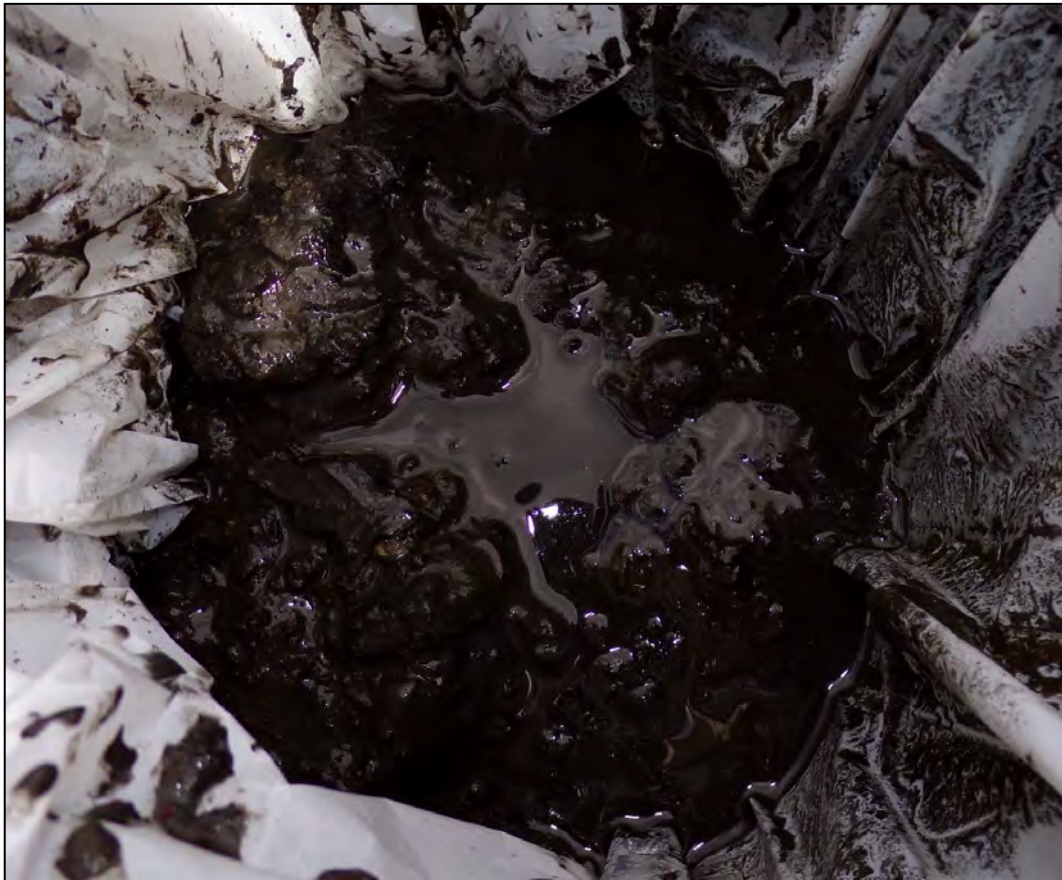
Project Name	River Clyde Maintenance Sampling July 2023	Location ID SL35/ SL35A
Project No.	178303	
Client	Peel Ports Group Ltd.

Notes: SL35 - Multiple attempts at obtaining material but an insufficient amount obtained for analysis. The location is adjacent to CWRR construction works, therefore there is a possibility that recent dredging work has been undertaken in the area.

SL35A - Relocated upstream.
