Buckie, Findochty, Portknockie, Cullen Best Practicable Environmental Options (BPEO) Report

Client: Arch Henderson LLP / The Moray Council
 Project Title: Buckie, Findochty, Portknockie, Cullen
 Report Title: Best Practicable Environmental Options (BPEO) Report
 Document number: 13349
 Project number: 377468

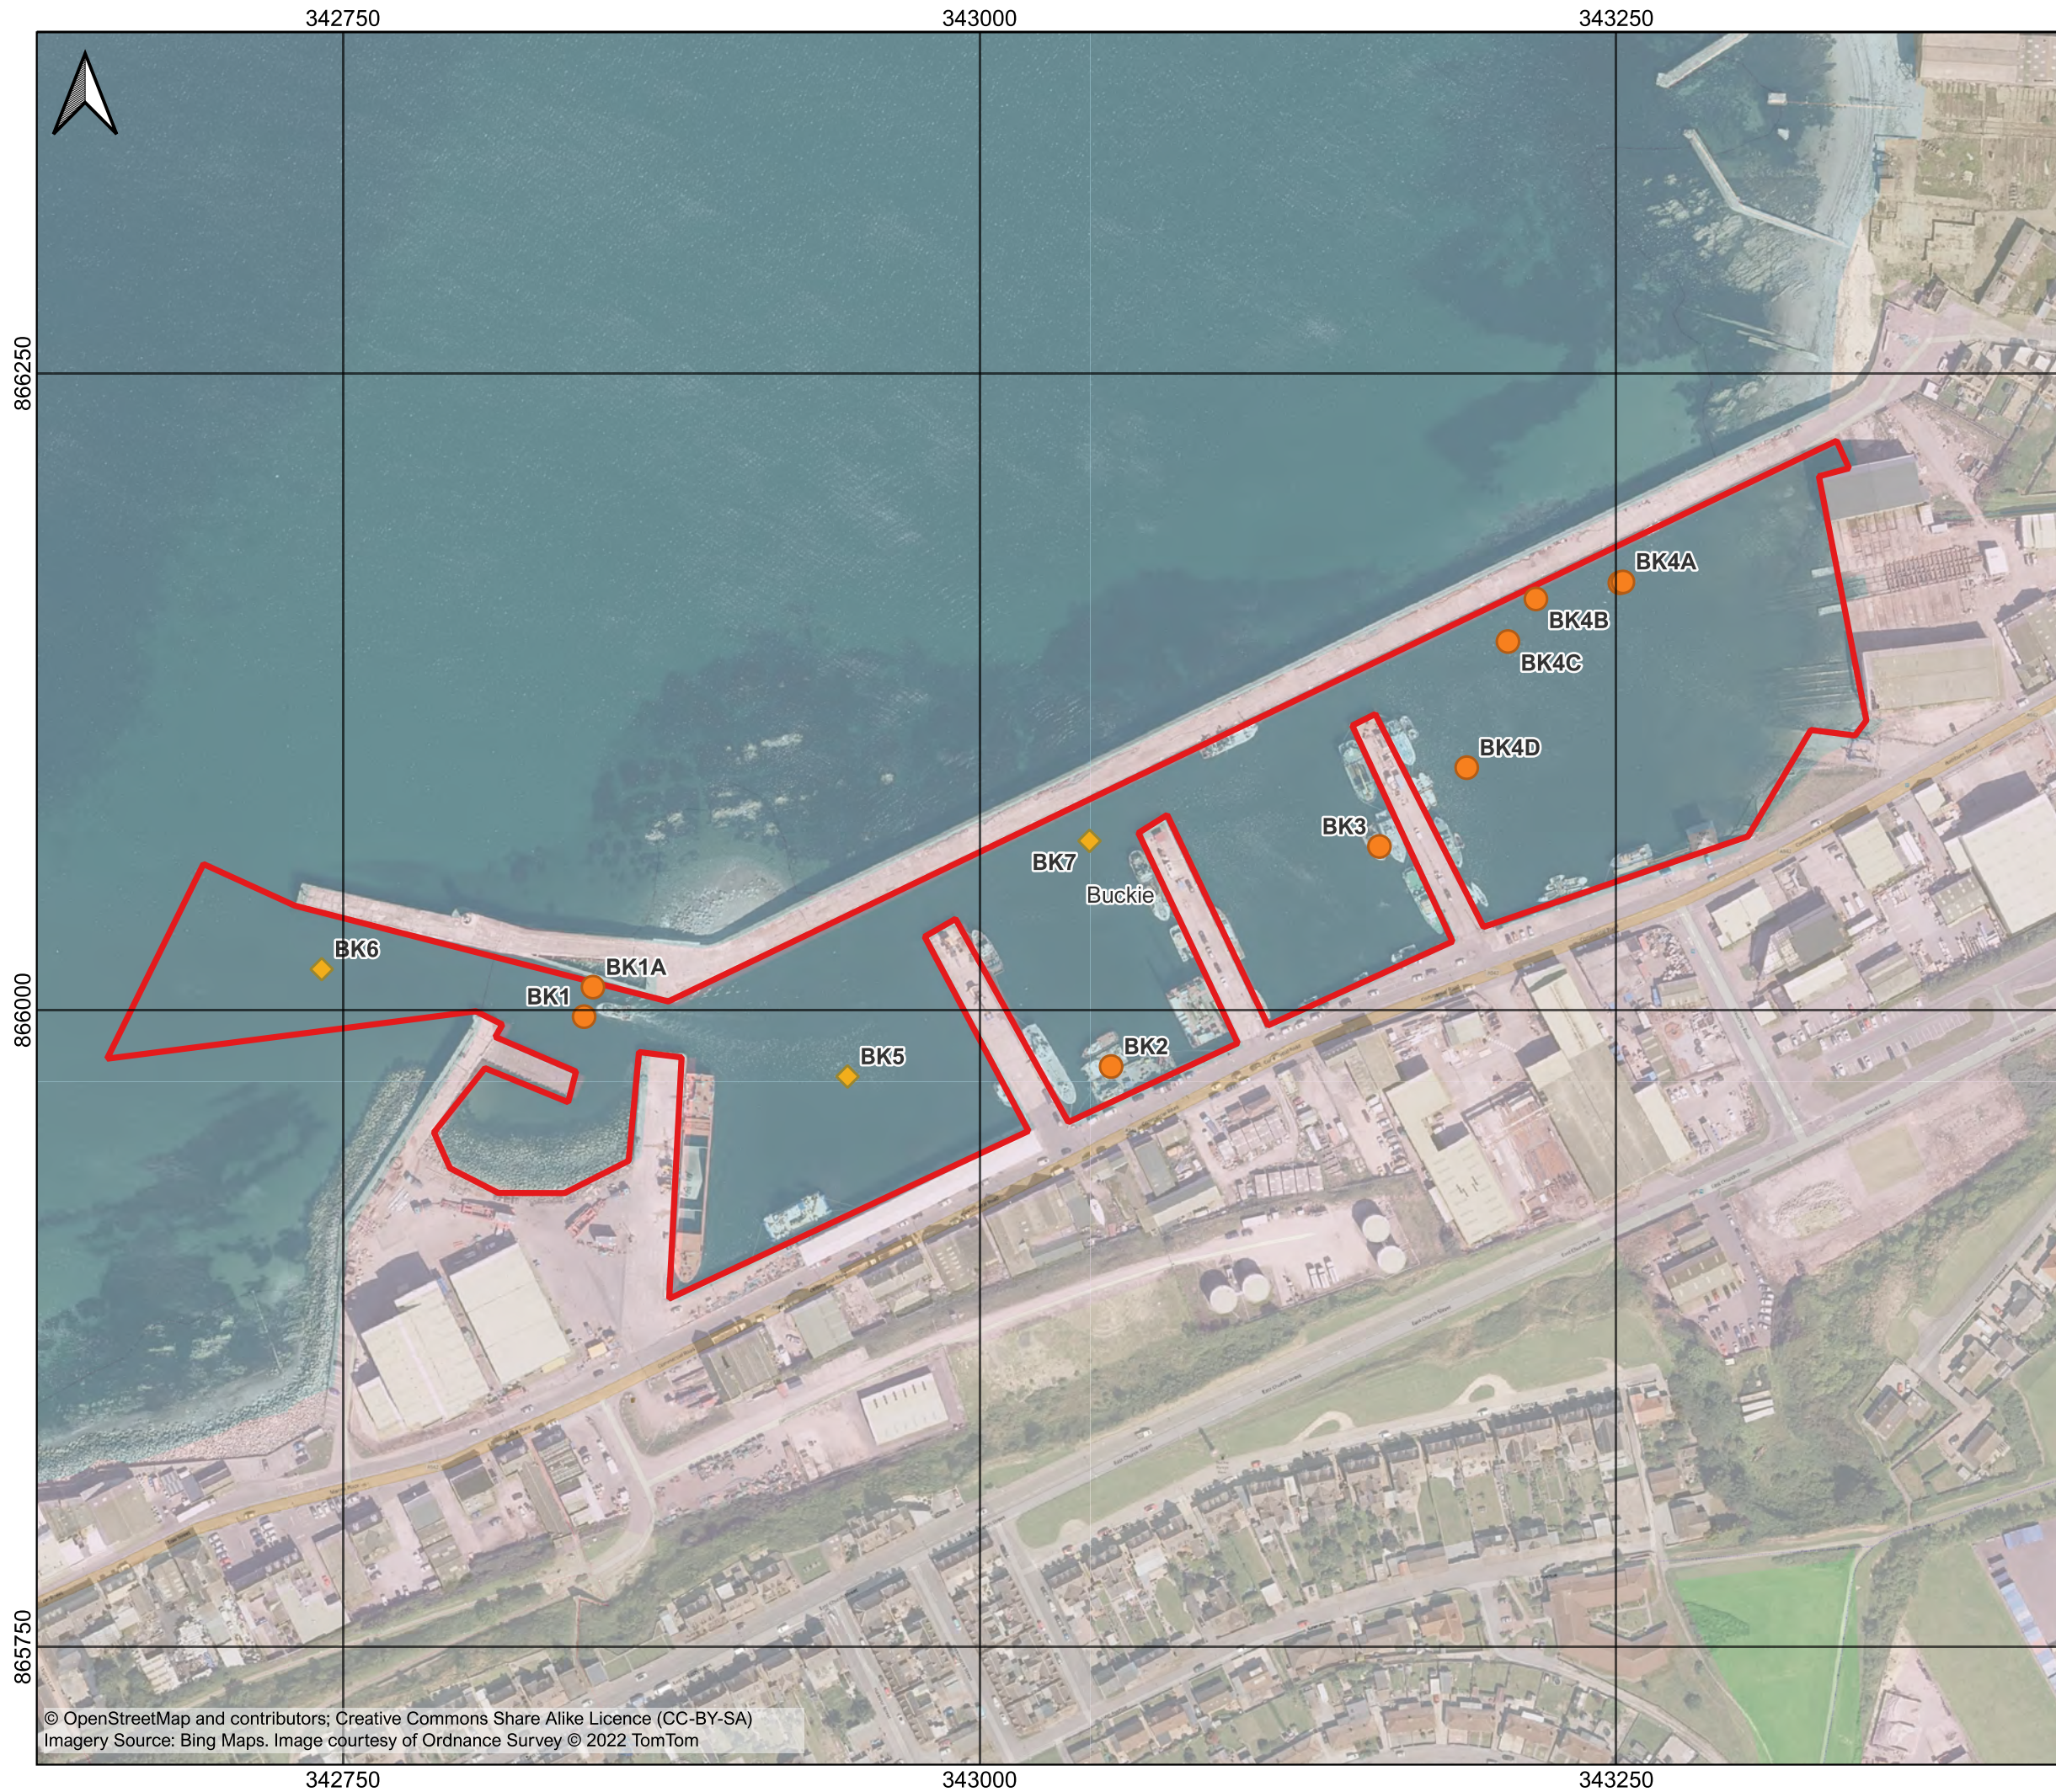
- Dredge Areas
- Sediment Samples**
- ◆ Grab
- Vibrocore

Sediment sampling was recently undertaken at the four sites with sample locations detailed in the drawings in Appendix A.

The proposed dredge areas and volumes are detailed in Table 1-1 below with the dredge areas presented in Appendix A.

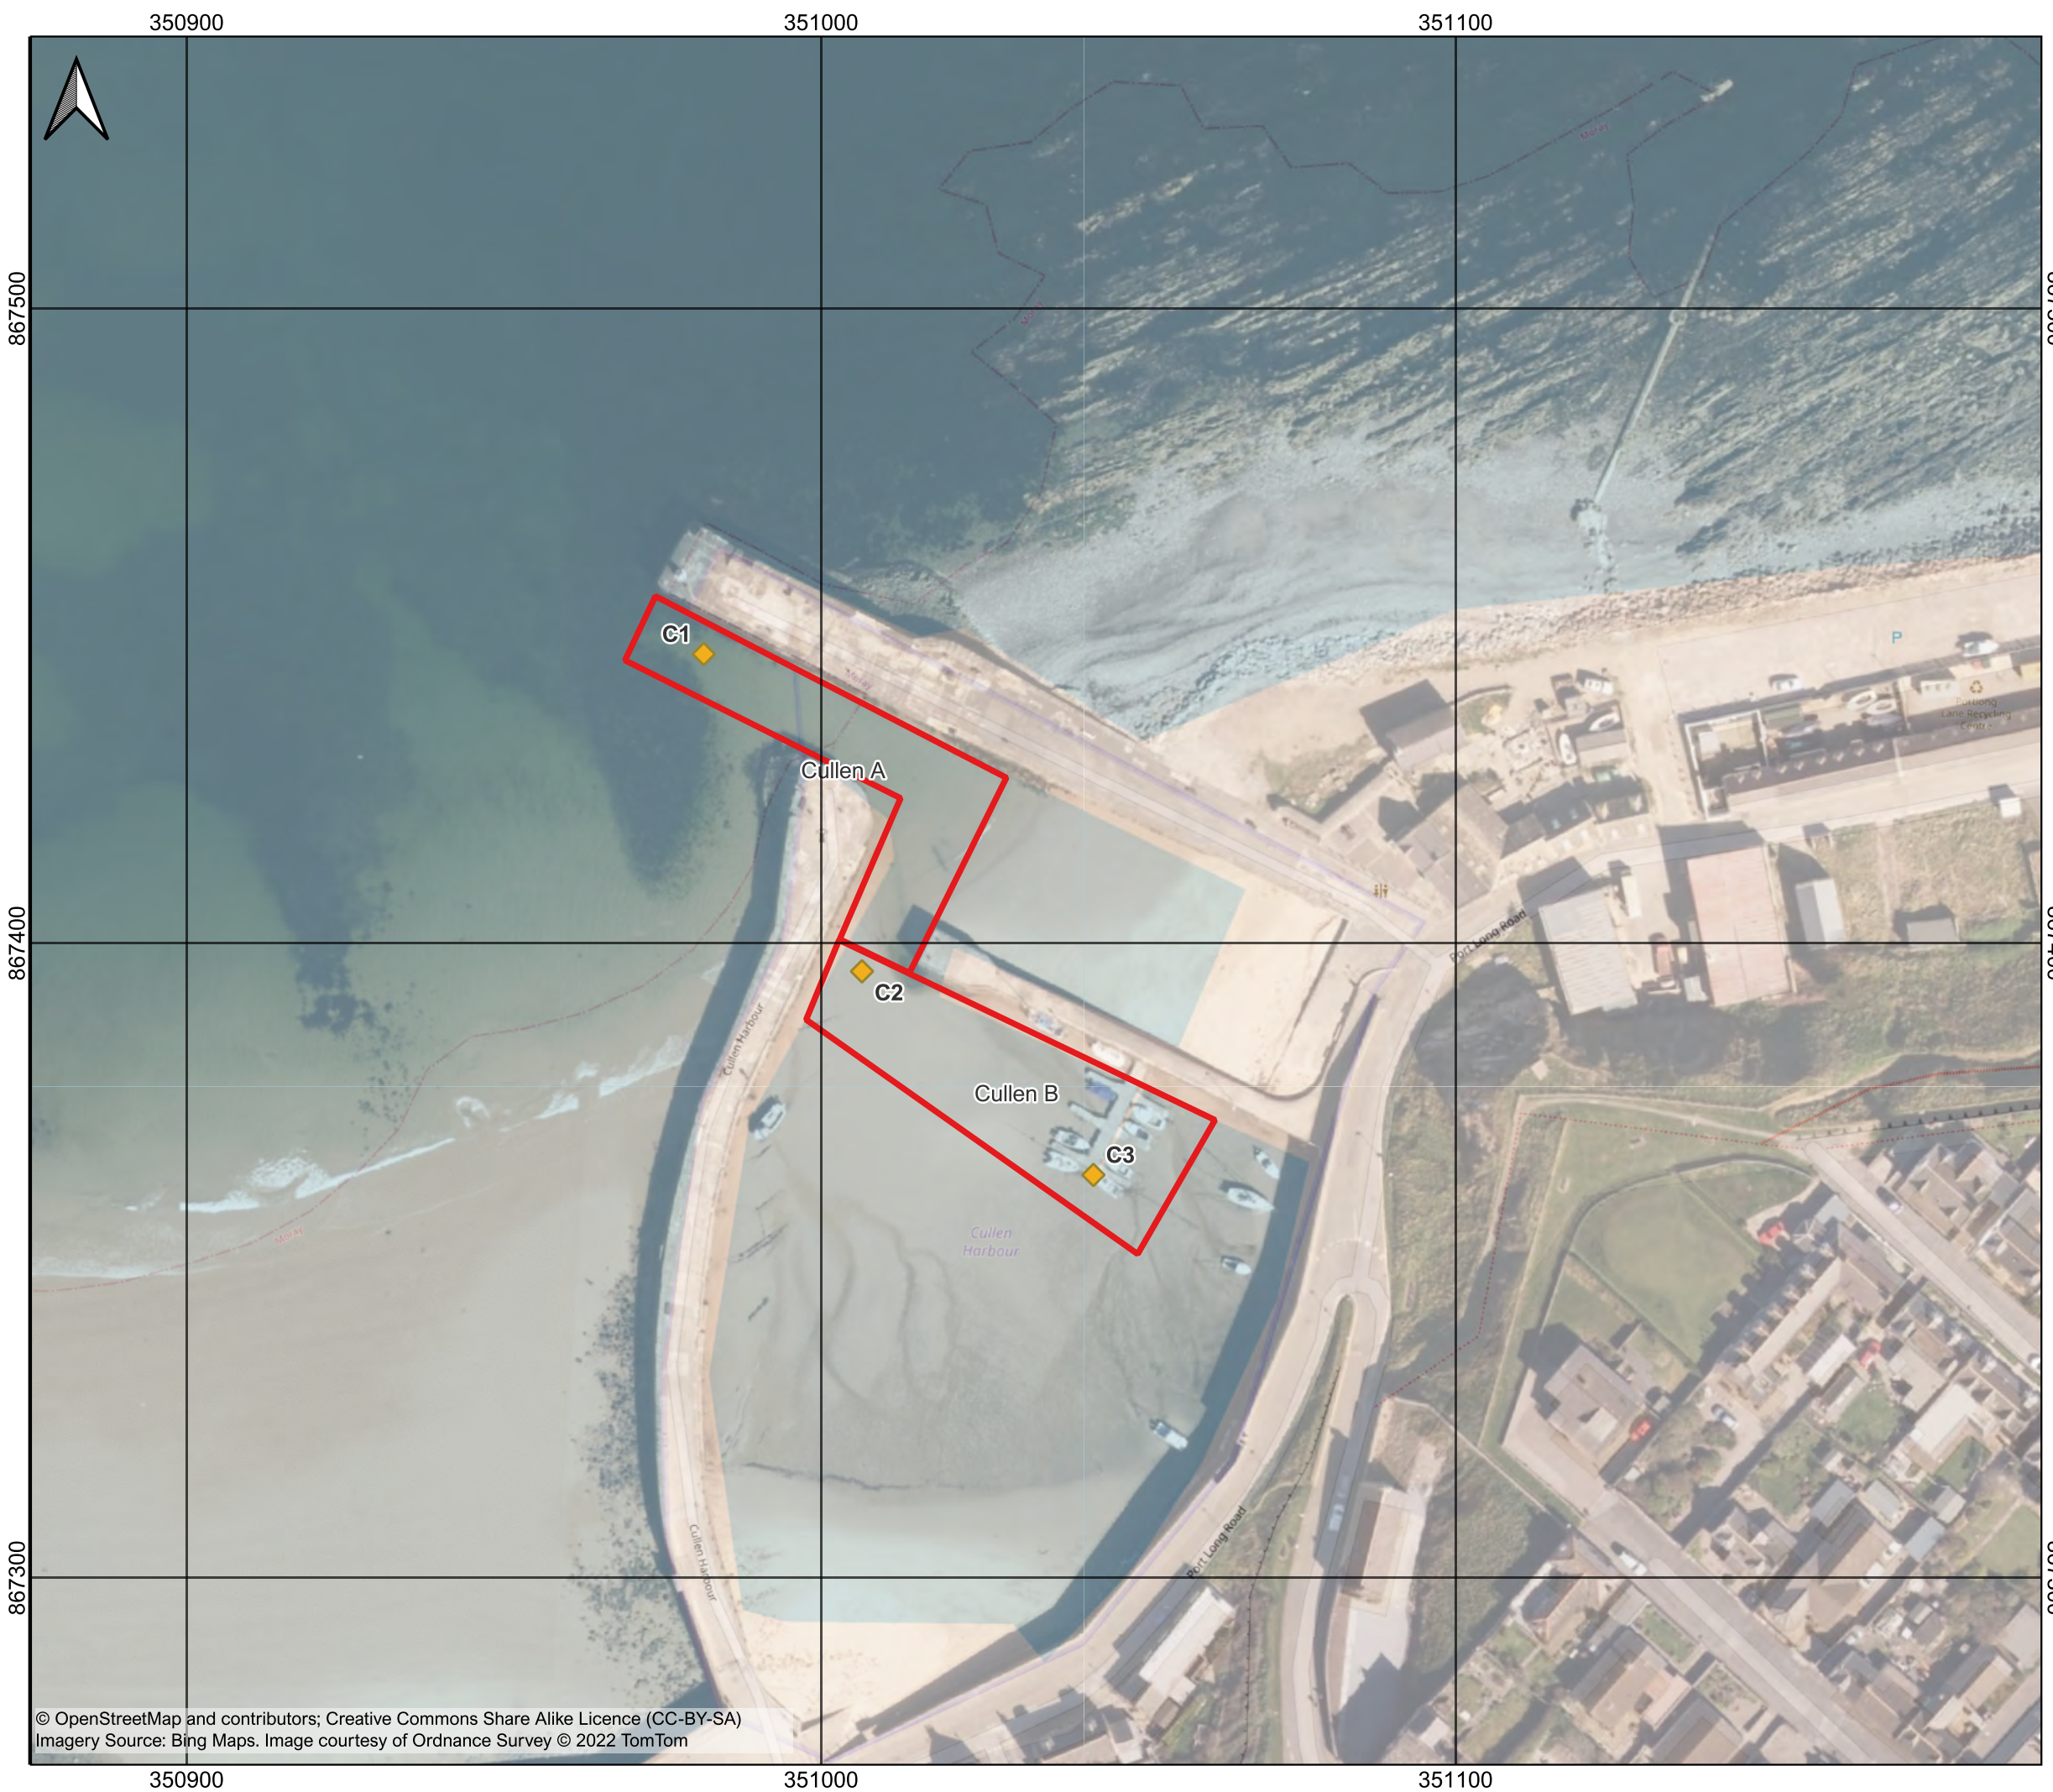
- Dredge Areas
- Sediment Samples**
- ◆ Grab

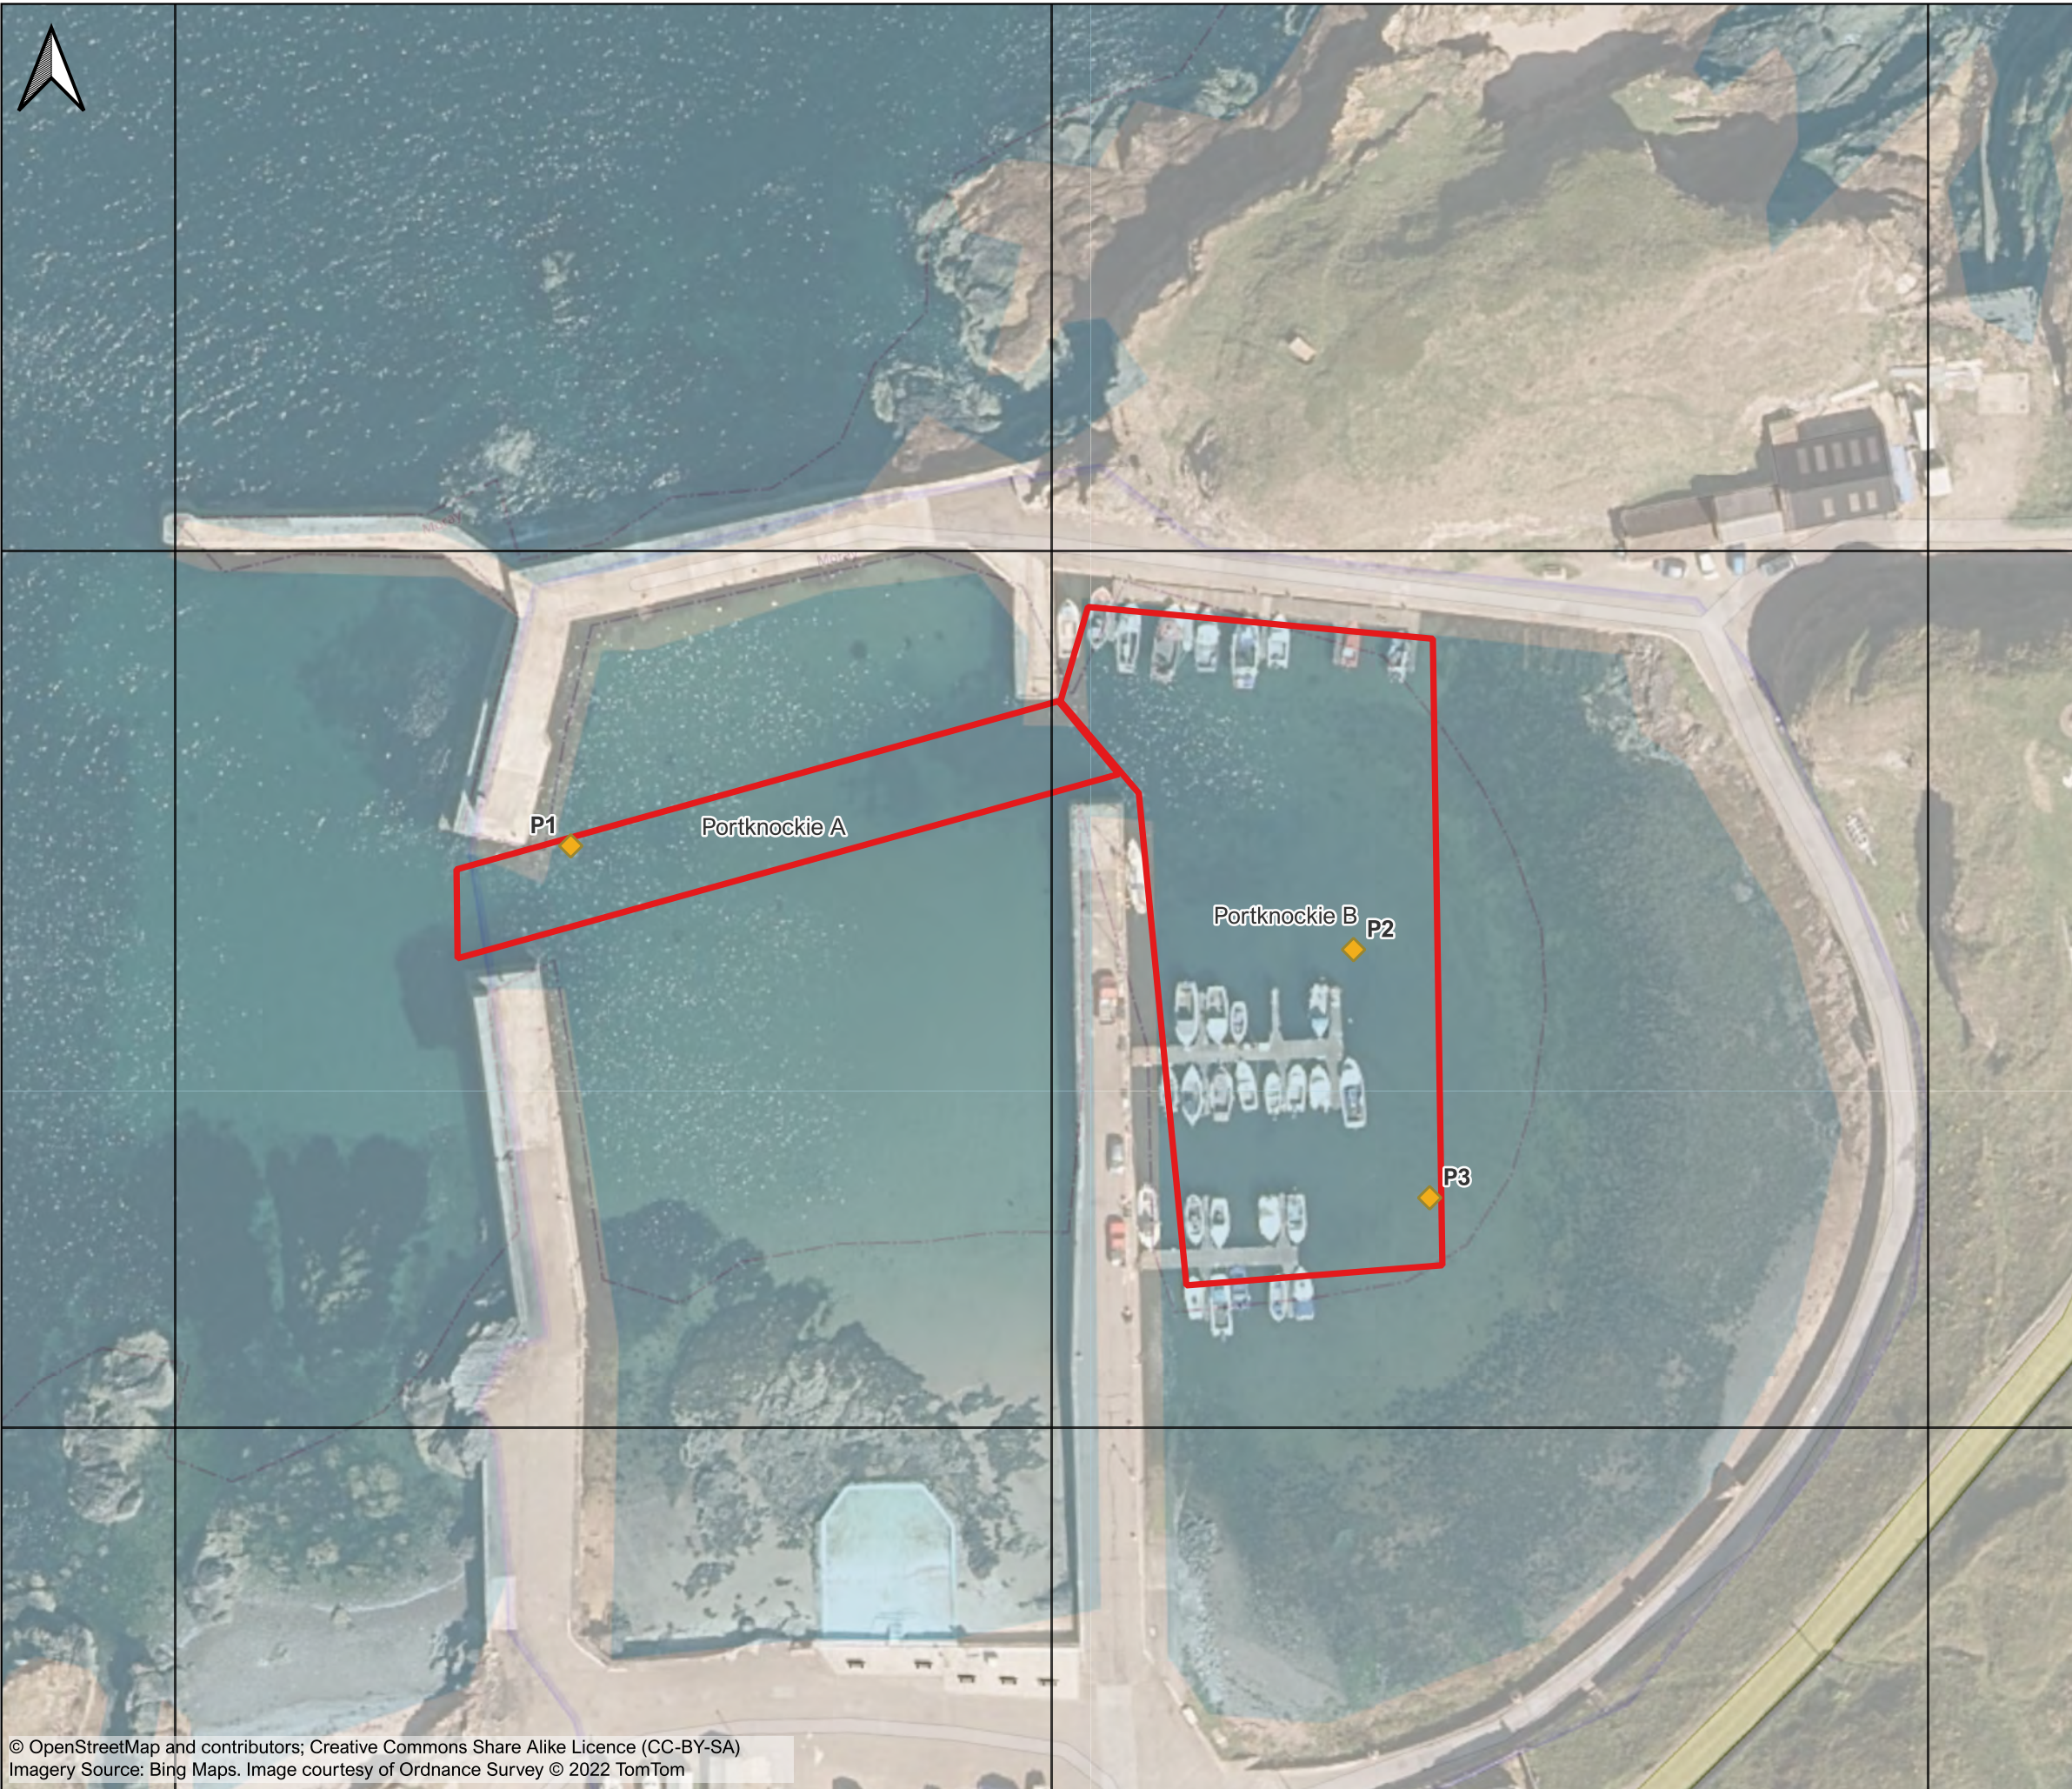
- Dredge Areas
- Sediment Samples
- ◆ Grab

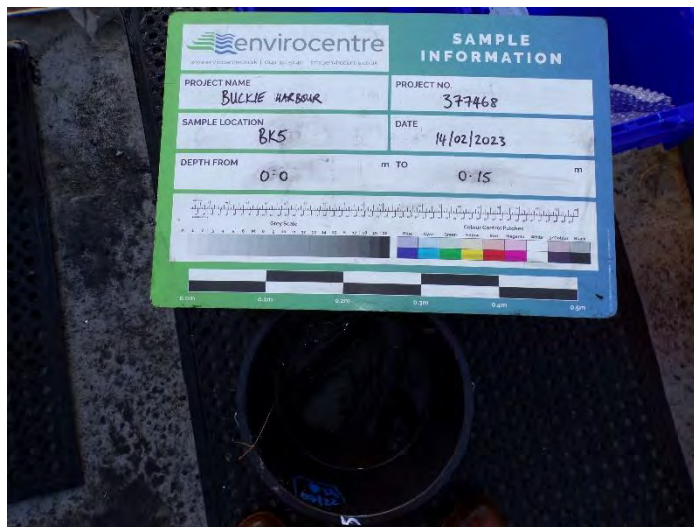
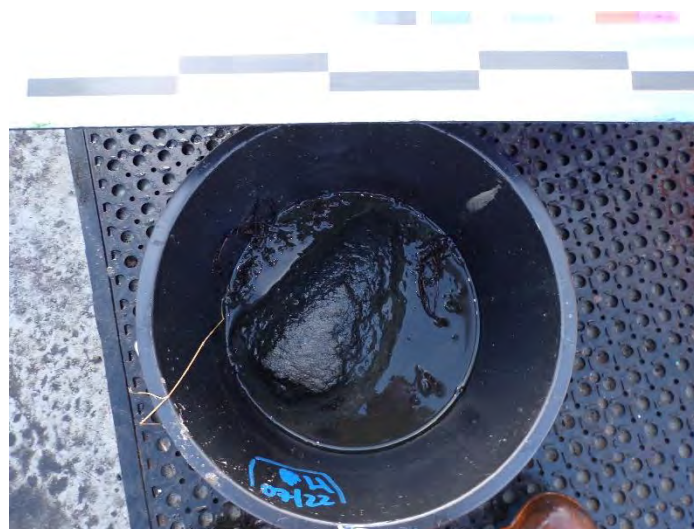
Date/Time	14/02/2022	Latitude	57.680337
Dredge Area	Buckie	Longitude	-2.9618005
Method	0.045m ² Van Veen Grab Sampler	Sampled/logged by	FR/AK

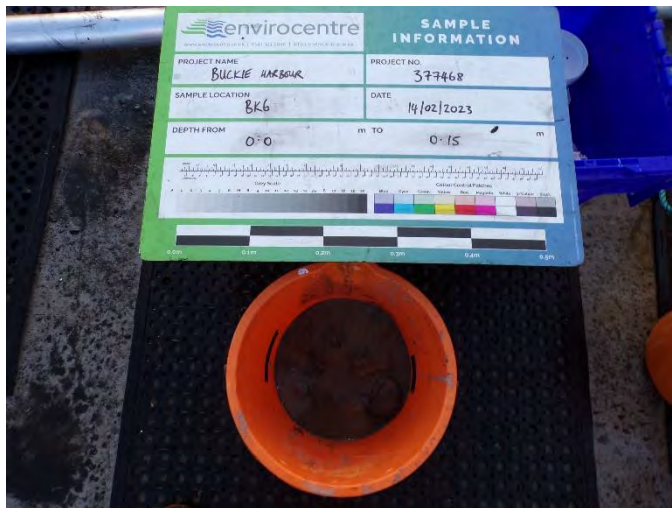
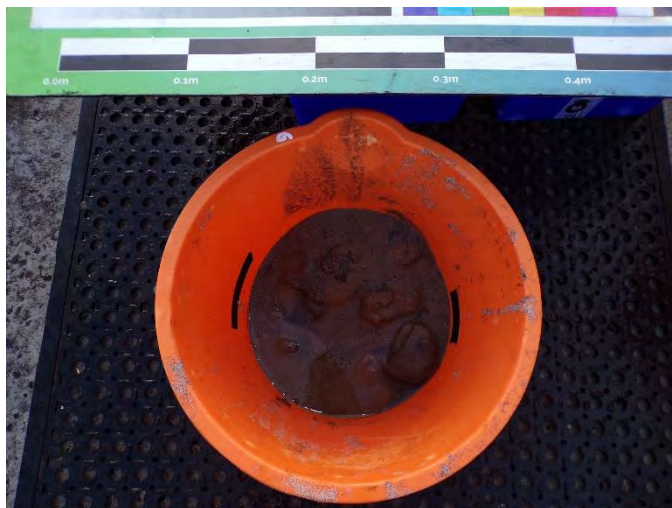
Date/Time	14/02/2022	Latitude	57.680828
Dredge Area	Buckie	Longitude	-2.9567577
Method	0.045m ² Van Veen Grab Sampler	Sampled/logged by	FR/AK

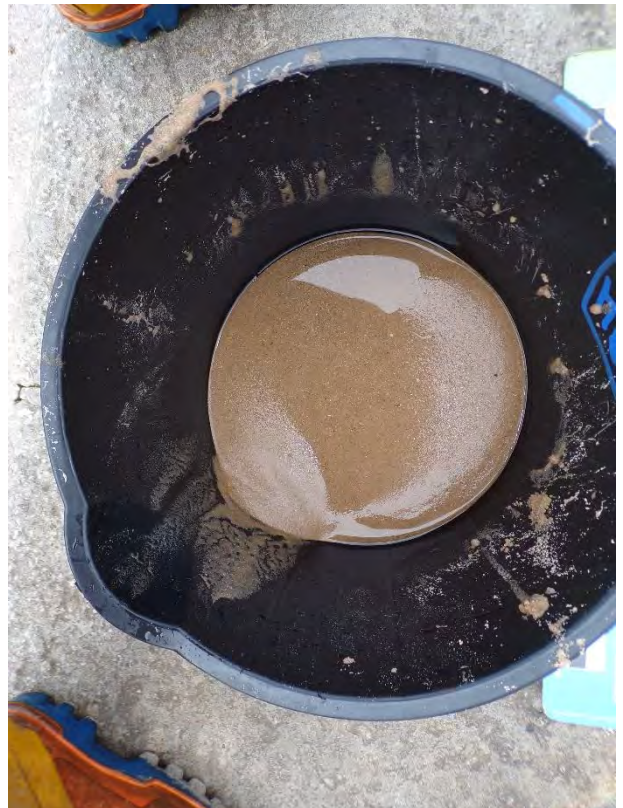
Project Name	Moray Harbours - Pre-Dredge Licensing Support	Location ID C2
Project No.	377468	
Client	Arch Henderson

Inputs:

Notes: -

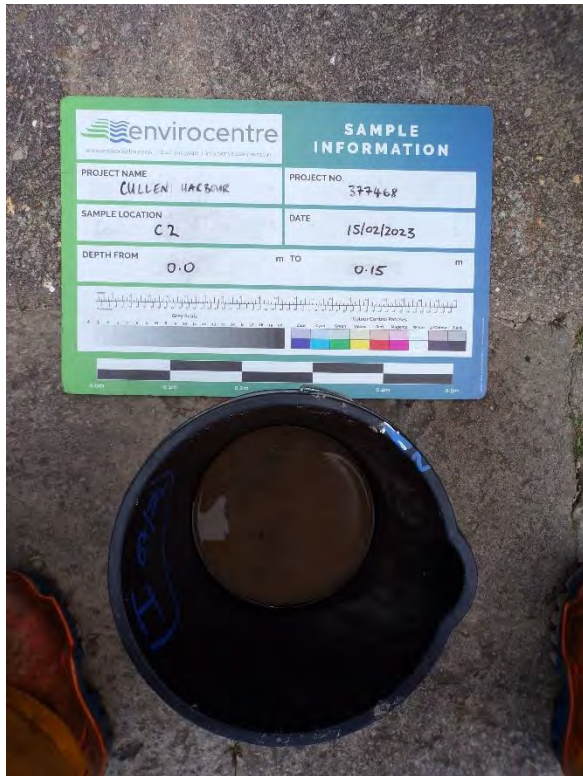
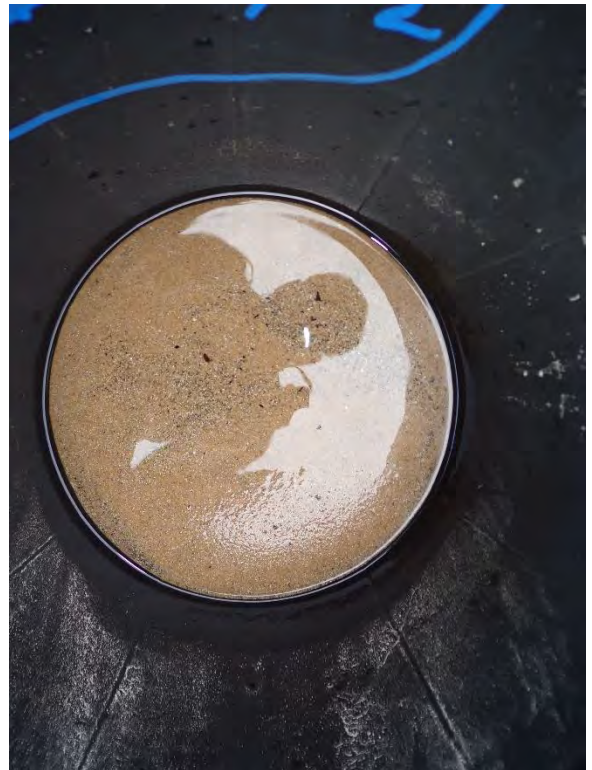
Project Name	Moray Harbours - Pre-Dredge Licensing Support	Location ID
Project No.	377468	C3
Client	Arch Henderson

Notes:

-

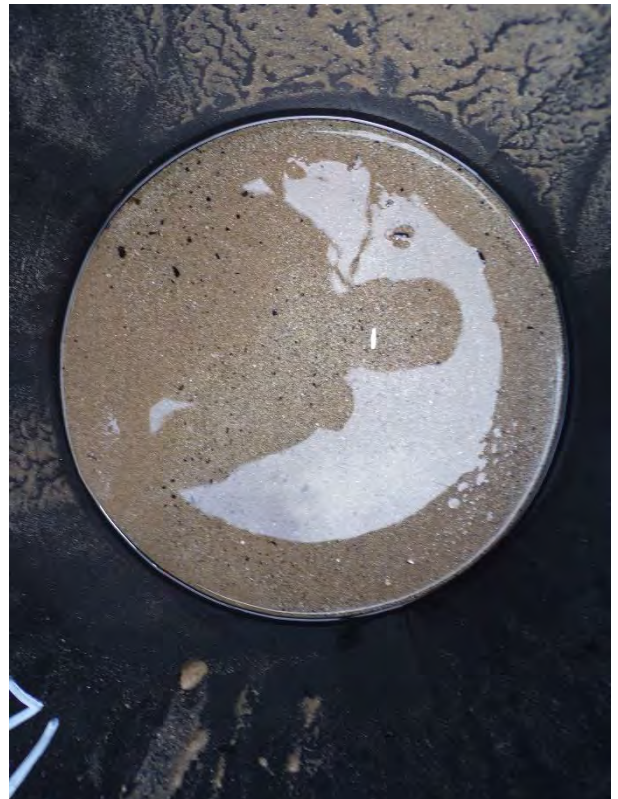
Date/Time	15/02/2023	Latitude	57.69872
Dredge Area	Findochty A	Longitude	-2.90397
Method	0.045m ² Van Veen Grab Sampler	Sampled/logged by	FR/AK

Notes: Multiple attempts made at location F1 and only recovered coarse gravel and cobbles. Sampling location relocated further into harbour as F1A.

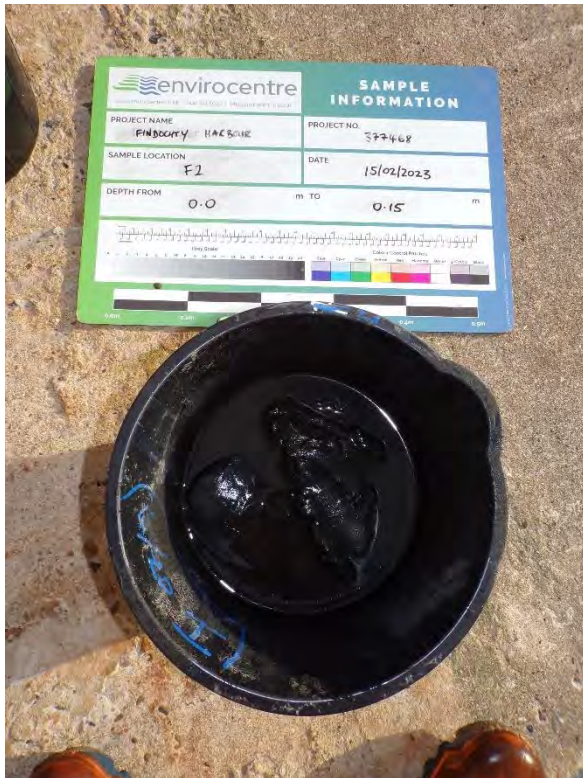
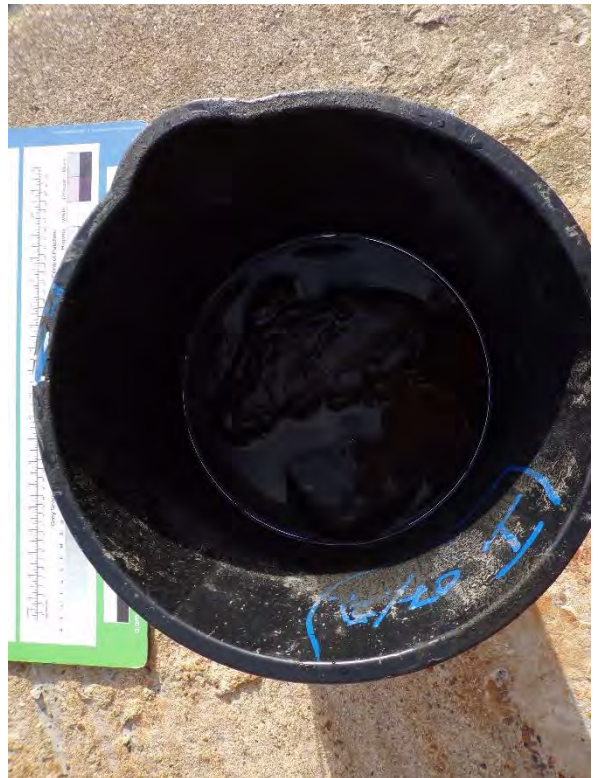
Date/Time	15/02/2023	Latitude	57.698413
Dredge Area	Findochty C	Longitude	-2.9043398
Method	0.045m ² Van Veen Grab Sampler	Sampled/logged by	FR/AK

Notes: Sample obtained from middle pier as there was no access to location during low tide.
