# NorthConnect

## Cable Burial Risk Assessment

CA Report No.: C831R01 - 04

18/05/18

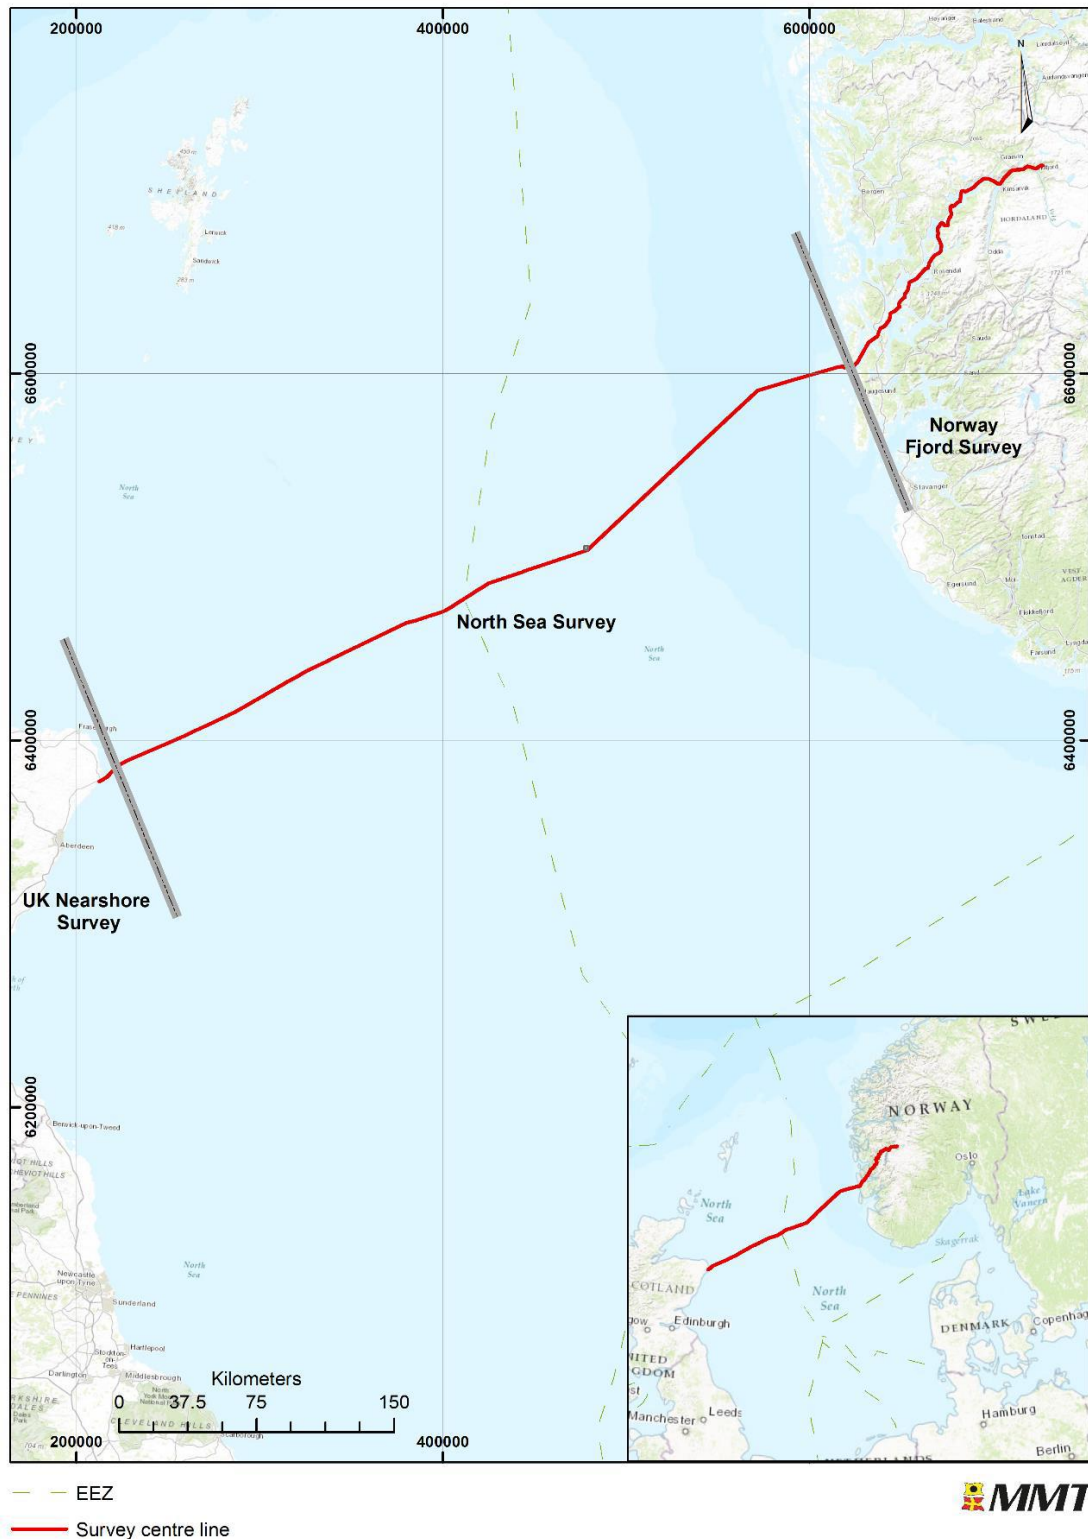
Figure 1: Overview of the NorthConnect survey corridor and original survey sections (Ref. 1)

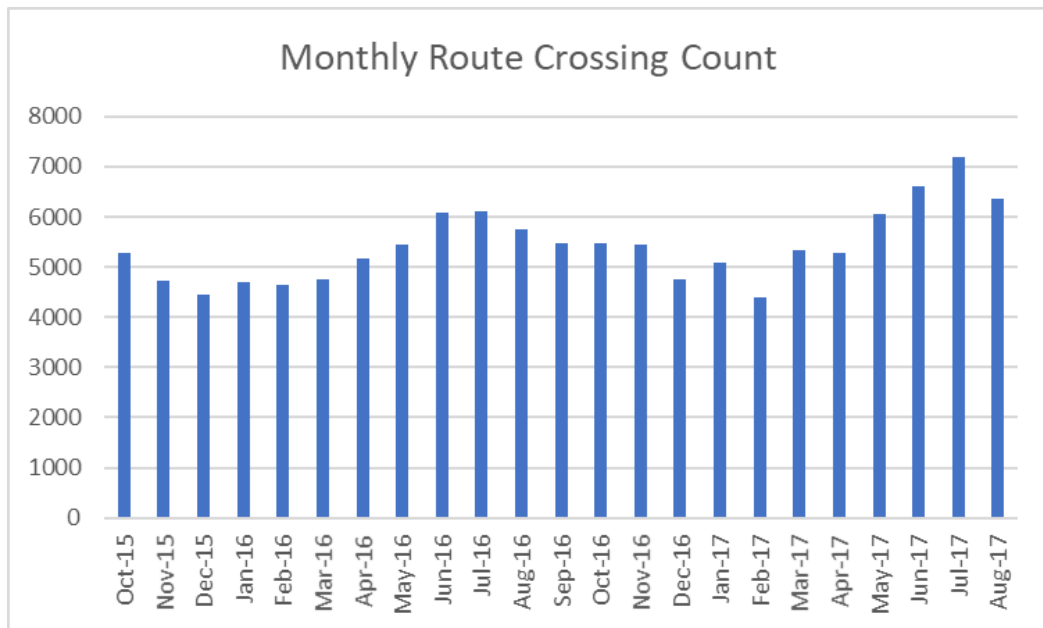
**Figure C.2. Crossing counts by month, KP 480.65 – 664.66.**

Note: Incomplete months from the beginning and end of the dataset were discarded.

- A monthly breakdown of cable route crossings (Figure C.1, C.2) shows a clear seasonal pattern with significantly lower traffic during the winter months, although the baseline level shows significant traffic in all seasons. Data is consistent for the two-year period with no obvious anomalous skews to the dataset, although Summer 2017 appeared to show a higher level of traffic compared to the previous year, both in the Fjord (C.2) and the North Sea (C.1).

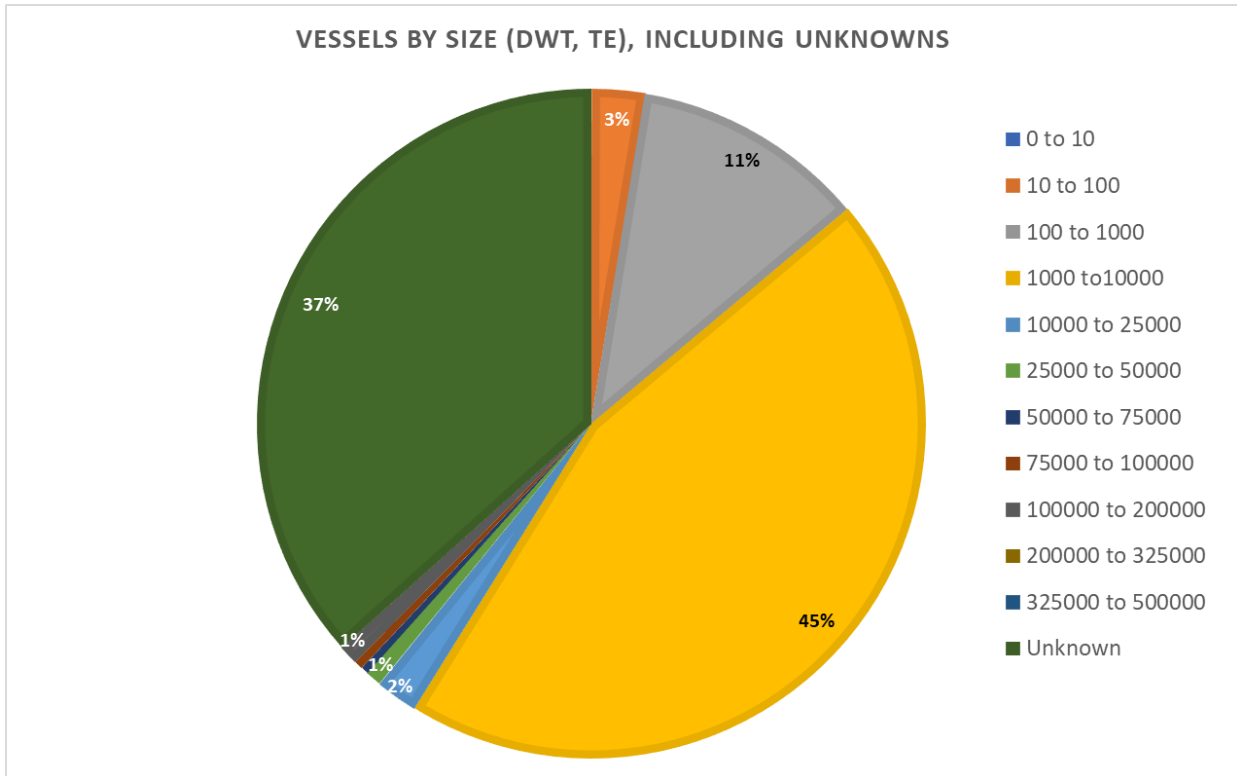
**Figure C.4: Vessel sizes (Nearest %, including unknowns)**

Figure C.4 below show the distribution of deadweight tonnage (DWT) of vessels which crossed the proposed cable route (KP 0.1 to 480.65) during the period covered by the AIS dataset. These proportions include a significant percentage of unknowns which remain even after the most commonly crossing vessels of unknown DWT were looked up. Figure C.5 shows the distribution of known DWT vessels only, which also represents the size distribution after the DWT unknowns had been reallocated proportionally among the known size ranges, according to their proportion)

The majority of vessels fall into the 1000 to 10000 Te category (71% of vessels for which DWT is known). Vessels of unknown DWT comprise 37% of vessel cable route crossings. For undertaking the probabilistic analysis, each class is scaled-up as discussed. Thus 45% of known vessel crossing DWT's in the 1000-10000 category scales to 71% of the upscaled probabilistic data. This scaling may represent an element of conservatism, as the unknown vessels appear to generally be smaller ships (fishing vessels etc) when looked up. However, there are also often large vessels, which for whatever reason, do not have their DWT information inputted to the AIS record, as received for processing. At present, no research has been conducted as to an average size distribution of vessels of unknown DWT, thus the directly proportional scaling has been applied. A much larger proportion of vessels in the Fjord are of unknown DWT. This may reflect their size, or the fact that many will be used as inshore vessels only and not deem it necessary to report statistics such as DWT on their AIS transmissions.

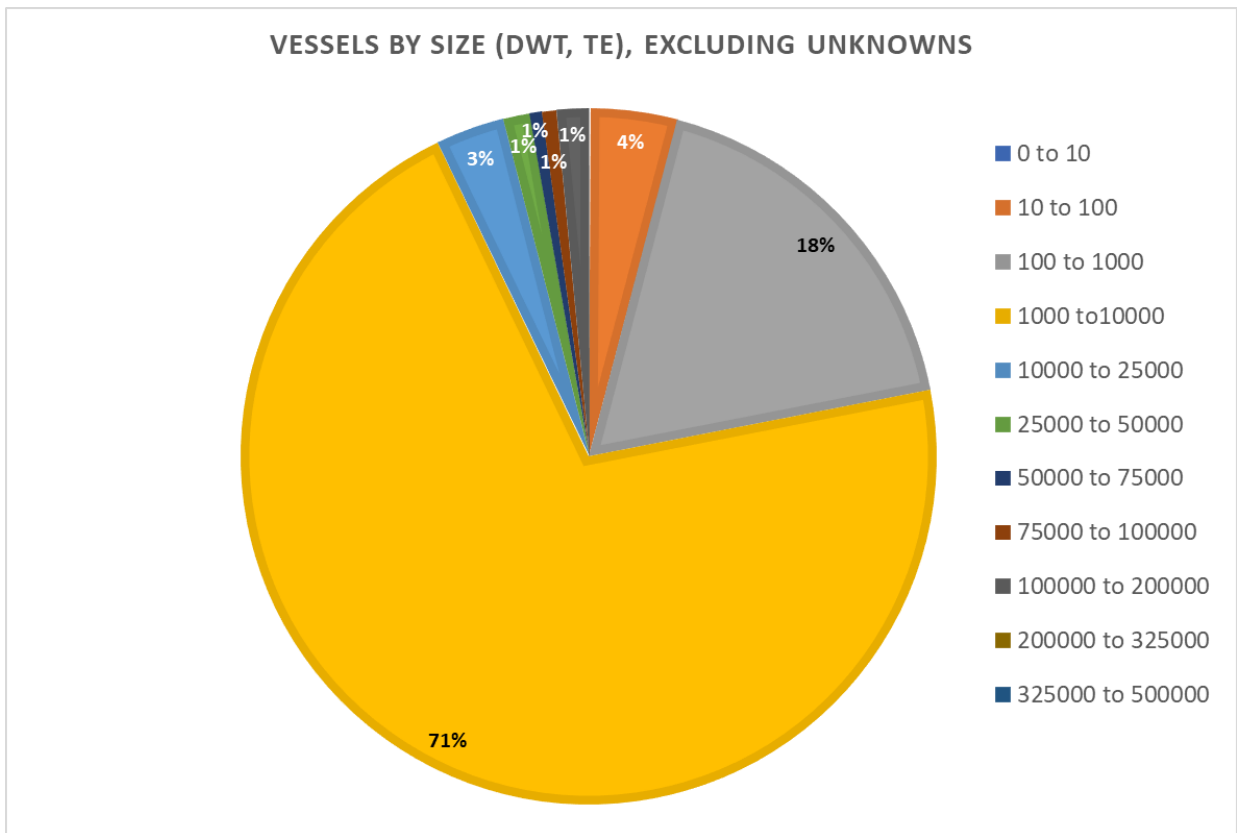
**Figure C.5 Vessel sizes (Nearest %, excluding unknowns)**
