# Project Overview

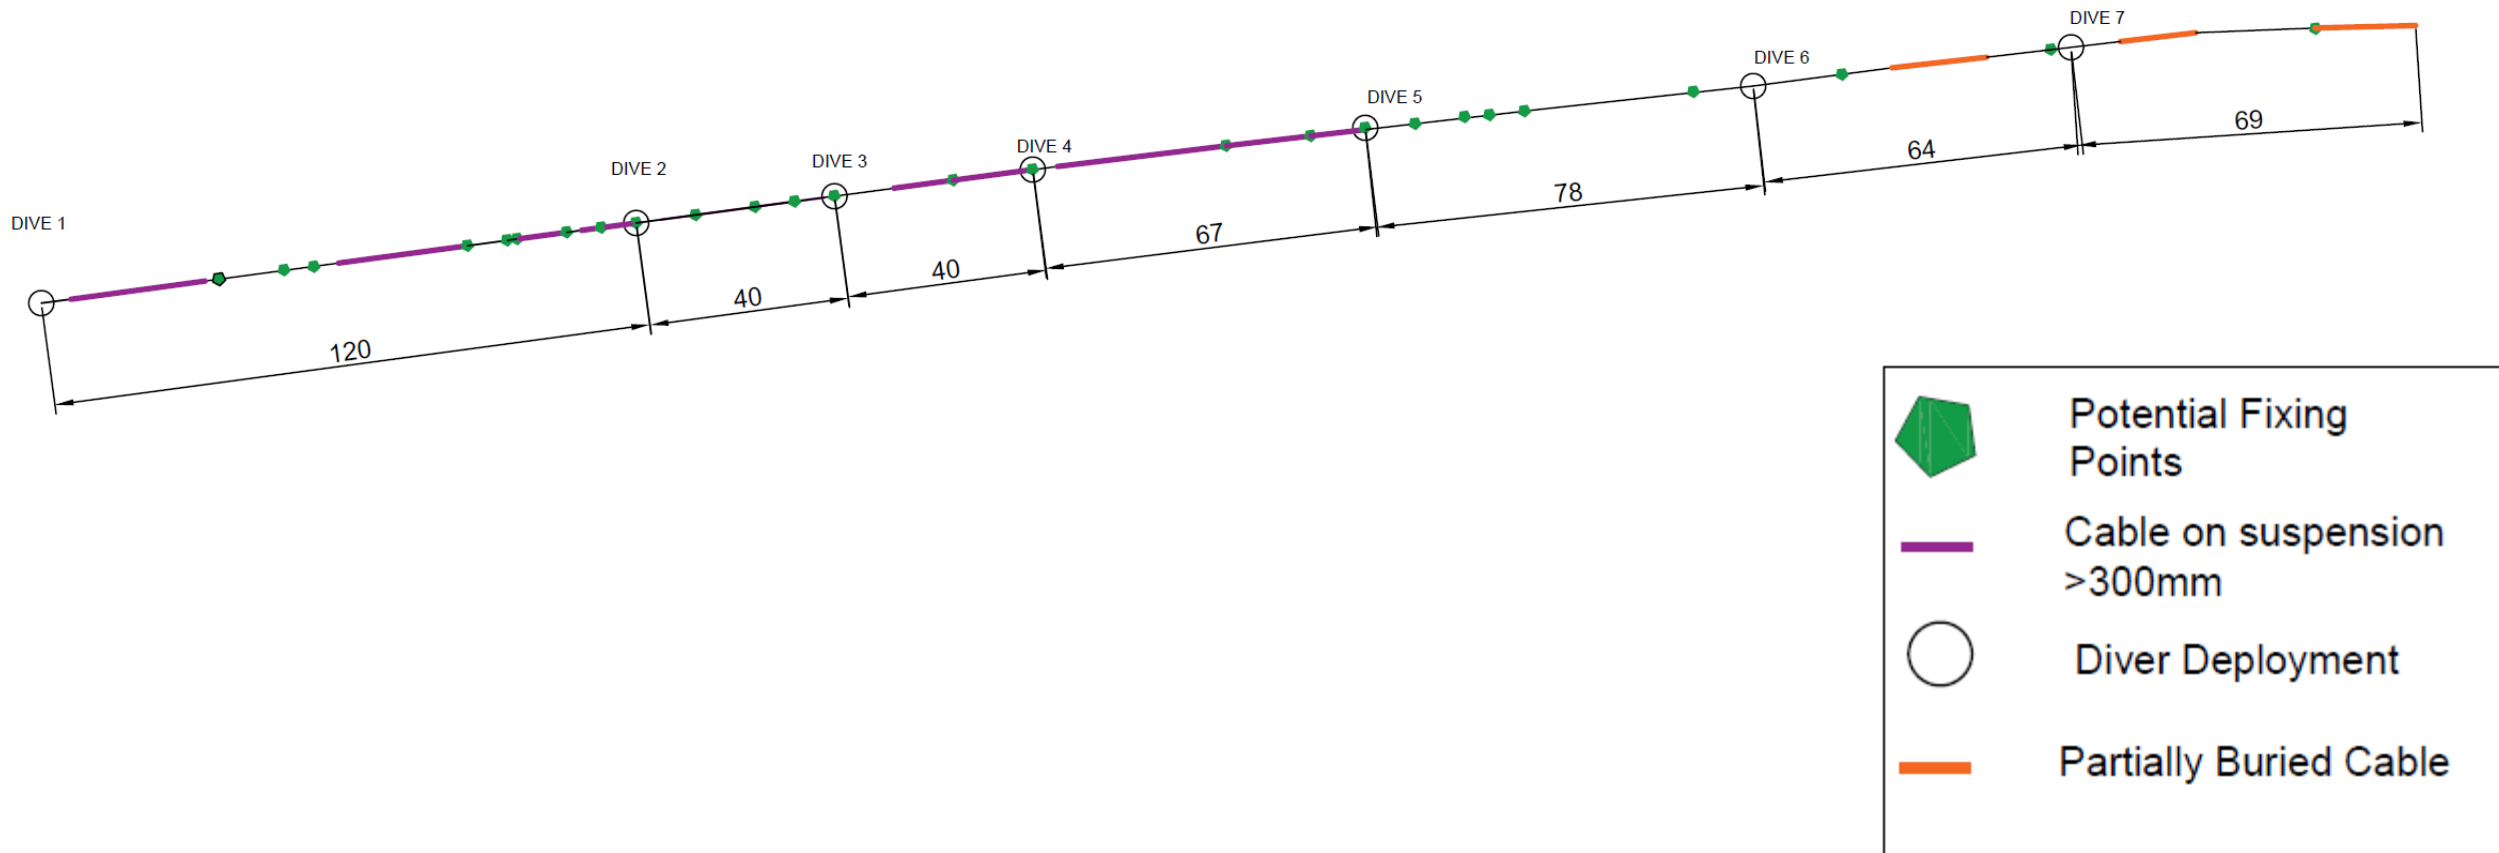
The most recent survey of the SHEFA cable shows that the cable has been rubbing against the rock of the seabed causing lost of the cable protecting cover.
