Pentland Firth East (2) Decommissioning Plan

P2577_R5827_Rev2 | 23 November 2022

Intertek Energy & Water Consultancy Services

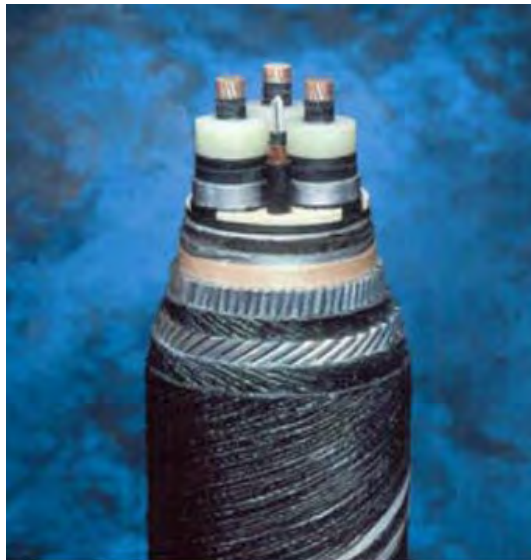
Figure 2-1 Installed cable structure (Global Marine 2019)

The now-faulted PFE (2) 33 kV subsea cable is a 400mm three core XLPE (cross-linked polyethylene) conductor with two x 48 fibre optic cables, encased within a double layer of 6mm steel wire armour. The double wired armour (DWA) construction provides the cable with additional mechanical protection and weight. Fibre optics are integral to the power cable for the purpose of cable condition monitoring, control and power systems protection. The cable structure is shown below in Figure 2-1.

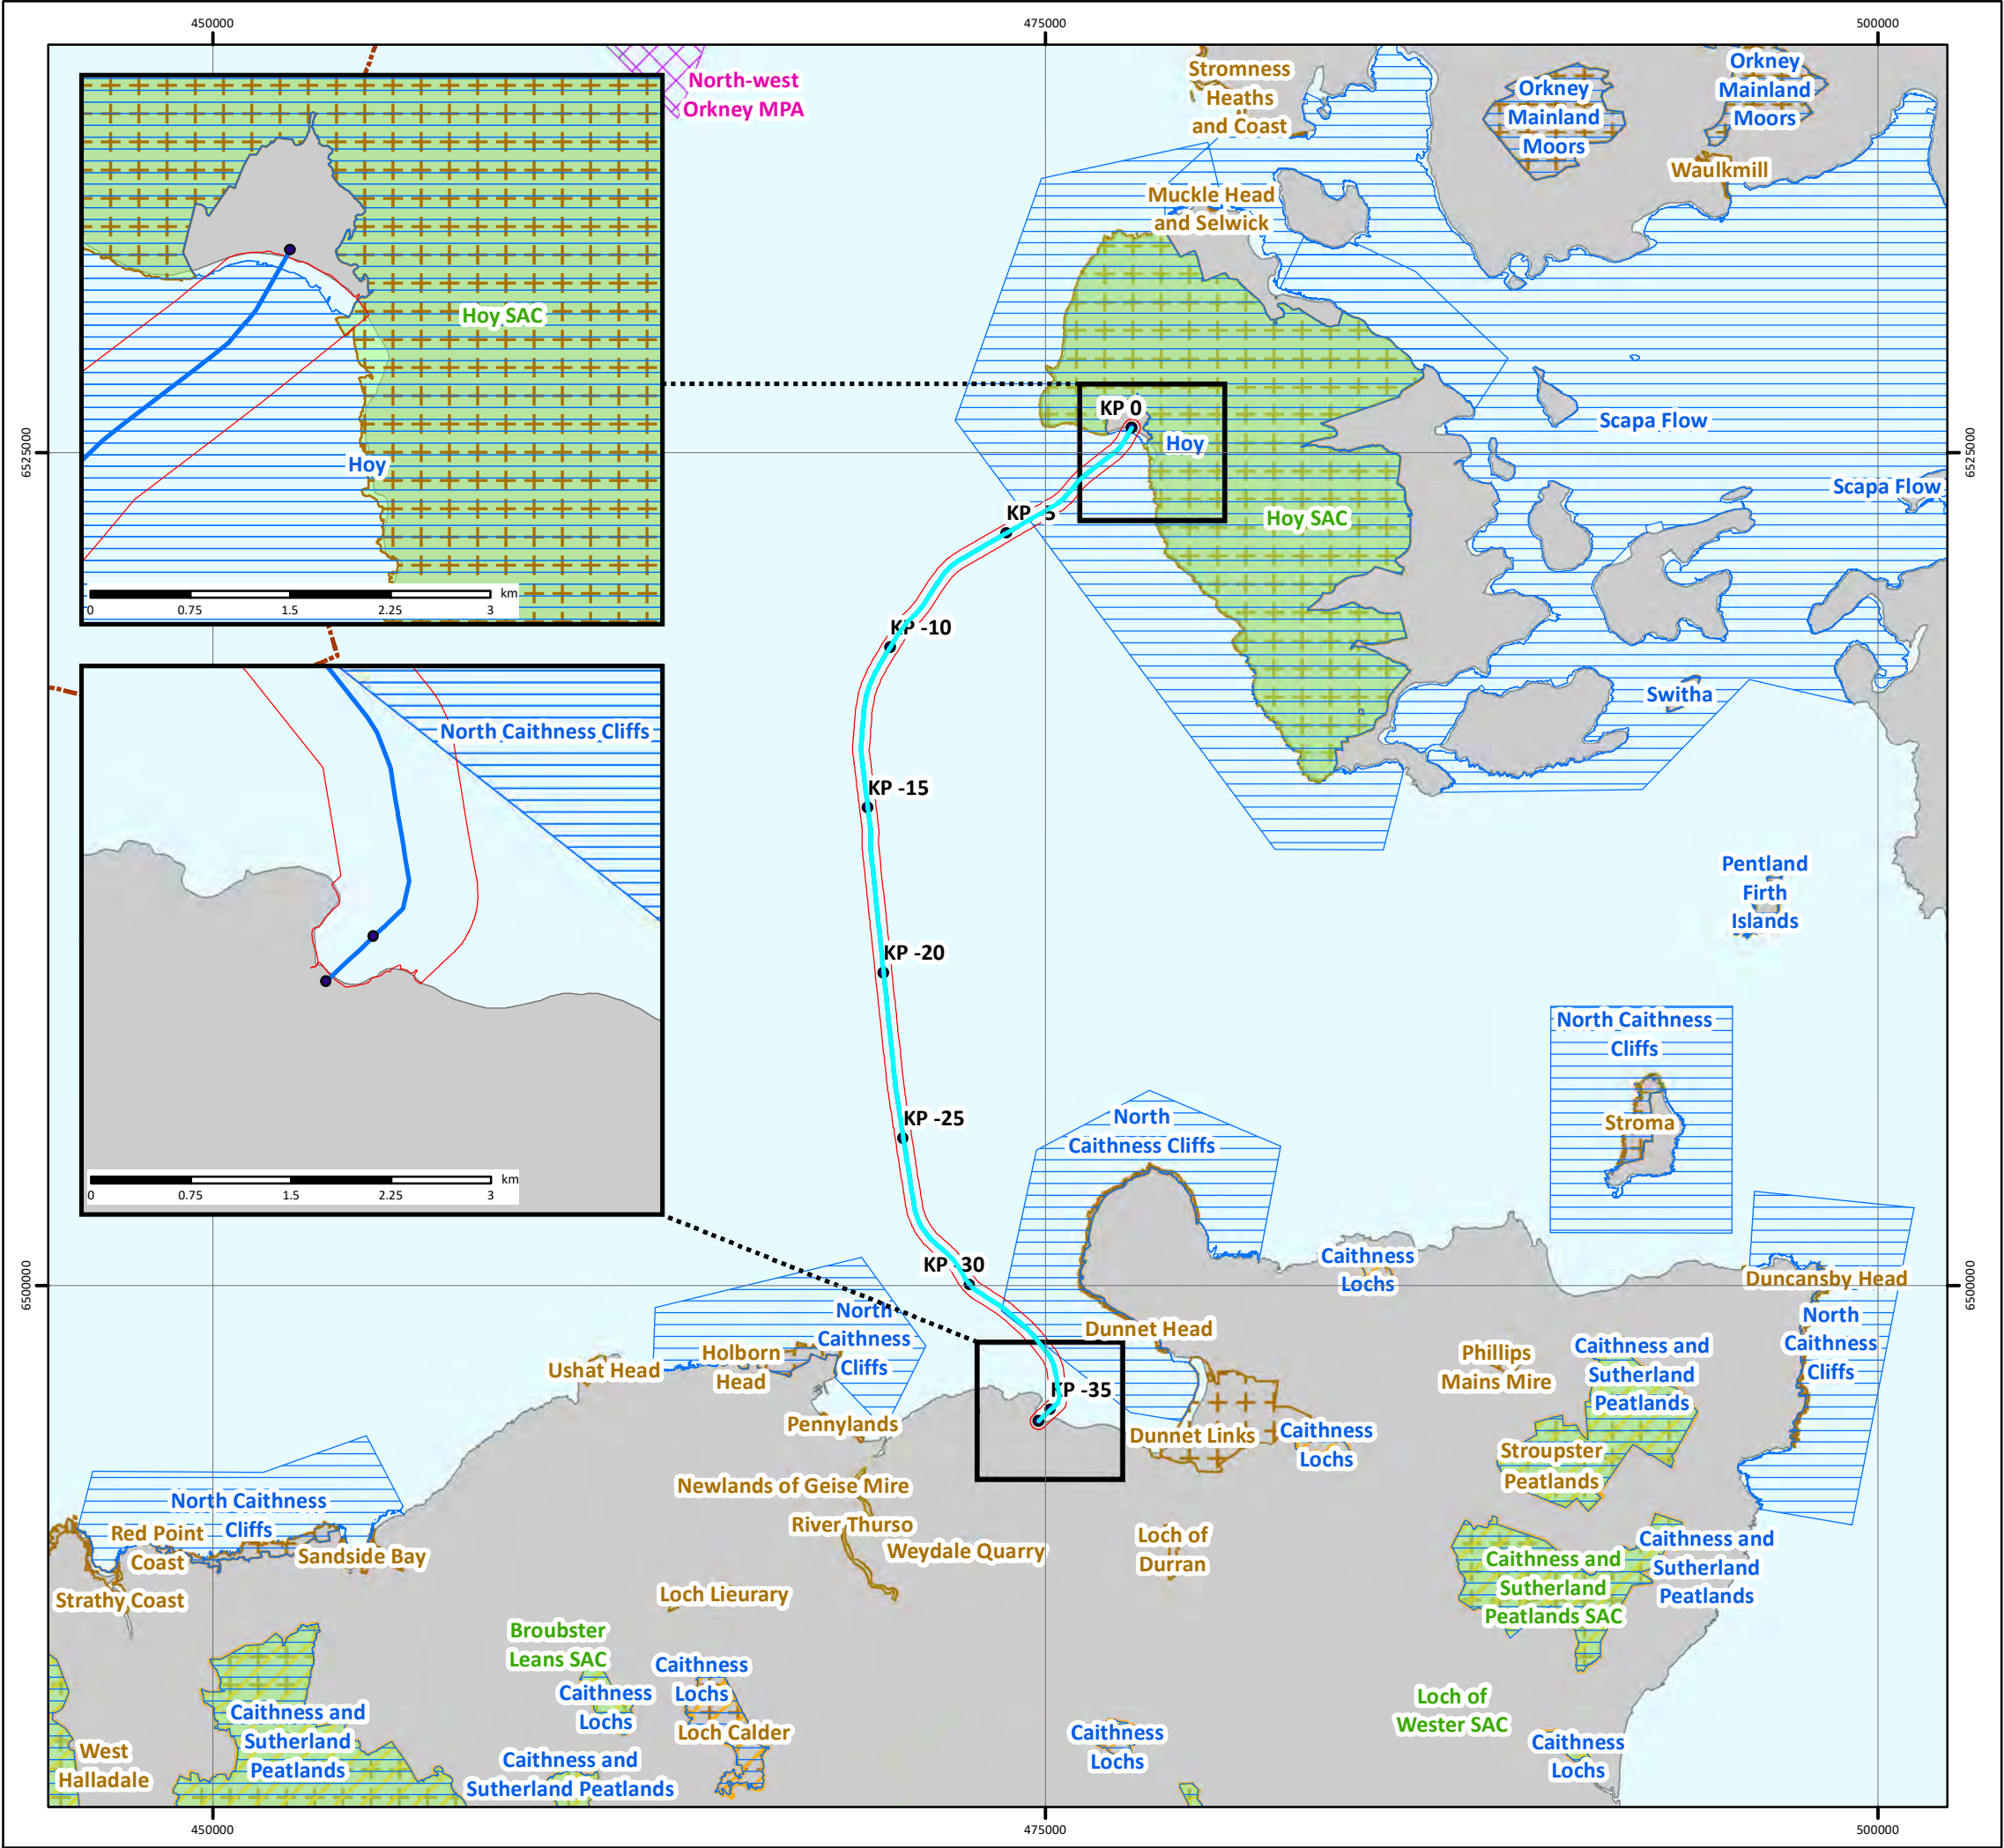
PENTLAND FIRTH CABLE REPLACEMENT
MARINE LICENCE SUPPORT

There are several existing and proposed protected sites within or in close proximity to the as-laid cable route and landfall sites. These sites are displayed in Figure 2-1

PROTECTED SITES
Marine Licence Corridor
