Toft Pier Development Dredge Disposal Area Camera Survey

Toft Pier Development Dredge Disposal Area Camera Survey Report

April 2019

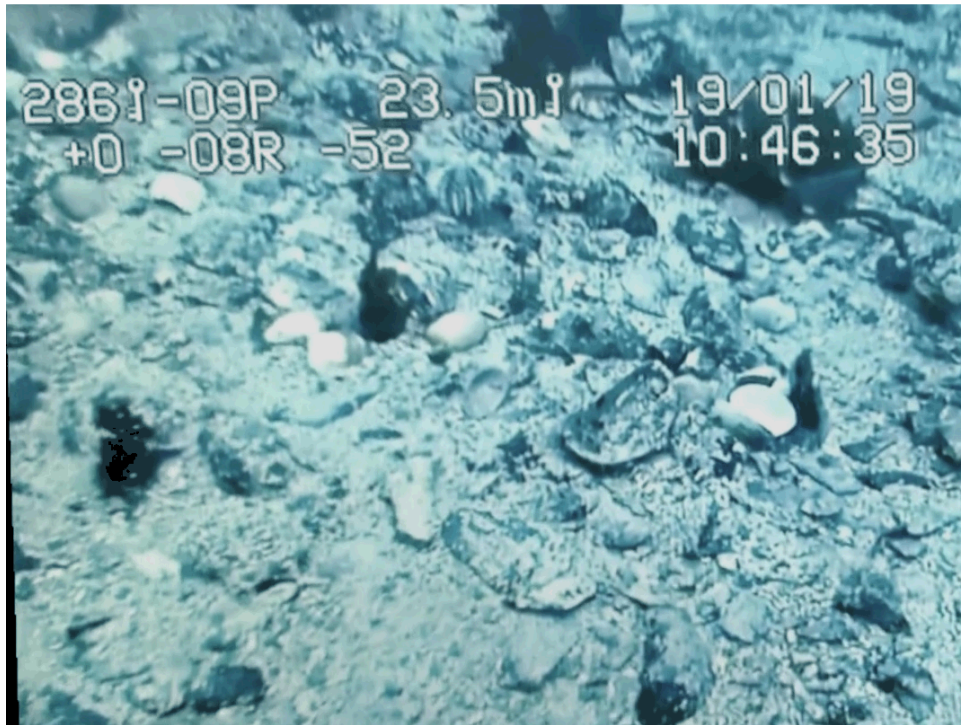
- 3.3. There may be empty *Modiolus* shell, although very limited numbers. It is not possible to tell directly if there are live individuals. Horse mussels often tend to embed, which would not be apparent at the resolution available; however, if there had been a more extensive colonisation of the site by this species then one would expect there to be more evidence of dead shells than is apparent (Figure 3).

Figure 3. Potential empty *Modiolus* shell seen at 3 minutes 54 seconds in video footage.

- 3.4. There is also generally a relative lack of associated epiflora and epifauna such as one might expect with a reef and, although more difficult to ascertain, no apparent topographical variation which might occur if sediments were being stabilised by the mussels.
- 3.5. This conclusion is also supported by marine specialists at Scottish Natural Heritage (SNH, email from Jonathan Swale dated 29 March 2019):
- 3.6. *"We agree with your assessment of the video with regard to Modiolus, i.e. that the absence of epifauna and epiflora and relative scarcity of dead shells indicates that horse mussels are unlikely to be present in sufficient concentrations to constitute a PMF horse mussel bed."*
