Appendix M.2: Vibrocore & Benthic Habitat Survey – Tarbert Ferry Terminal, Isle of Harris – December 2017

VIBROCORE & BENTHIC HABITAT SURVEY

TARBERT FERRY TERMINAL, ISLE OF HARRIS

PROJECT REF: A6488

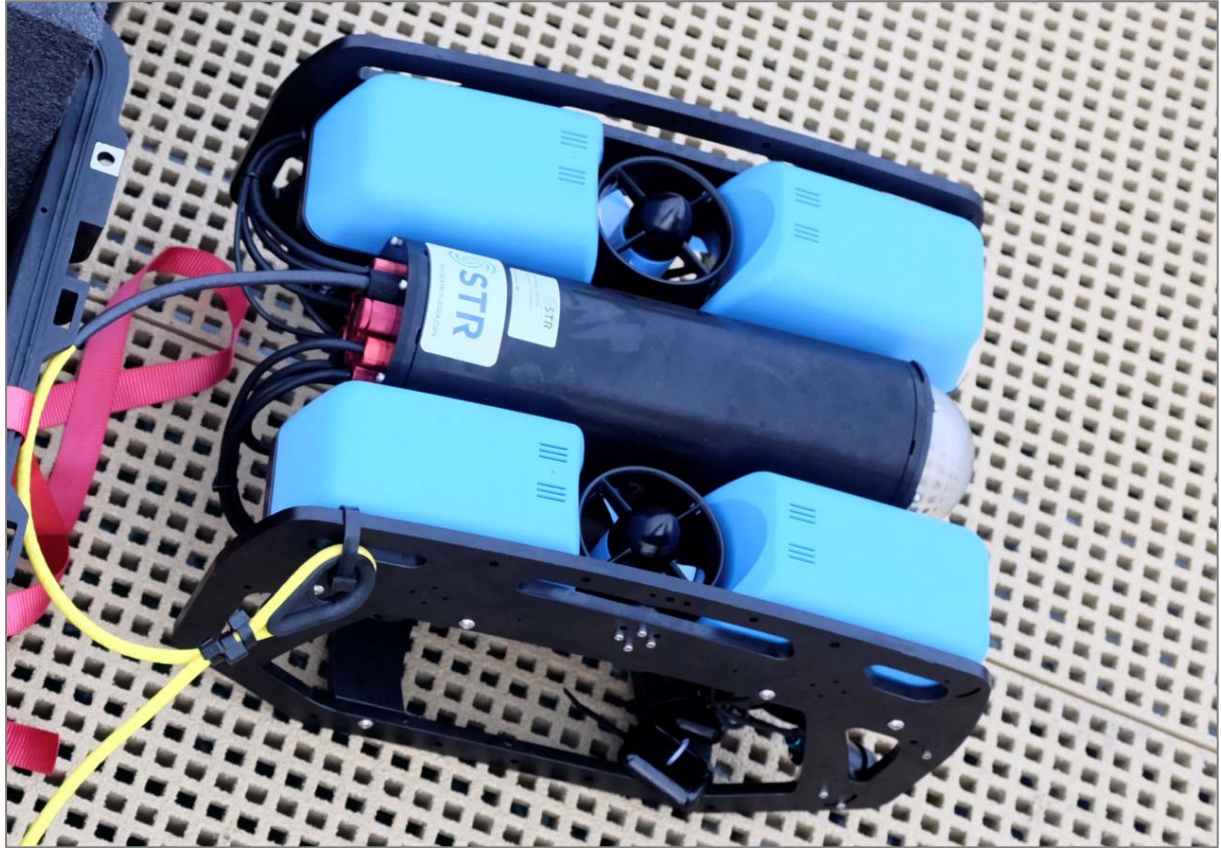
Video transect conduct and analysis was sub contracted to APEM. The video transects were carried out using a Blue ROV2 remote operated vehicle with an integrated HD camera and lighting.

FIGURE 4 - BLUE ROV2 DEPLOYED TO SITE

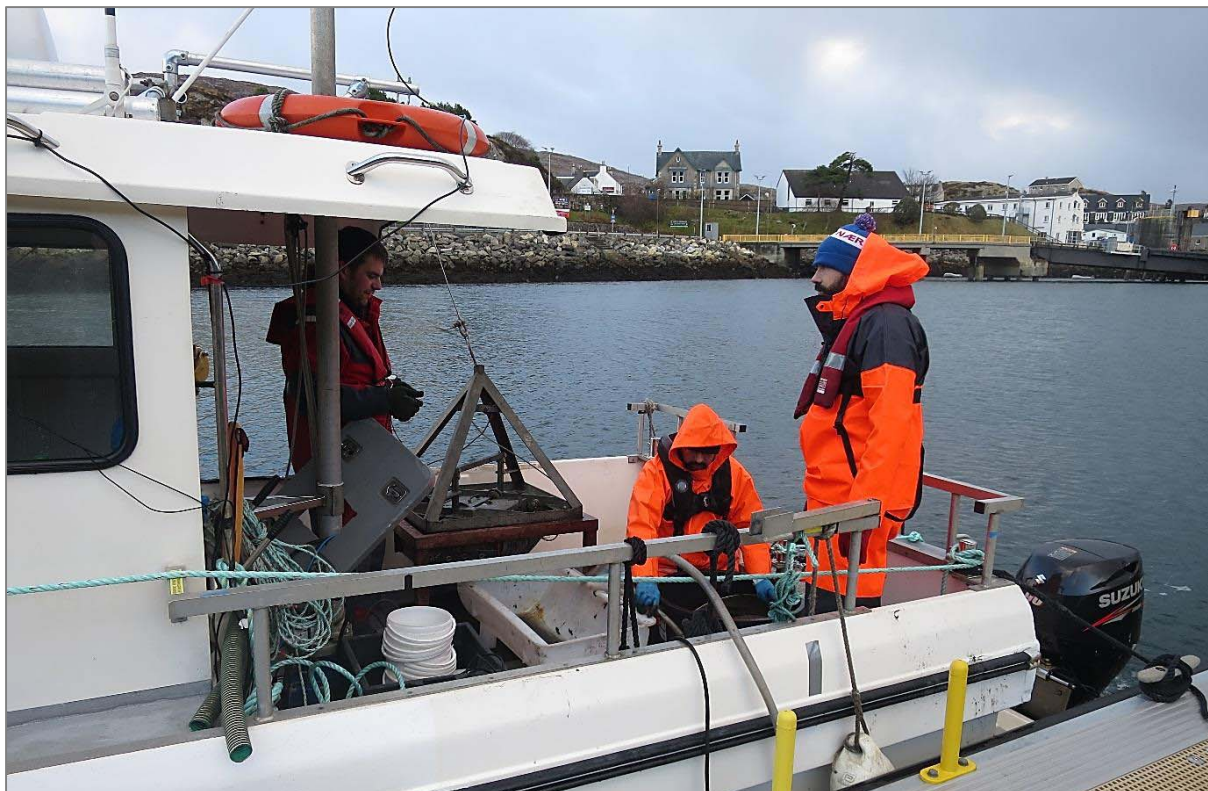
A day grab was used in order to gain the samples. This was deployed from the over-side manually operated davit on the survey vessel Remote Sensor.

FIGURE 7 - DAY GRAB AND SAMPLE ANALYSIS ON REMOTE SENSOR

The grab samples were sieved on board to remove sediment allowing the biological material to be fixed in Formalin for transfer to the laboratory.

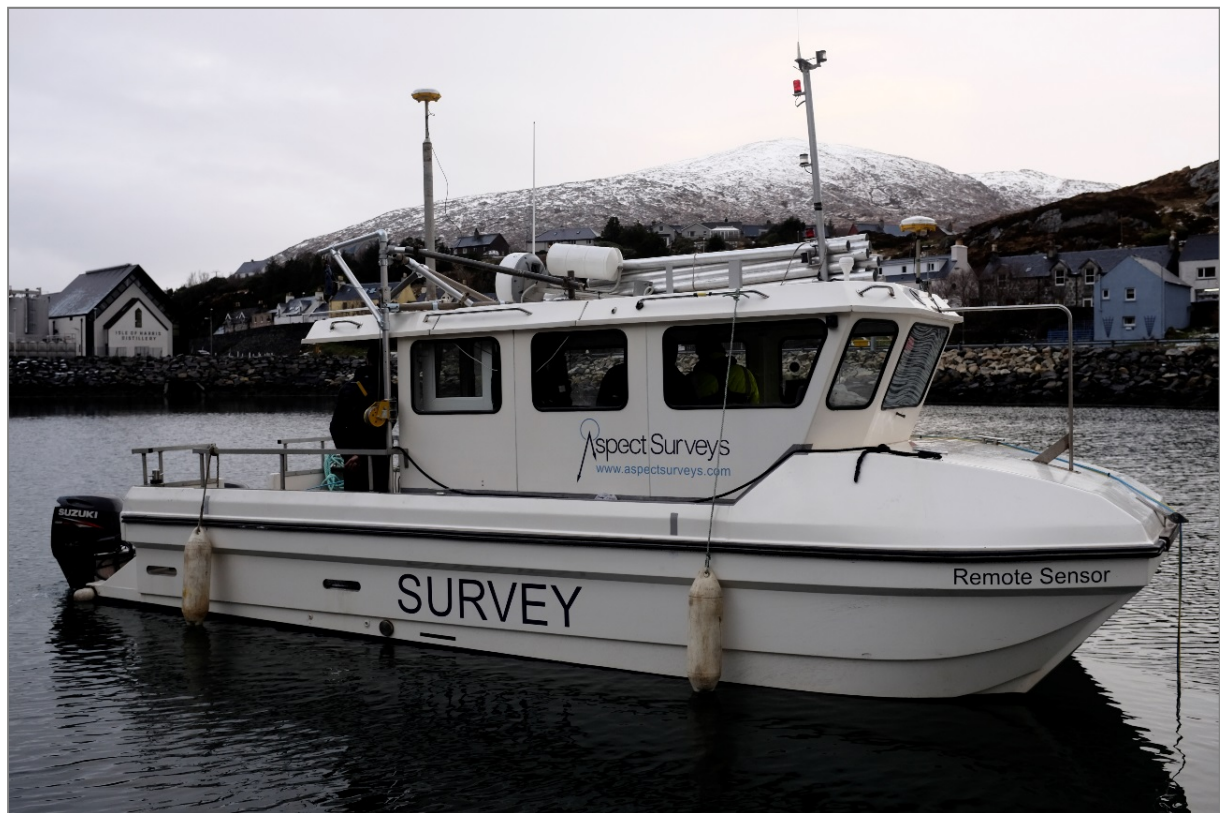
The shallow draught and high manoeuvrability of *Remote Sensor* made it ideal for operating in the survey area which was both shallow and navigationally constrained. The vessel was transported to Tarbert Harbour by road and launched at the slipway in the harbour.

FIGURE 15 - ALHS' SURVEY VESSEL REMOTE SENSOR

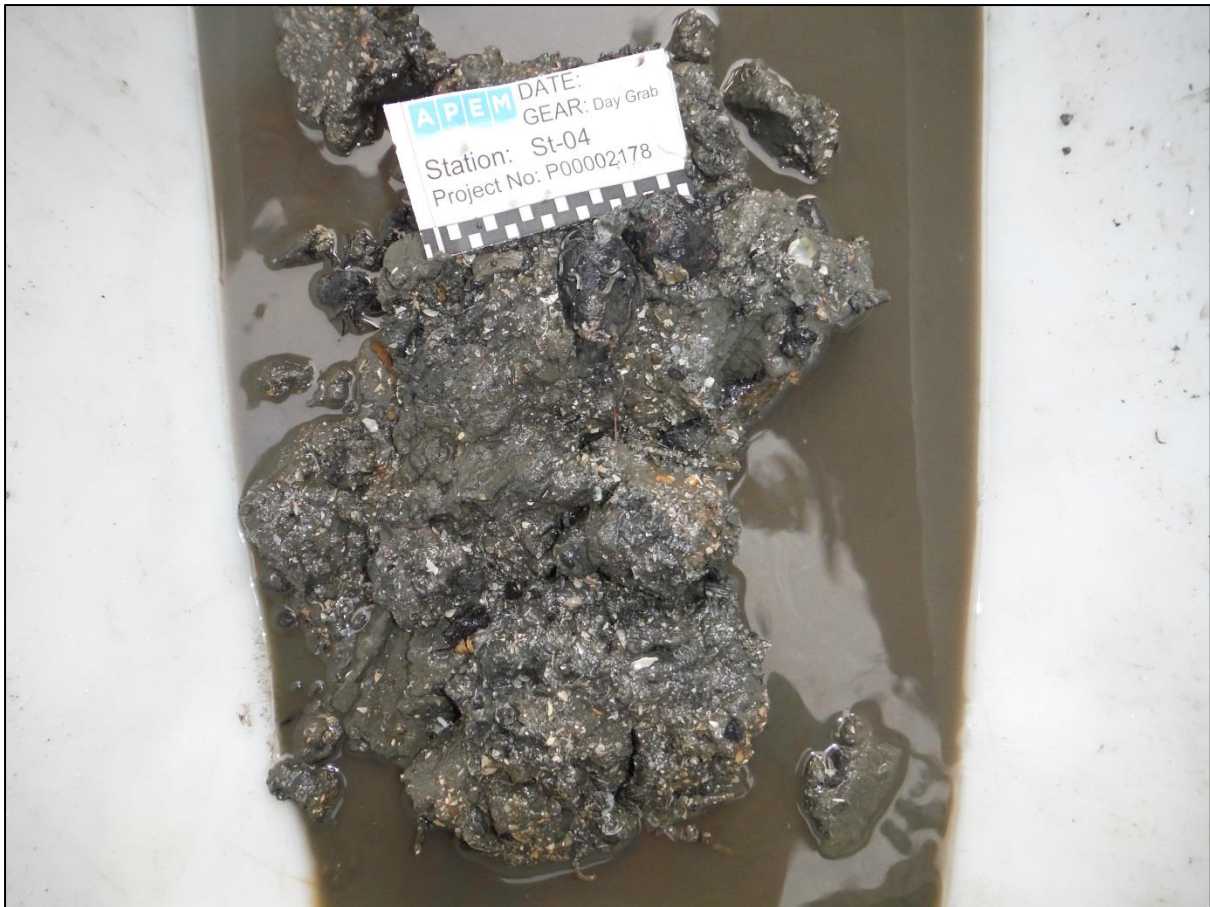
Figure 2-4 Unsieved grab sample from Station 4 in Tarbert Harbour.

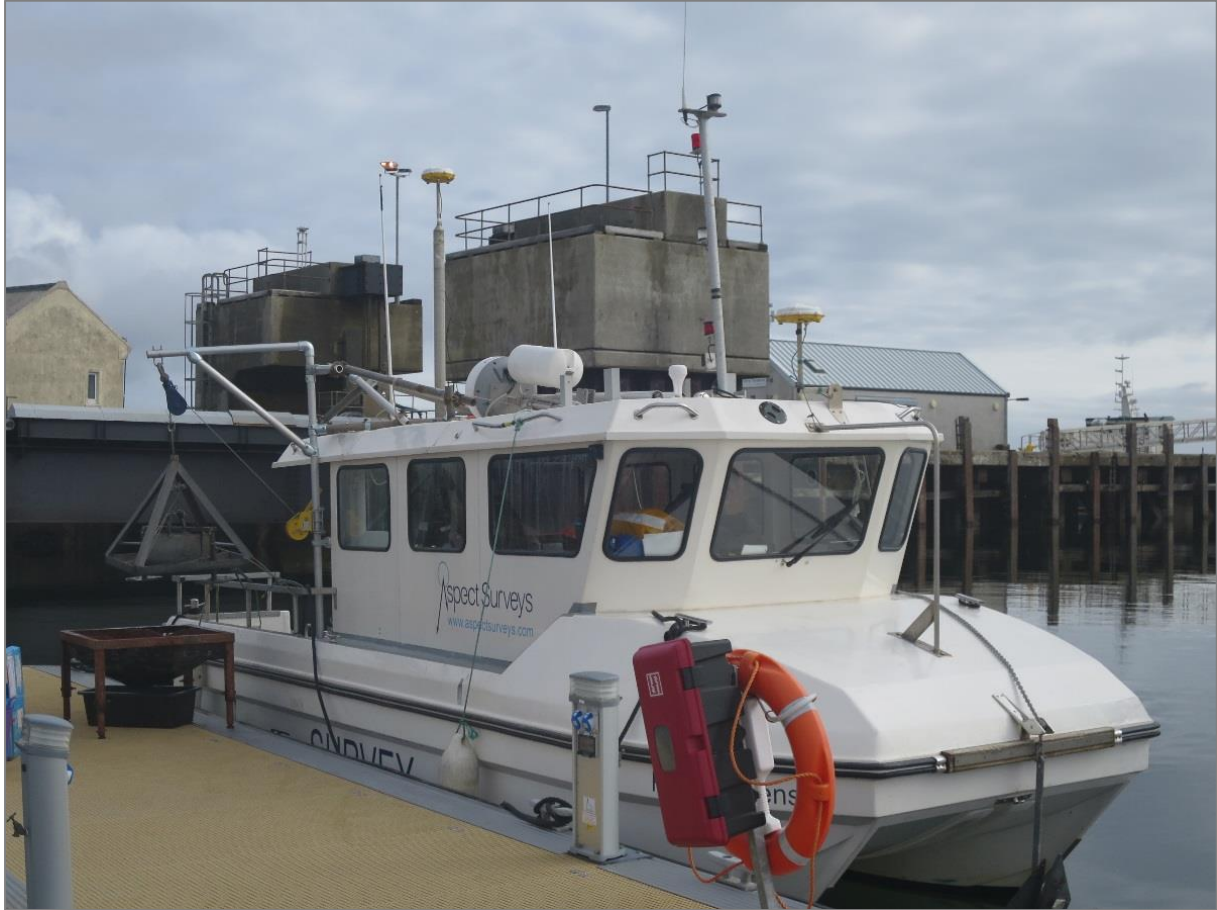
The grab samples were carried out from the survey vessel Remote Sensor using a Day Grab. This was deployed from the over-side manually operated davit.

FIGURE 3 - DAY GRAB ON REMOTE SENSOR

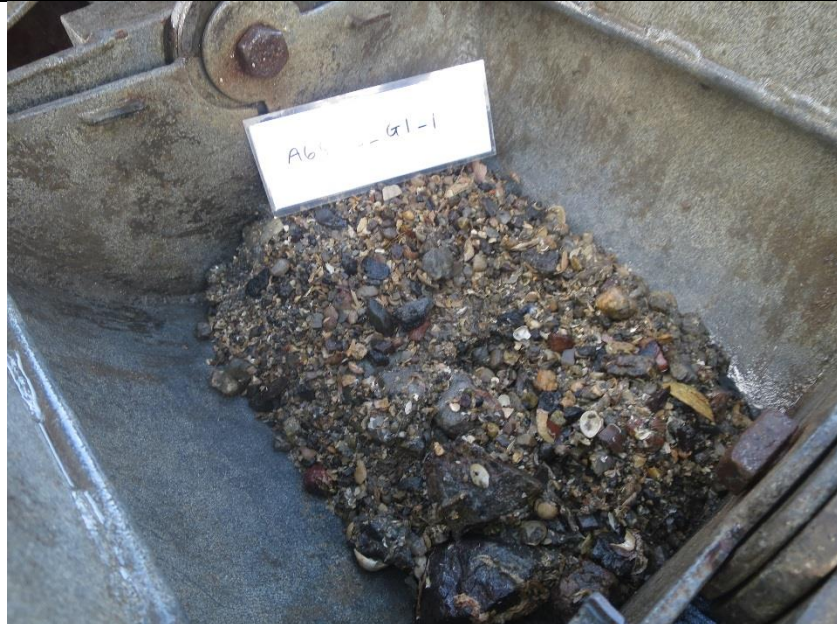
Notes on field Sampling: Medium gravel, shell, broken shell, brown mud.			
Lab Analysis:			
GRAVEL	SAND	SILT	
50.8	30.8	18.4	
Full analysis is available in the accompanying lab report

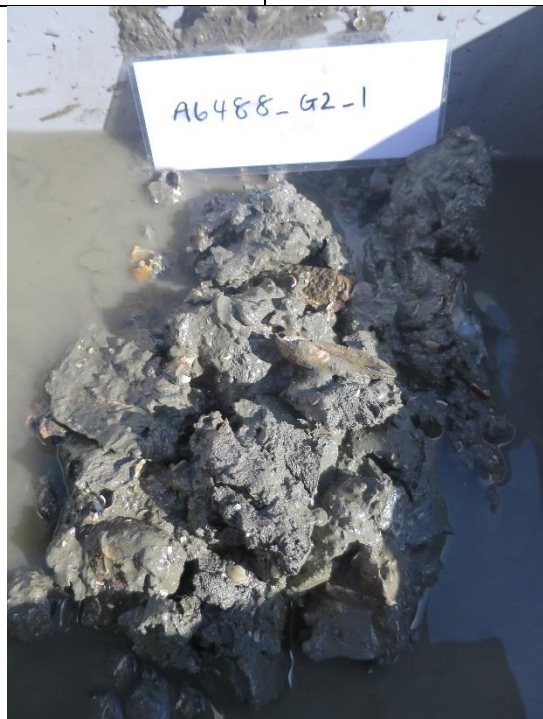
Notes on Sampling Green/brown mud, shell, broken shell, medium gravel.			
Lab Analysis:			
GRAVEL	SAND	SILT	
27.4	11.9	60.7	
Full analysis is available in the accompanying lab report

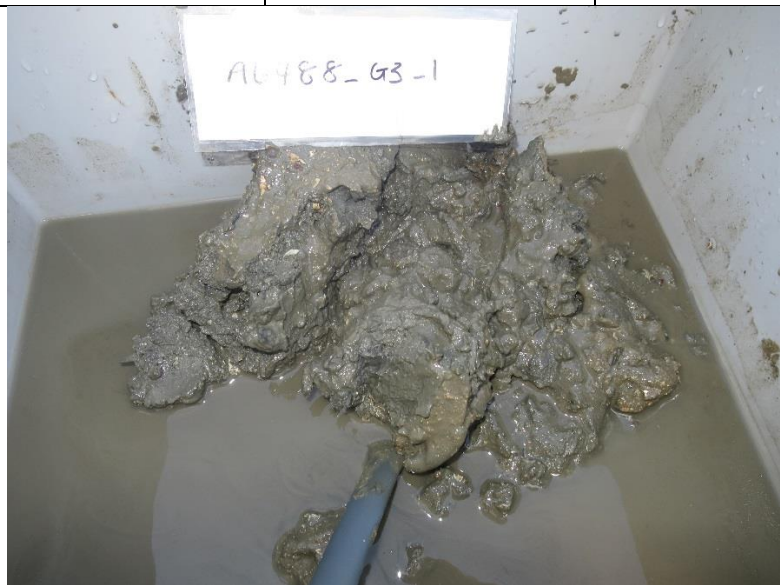
Notes on Sampling Green/brown mud, broken shell, medium-small gravel.			
Lab Analysis:			
GRAVEL	SAND	SILT	
4.6	21.5	73.9	
Full analysis is available in the accompanying lab report

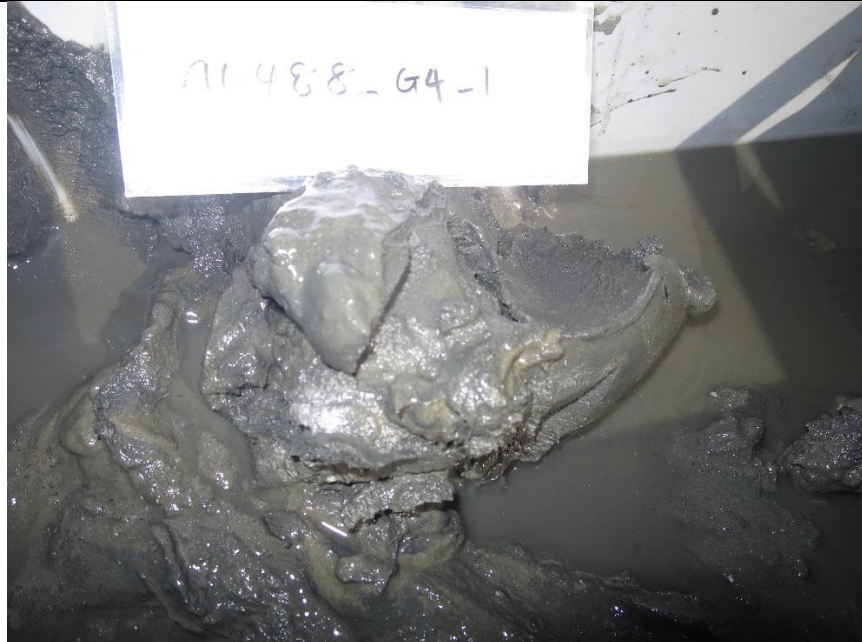
Notes on Sampling Black/brown Mud and small amount of broken shell.			
Lab Analysis:			
GRAVEL		SAND	SILT
0		31.6	68.4
Full analysis is available in the accompanying lab report

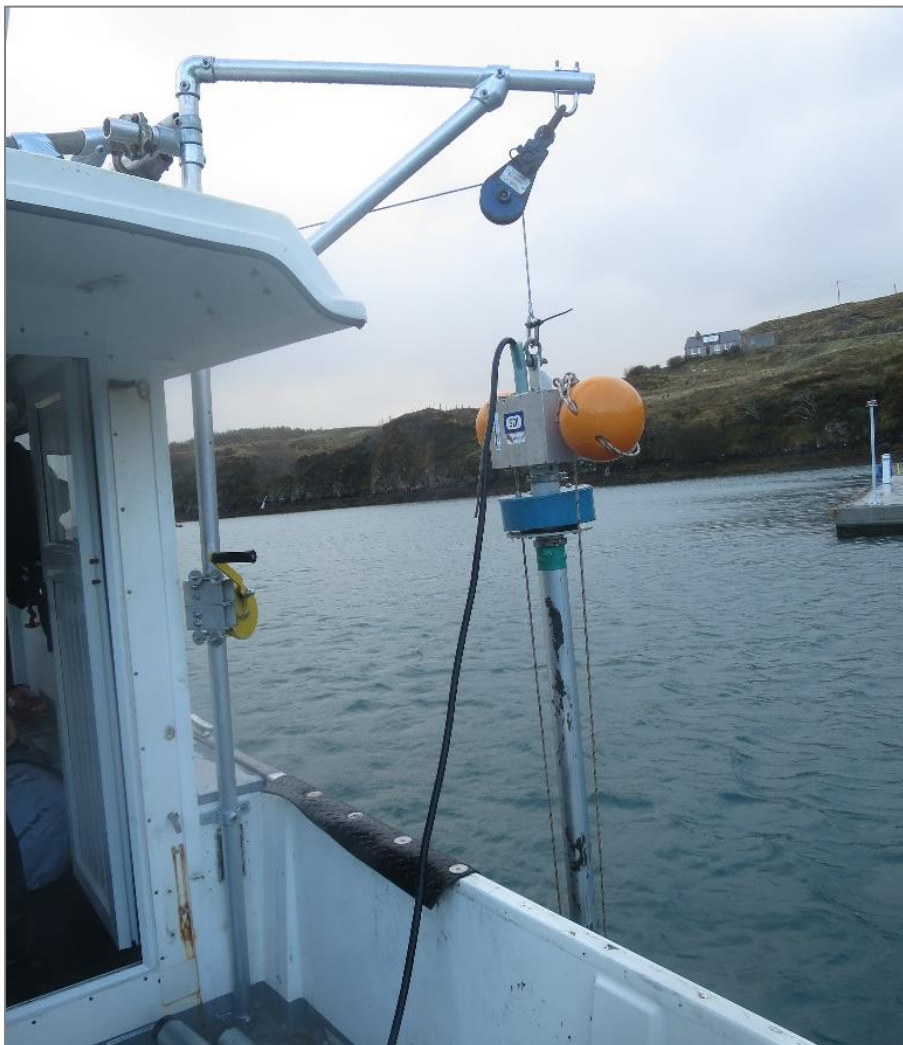
The vessel was manoeuvred to each of the locations in turn and anchored fore and aft to avoid swinging during the sampling operation.

FIGURE 4 - VIBROCORE DEPLOYED ON REMOTE SENSOR

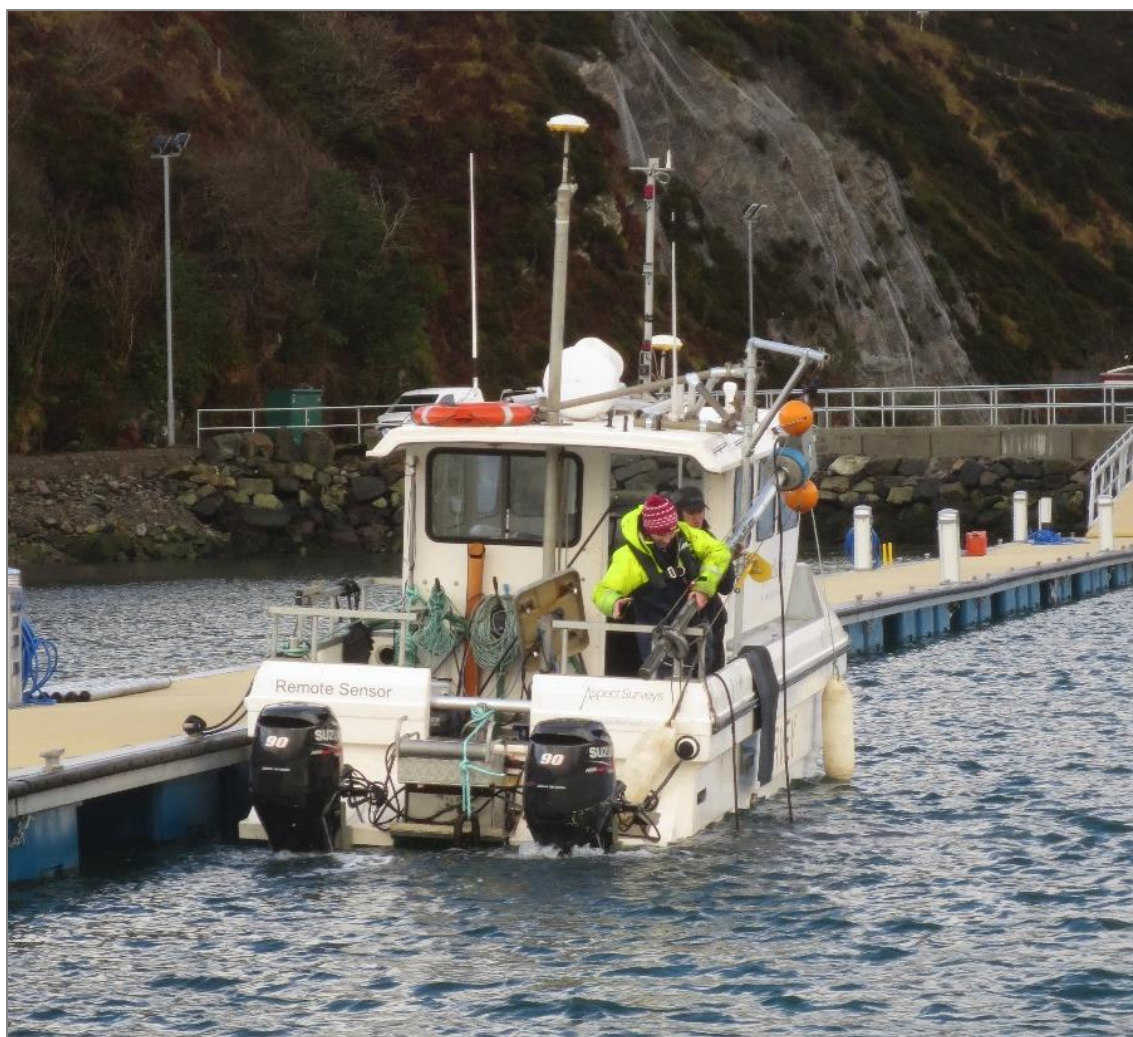
The sediment was pushed out of the core tube prior to sampling the cores and then sampled with care being taken not to sample material that had come into contact with the sample tube wall.

FIGURE 5 - SDI D-4 VIBROCORER ON DECK

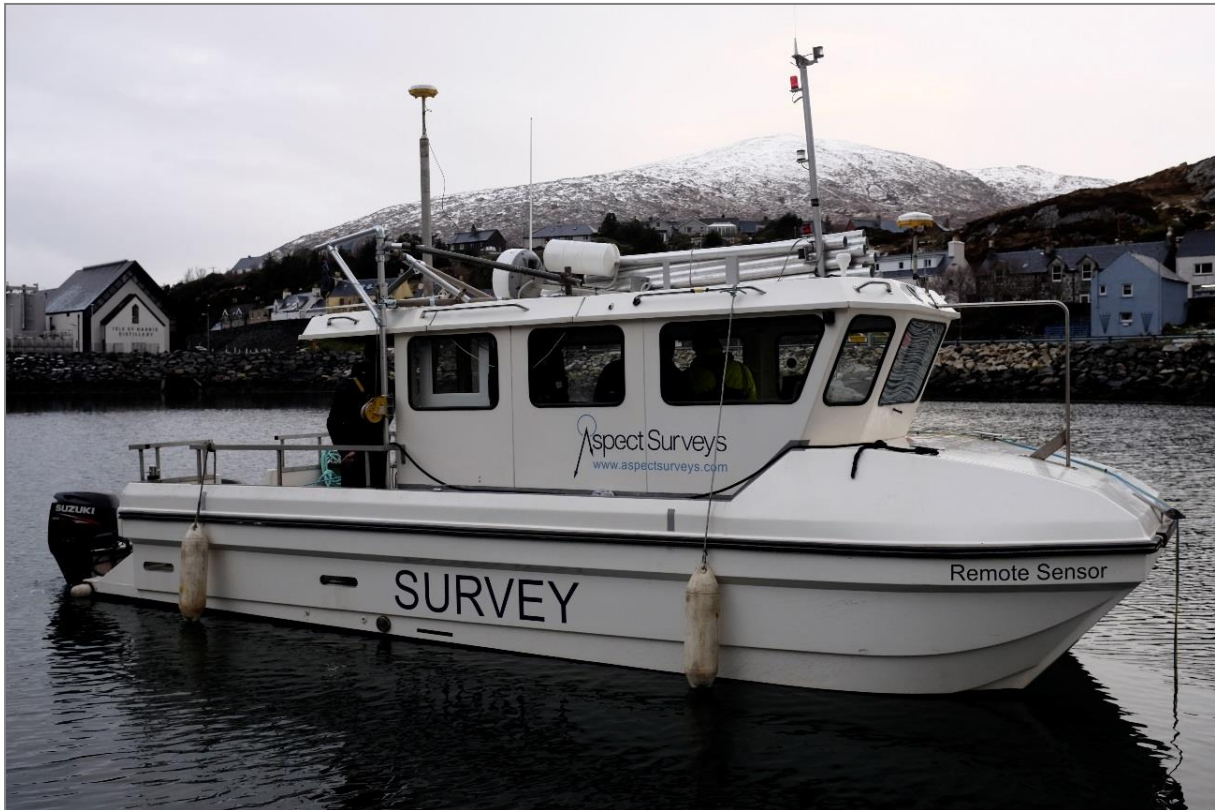
The shallow draught and high manoeuvrability of *Remote Sensor* made it ideal for operating in the survey area which was both shallow and navigationally constrained. The vessel was transported to Tarbert Harbour by road and launched at the slipway in the harbour.

FIGURE 6 - ALHS' SURVEY VESSEL REMOTE SENSOR

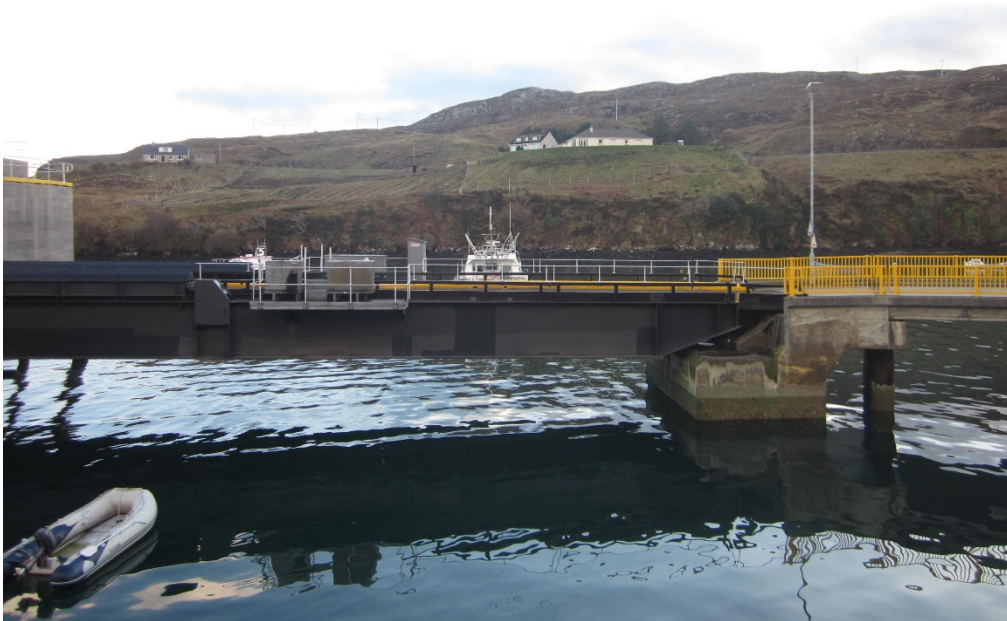
Photo 3: Linkspan Abutment – Lowest point
