Shetland Tidal Array Monitoring Report Subsea video monitoring 2020-2022

Title:	Shetland Tidal Array Monitoring Report Subsea video monitoring 2020-2022
Document ID:	EnFAIT-0393
Version	Version 2.0
Prepared for:	Marine Scotland Licensing Operations Team Shetland Islands Council
Author:	Kate Smith, Ruairidh Norwood, Sam Olsen
Approved by:	Gavin McPherson
Release date:	12-Dec-22
Confidentiality:	COMMERCIAL IN CONFIDENCE

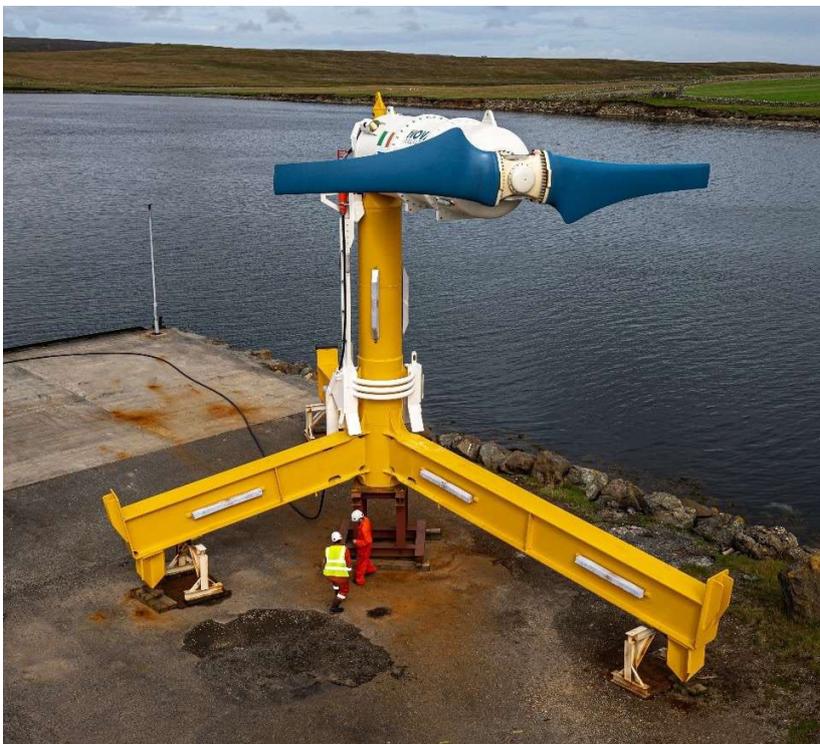
The Shetland Tidal Array currently consists of four Nova 100 kw tidal turbines, 2-bladed, horizontal axis devices, shown in Figure 2-2. The fourth turbine installed is a direct drive device (no gearbox).

Figure 2-2 The Nova M100 turbine. Source: Nova Innovation 2018

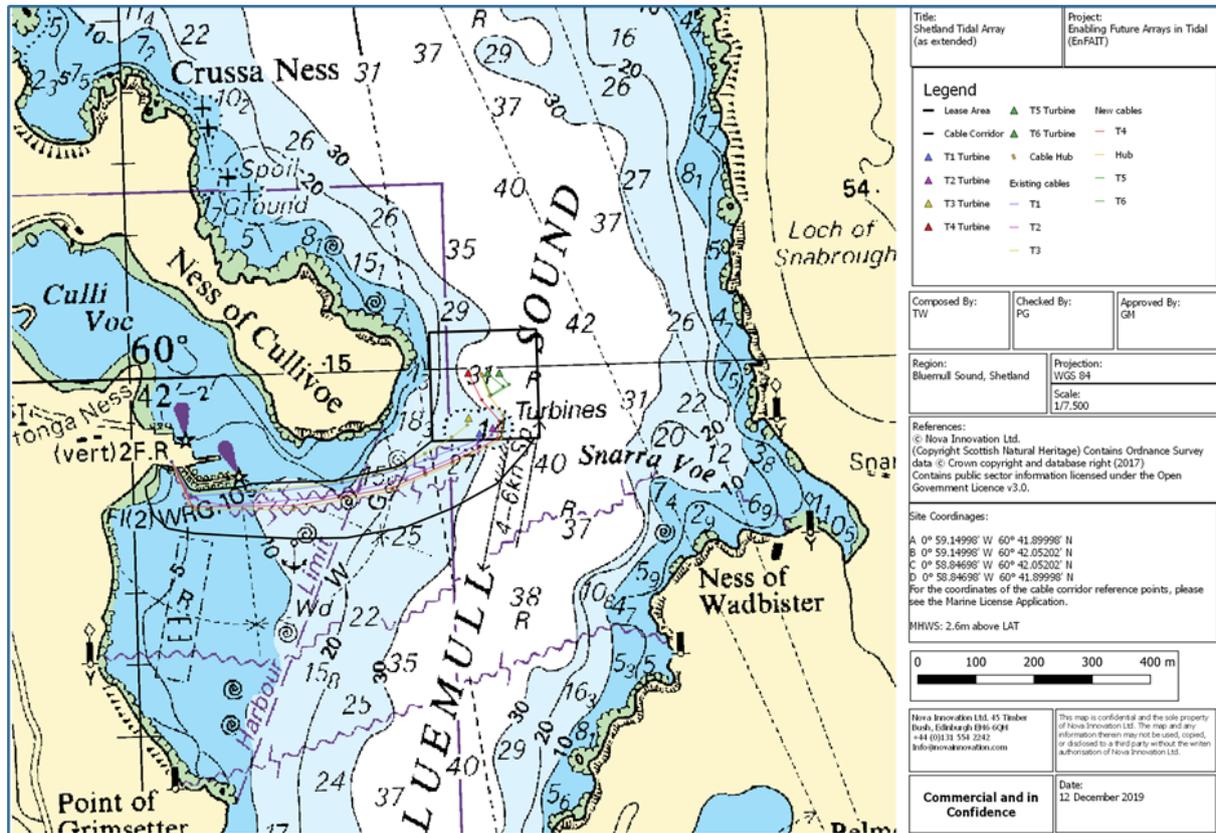
All four turbines are installed subsea at a depth of 30-40m. The turbines use gravity base foundations that require no piling or drilling. Figure 2-3 shows the layout of the existing four turbines and infrastructure in the Shetland Tidal Array, as well as the planned location of two further turbines (T5 and T6) scheduled to be installed in late 2022/early 2023.

Figure 2-3 Shetland Tidal Array layout (Admiralty Chart). Source: Nova Innovation 2020 © Crown Copyright

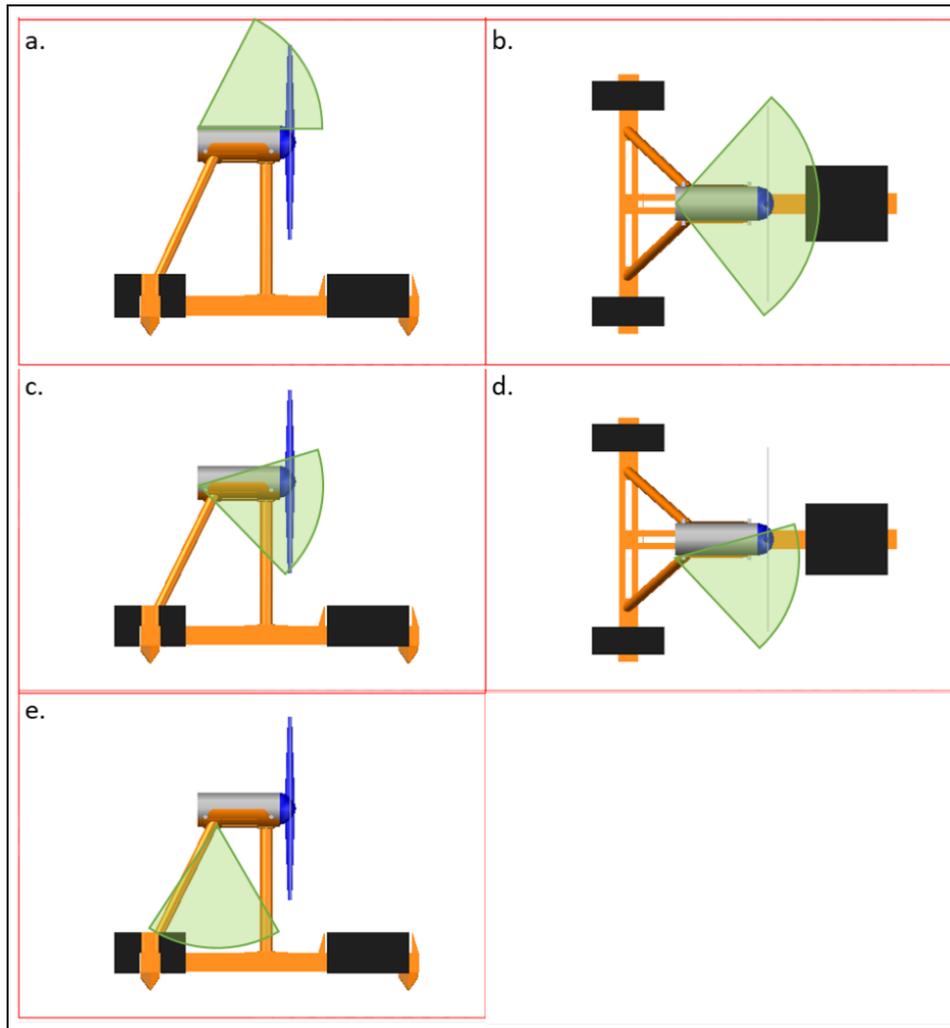
Figure 3-1 Configuration of turbine-mounted subsea cameras on T1, T2 and T3, showing (a & b) TOP camera looking towards the blades, (c & d) SIDE camera looking towards the blades and (e) DOWN camera looking towards the seabed. Figure is illustrative and not an accurate depiction of fields of view. Copyright © Nova Innovation 2022.

Figure 3-1 provides an indicative illustration of the location and approximate field of view of the three turbine-mounted cameras on T1 to T3.

The nine cameras utilized for T1, T2 and T3 have a horizontal field of view in water of 70°, a sensitivity LUX rating of 0.001 and a resolution of 750 TV lines (TVL). They are colour submersible bullet charge-coupled device (CCD) cameras with a resolution of 412,000 pixels. Files are coded into MPEG and the capture rate is 16 Frames Per Second (FPS).

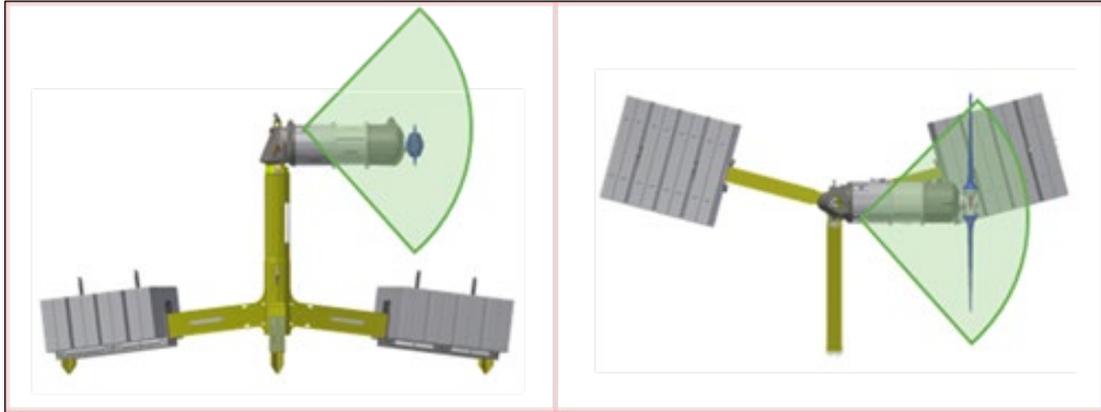
The camera on T4 is mounted to the nacelle, facing the turbine blades, as indicated in Figure 3-2.

Figure 3-2 Subsea camera system for T4. Camera position and field of views is indicative only, for illustrative purposes. Cameras is attached to the turbine nacelle. Copyright © Nova Innovation 2022.

A UV light, directed onto the lens is used on the camera mounted on T4. This was trialed to determine its effectiveness in reducing biofouling to improve performance of the system. Further details are provided in Section 5.3.

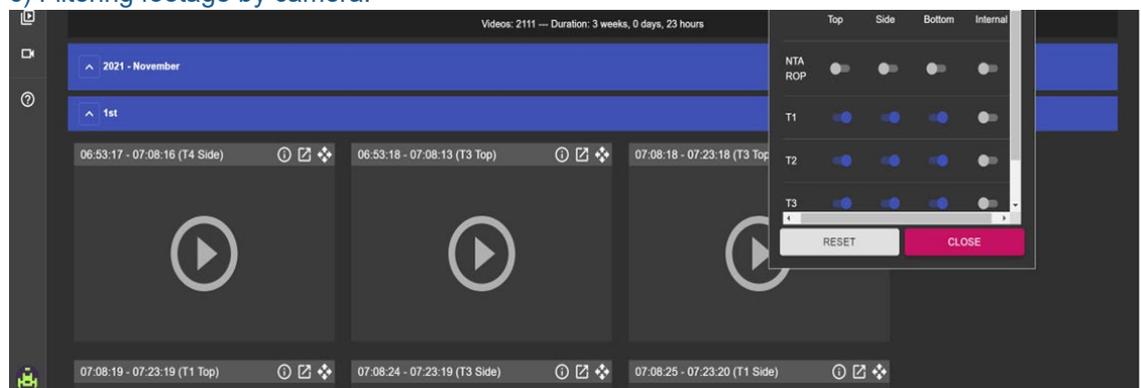
Figure 3-3 AWS-based system used to store and access video footage, showing ability to filter footage by a) date, b) time and c) camera.

The cloud-based system has a front-end portal which provides remote access capabilities. Users can extract samples of footage from the full dataset, filtering by date and time, as well as by specific turbines and camera positions (TOP, DOWN, SIDE), as illustrated in Figure 3-3. Users can also add tags to video clips to aid filtering and build analysis efficiencies.

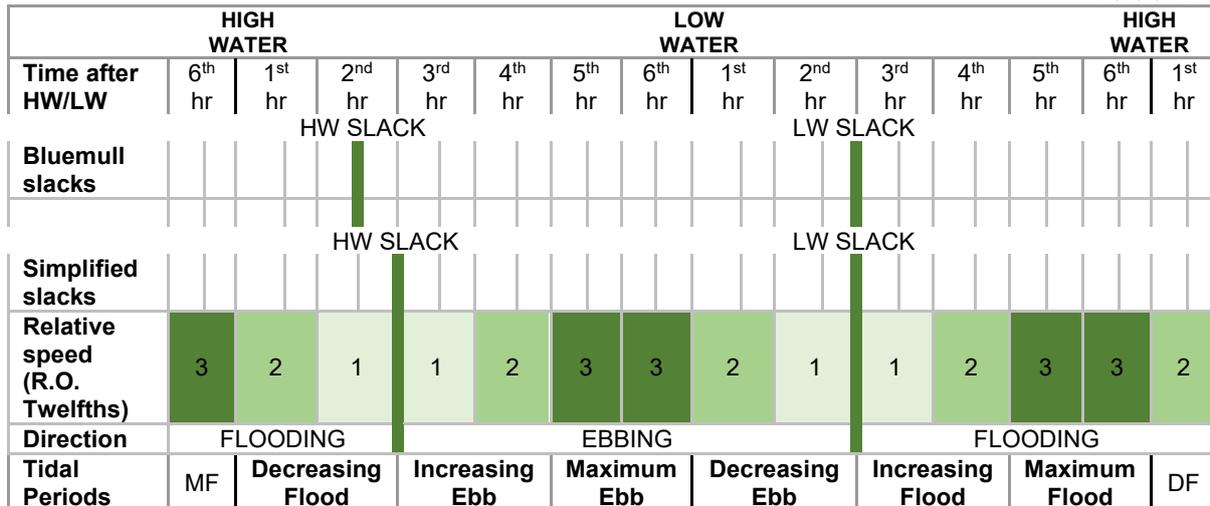
1. Increasing flood: 2-4 hours after low water (LW), starts immediately after LW slack in Bluemull Sound.
2. Maximum flood: 4-6 hours after LW.
3. Decreasing flood: 0-2 hours after high water (HW), starts 1.5 hours before and straddles HW slack in Bluemull Sound.
4. Increasing ebb: 2-4 hours after HW, starts around 30 minutes after HW slack in Bluemull Sound.
5. Maximum ebb: 4-6 hours after HW.
6. Decreasing ebb: 0-2 hours after LW, starts 2 hours before LW slack in Bluemull Sound.

Figure 4-1 The six tidal periods within the tidal cycle in Bluemull Sound.

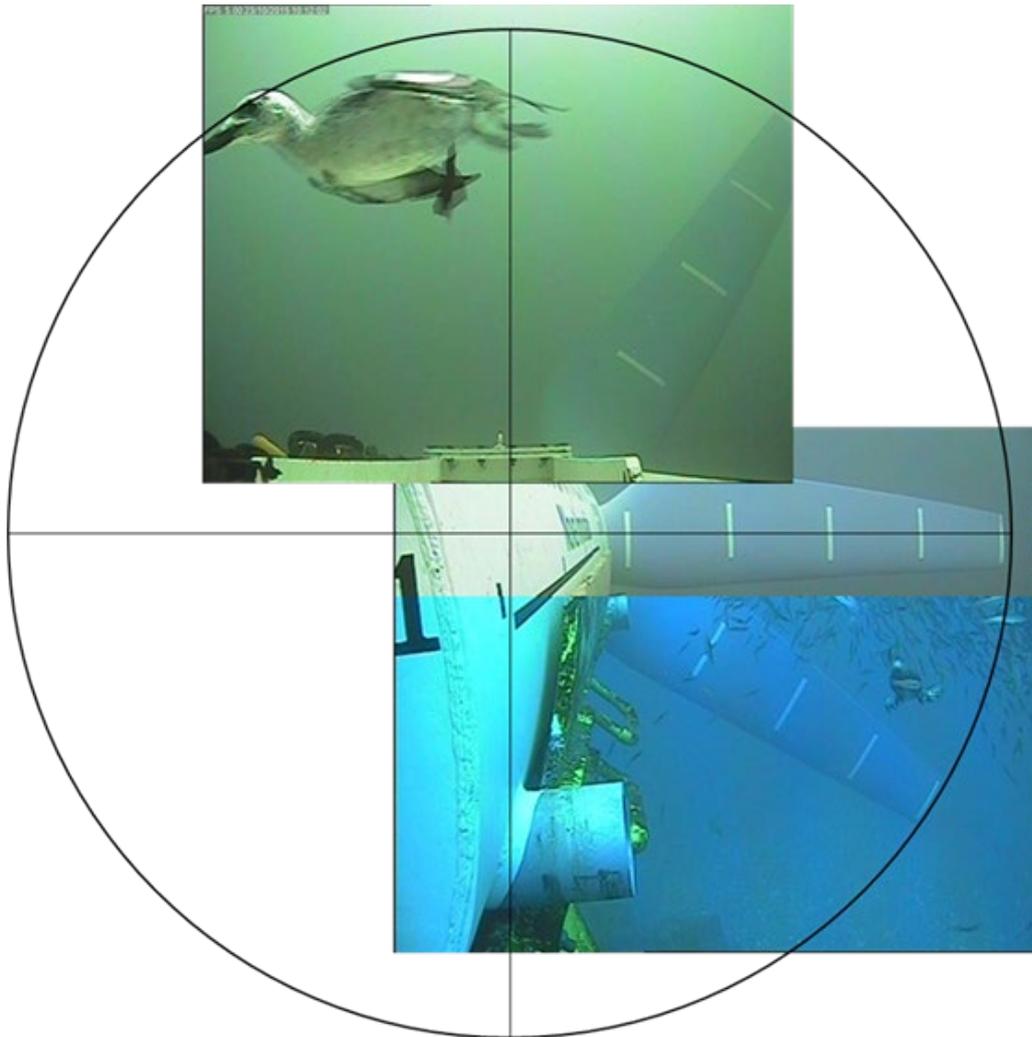
Combined, the two cameras facing the turbine blades (TOP and SIDE) on each of T1 to T3 provide approximately 60-65% coverage of the rotor-swept area. This has been estimated from combined images of the two fields of view using Computer-Aided Design (CAD), shown in Figure 5-1.

Figure 5-1 Field of view of TOP and SIDE cameras mounted on T1, T2 and T3 in the Shetland Tidal Array. Copyright © Nova Innovation 2022.

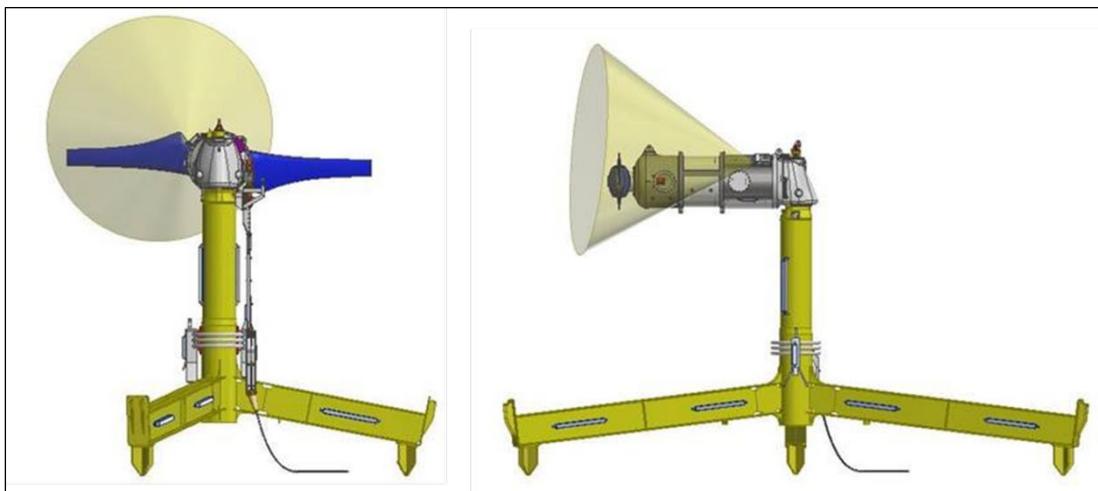
The rotor swept area that is within the field of view of the camera on T4, based on CAD modelling, is indicated in Figure 5-2, estimated to be 30-35% of the rotor swept area.

Figure 5-2 Field of view of the subsea camera mounted on T4.

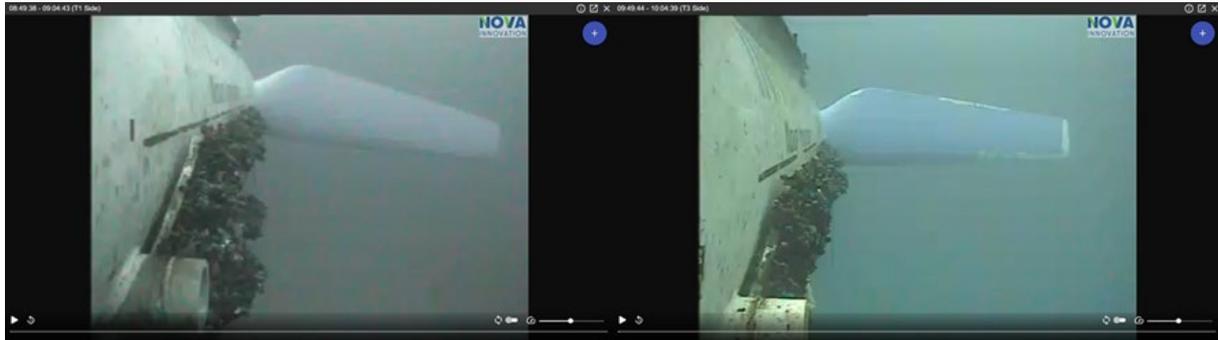
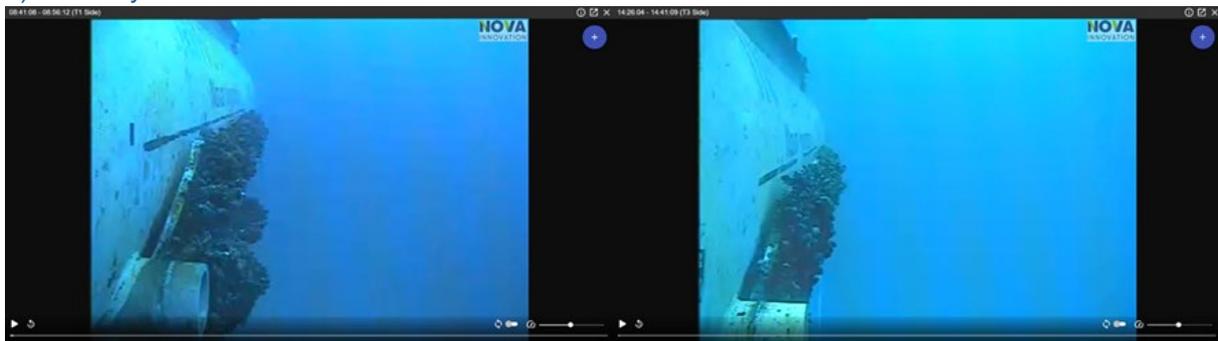
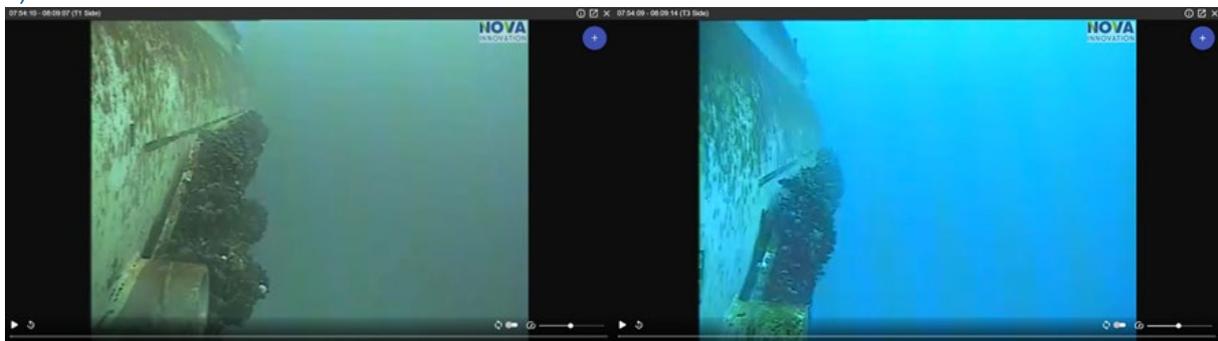
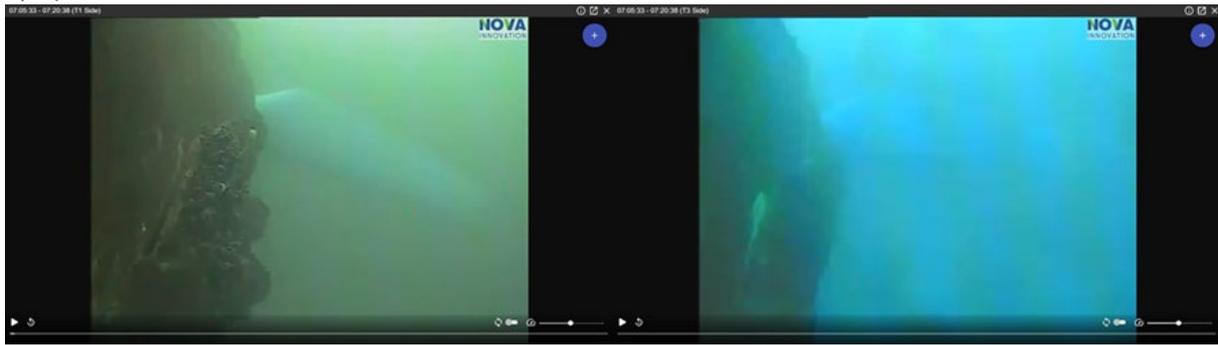
Figure 5-1 shows the change in image quality on the side-mounted cameras on turbines 1 (T1) and 3 (T3) over time through biofouling, between January and June 2021. It is only in the final images for June 2021 that images are completely obscured by biofouling.

Figure 5-1 Monthly images showing the change in image quality on the side-mounted cameras on T1 (left) and T3 right) over time through biofouling, between a) January 2021 and f) June 2021.

The quality of video footage generally degrades over time due to biofouling on the lenses of the turbine-mounted cameras. The rate of biofouling on cameras and turbines varies with time of year, but it generally takes several months before images are completely obscured by biofouling and footage is rendered unusable. Camera lenses are routinely cleaned during all turbine maintenance operations to limit the effects of biofouling, while the use of multiple cameras on multiple turbines reduces the overall effects of biofouling on dataset continuity

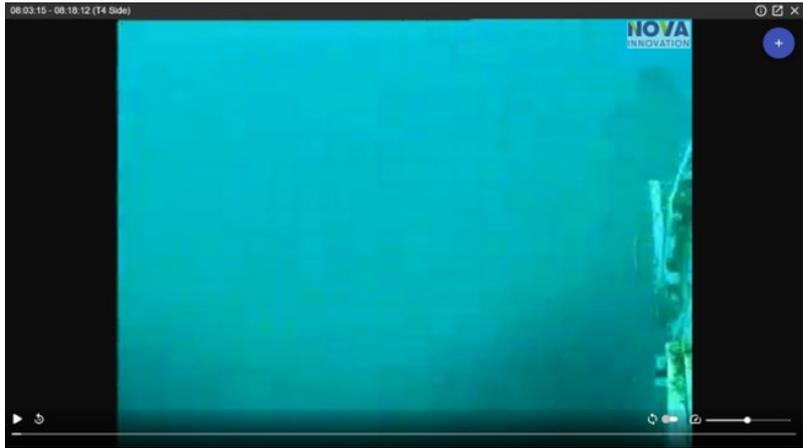
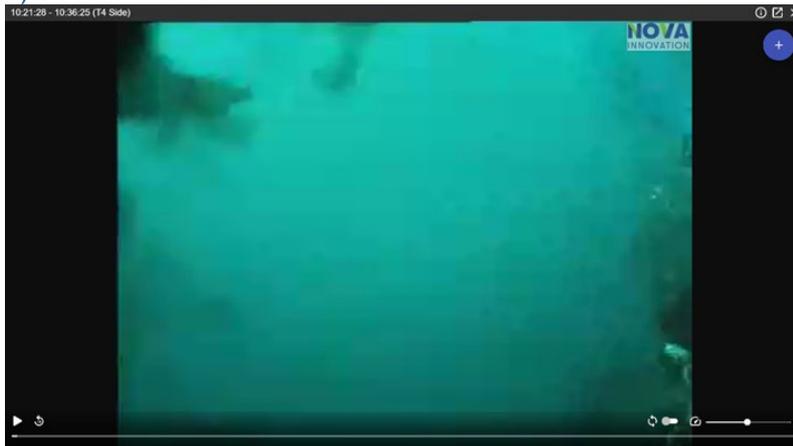
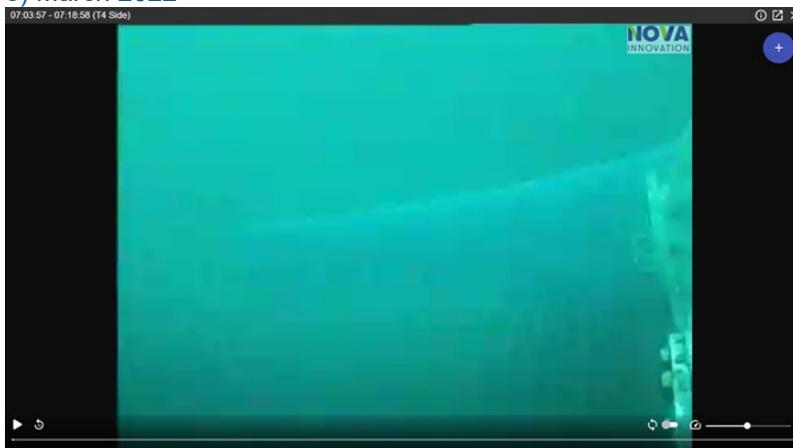
Figure 5-2 shows how the image quality of the camera on T4 degraded due to biofouling between March 2021 and March 2022. Some obstruction of the lens can be seen in June 2021 which is not present in September 2021. This is likely to be caused by the growth of mussels on the nacelle and camera-housing, rather than biofouling the lens itself, which can still be seen to be free of growth. Large settlements of mussels occur from time to time on the turbine nacelles, reaching a critical mass before being dislodged by the strong tidal flows. In this case, the UV light appears to have prevented mussel larvae from settling onto and colonising the camera lens.

Figure 5-2 Images showing the change in image quality on the side-mounted camera on T4 over time through biofouling, between a) March 2021 and e) March 2022.

During this reporting period a new approach to managing biofouling on the camera lens of the fourth installed turbine (T4) has been trialed. An Ultra-Violet (UV) light was mounted to the nacelle of T4 prior to its installation in October 2020 and directed onto the camera lens. Results of this trial indicate that the rate of biofouling on the T4 camera lens UV light has been lower than on the other three turbines.

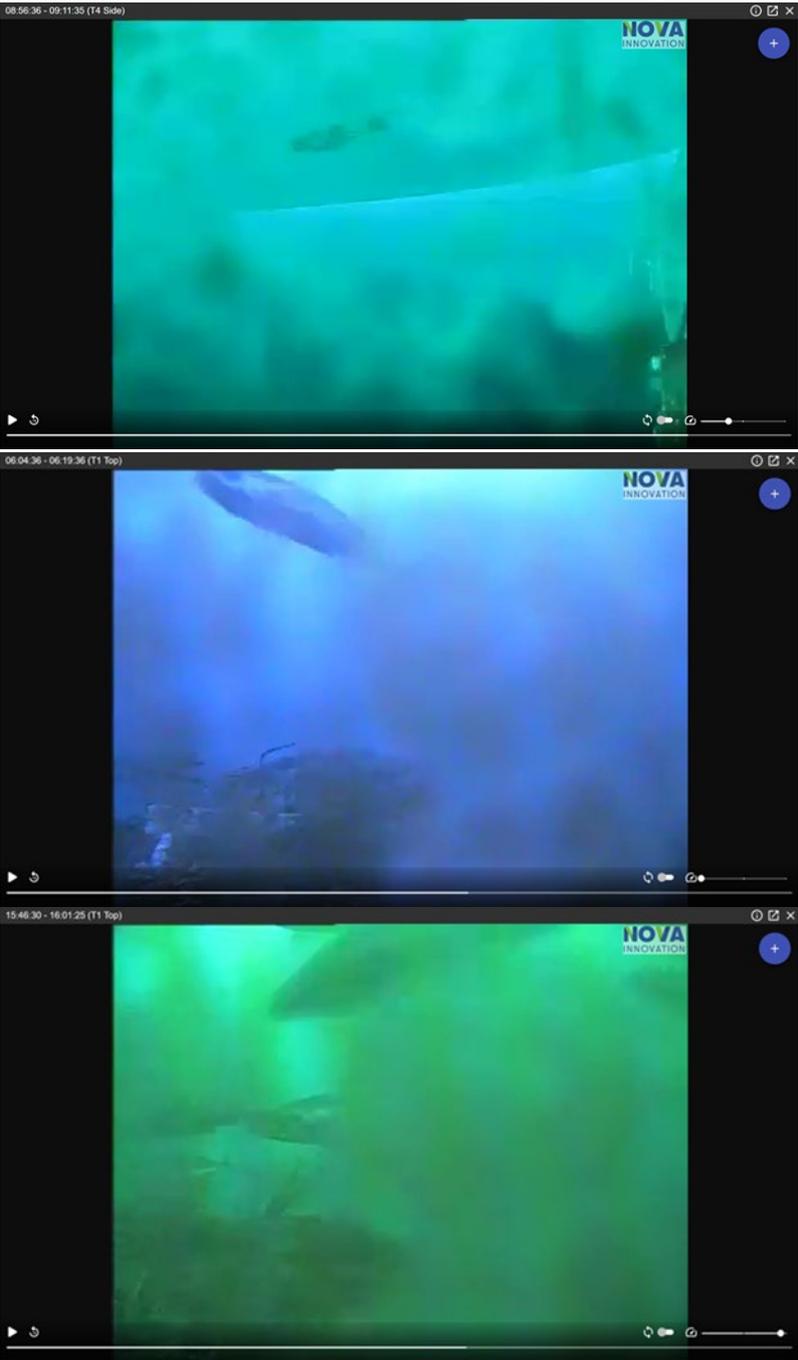
Levels of biofouling which prevented the ability to scan images for mobile species were seen in approximately 40% of the footage reviewed. In the remaining footage subject to biofouling, it was still possible to identify mobile species. Figure 5-3 shows some examples of such videos partially affected by biofouling, but in which fish can still be seen.

Figure 5-3 Examples of biofouling not obstructing the ability to identify fish observations in video footage.

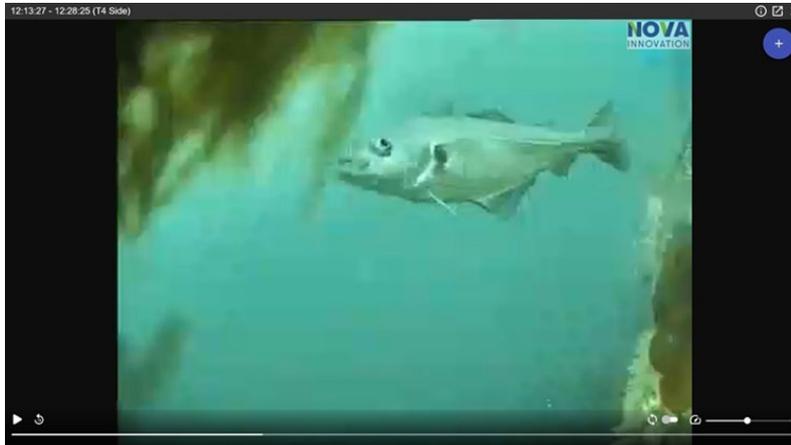
Figure 6-1 T4 SIDE 11/08/2021 12:13-12:28. Individual saithe (*Pollachius virens*).

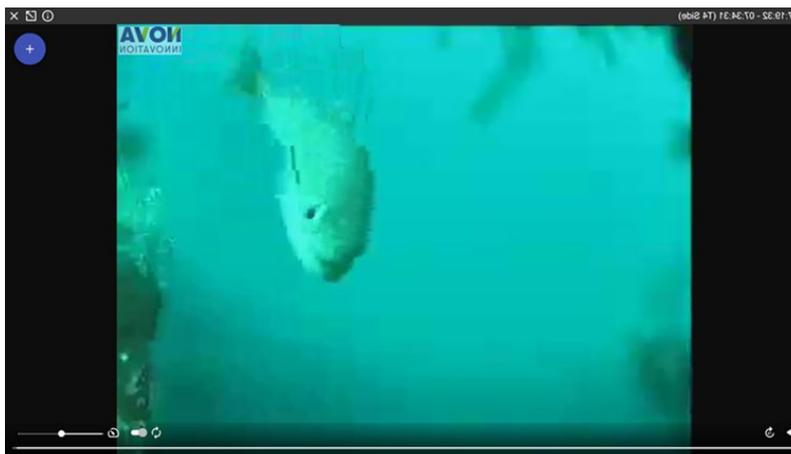
Figure 6-2 T4 SIDE 30/09/2021 07:19-07:34. Individual saithe (*Pollachius virens*).

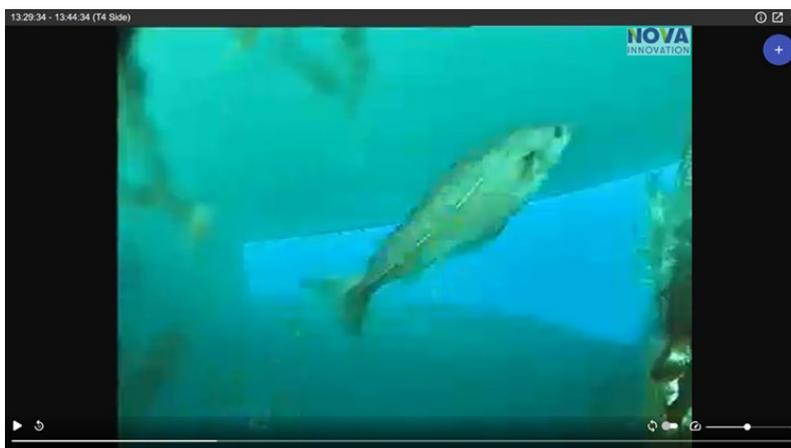
Figure 6-3 T4 SIDE 27/08/202 13:29-13:44. Individual saithe (*Pollachius virens*). The stationary turbine rotor can be seen in the background.

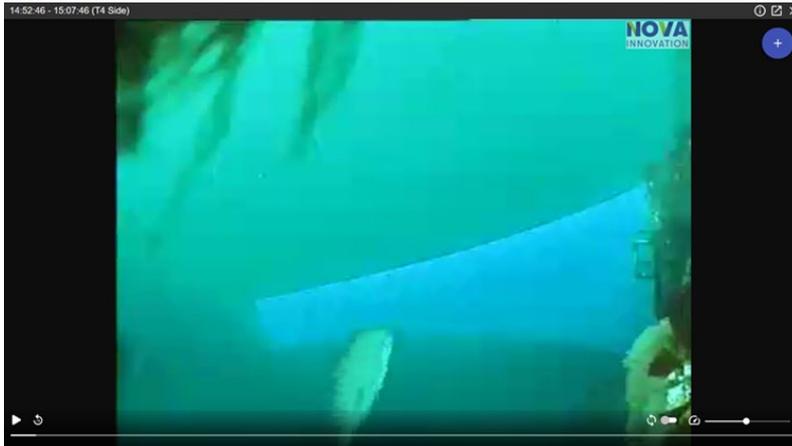
Figure 6-4 T4 SIDE 30/07/2021 14:52-15:07. Individual fish, possibly the same saithe in Figure 6-3 approaching the stationary turbine rotor.

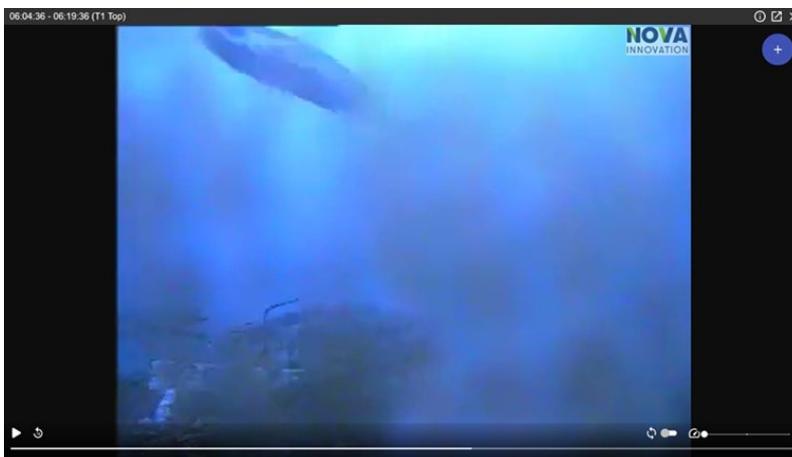
Figure 6-5 T1 TOP 27/10/2020 06:04-06:19. Individual fish, *Pollachius* sp. Despite some biofouling on the cameras lens the fish can still be observed.

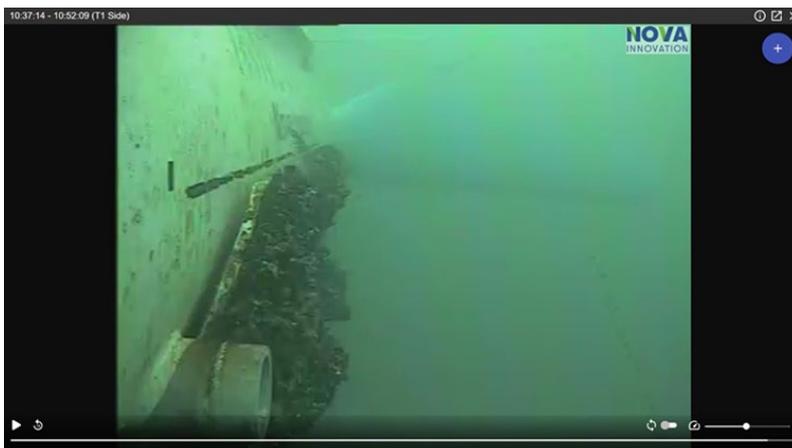
Figure 6-6 T1 SIDE 01/12/2020 10:37-10:52. Individual fish, likely to be *Pollachius* sp. Despite some turbidity in the water the fish can still be observed.

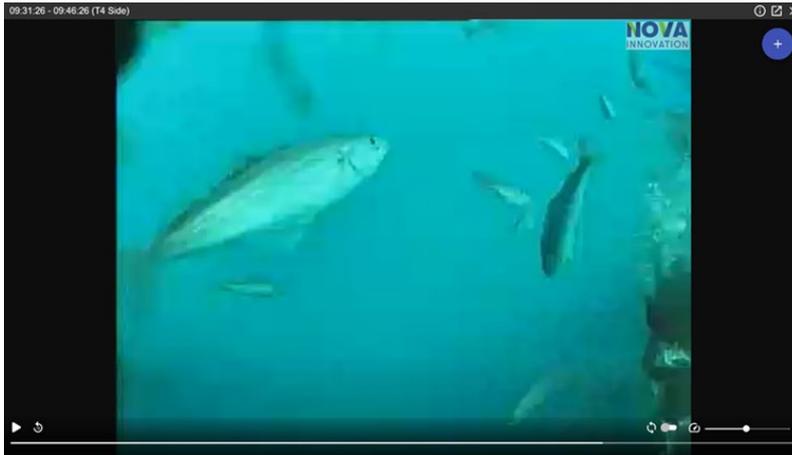
Figure 6-7 T4 SIDE 05/10/2021 09:31-09:46. Group of fish, *Pollachius* sp. Milling around the turbine. The stationary turbine rotor can be seen in the background.

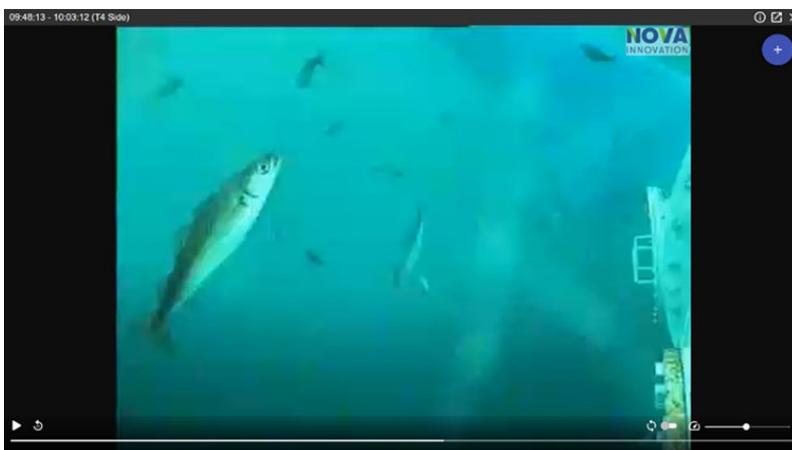
Figure 6-8 T4 SIDE 09/10/2020 09:48-10:03. Group of fish, *Pollachius* sp. milling around the turbine. The stationary turbine rotor can be seen in the background.

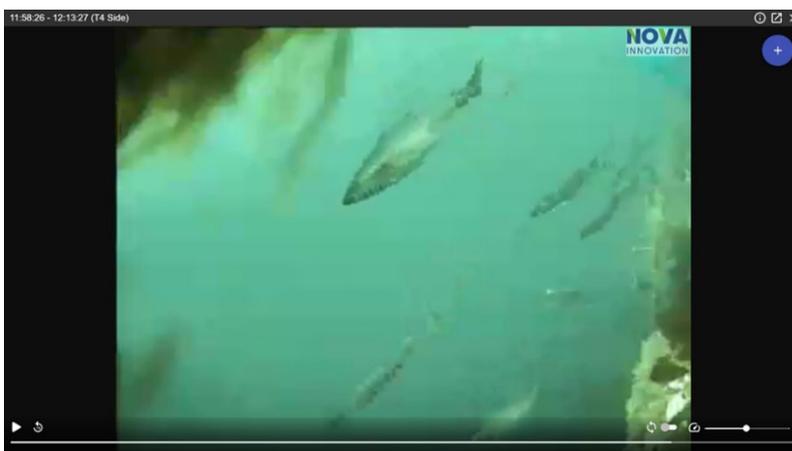
Figure 6-9 T4 SIDE 11/08/21 11:58-12:13. Group of fish, *Pollachius* sp. milling around the turbine. More fish than are seen in this still were observed in the video, moving in and out of the frame. Turbine rotor cannot be distinguished in image, but review of video footage confirmed the turbine was not operating.

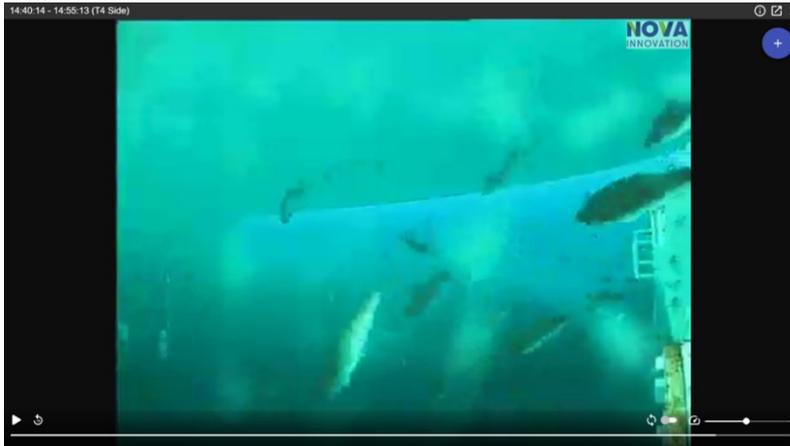
Figure 6-10 T4 SIDE 13/09/21 14:40-14:55. Group of fish, *Pollachius* sp. milling around the stationary turbine. Despite some biofouling on the cameras lens the fish can still be observed.

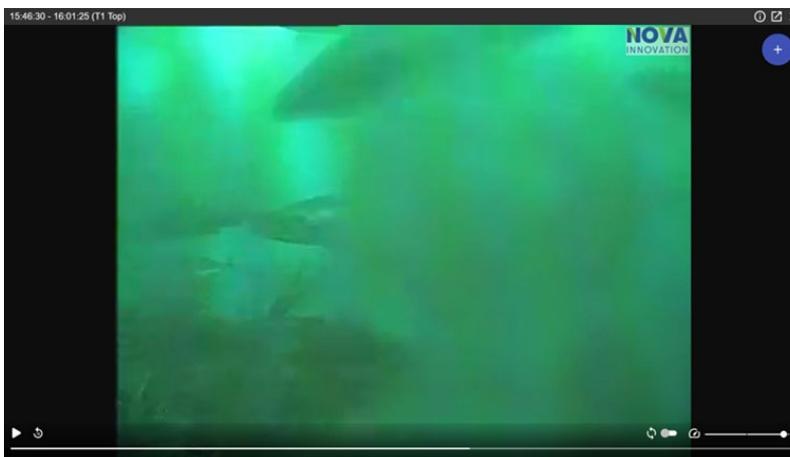
Figure 6-11 T1 SIDE 05/10/2021 15:46-16:01. Group of fish. Despite some biofouling on the cameras lens the fish can still be observed, most likely to be *Pollachius* sp.

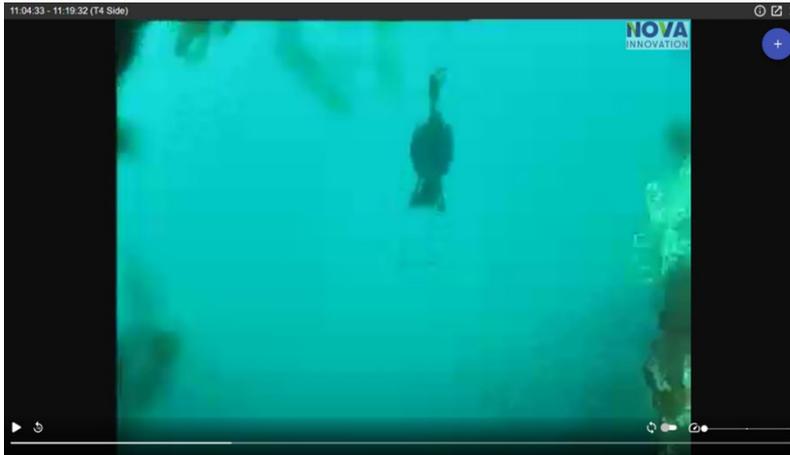
Figure 6-12 T4 SIDE 30/09/2021, 11:04-11:19. European shag (*Gulosus aristotelis*). Turbine rotor cannot be distinguished in image, but review of the video footage confirmed that the turbine was not operating.

Camera	Time	Tidal period	Turbine operating?	Key observations
T4 Side	11:04 - 11:19	Decreasing ebb	N	Shag swims up quickly from below past camera

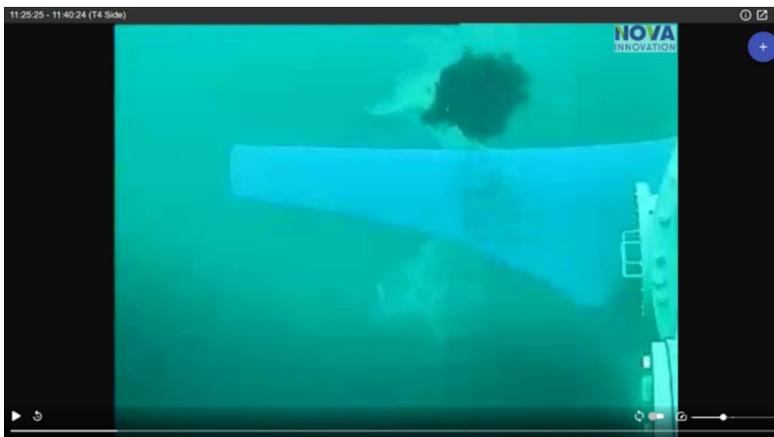
Figure 6-13 T4 SIDE 25/08/2020 11:25-11:40. Lion’s mane jellyfish (*Cyanea capillata*).
