# Friarton Bridge: Ecological walkover and INNS survey

June 2018

BEAR Scotland are proposing to carry out a project around the piers on LHB of River Tay near Perth at NGR 313028 721527. Erosion on bankside below piers has been ongoing and works are proposed to install rock armour along the riverbank to stabilise the embankment.

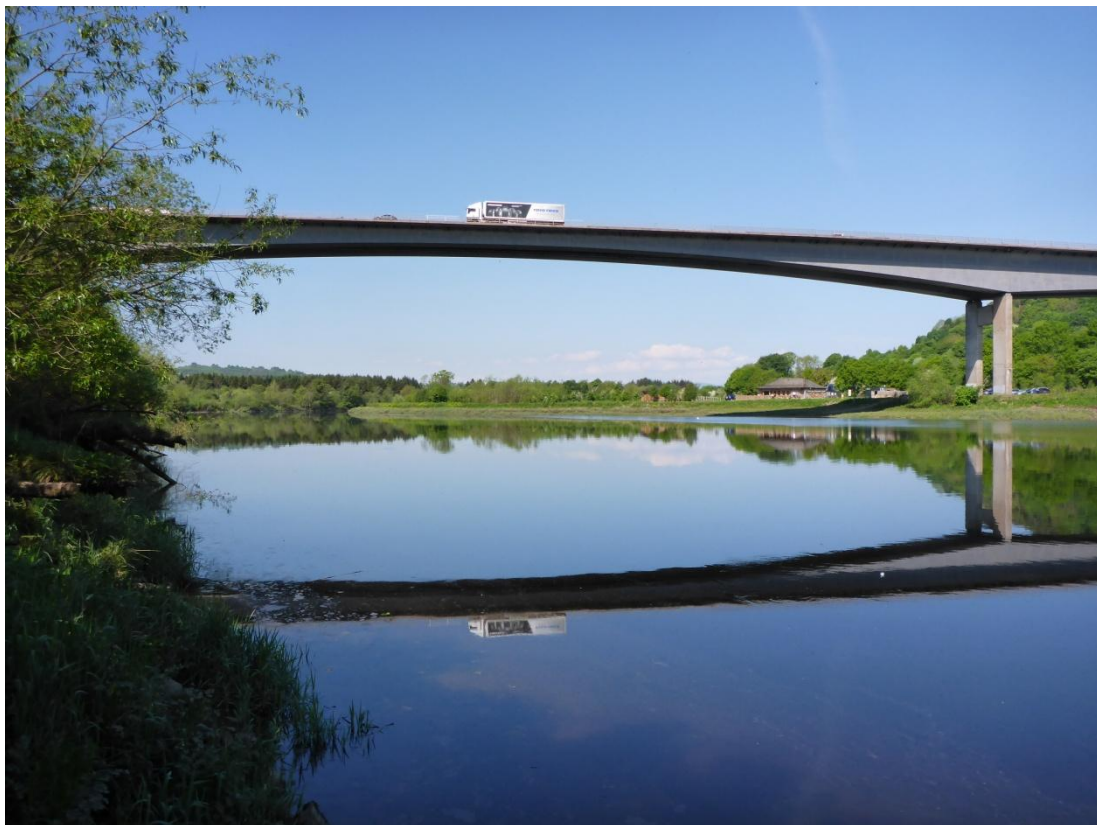
Fig 1 The Friarton Bridge viewed from the east with the eroding pier just out of shot

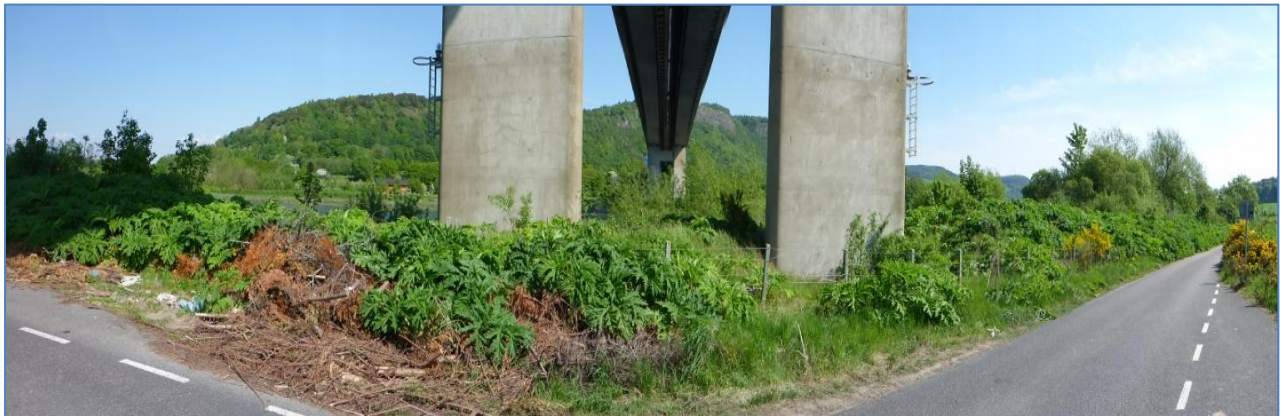
The area is dominated by Giant Hogweed with smaller areas of gorse, broom and immature trees including; ash, sycamore and willow. The area is partly fenced off from a minor road that runs alongside the River Tay. An agricultural field under a grass ley lies to the south and the road widens around the piers of the bridge with a layby on both sides of the tarred road.

**Figure 2 Development Area – viewed from layby opposite bridge piers**

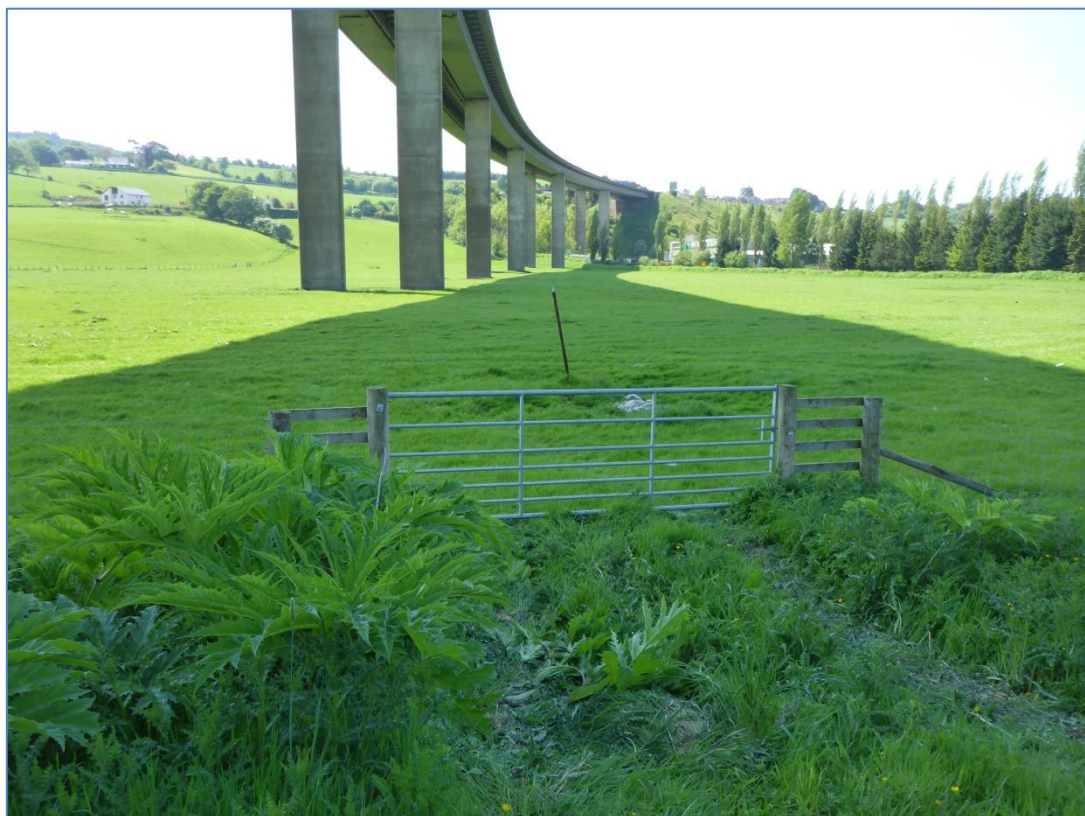
Figure 3 Area of land to south of site.

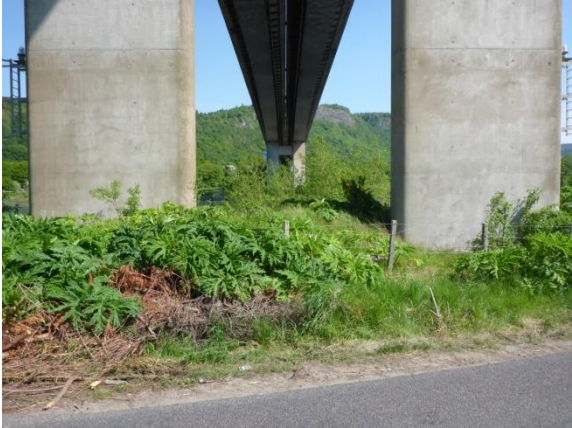
Target Note	Description	Image
1	Piers on LHB of River Tay – erosion on bankside below piers has been ongoing and works are proposed to install rock armour along the riverbank to stabilise the bank.

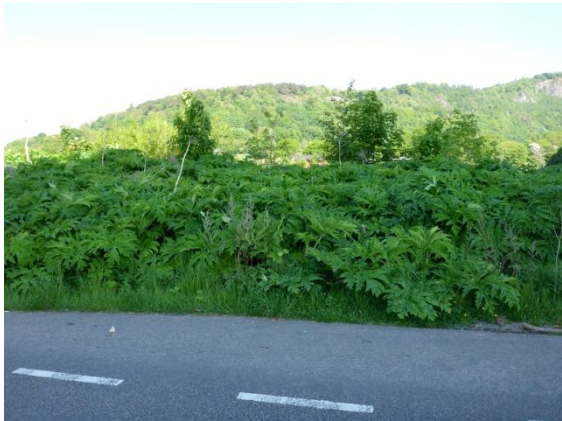
A close-up photograph of a dense patch of Giant Hogweed plants. The leaves are large, green, and deeply lobed. Some small purple flowers are visible on the right side.
3	As above

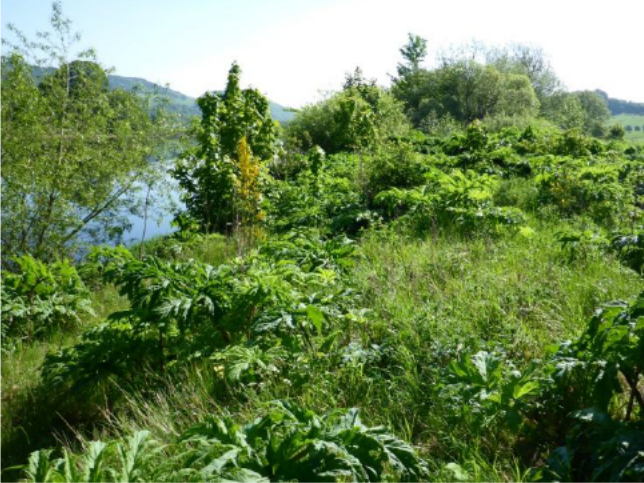
4	<p>As above. There are some open areas within the site but these are likely to be contaminated with seeds from adjacent plants.</p>

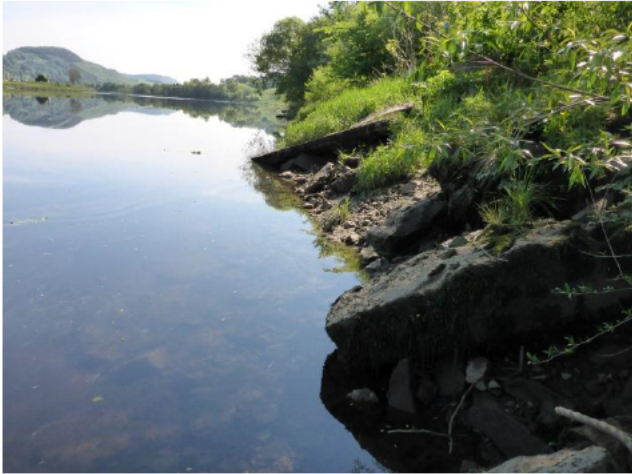
5	<p>View looking east from below piers.</p>

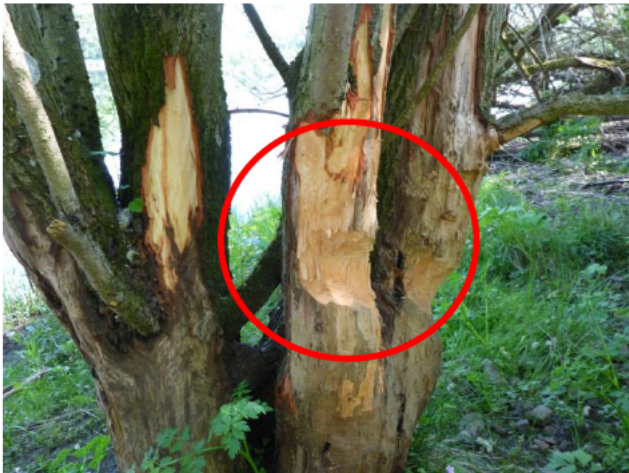
6	<p>Beaver activity with this tree partly felled and bark stripped.</p>

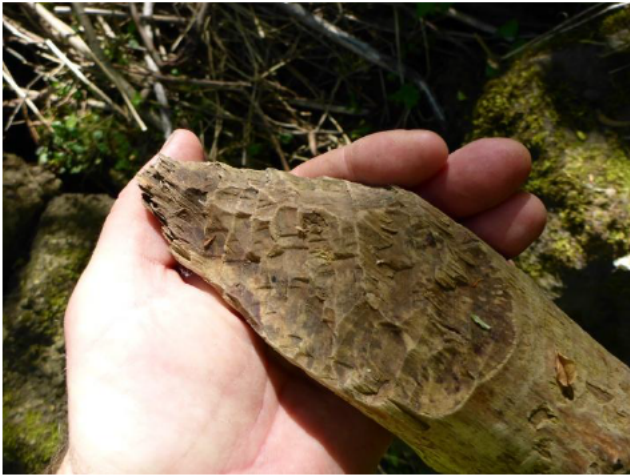
7	Evidence of beavers cutting and storing material along flood zone.

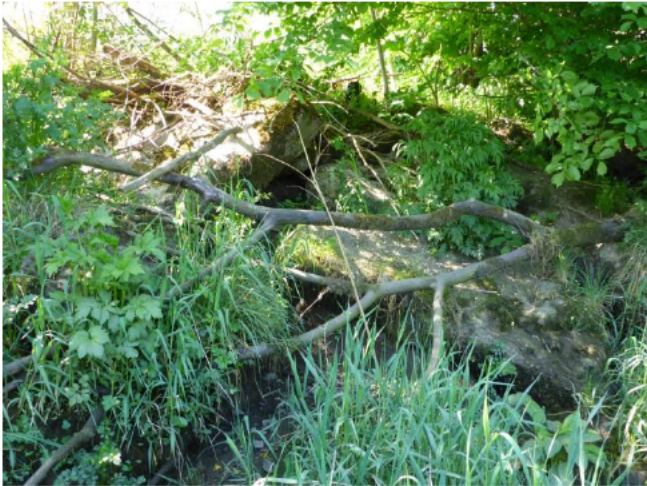
8	Active otter couch under large boulder along bank (> 200m from site)

1. **Otter** – otters are using the River Tay within the work area for commuting and there is one resting place just over 200m downstream. There are no licensable issues associated with the presence of otters in the vicinity of the works. A check should be made of the area ahead of works by an experienced ecologist prior to earth movement or placement of rip-rap armour.

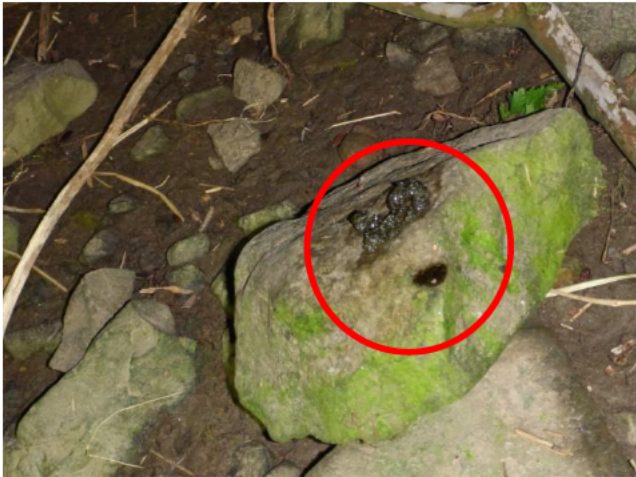
9	As above with fresh otter spraint evident.

10	<p>The presence of Giant Hogweed plants on edge of road at gate and edge of field. If this area is to be used for storage of rock armour or access then the method statement should take account of the contaminated land around the gate and provide mitigation to prevent its spread.</p>	 
----	---	--
