**A828 Connel Bridge**  
**Environmental Summary Report**

| SCHEME DETAILS | | |
|---|---|--|
| Scheme reference | | 17 NW 1203 041- 5 Year Marine Licence – Connel Bridge |

**A828 10 Connel Bridge**  
**Scheme Number: 17NW1203/041**  
**5 Year Marine Licence Application**

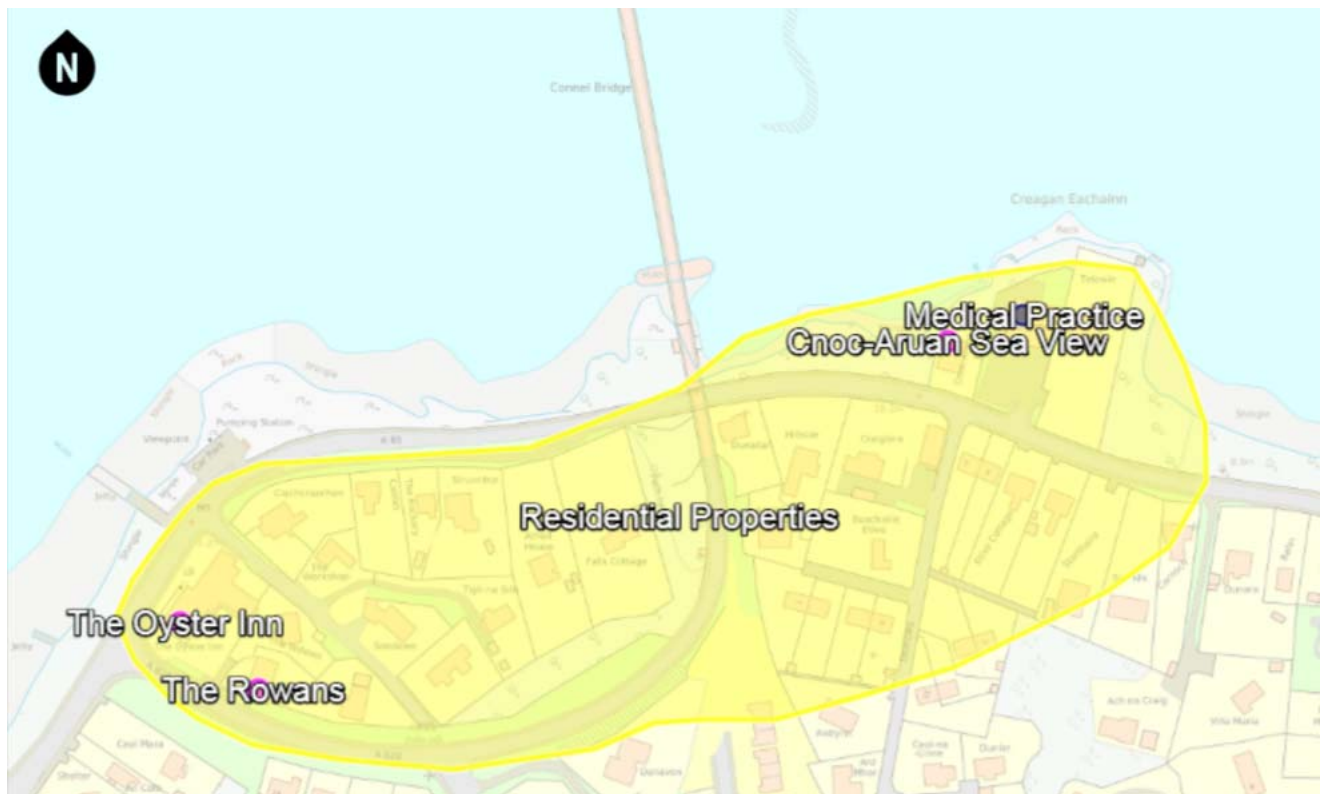
Figure 1: Potential receptors on southern section of the bridge. Residential properties (yellow polygon), commercial properties (pink point) and community receptor (blue point).

On the southern aspect, there are approximately 40 residential properties within 200m of the bridge. Additionally, there are three commercial properties:

Refer to Appendix A for map and table identifying sensitive human receptors.

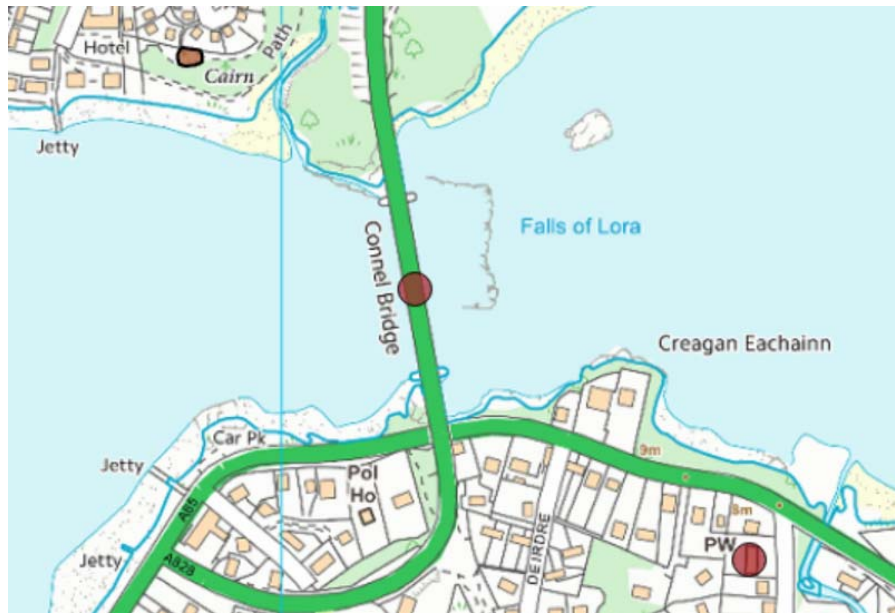
Figure 2: RCAHMS PastMap search results accessed 1<sup>st</sup> May 2018. Listed Buildings marked with brown circles and Barrow Scheduled Monument depicted with brown polygon.

Refer to Appendix B for RCAHMS map of area.

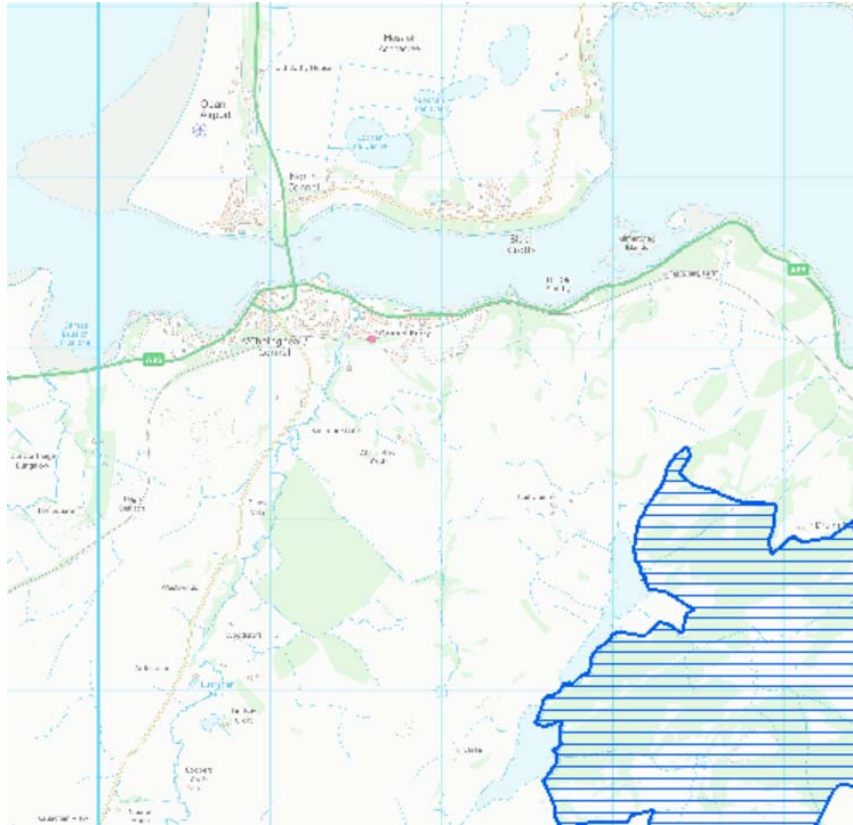
Figure 3: SNH Sitelink search results accessed on 1st May 2018. Loch Etive Woods located 2.5 km south of works (blue hatching).

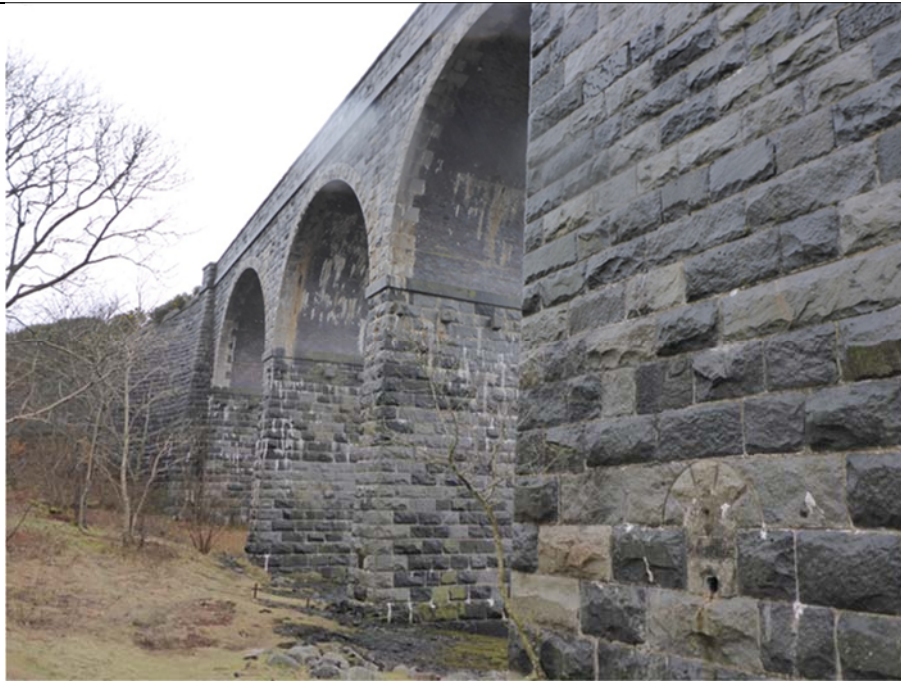
Figure 4: Masonry archways with bat roost potential (north-west side of Connel Bridge)

Two 46m long 3-span masonry arch viaducts at either end of the bridge presents some features consisting of small cracks and missing mortar between bricks, that may have the potential for roosting bats. Woodland to the south-west of the bridge may provide a foraging habitat for bats. No suitable features were noted in trees adjacent to the bridge; however, many of the trees had thick ivy (*Hedera helix*) growing along their lengths, which may present suitable roosting habitat (NM 91139 34354).

Bat activity surveys may be required depending on likely disturbance to the arches and the steel structure during works; this should be factored in to any programming of works to these areas. If bats are found to be roosting in Connel Bridge a derogation licence and consultation with SNH may be required.

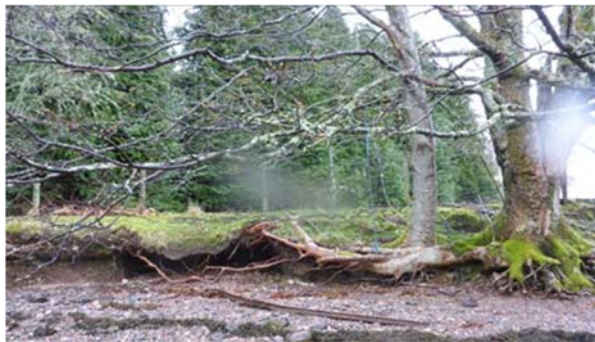
Figure 5: Otter couch recorded beneath tree root overhang (NM 91204 34732).

| Field Sign | Description | National Grid Reference (NGR) |
|---|--|---|
| Couch | Beneath overhang of tree roots, approximately 135m east. | NM 91204 34732 |

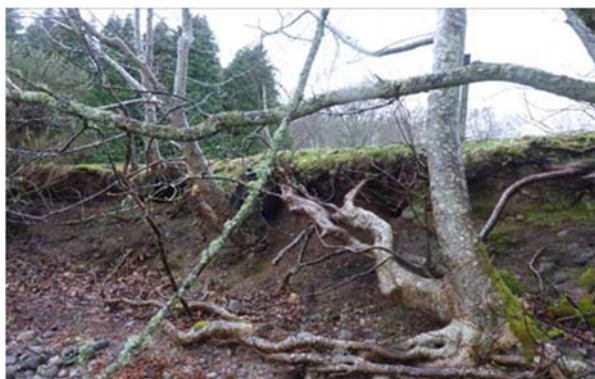
Figure 6: Potential otter holt recorded in bank (NM 91218 34749).

| Field Sign | Description | National Grid Reference (NGR) |
|---|--|---|
| Holt (potential) | Approximately 160m east of bridge. | NM 91218 34749 |

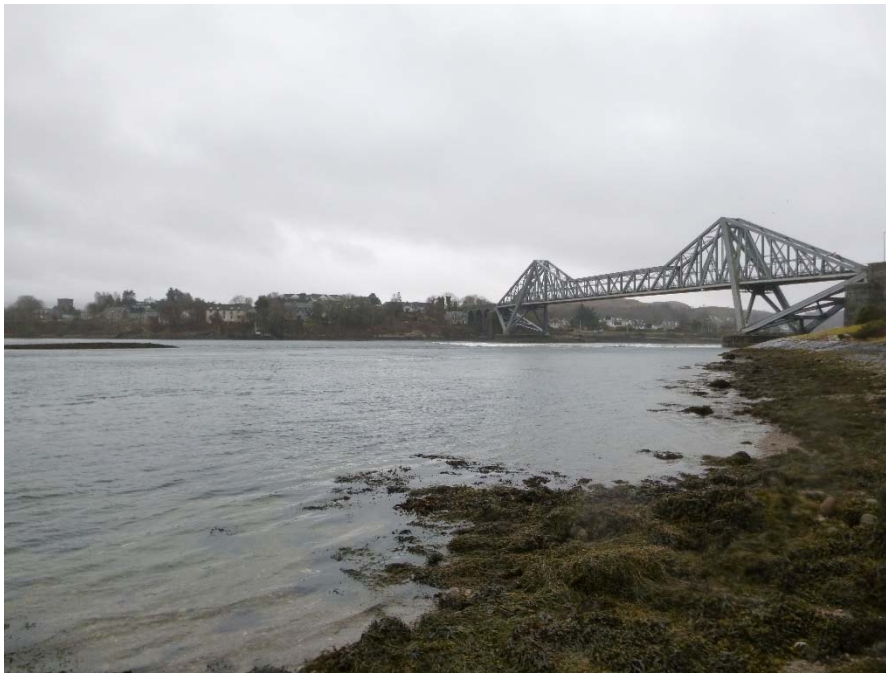
Figure 13: Loch Etive (facing south).

Baseline data has been obtained from Scottish Environment Protection Agency (SEPA) online mapping tool. A walkover survey was used to determine the condition of any noted waterbodies and the location of any road drainage outfalls within the study area.

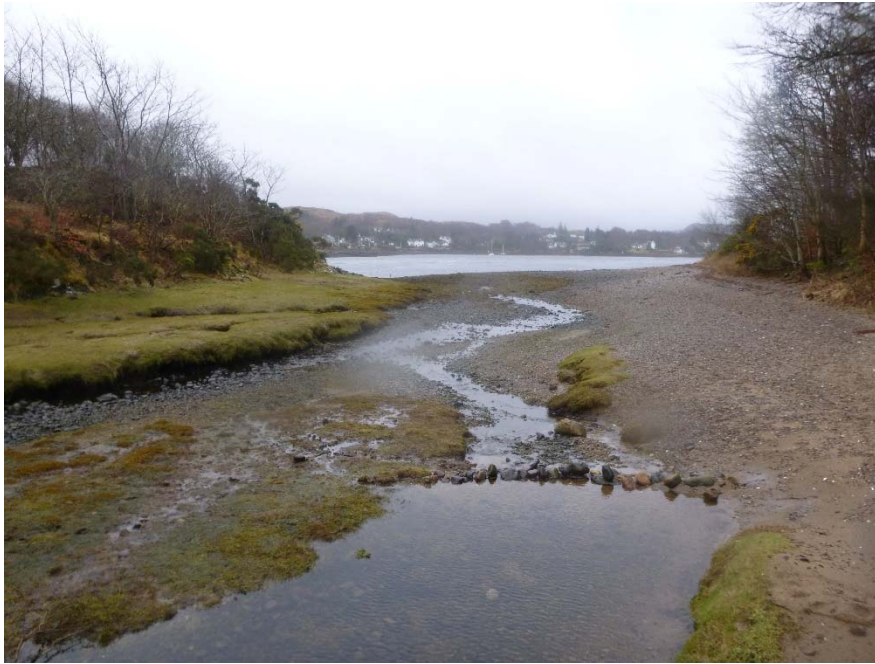
Figure 14. Unnamed watercourse 100m west of Connel Bridge (NM 91012 34614), facing south.
