**Sutherland Pier, Flotta
Dredging Best Practicable Environmental Option
Report**

September 2025

Client: Orkney Islands Council
 Project Title: Sutherland Pier, Flotta
 Report Title: Dredging Best Practicable Environmental Option Report
 Document number: 15490
 Project number: 682009

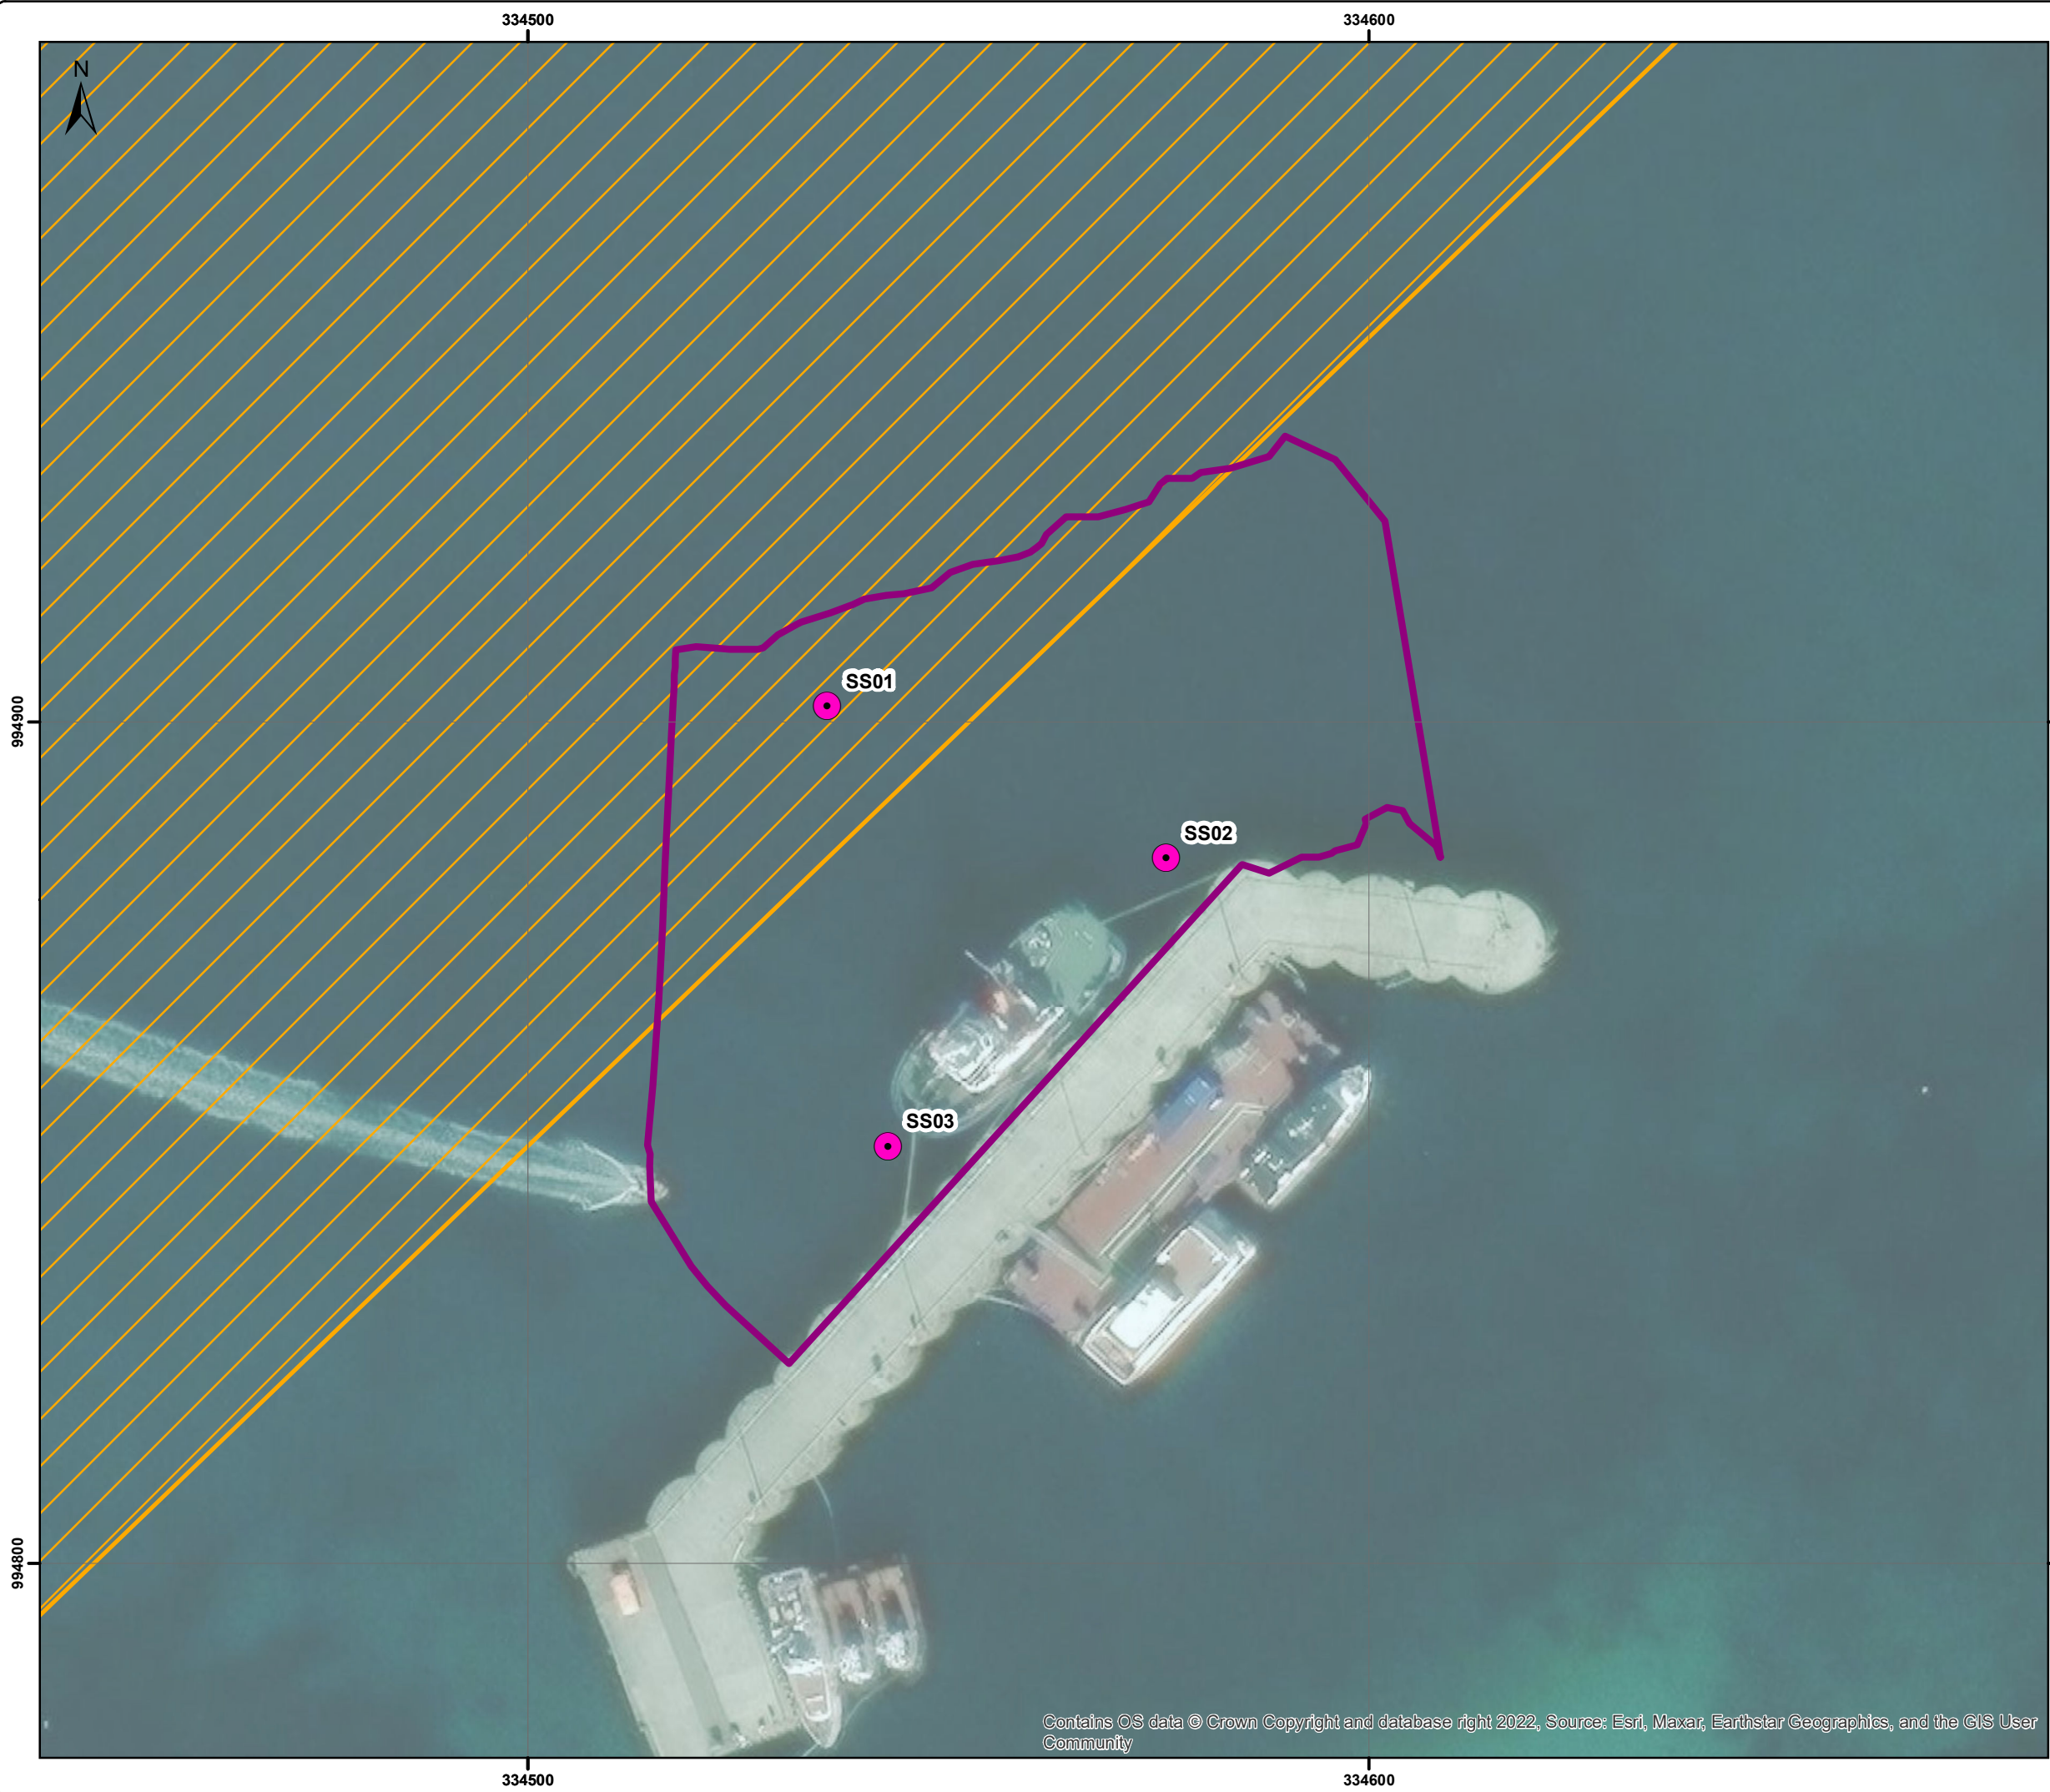
| Drawing No. 682009-GIS002 | Revision - | Date 09 May 2025 |

- Legend**
- Proposed Sediment Sample Stations
 - Proposed Flotta Dredge Area
 - Special Protection Areas

Title
Proposed Sediment Sample Stations Plan

Dredge area and sampling locations are detailed in within Drawing No. 682009-GIS002 provided in Appendix A.

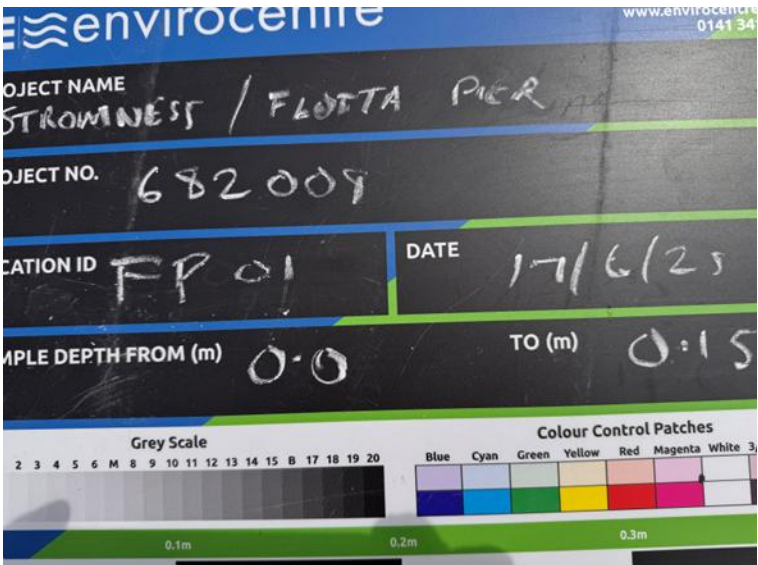
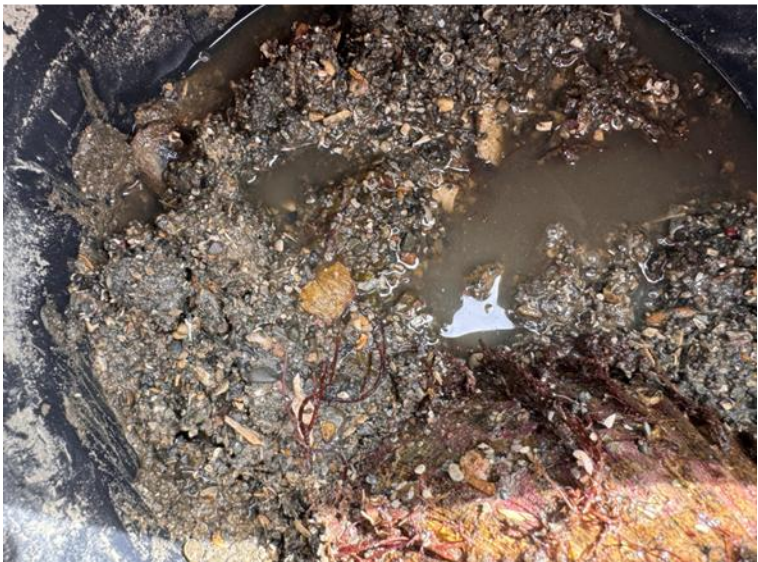
| | Project No. | 682009 | FP (SS)01 |

Remarks: 0.00 – 0.15m Gravelly coarse sand with mixed shell content, including some large fragments.

Biota: Shell fragments and large scallop shell.

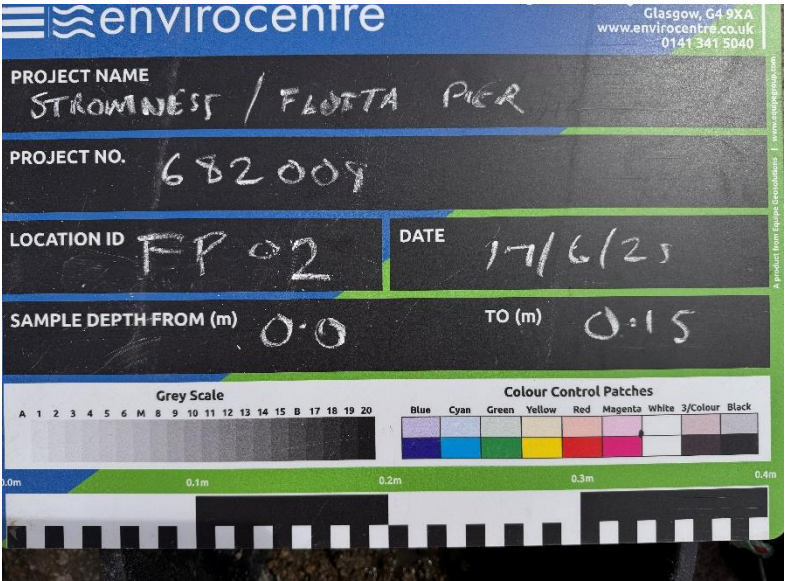
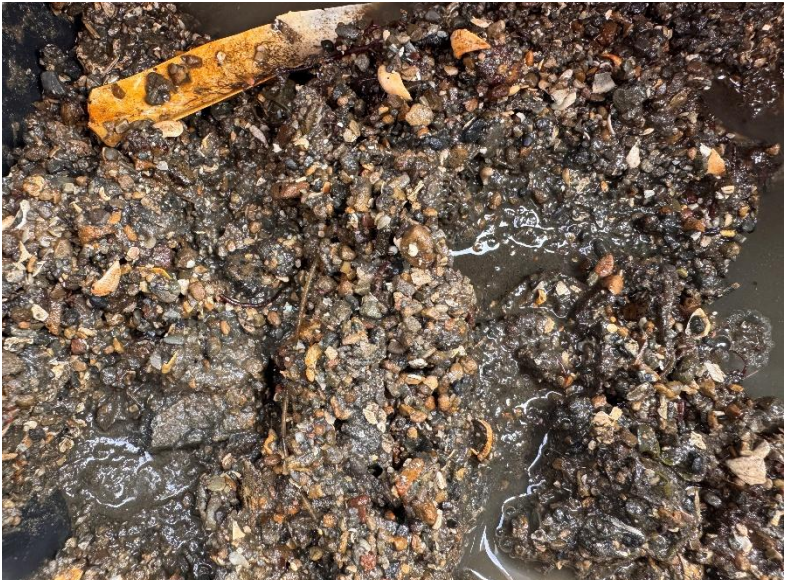
| | Project No. | 682009 | FP(SS)02 |

0.00 – 0.15m Coarse shelly sand with some shell fragments.

Intact razor clam and clam shells.

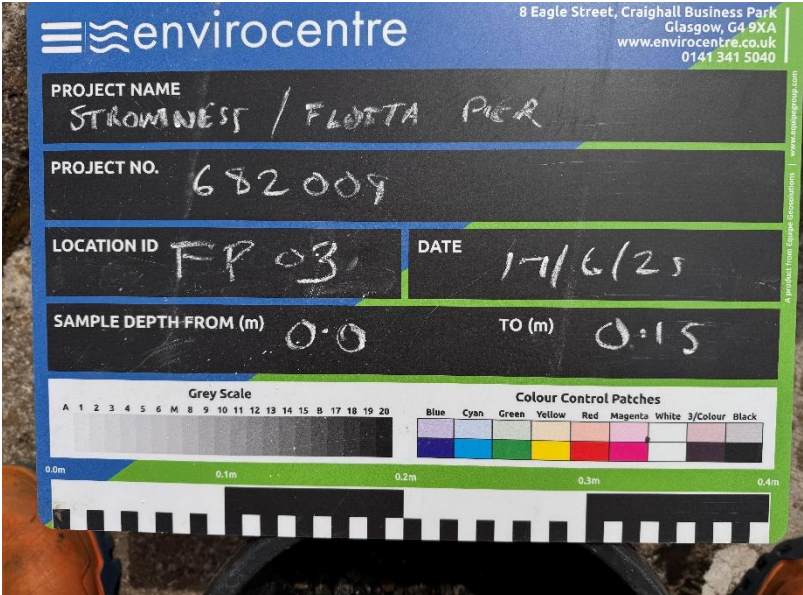
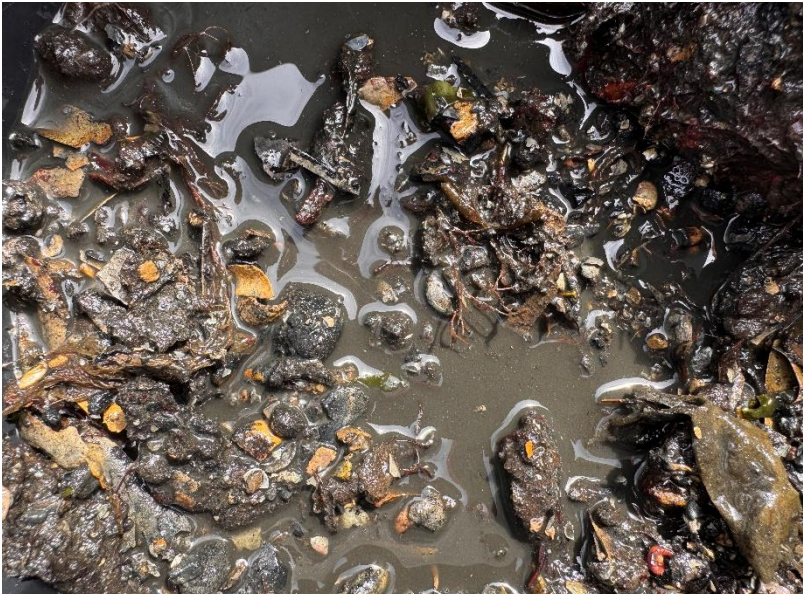
| <div> </div> <div> 8 Eagle Street, Craighall Business Park, Glasgow, G4 9XA </div> | Project Name | Stromness and Flotta Dredge Samples | Location ID FP(SS)03 |

0.00 – 0.15m Gravel with large shell fragments, occasional cobbles.

Shell fragments and seaweed fronds.
