R100 Scottish Isles Fibre-optic Project

Marine Environmental Appraisal - Inner Hebrides

A.1 INTERTIDAL SURVEY REPORT FOR CABLE CORRIDOR 2.13 EIGG TO MAINLAND: EIGG LANDING POINT

Phase 1 Intertidal Survey Report for Bay of Laig, Eigg (Route 2.13)

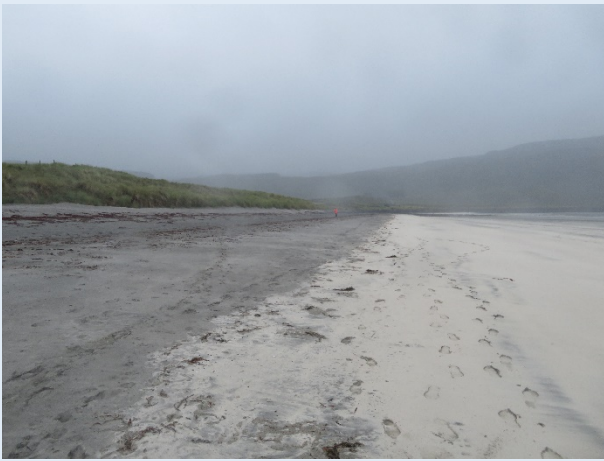
Target note No.	Description	Photograph
T1	Dig-over site #1 in upper shore (approx. MHWS) at north end of survey area (view along beach to south). Strandline visible to left. Mobile well sorted fine grey sand with a single amphipod observed

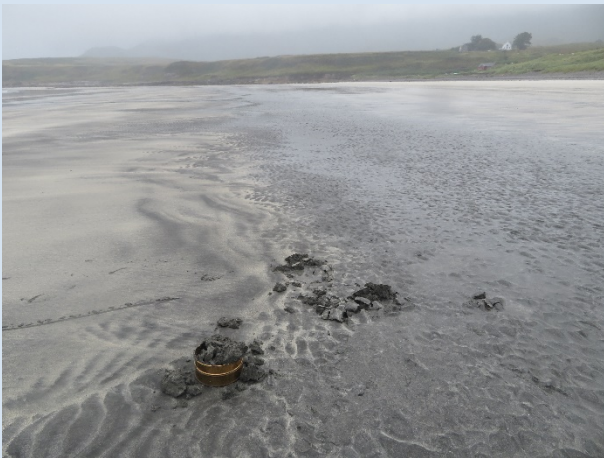
T2	Dig-over site #2 in upper shore – at upper edge of sandbank in upper shore, north end of survey area (view along beach to north); mobile well sorted fine grey sand with no life observed

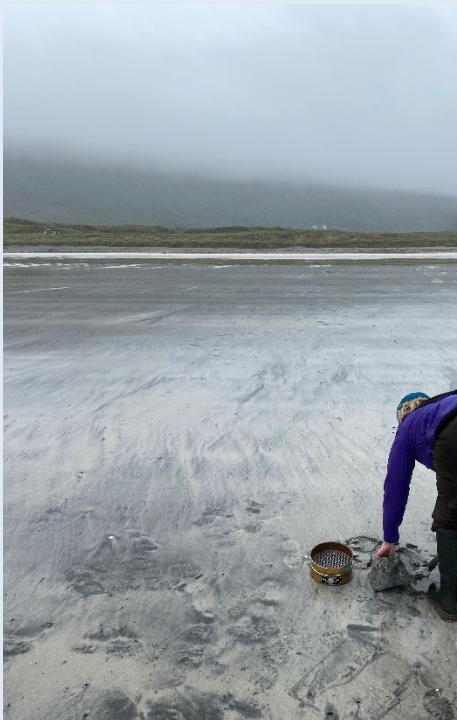
Target note No.	Description	Photograph
T3	Dig-over site #3 in mid/lower shore at north end of survey area. View up shore along northern edge of survey area. Mobile well sorted fine grey sand with a single tellin bivalve mollusc observed

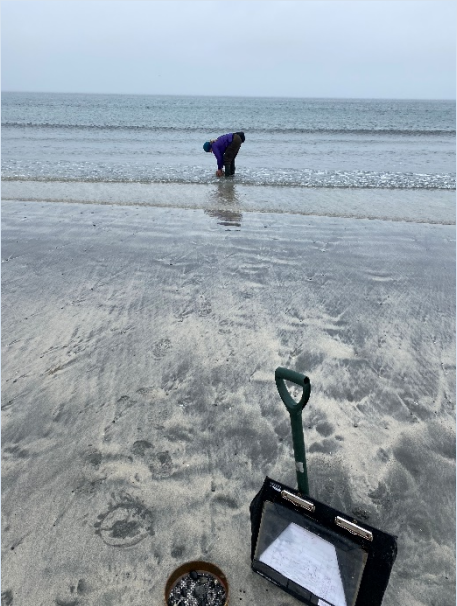
T4	Dig-over site #4 in lower shore towards north end of survey area; mobile well sorted fine grey sand with two polychaetes (<i>Nephtys</i> sp) observed

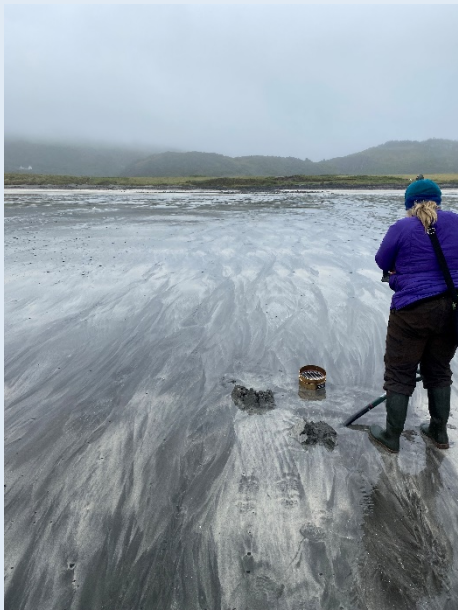
Target note No.	Description	Photograph
T5	Dig-over site #5 in lower shore directly below the burn; view up shore. Mobile well sorted fine black river sand evident, with no life observed

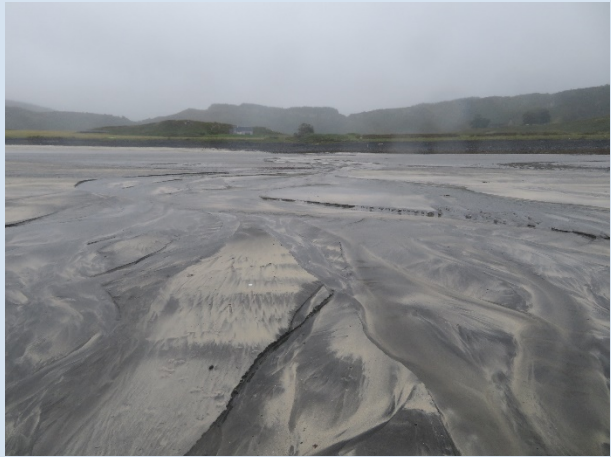
T6	Dig-over site #6 in lower shore close by the proposed cable route; view up shore. Mobile well sorted fine sand with black river sand evident, with a single tellin bivalve mollusc observed

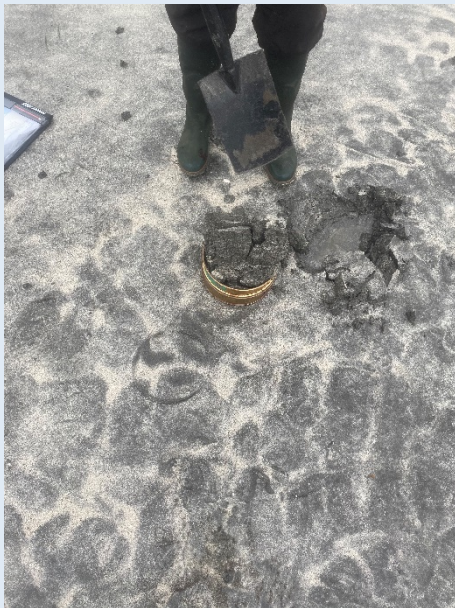
Target note No.	Description	Photograph
T7	Dig-over site #7 in mid shore at southern edge of sandy beach; mobile well sorted fine grey sand with frequent <i>Arenicola marina</i> casts; plus three polychaetes (single sphaerodoriid and two <i>Nephtys</i> sp) observed in sieve

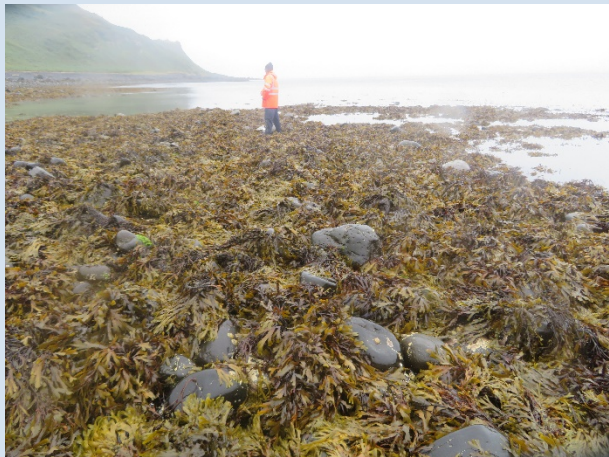
T8	Lower shore boulders, at upper edge of <i>Fucus serratus</i> zone (biotope is <i>Fucus serratus</i> on moderately exposed lower eulittoral rock; LR.MLR.BF.Fser).

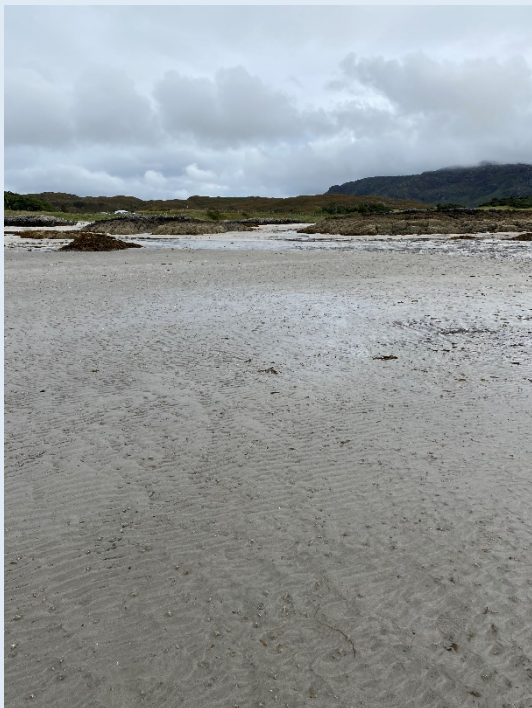
Target note No.	Description	Photograph
T1	View up shore along proposed new cable route from the water's edge

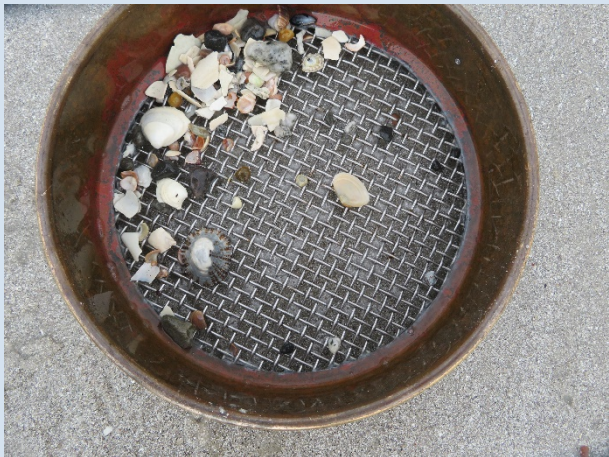
Target note No.	Description	Photograph
T5	Sediment dig-over #5, northern end of main sandy bay Camas Rubha a' Mhurain by proposed cable route; mid shore fine shell gravel sand. <i>Arenicola marina</i> casts and sand mason worm tubes (<i>Lanice conchilega</i>). Bivalve mollusc <i>Macomangulus tenuis</i> seen in sieve.

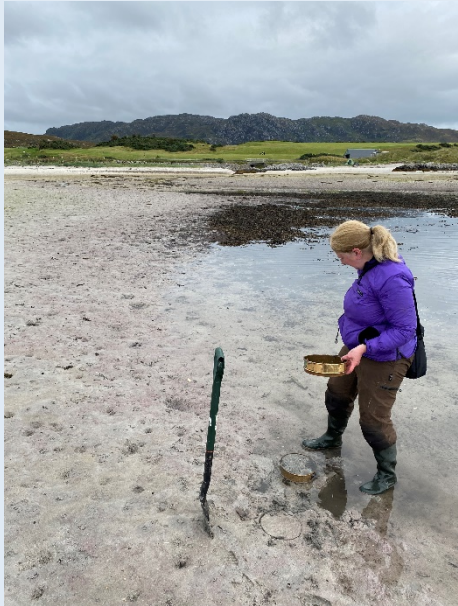
T6	Sediment dig-over #6 by burn crossing the bay; mid shore fine shell gravel sand. <i>Arenicola marina</i> casts and sand mason worm tubes (<i>Lanice conchilega</i>) together with organic debris. Sediment coloured pink, possibly by diatoms.

Organic debris and lugworm seen in sieve.

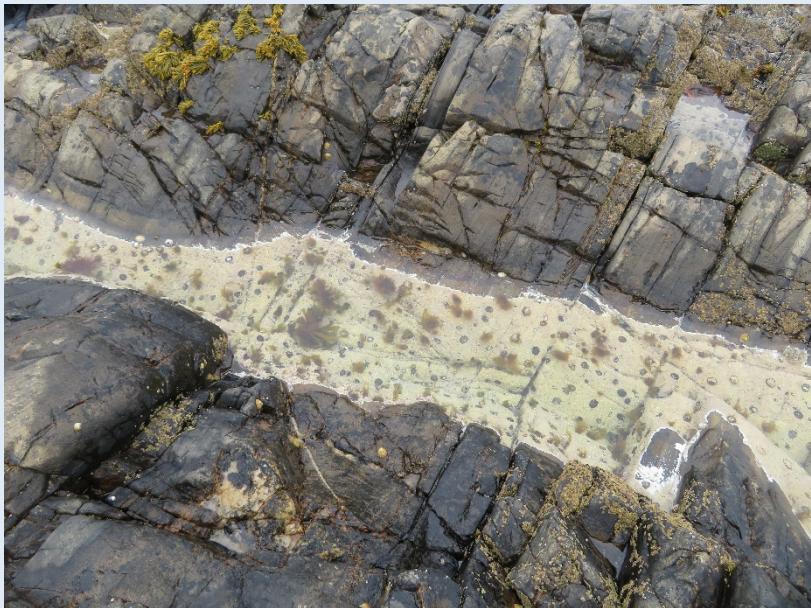
Target note No.	Description	Photograph
T7	An example of a coralline rock pool.

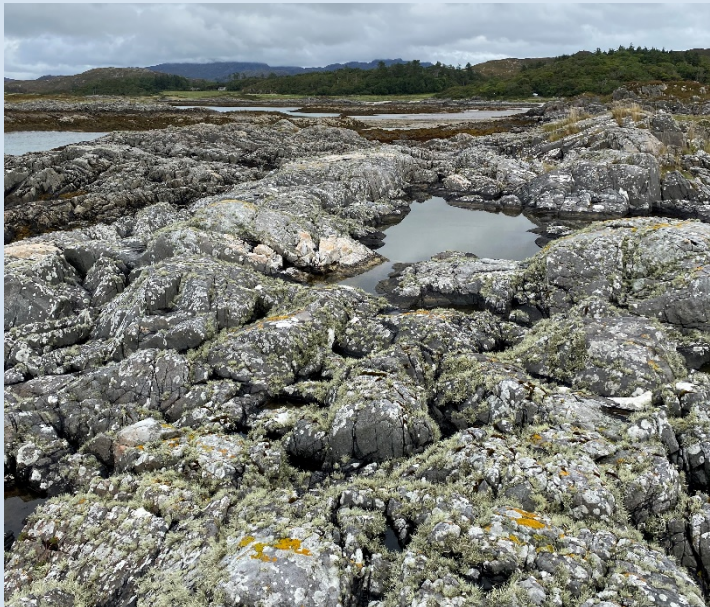
T8	An example of a green algal rock pool

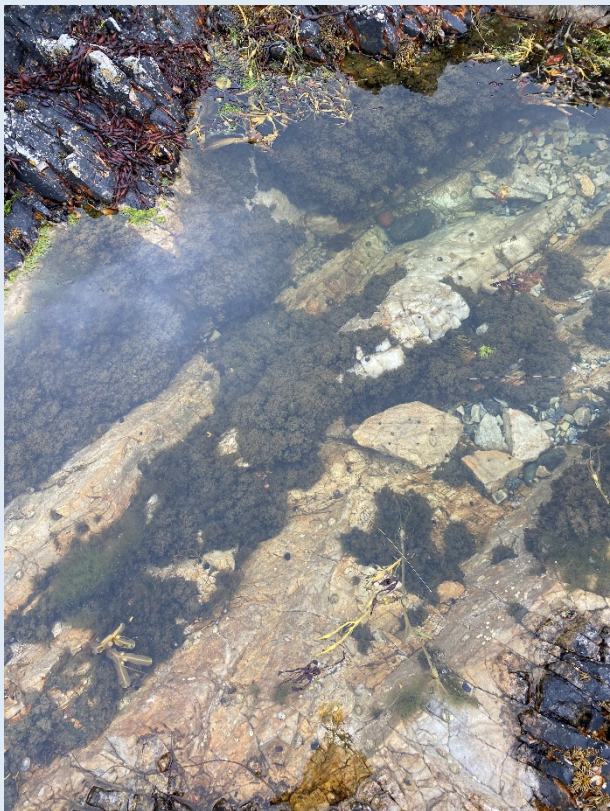
Target note No.	Description	Photograph
T1	Rockpools with green seaweeds in supralittoral (just above MHWS) at south end of survey area.

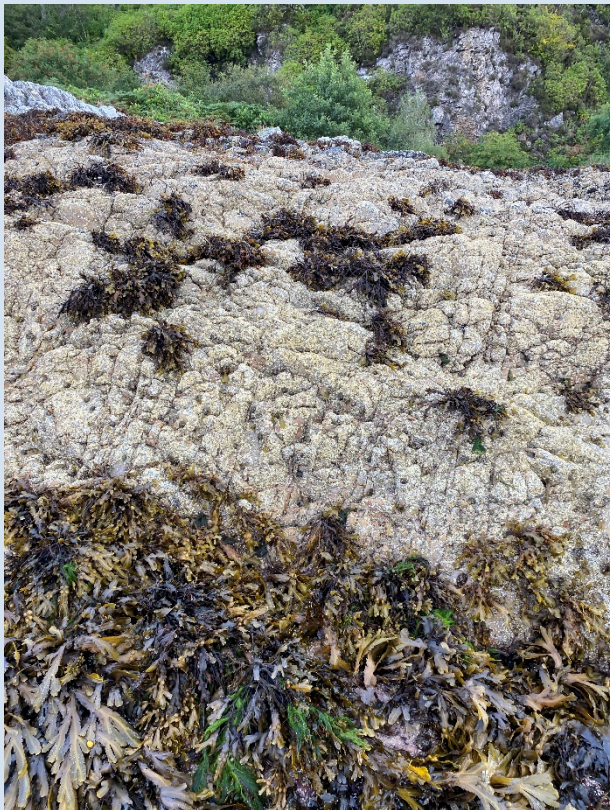
Target note No.	Description	Photograph
T2	Biotope LR.HLR.MusB.Cht <i>Chthamalus</i> spp. on exposed upper eulittoral rock. On a restricted area of steep or vertical rock in the sheltered upper shore at the southernmost edge of the survey area.

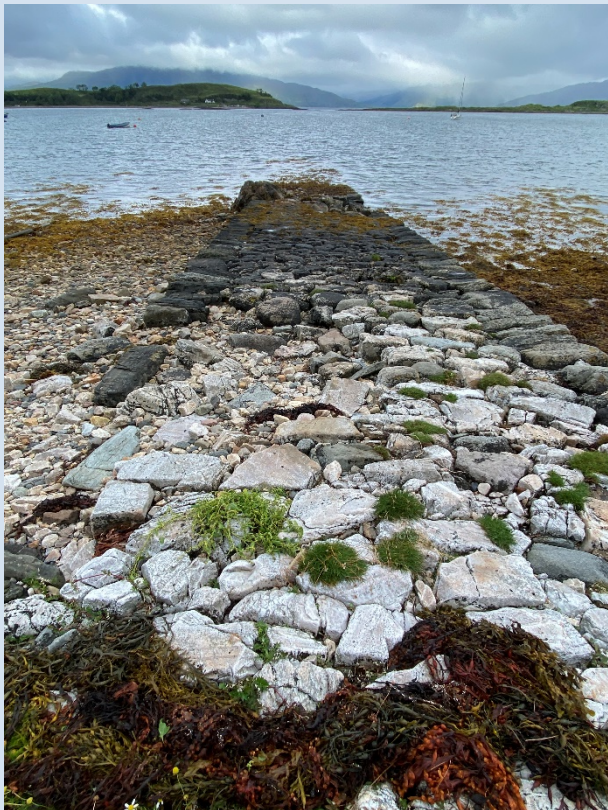
Target note No.	Description	Photograph
T6	Small stone jetty/slipway near north end of survey area

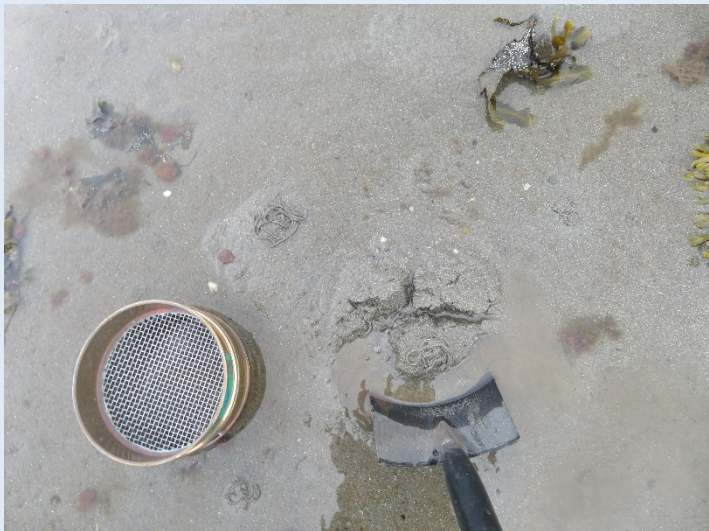
Target note No.	Description	Photograph
T1	Sediment dig-over #1, upper mid shore near north end of survey area. Fine gravelly sand with lugworm casts (<i>Arenicola marina</i>). Animals seen in sieves include ?spionid polychaete tubes and 1x brown shrimp <i>Crangon crangon</i> .

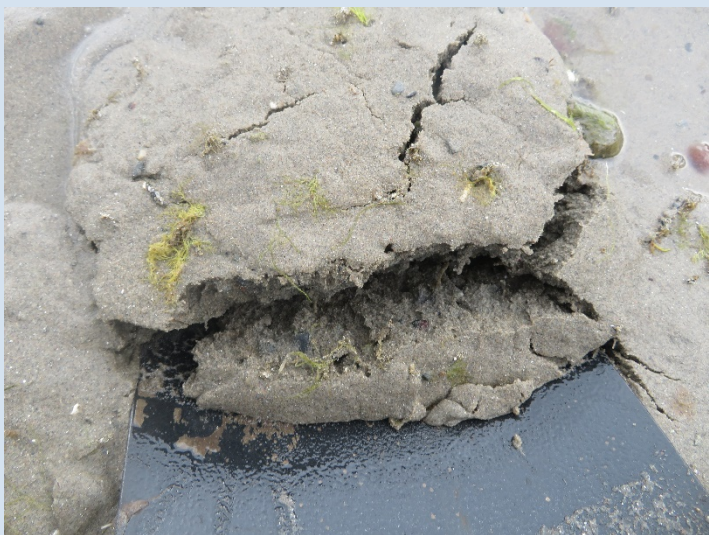
T2	Sediment dig-over #2, lower mid shore in centre of survey area on proposed new cable landfall. Fine gravelly sand with lugworm casts (<i>Arenicola marina</i>) and sand mason worm tubes (<i>Lanice conchilega</i>). Animals seen in sieves include several <i>L. conchilega</i> , ?spionid polychaete tubes, and the bivalve molluscs <i>Clausinella fasciata</i> and <i>Macomangulus tenuis</i> .

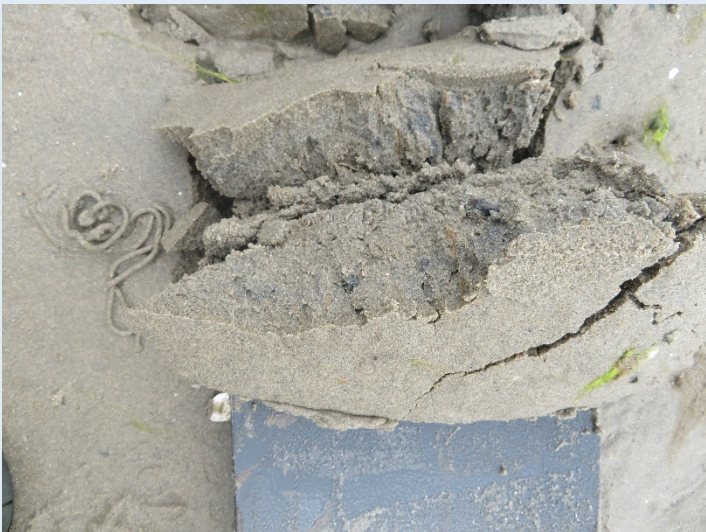
Target note No.	Description	Photograph
T3	Sediment dig-over #3, upper mid shore on route of proposed new cable landfall. Animals seen in sieves include several <i>L. conchilega</i> , ?spionid polychaete tubes, a fragment of Nephtyid polychaete and several unidentified amphipod crustaceans.

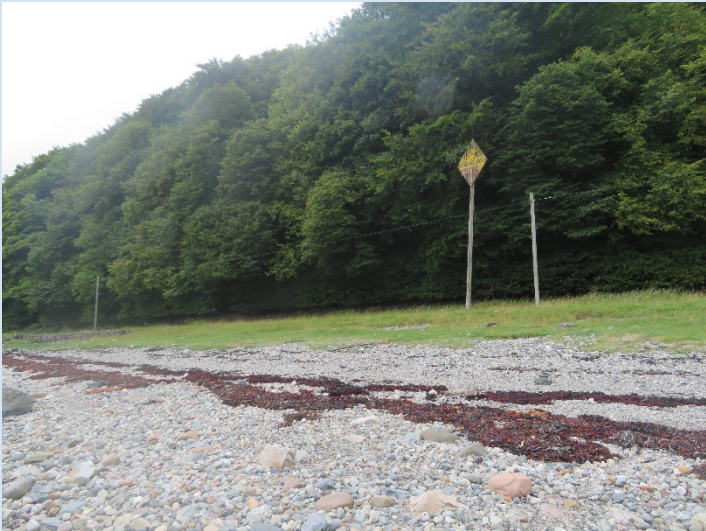
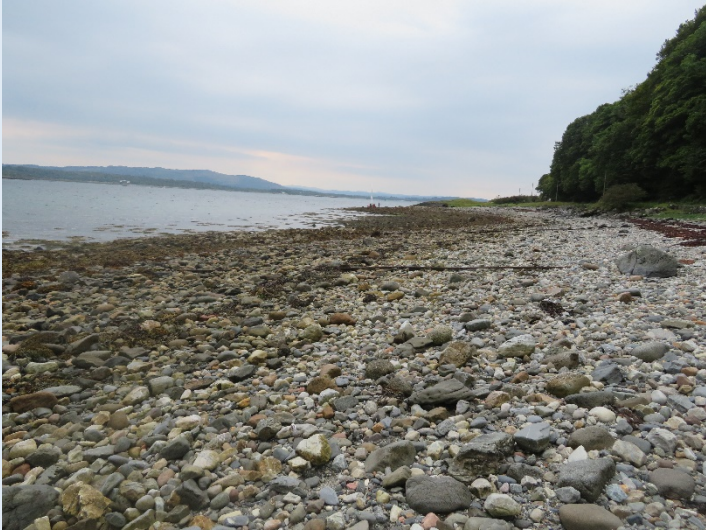
T4	Two rusty old cables emerging from burial at top edge of beach, by telegraph cable marker approximately 120m south of proposed new cable landfall.

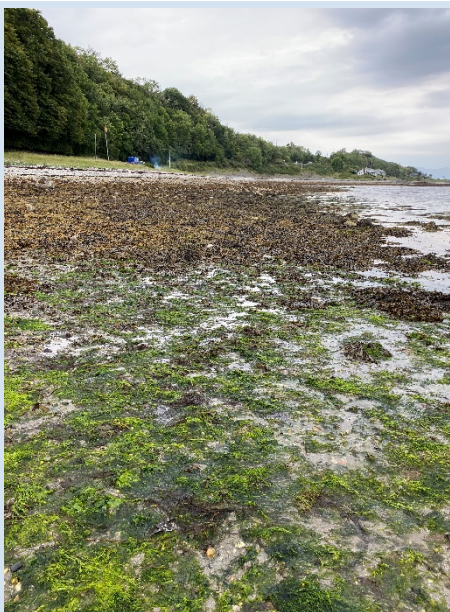
Target note No.	Description	Photograph
T5	Large area of green algae in mid shore towards south end of survey area.
