A.5 INTERTIDAL SURVEY REPORT FOR CABLE CORRIDOR 2.15 IONA TO MULL: IONA LANDING POINT

Phase 1 Intertidal Survey Report for Sligneach, Iona (Route 2.15)

A.6 INTERTIDAL SURVEY REPORT FOR CABLE CORRIDOR 2.15 IONA TO MULL: MULL LANDING POINT

A.9 BENTHIC SURVEY REPORT FOR CABLE CORRIDOR 2.14 MAINLAND TO LISMORE

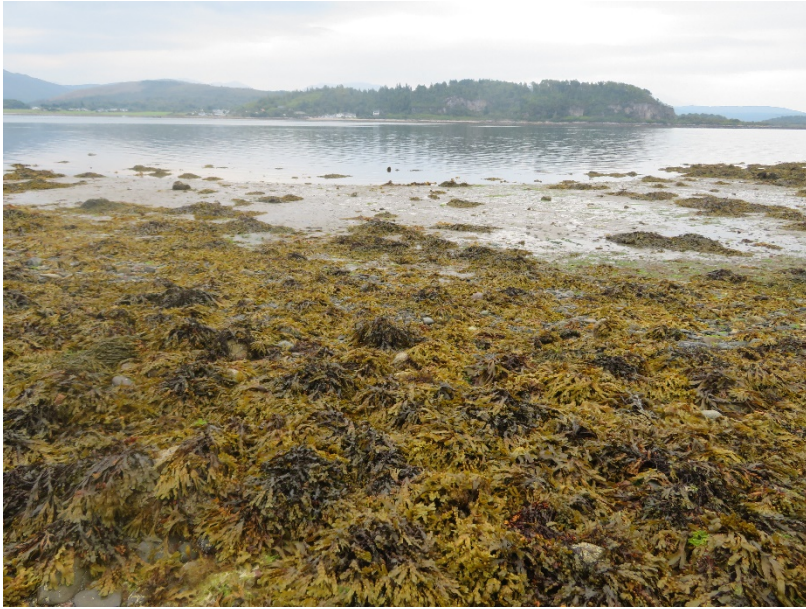
Photo 5c View down shore from strandline at approximate line of cable landfall including overview of sediment dig-over sites #2 and #3

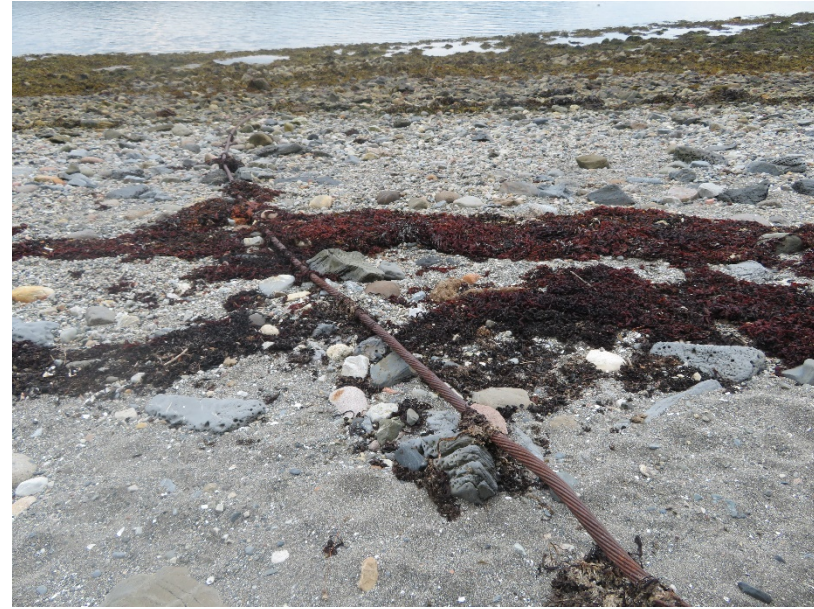
Photo 5d View down shore from top of mid shore furoid zone at approximate line of cable landfall, including overview of sediment dig-over sites #2 and #3

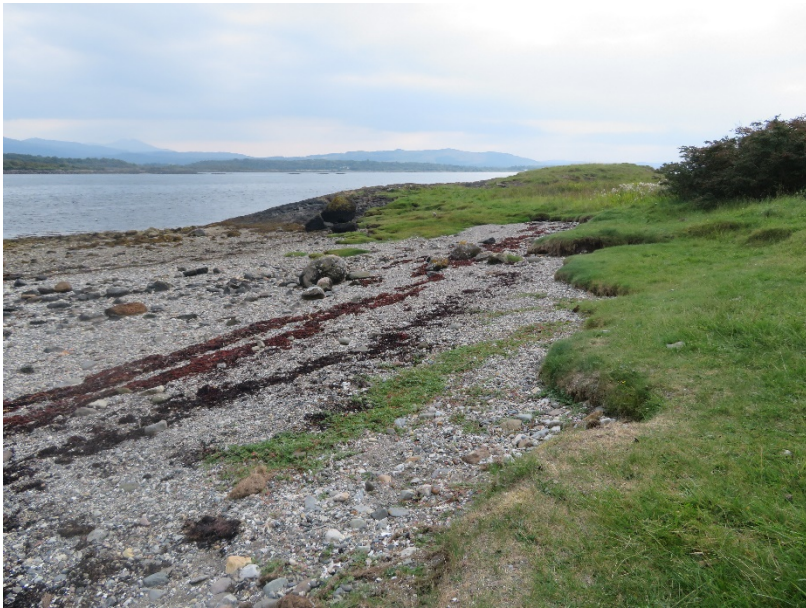
Photo 6 View down shore from strandline approximately 120m south of proposed cable landfall, where old cables emerge from burial

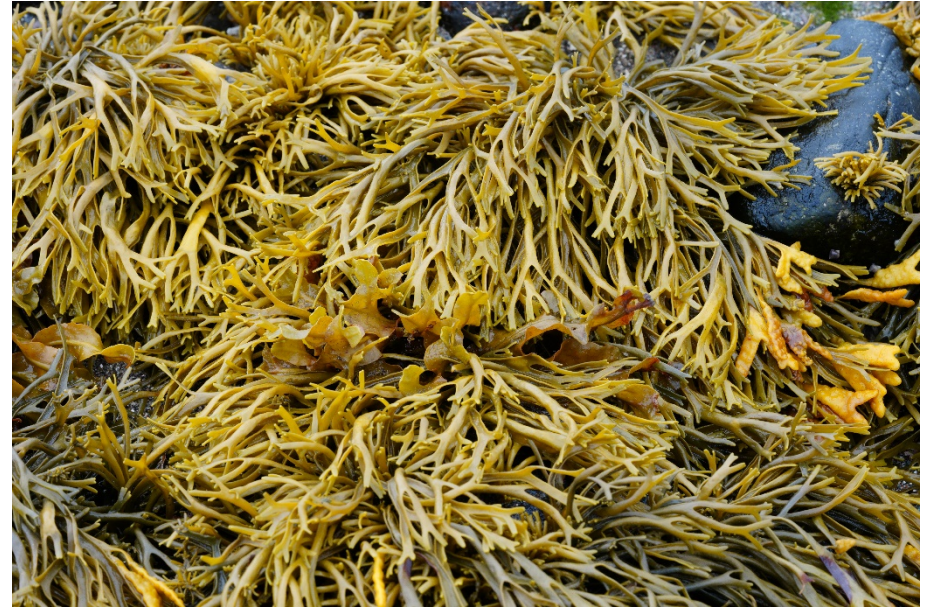
Photo 9 Example image of biotope LR.LLR.F.Pel and LR.LLR.F.Fspi.X (channelled wrack *Pelvetia canaliculata* and spiralled wrack *Fucus spiralis*) on upper shore cobbles

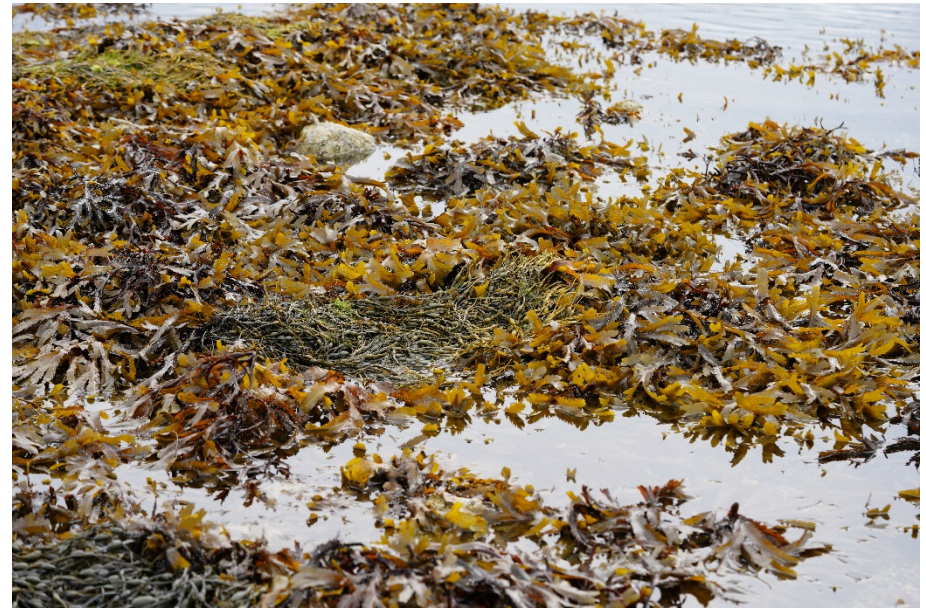
Photo 11 Example image of egg wrack *Ascophyllum nodosum* and bladder wrack *Fucus vesiculosus* on mid shore cobbles

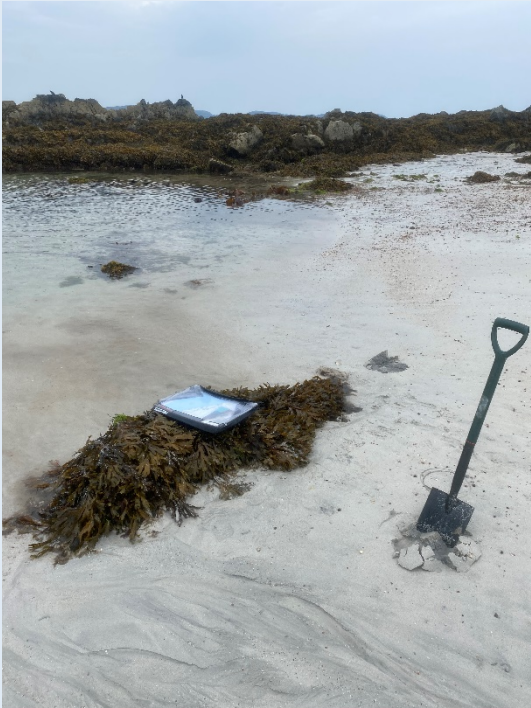
Target note No.	Description	Photograph
T1	Sediment digover site 1, at water's edge at low water, northern boundary of survey area.

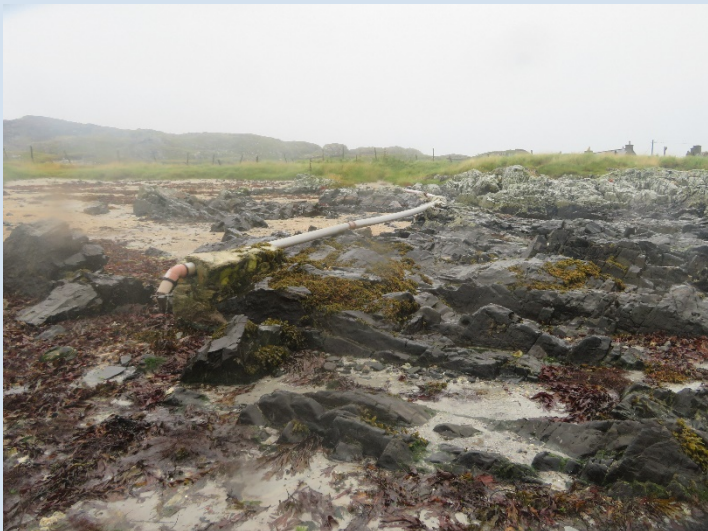
Target note No.	Description	Photograph
T4	Pipe discharging raw sewage into upper shore

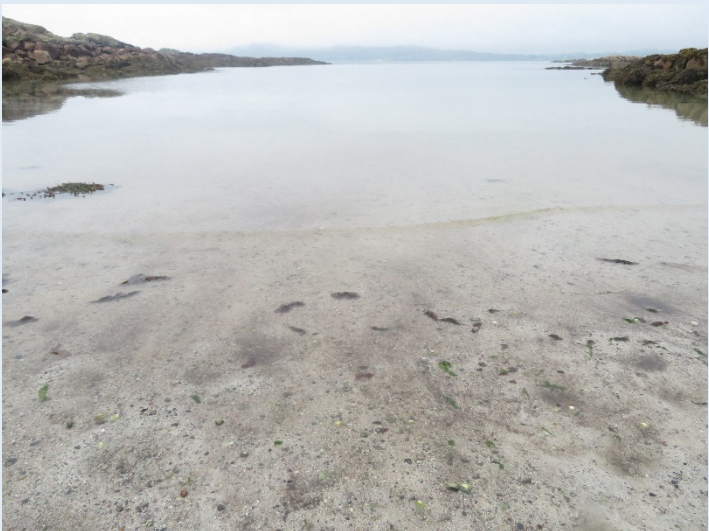
Target note No.	Description	Photograph
T1	Sediment digover site 1, at water's edge at low water, sandy bay at centre of survey area. With evidence of infauna, including casts of the lugworm <i>Arenicola marina</i> . <i>A. marina</i> specimen also seen in sieve.

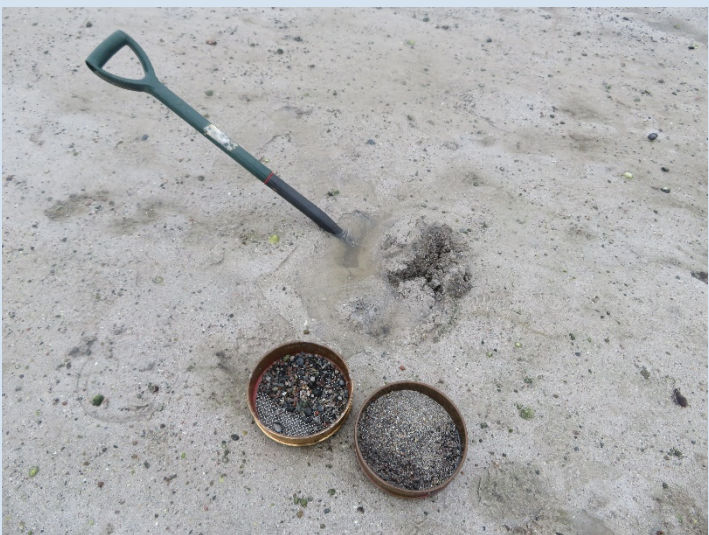
T2	Sediment digover site 2, in mid shore, sandy bay at centre of survey area. with evidence of infauna including casts of the lugworm <i>Arenicola marina</i> .

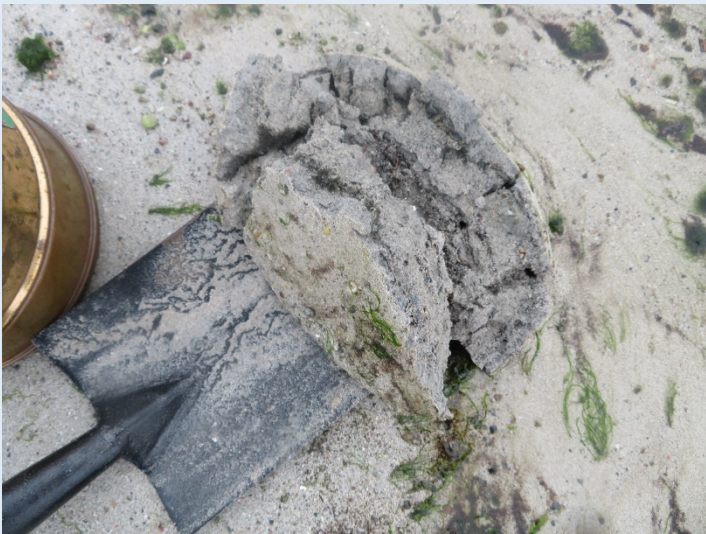
Target note No.	Description	Photograph
T3	Sediment digover site 3, in upper shore, sandy bay at centre of survey area. No species seen.

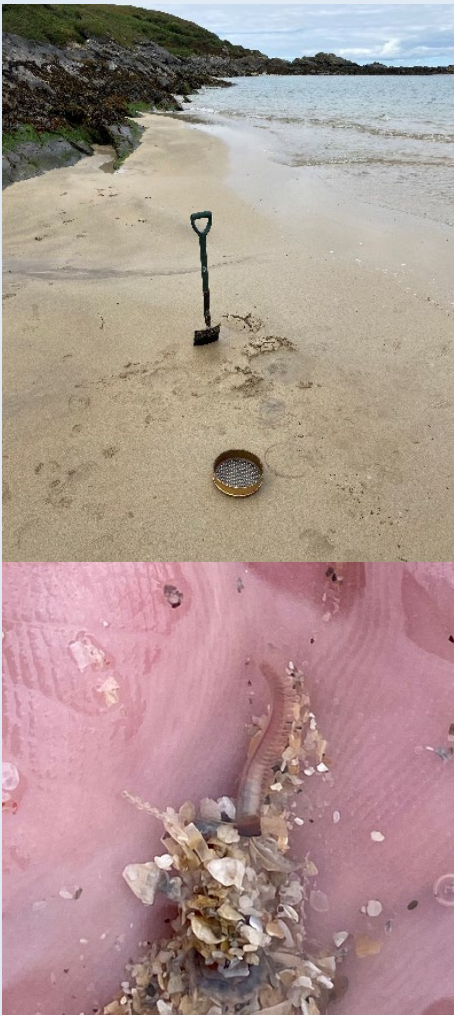
Target note No.	Description	Photograph
T5	Dig-over site #1 in mid shore at west end of survey area; mobile well sorted medium sand with one tube-dwelling polychaete <i>Scolelepis</i> sp. observed

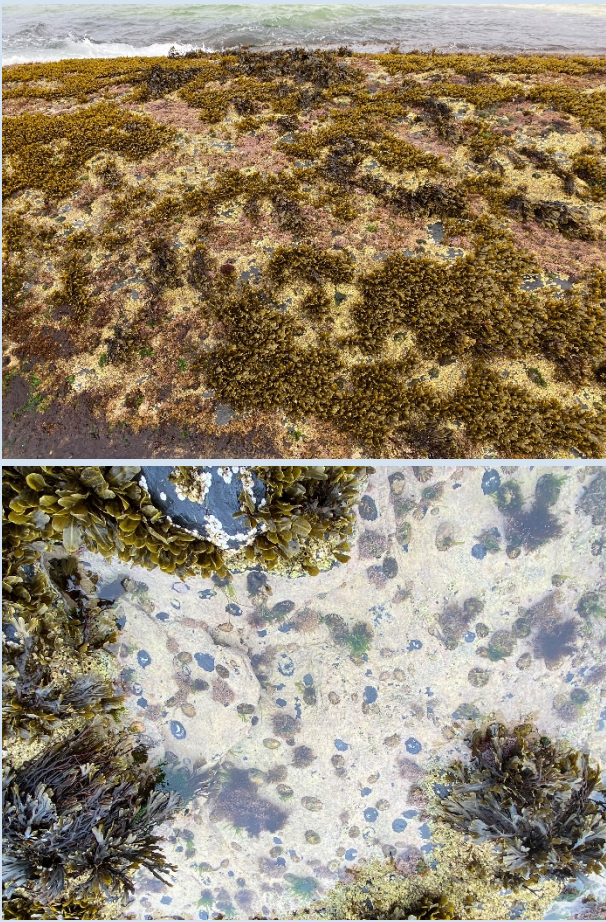
Target note No.	Description	Photograph
T6	<p>Mosaic on mid/lower shore rock outcrops of three biotopes:</p> <ol style="list-style-type: none"> 1. <i>Fucus vesiculosus</i> sporelings, <i>F. vesiculosus</i> var. <i>linearis</i>, <i>Corallina officinalis</i>, <i>Osmundea</i> sp. with barnacles and limpets (LR.HLR.MusB.Sem.FvesR) 2. <i>Corallina officinalis</i>; Pink coralline algal crust; <i>Ceramium</i> sp.; <i>Ulva</i> sp. indet; <i>Patella</i> spp. and <i>Actinia equina</i> in rockpools in mid to lower shore (LR.FLR.Rkp.Cor.Cor) 3. Sand-scoured rock with <i>Rhodothamniella floridula</i> (LR.MLR.BF.Rho)

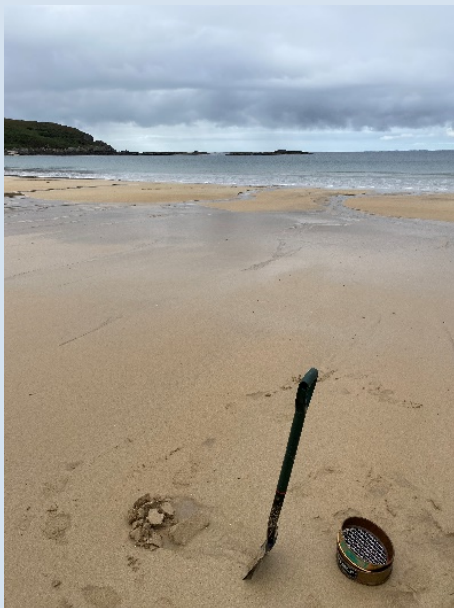
Target note No.	Description	Photograph
T10	Dig-over site #5 on boundary in upper mid shore near proposed cable route; mobile well sorted medium sand with no visible fauna

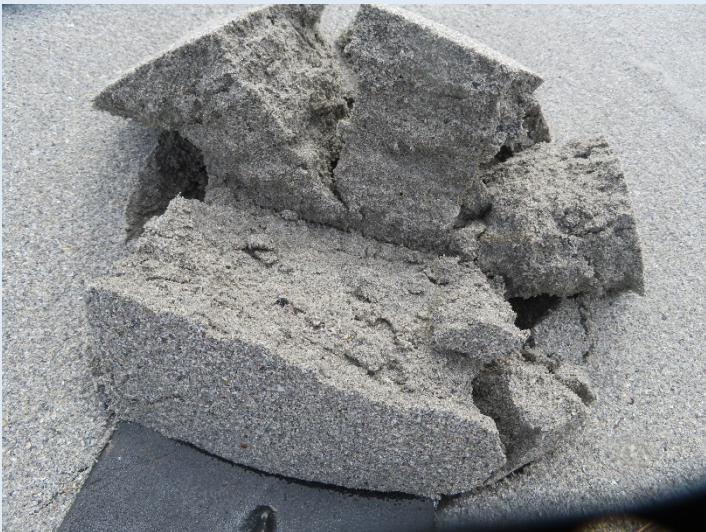
Target note No.	Description	Photograph
T2	Sediment digover site 2, in mid shore wet sand, sandy bay at centre of survey area. Infauna observed included spionid polychaetes <i>Scolecopsis squamata</i> .

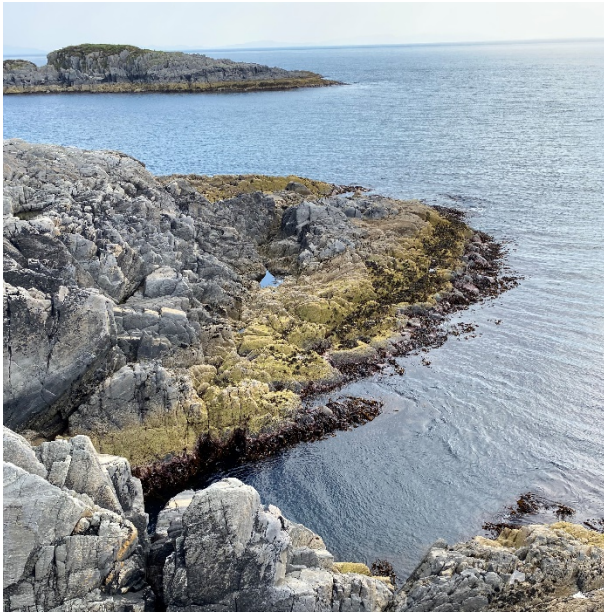
Photo 5a View of shore zonation from cliff top on Garbh Eilean, overlooking southern boundary of Kilvickeon intertidal survey area

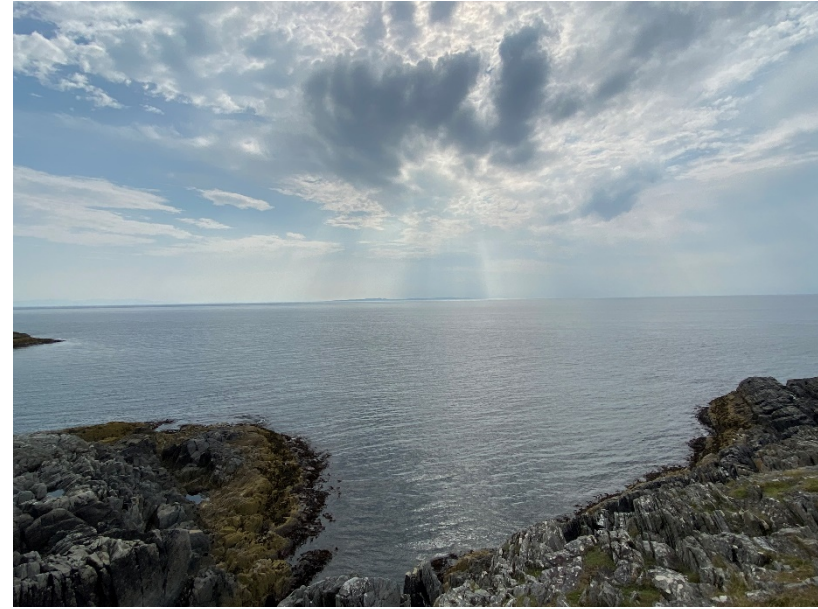
Photo 5b View of shore zonation from cliff top on Garbh Eilean, overlooking southern boundary of Kilvickeon intertidal survey area

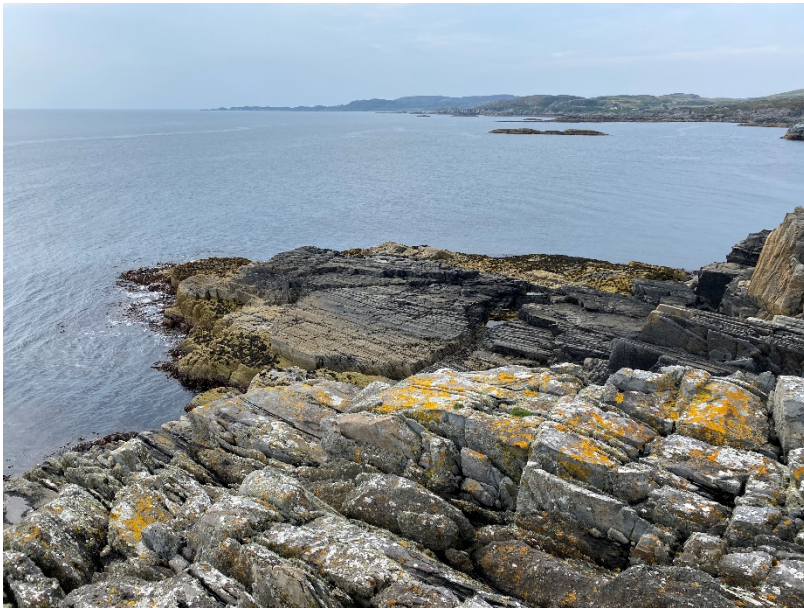
Photo 6 View over shore zonation at southwest tip of Garbh Eilean from cliff top on headland to south of Kilvickeon Bay

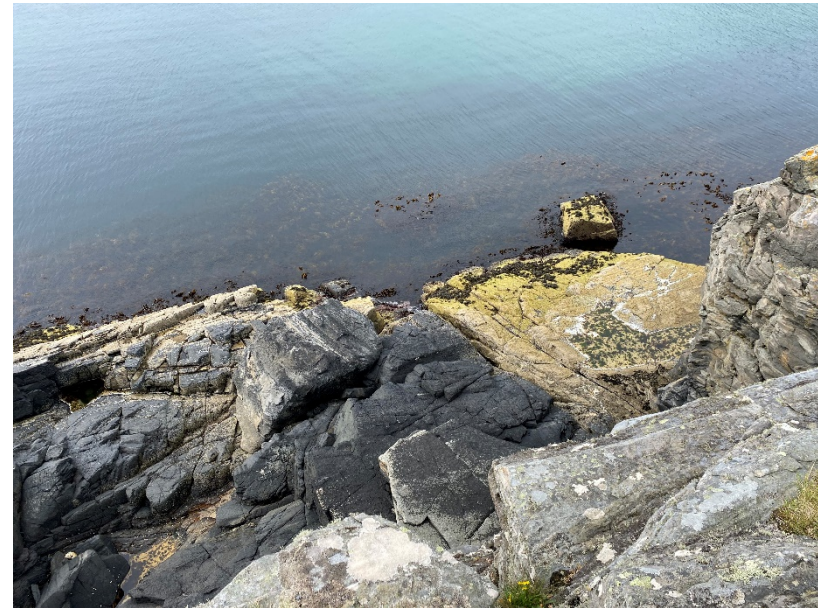
Photo 7 View over shore at west tip of Garbh Eilean from cliff top on headland to south of Kilvickeon Bay

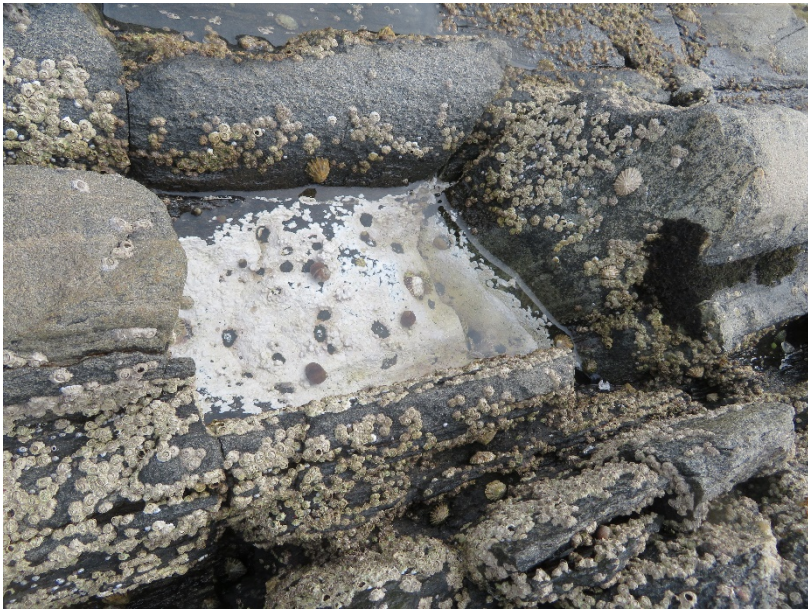
Photo 8a Barnacle and limpet-dominated biotope in mid shore with patches of black lichens *Verrucaria maura* and *Lichina pygmaea*, and small coralline rock pool

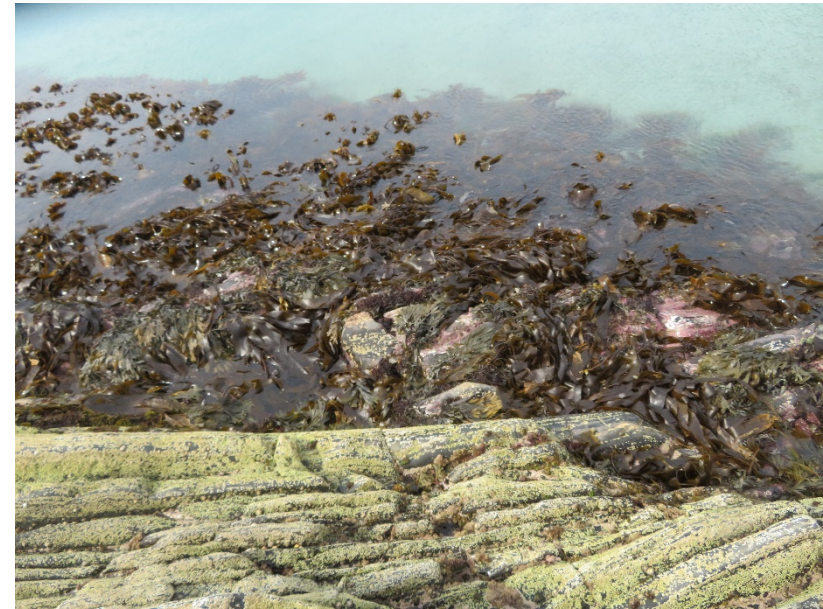
Photo 8b Barnacle and limpet-dominated biotope in mid shore, grading into lower shore fucoids and red seaweeds, and down into sublittoral brown seaweeds

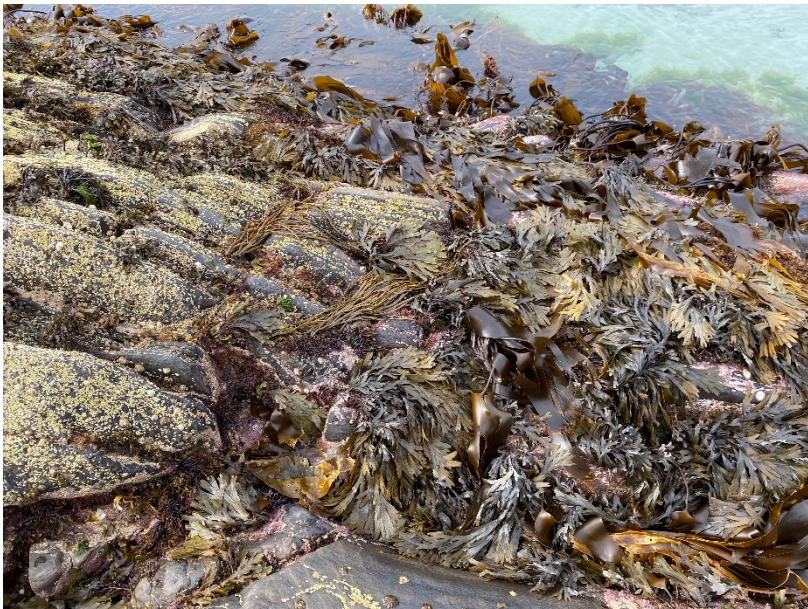
Photo 9 *Fucus serratus*, *Himanthalia elongata* and red algae in lower shore, and brown kelp *Laminaria digitata* in sublittoral

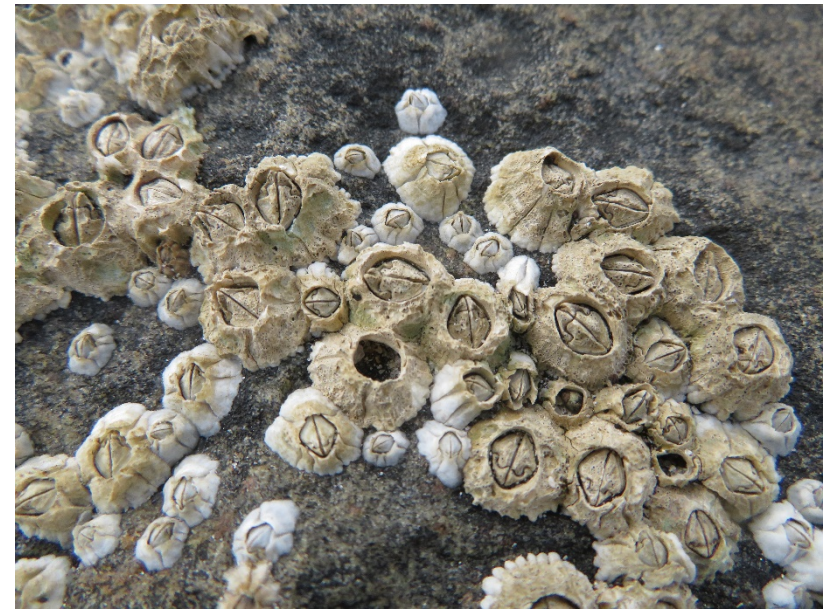
Photo 10 Two barnacle species in mid and upper shore: *Chthamalus montagui* (upper left) and *Semibalanus balanoides* (centre and lower right)

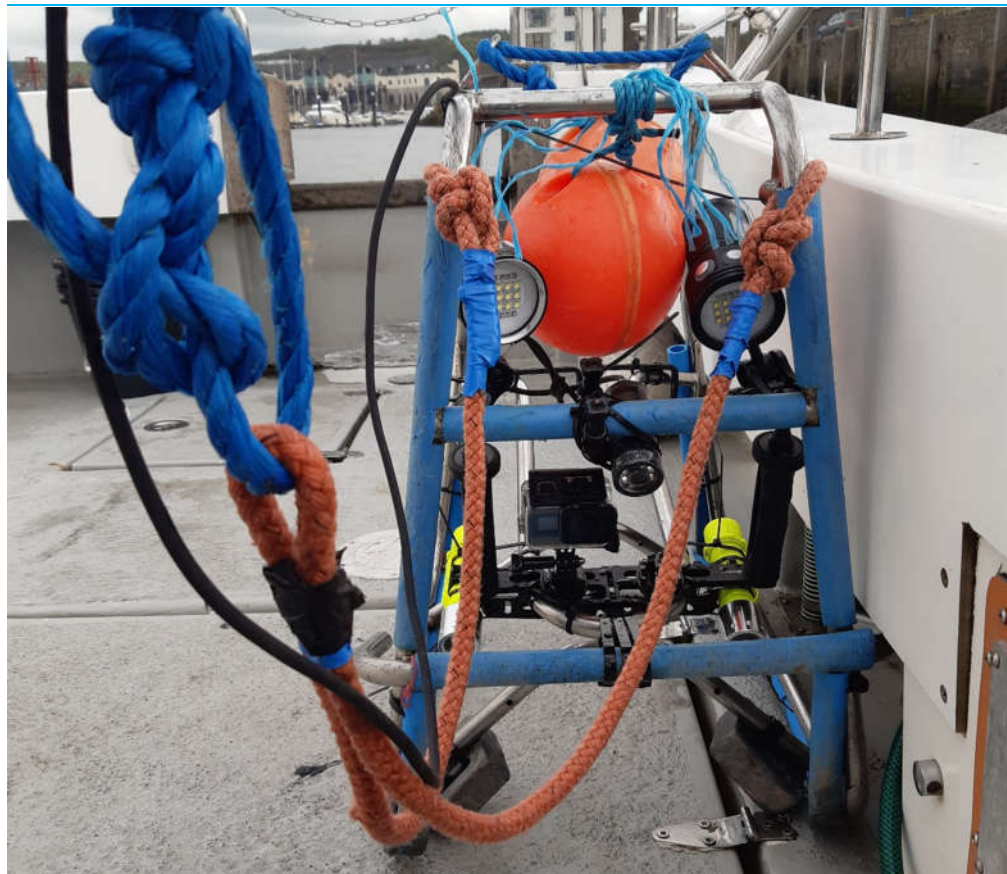
A DDV camera was deployed to collect information on the biology of the seabed and to verify the physical and biological nature of the seabed. ENVISION designs, builds and operates a range of camera systems tailored to the local environmental conditions within the proposed survey areas. The system used on this survey was built specifically for benthic survey in rugged environments and is shown in Figure 3. Its robust structure was designed to enable it to maintain position in strong current as well as to glide easily over a variety of substrates without snagging.

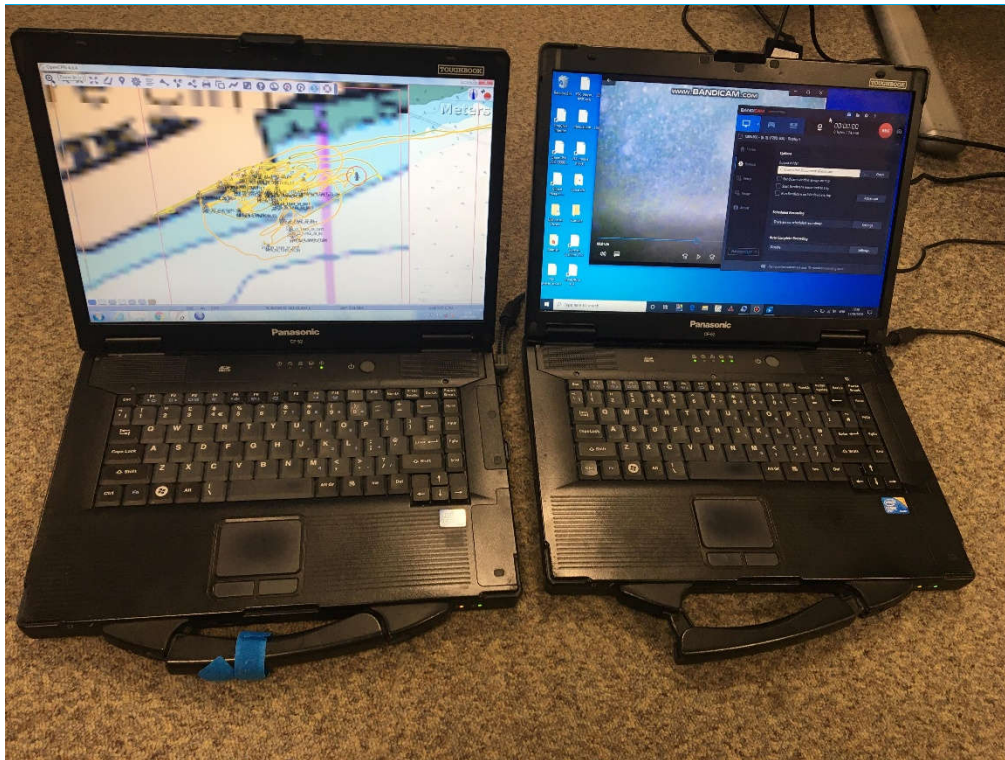
**Figure 4.**

The system comprised two video cameras: a high-resolution CCTV camera connected to the surface via an umbilical and a high definition (HD) camera. The CCTV camera was connected to a screen and a digital capture device and was used primarily for real-time viewing, allowing the operator of the camera frame to view its progress and adjust height and speed over the seabed as required. Figure 4 shows an example of the topside equipment.
