Diving Report

Alabama Wreck Depth Survey

Document Number:
LSK-11001-DR01-R02 – Alabama Wreck Depth Survey

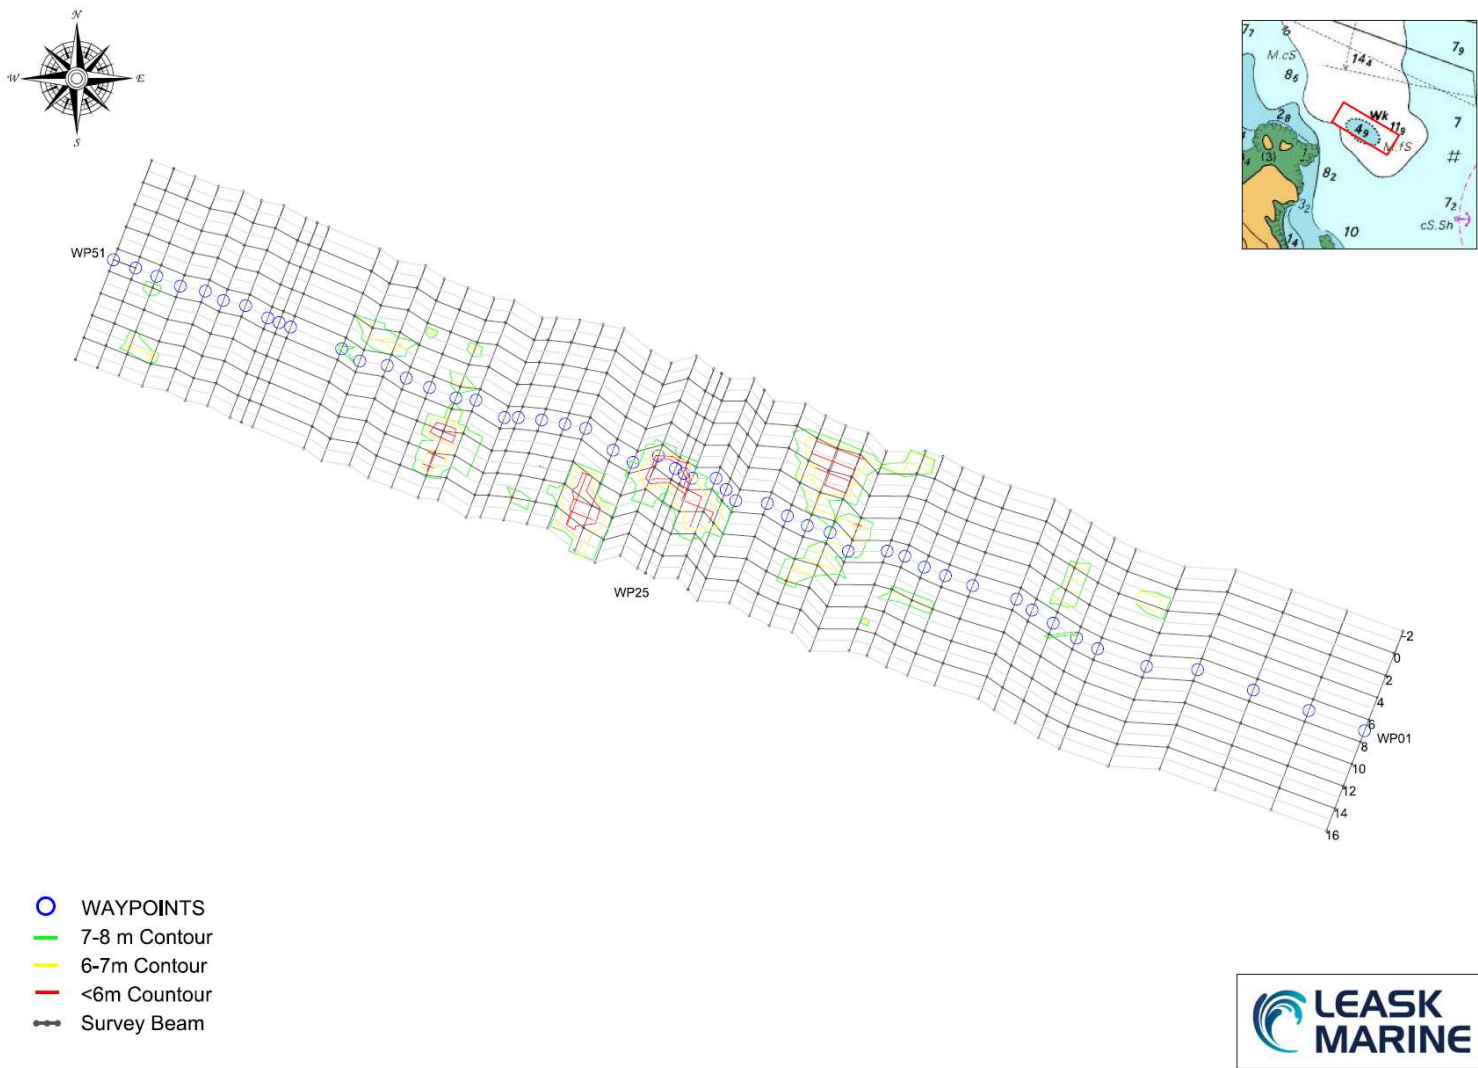
Figure 3: Survey waypoints and Contour Depths

Figure 2 shows the plotted waypoints over the contour level created after the findings of the survey.

Thanks to the figure obtained by combining the waypoints grid and the contour depths it is easier to visualise at which marker and at what waypoint the shallow areas located.

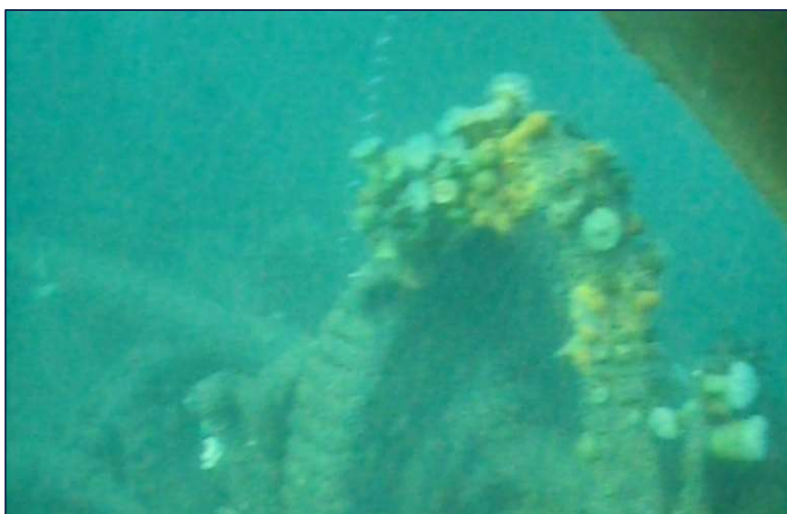
Figure I2: WP26 Remains of a winch

Other details that diving team was able to identify is that the vessel is laying on its port side and some machinery is still on-site as is the case of a vessel winch (WP26) and the propeller of the ship was found at stern of the wreck.

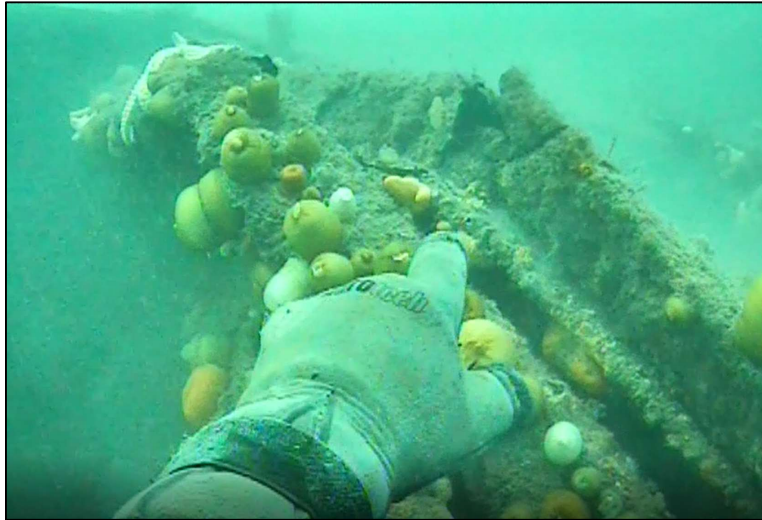
Figure 16: Fracture on I beam

Figure 16 & Figure 17 show the new highest point at WP25 previously recorded at -3.5m at marker 6 and -3.2 at marker 7, these dimensions have changed as the survey beam pushed down on both I beams by approximately 0.5m giving a new height of -4.2m at marker 6 and -4 at marker 7.

Given that the survey beam was able to push down the steel beams it can be assumed that there is a minimal structural strength on the steel, Figure 16 shows the fracture caused by the bending action.
