Marine Mammal Mitigation Report

Caithness to Moray Offshore High-Voltage Direct Current (HVDC) Cable
Installation Works 2018

Anna Sweeney

13/07/2018

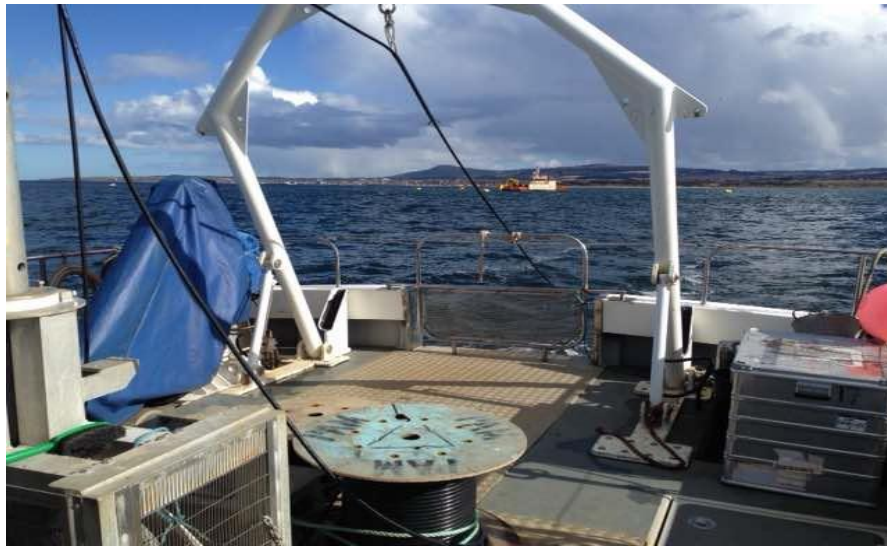
The hydrophone cable was deployed whilst the mitigation viewing vessel was stationary. The tail rope of the hydrophone cable was attached to a weight that was lowered from the vessel to allow the hydrophone cable to be deployed vertically in the water column. At the deck end of the cable, a Kellum's grip was coupled to a secure point on the vessel to take the strain in the eventuality that the hydrophone cable detached from the weight (Figure B)

Figure B: PAM set-up on the deck of MV *Coral wind* showing how the hydrophone cable was deployed

The dry-end of the hydrophone cable connected to a 20 m deck cable that ran from the hydrophone cable reel on the deck (Figure B) to the data processing equipment in the cabin (Figure C).

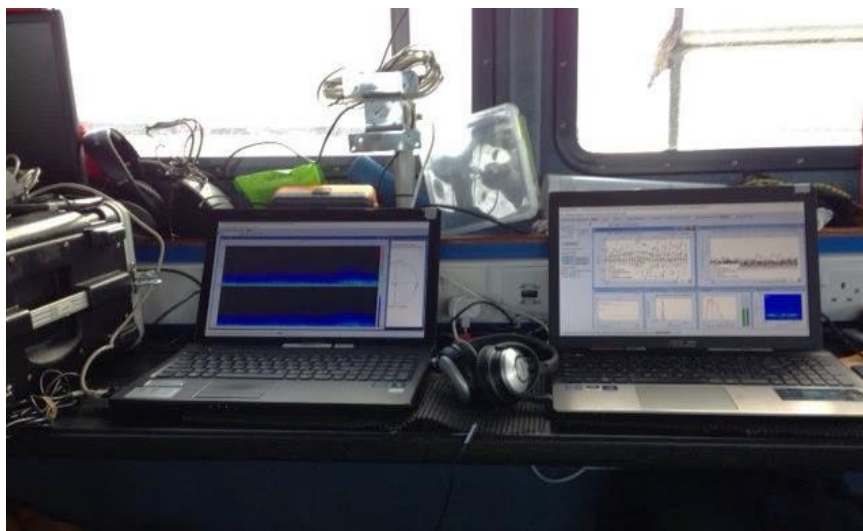
The data processing equipment comprised an amplifier/conditioner unit, a National Instruments (NI) Data Acquisition (DAQ) card and a power supply contained within an instrument case (Figure C). The deck lead connected to the rear of an amplifier/conditioner unit. Connecting headphones to the headphone output on the unit allowed direct auditory monitoring in addition to running PAMGuard (open source passive acoustic monitoring software that can provide real-time localisations of vocalisations) for acoustic visualisation and detection.

Figure C: PAM monitoring station was within the wheelhouse of the MV *Coral Wind*

The output from the NI DAQ card was fed into a laptop via USB. PAMGuard was utilised as the primary user interface software during the survey. PAMGuard can provide visual interpretation of acoustic data in addition to automated detection and localisation of marine mammal vocalisations. The software includes real time spectrogram displays in addition to whistle and click detector algorithms.

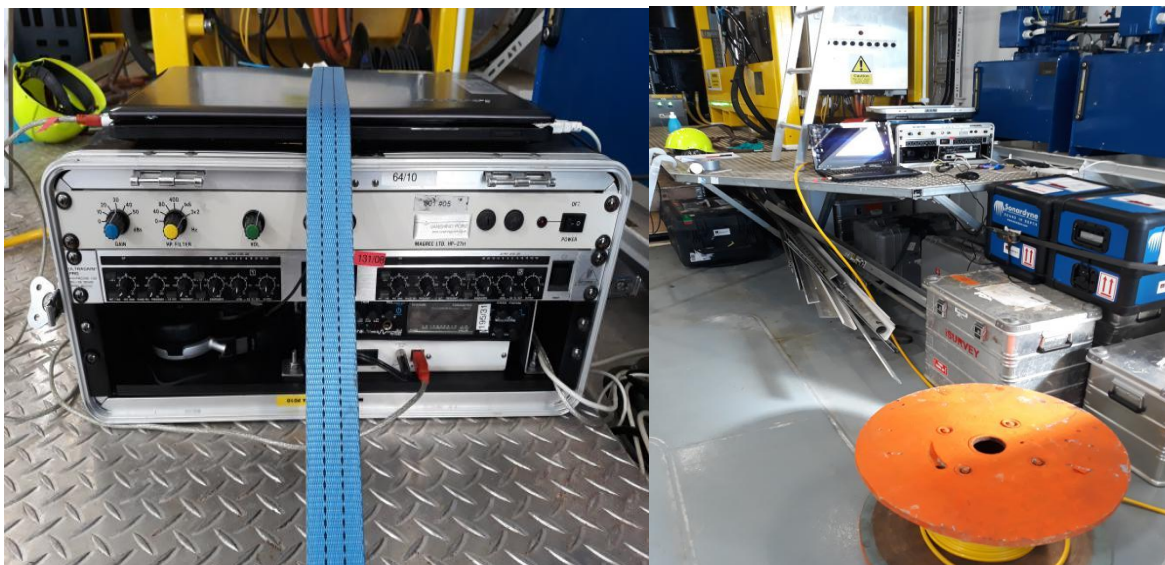
Audio data were monitored aurally, using the headphones, and visually, by watching the PAMGuard displays. Marine mammal detections could be recorded by means of the sound recorder module in PAMGuard. Recordings could then be reviewed to provide information such as numbers of whistles and clicks, duration, frequency bandwidth and, in some cases, species identification. In the event of an acoustic detection, the PAM operator also collected screenshots of the PAMGuard displays and completed a sightings/detection data form.

Figure D: Acquisition unit and laptop (left); Deck cable coiled on the spool (right).

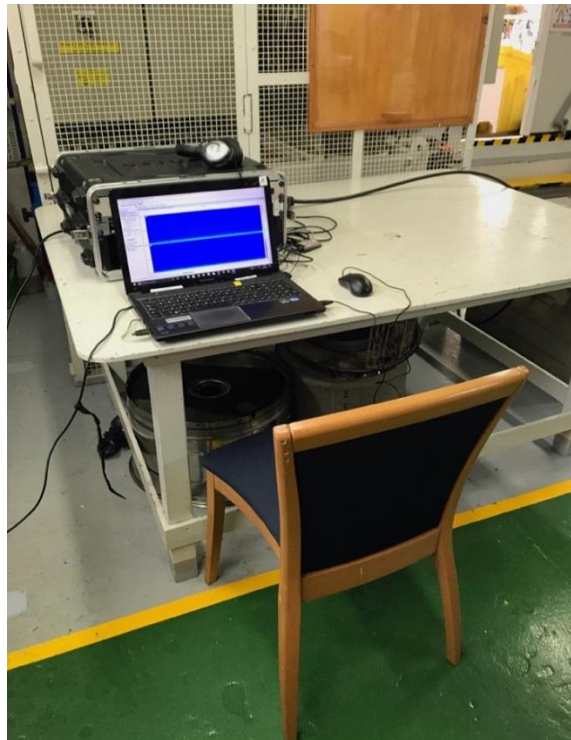
A Vanishing Point Marine hardware system was used for PAM and PAMGuard software was used. The PAM data acquisition unit, along with one laptop, has been set up on a desk in a room on the work deck level (see Figure E). The deck cable was rigged up to the higher mezzanine deck for ease of use. A vertical hydrophone array was being used for this survey. The array consists of 2 hydrophone elements and has a weight attached at the end for optimal detection results. Acoustic pre-work searches were conducted when conditions were unsuitable for visual pre-work searches, prior to activation of the sound source.

Figure E: PAM monitoring station

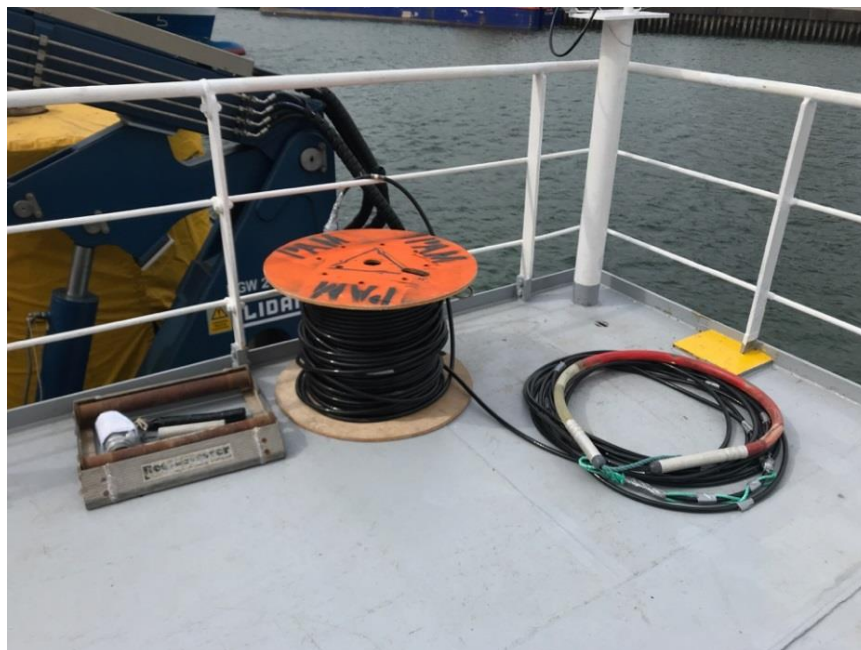
The distance from the hydrophone deployment point to the data acquisition unit was minimal. The deck cable has been rigged up to the higher mezzanine deck for ease of use (Figure F).

Figure F: Hydrophone cable deployment area showing where the cable has been coiled and secured

The hydrophone cable, fed from the deck below, is coiled and stored ready for a quick deployment. 12.5m of cable, plus the fluid-filled hydrophone section, is required for deployment from the rail to which it is attached with a Chinese finger knot.

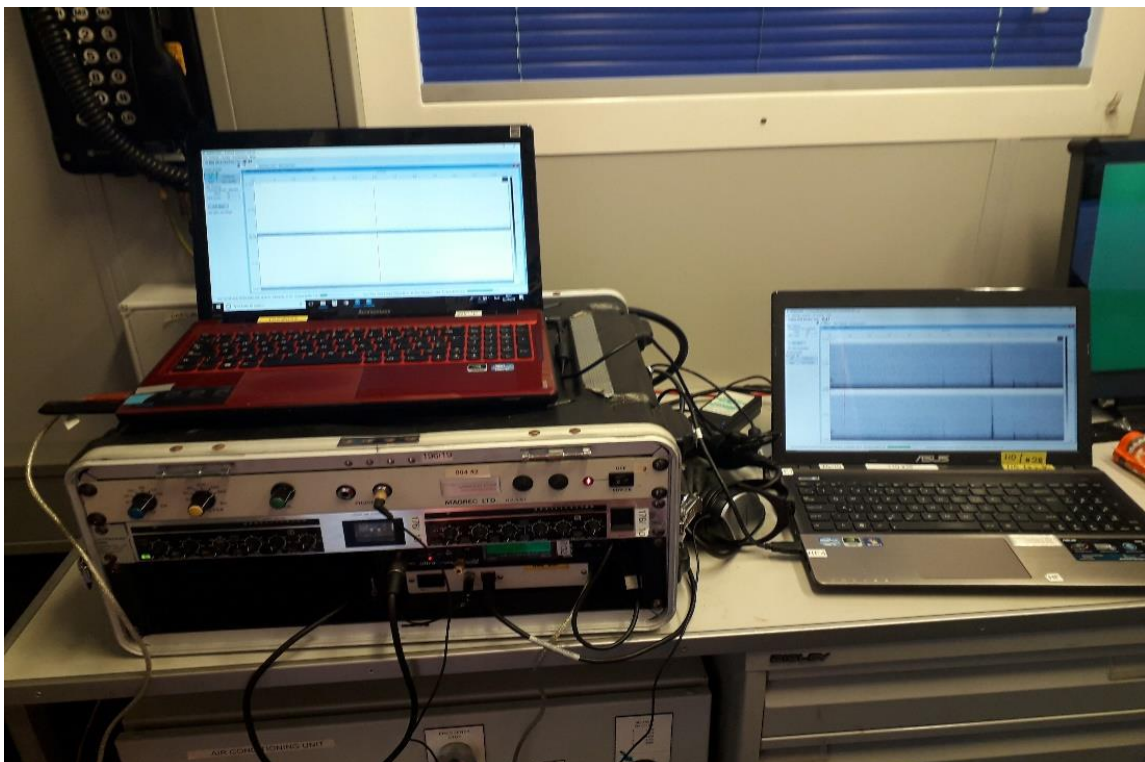
A Vanishing Point Marine hardware system was used for PAM and PAMGuard software was used. The PAM system used two laptops to maximise processing power, screen area and add redundancy. The data acquisition unit and laptops were secured to the survey desk (Figure G), the deck cable run through the bulkhead and out to the port side attached to the PAM cable to overboard. Only a short cable run was required for the deck cable, the remainder was coiled and secured on deck. The unprocessed acoustic signal is monitored by headphones.

Figure G: PAM monitoring station

During these works, PAM operations were only conducted when the vessel was stationary, thus a vertical hydrophone array was used. This array comprised 4 hydrophone elements in a protective filament and was used with a cable length of 125 m. The PAM cable was fed out from a side vent on the vessel (Figure 2.2); this angled the cable away from the side of the vessel. The hydrophone section was lowered in to the water until it was 5m below water line (this was measured and marked prior to deployment) this was then secured with a Chinese finger to deck and laid back on deck ready for deployment with the remainder of the 125m cable coiled back on the drum and securely fastened. A weight was attached to the end of hydrophone array to assist sinking.

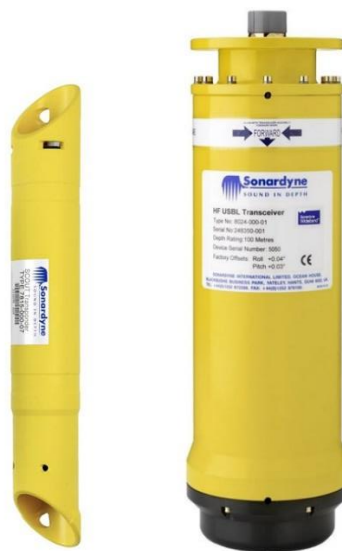
The *Voe Vanguard* used a Feritech FT550 vibrocorer to collect the samples. To accurately position the vibrocore, a Sonardyne Scout USBL (Ultra Short Baseline) acoustic system was used, which consists of two main acoustic components. A Beacon or transponder (Figure 1.1.1, left) was attached to the vibrocore frame which was interrogated acoustically by a pole mounted USBL transceiver (Figure 1.1.1, right) mounted over the side of the *Voe Vanguard* to provide a range and bearing to the vibrocore on the seabed, relative to the ships GPS.

Figure 1.1.1: USBL system components – Beacon (left) and pole mounted Transceiver head (right)
