Moncrieffe Causeway, Perth
Preliminary Ecological Assessment (PEA)
For Perth & Kinross Council

30th May 2024

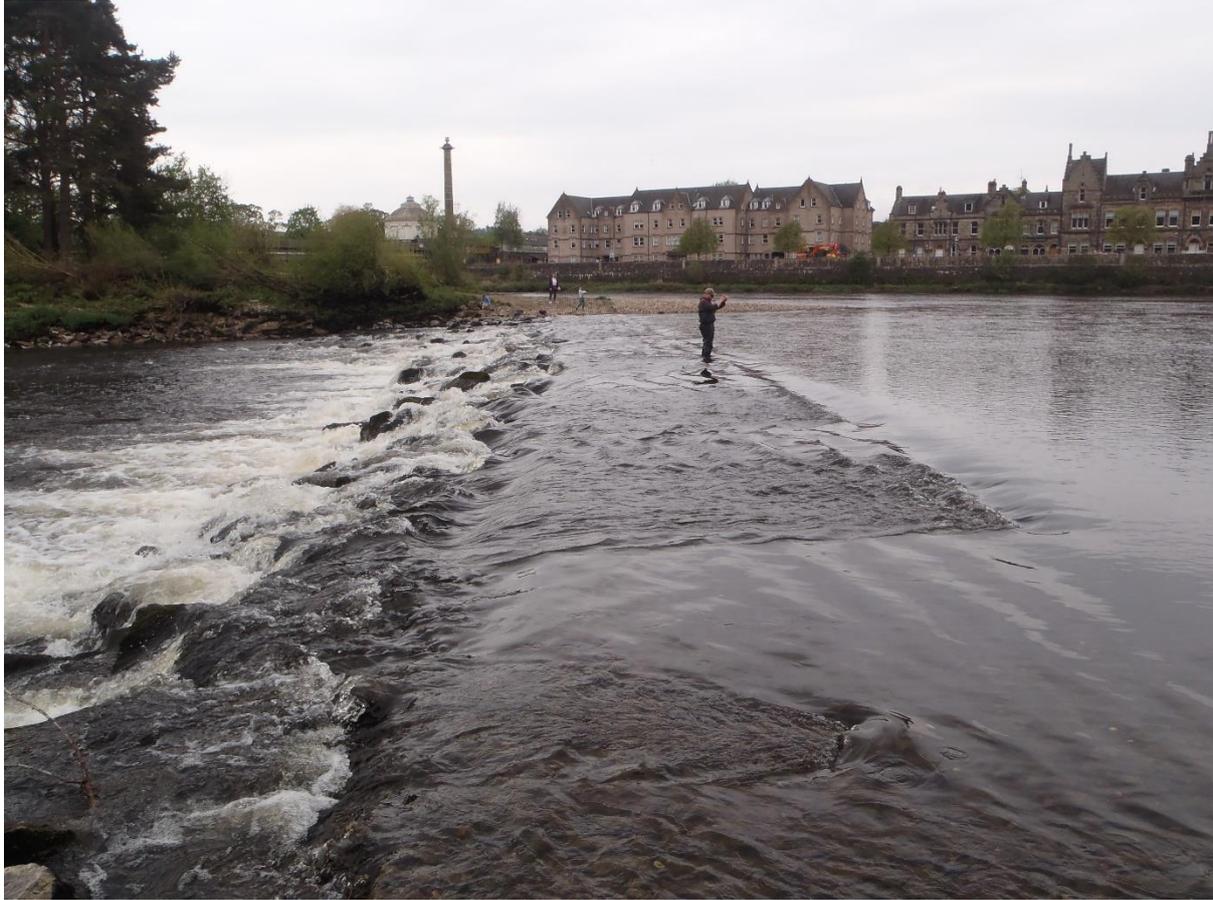
Photograph 1: showing a view of Moncrieffe Causeway

The River Tay is approximately 40m wide through the survey area, with Moncrieffe Causeway located to the north of Moncrieffe Island. The left bank borders a public park with some residential properties to the southern end of the survey area. The bank is dominated by a mix of mature broad-leaved woodland.

A railway bridge crosses the river to the south of the survey area where gabion reinforcement is present around bridge footings forming a walkway across the river. Downstream the right bank borders allotments and a golf course and is heavily used for recreational purposes. A significant old rock revetment was noted to be present on the downstream right bank which is breaking down.

The substrate within the river corridor was characterised by silt and fine sand, coarse sand, gravel, pebble, cobbles, boulders and bedrock, with an average water depth of 0.5m; although this was noted to vary between 0.1m and 1.0m across the survey area.

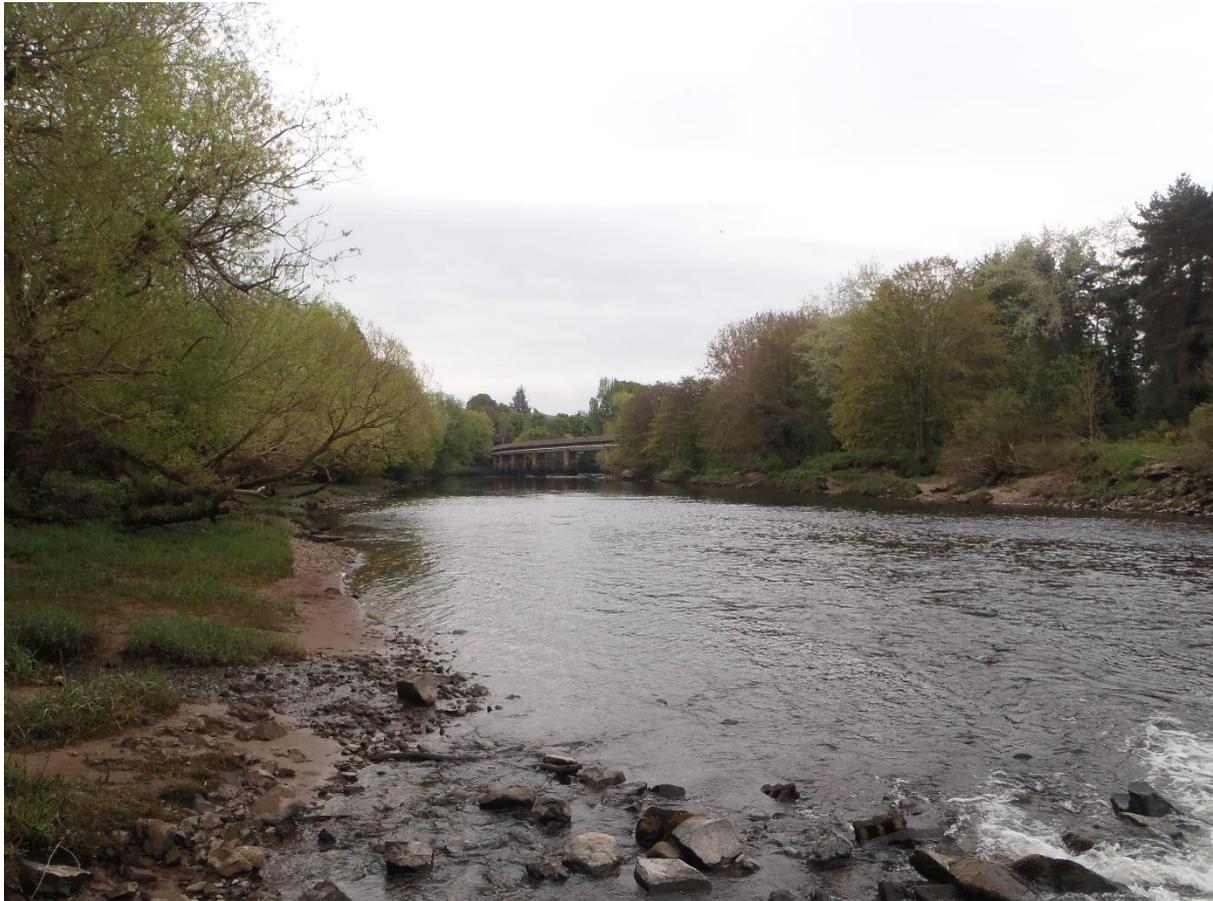
Photograph 2: showing a view of the woodland habitat

Along the bank of the River Tay there are areas of broad-leaved woodland, which is semi-natural. Species present include alder *Alnus glutinosa*, silver birch *Betula pendula*, Scots pine *Pinus sylvestris*, horse chestnut *Aesculus hippocastanum*, European larch *Larix decidua*, sycamore *Acer pseudoplatanus*, dog-rose *Rosa canina* and elder *Sambucus nigra*.

Ground flora included dog's mercury *Mercurialis perennis*, ransoms (wild garlic) *Allium ursinum*, willow herb *Epilobium sp.*, lupins *Lupinus sp.*, ribwort plantain *Plantago lanceolata*, cleavers *Galium aparine*, common nettle *Urtica dioica*, vetchling *Lathyrus sp.*, wood avens *Geum urbanum*, angelica *Angelica sp.* and hairy wood rush *Luzula pilosa*.

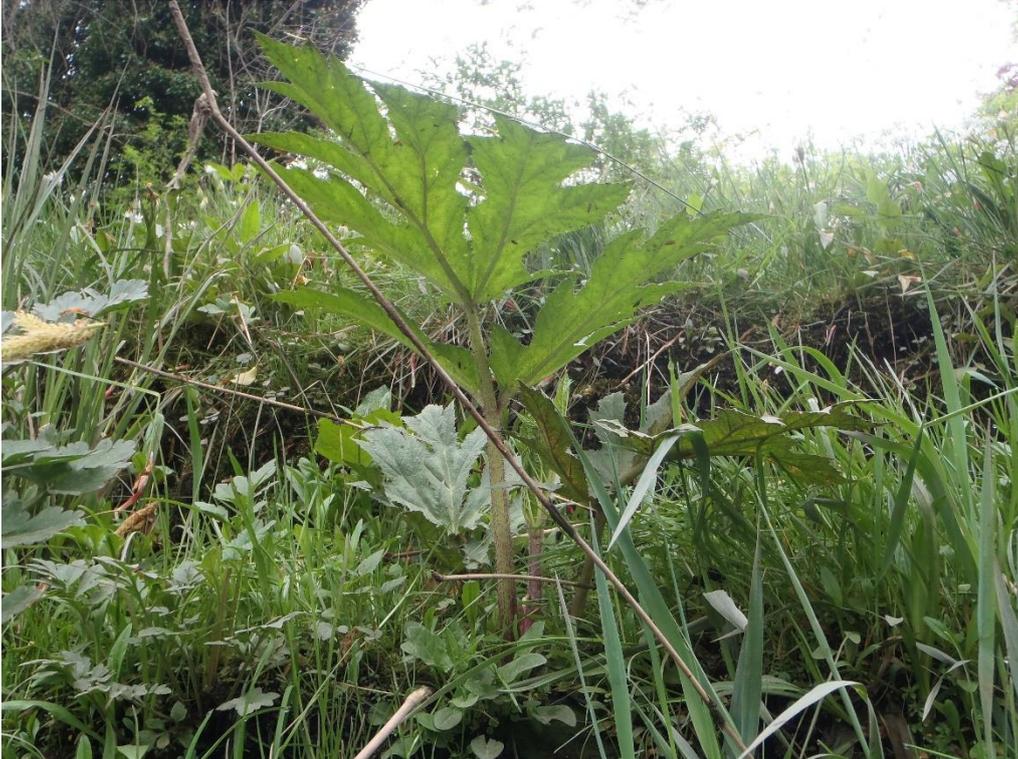
Photograph 3: showing a view of the giant hogweed

Giant hogweed was identified during the survey along the banks of the river. This is an invasive non-native species (INNS) to the UK and is a toxic plant that can cause severe skin blisters, burns and even blindness. Japanese knotweed was also identified during the survey along the river banks, particularly to the north of the causeway where it forms a dense stand on the island adjacent to the right bank of the River Tay.

Japanese knotweed and giant hogweed were found along the riverbanks forming dense stands in places. All care should be taken to ensure these are not spread by the works. In addition, giant hogweed can cause severe skin irritation if touched. All personnel should be briefed to ensure they do not become exposed to it.

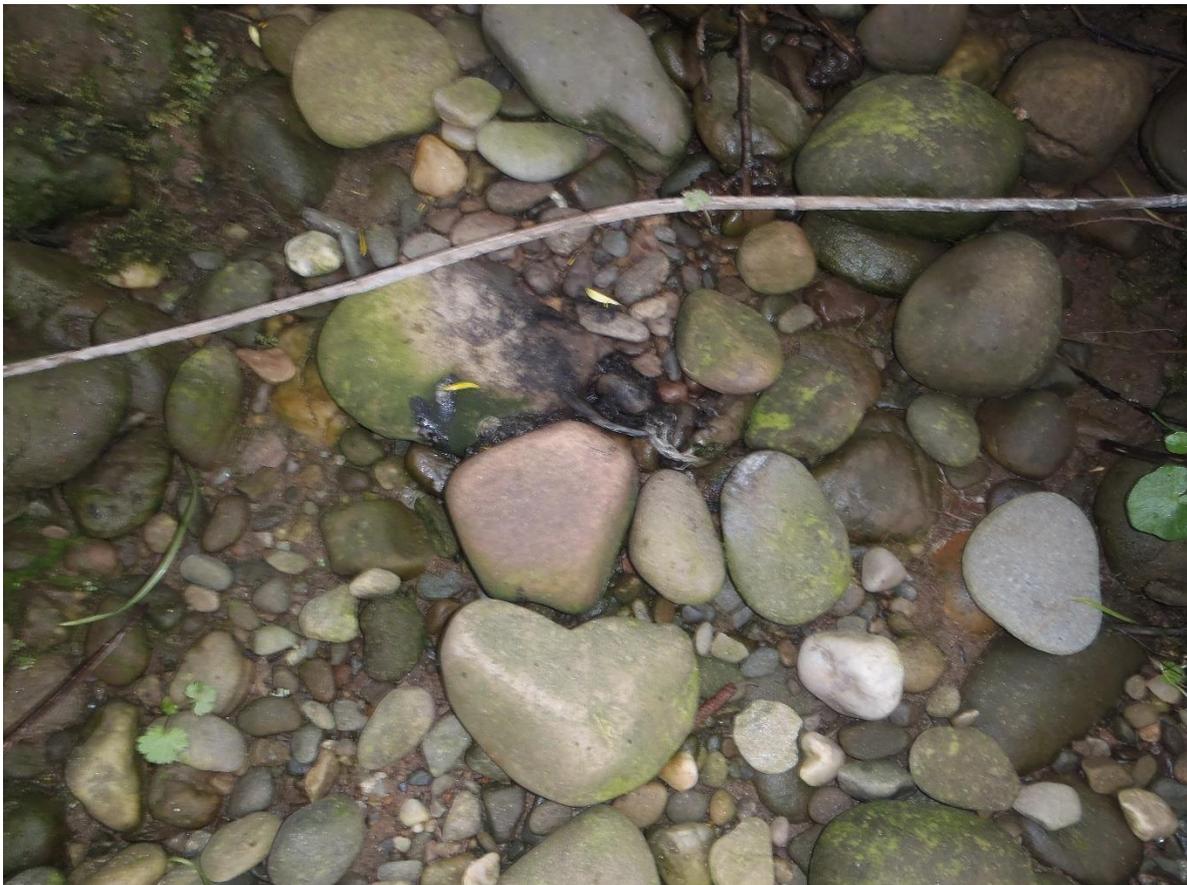
Photograph 5: showing an otter spraint on the bank of Moncrieffe Island

An otter spraint was identified on the bank of Moncrieffe Island in an area of exposed substrate where footprints were also found. A cavity was found in the bank near to the spraint; however, no evidence was found to suggest it is being used by otter.

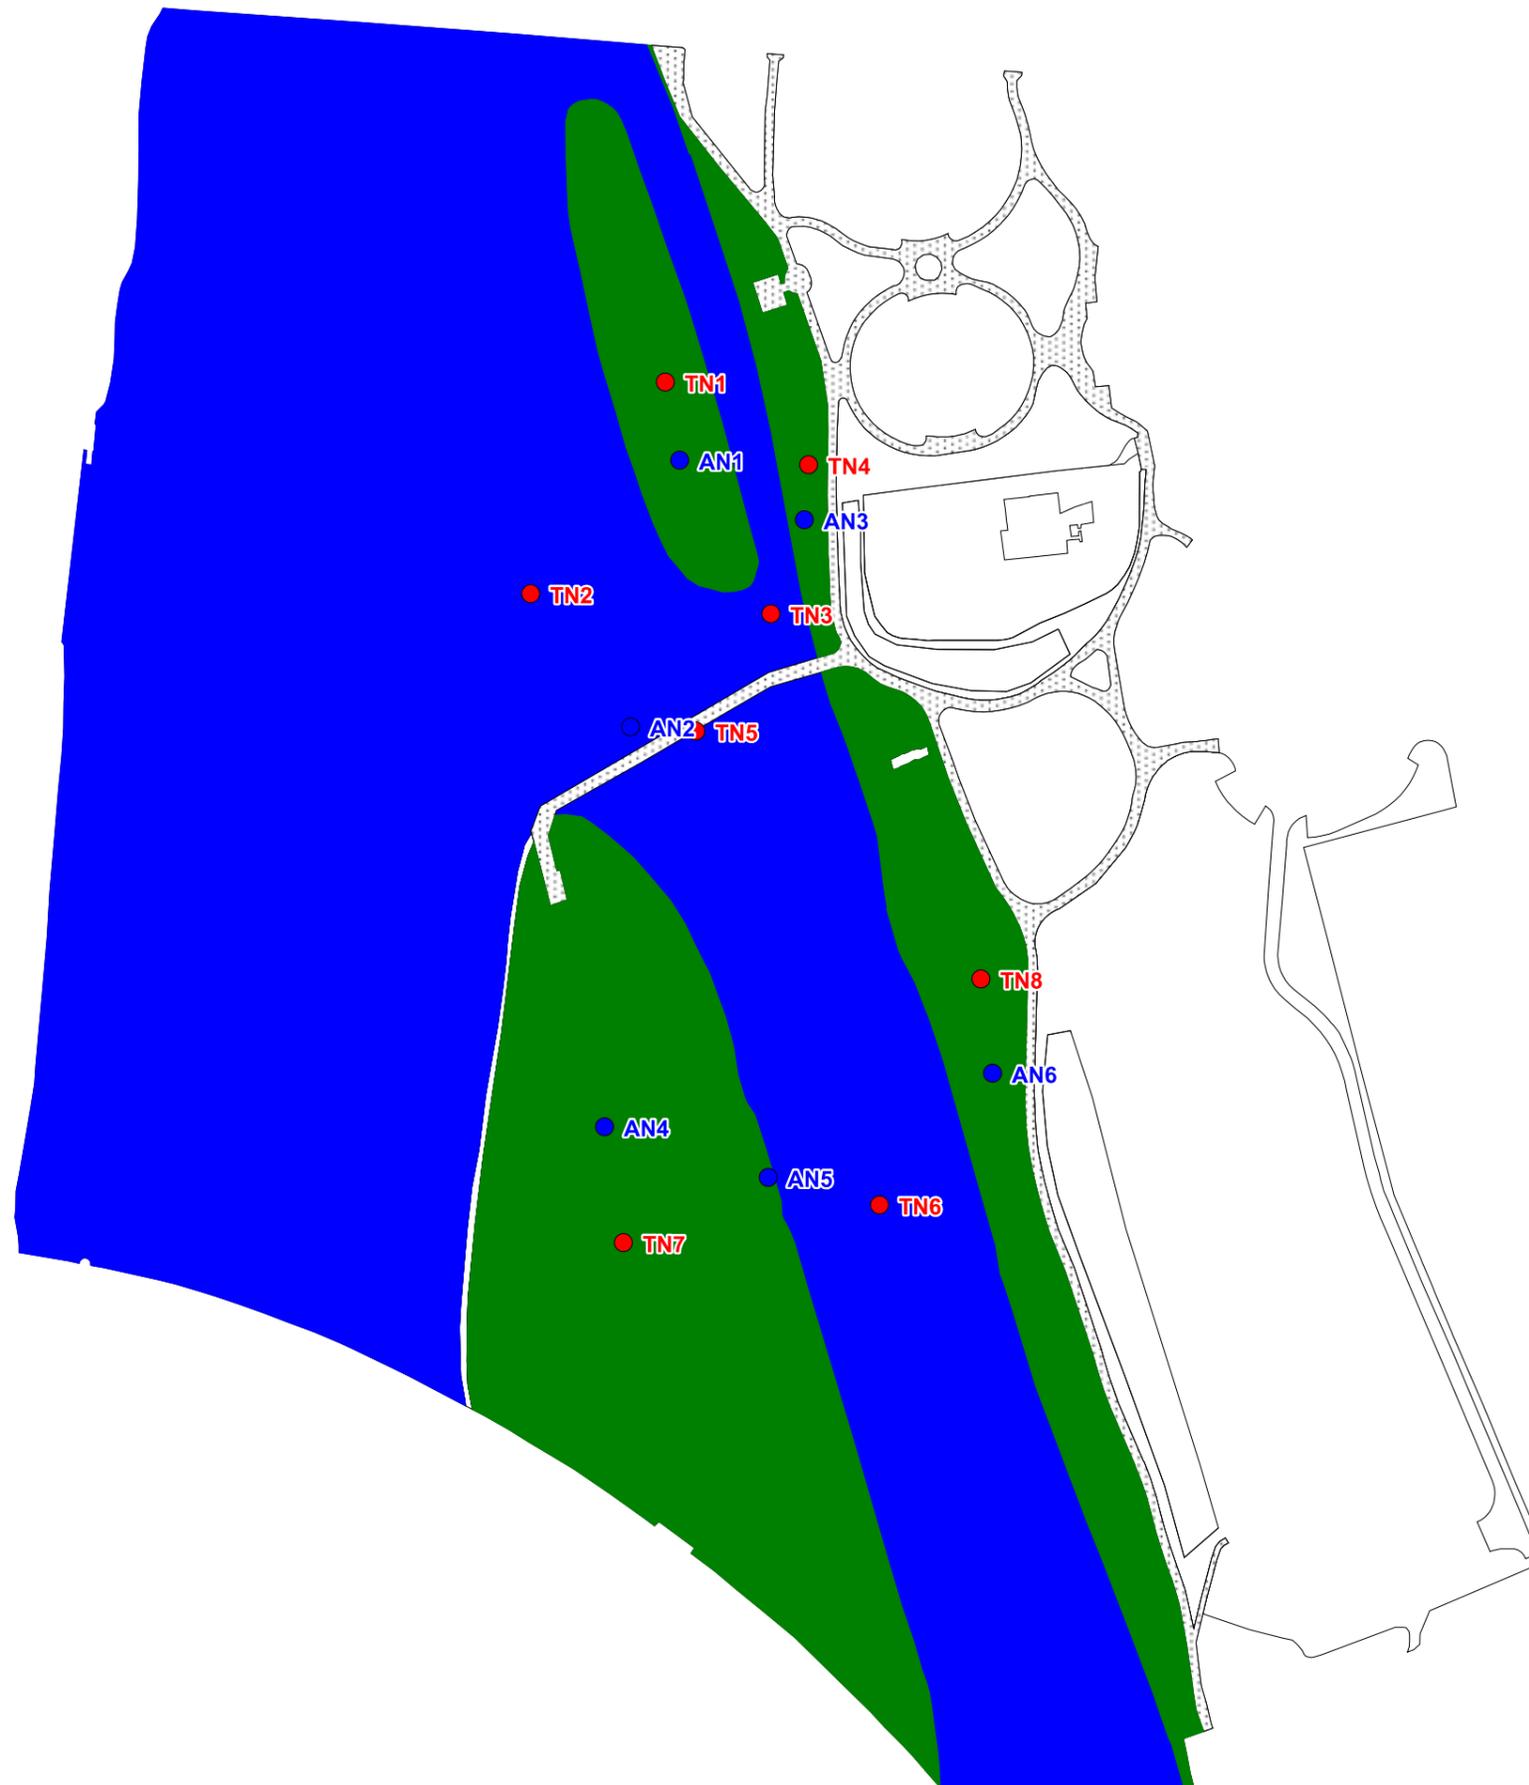
Drawing Title;
Moncrieffe Causeway, Perth
Extended Phase 1 Map

TN1 - A small island to the north of the causeway covered with broad-leaved woodland and a dense understory of Japanese knotweed.

TN2 - River Tay.

TN5 - Moncrieffe Causeway.

AN2 - European flounder identified at the causeway during the survey for FWPM.

AN5 - Otter spraint found on an exposed rock at the edge of the river.
