# Nova Innovation Ltd

## Shetland Tidal Array Cable Protection Risk Assessment

Author:	Gavin McPherson
Version:	0.1
Release Date:	20/07/2015
Total Number of Pages:	31

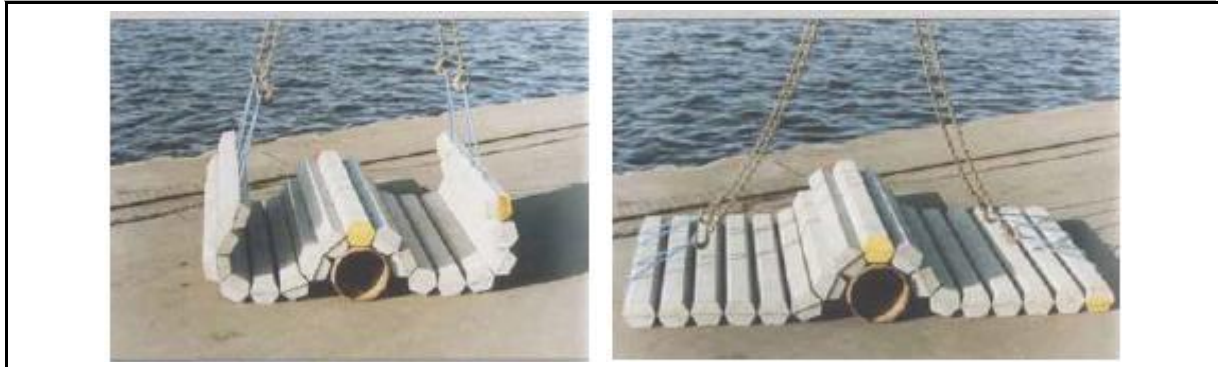
Figure 2.2 Concrete mattress being deployed over a pipe section

Concrete mattresses are commonly used to protect subsea cables and pipelines, particularly at their intersection, and as scour protection around subsea structures. They consist of a matrix of prefabricated concrete blocks connected by polypropylene rope. The installation of concrete mattresses typically requires diver intervention to assist with accurate placement (BERR 2008). It also involves significant surface operations and is not typically conducted in strong tidal streams. Concrete mattresses can each weigh up to 10 tonnes and a typical mattress would measure 5 m x 3 m x 300 mm thickness, though smaller and lighter mattresses are also available.

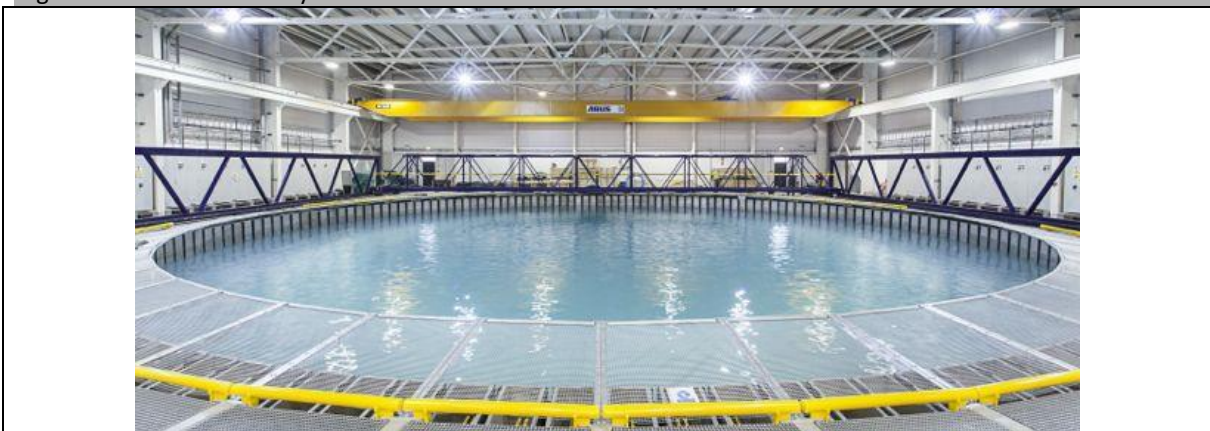
Figure 4.3: FloWave facility

In order to empirically test cable stability at conditions typically found at a tidal site Nova Innovation conducted a series of tests in the FloWave Test Tank at Edinburgh University. A variety of cables were laid on an analogue sea floor and their stability under different flow conditions was analysed.

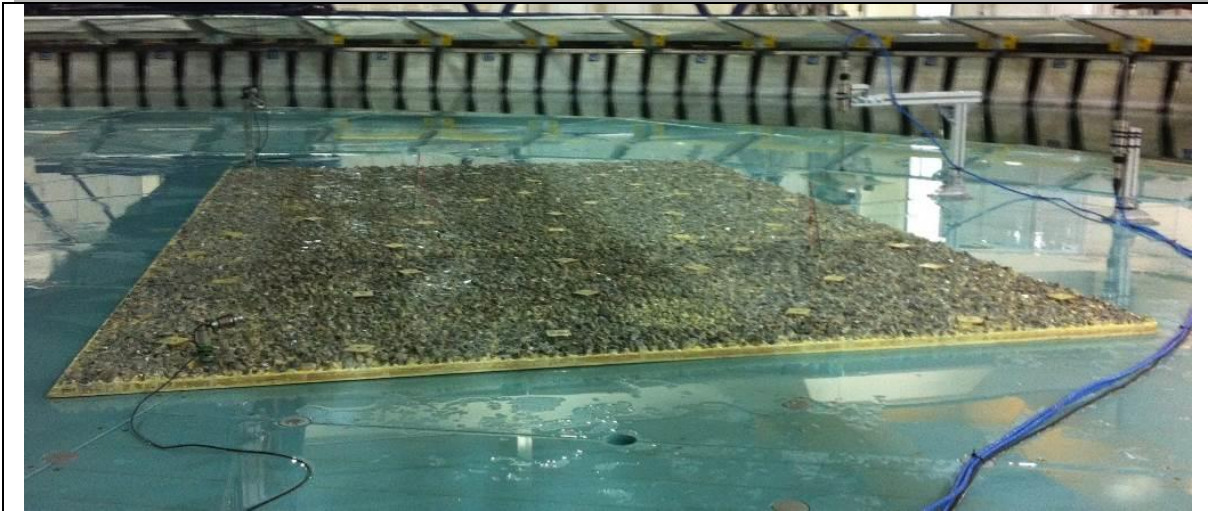
Figure 4.4: Seabed analogue secured to the FloWave submersible floor, subsea cameras and flow meters in place

. Figure 4.4 shows the three seabed sections assembled together and secured to the FloWave tank floor.

Empirical observations of the onset of cable instability were compared to predictions derived from DNV-RP-F109 and it was found that instability occurred at a flow rate approximately 20-40% higher than that predicted by naive application of the DNV formula. Measurements of the friction coefficient of cables to the analogue sea bed gave an indication as to why this might be the case: on a floor with roughness similar in scale to the diameter of the cable the cable has to slide upwards over a roughness feature (e.g. a boulder) in order to move laterally. This increases the effective friction coefficient of the surface, and can lead to the cable becoming “pinned” by a features on the seabed. Where a cable does experience local motion on a rough sea bed it is likely that it will move until it finds a stable location.

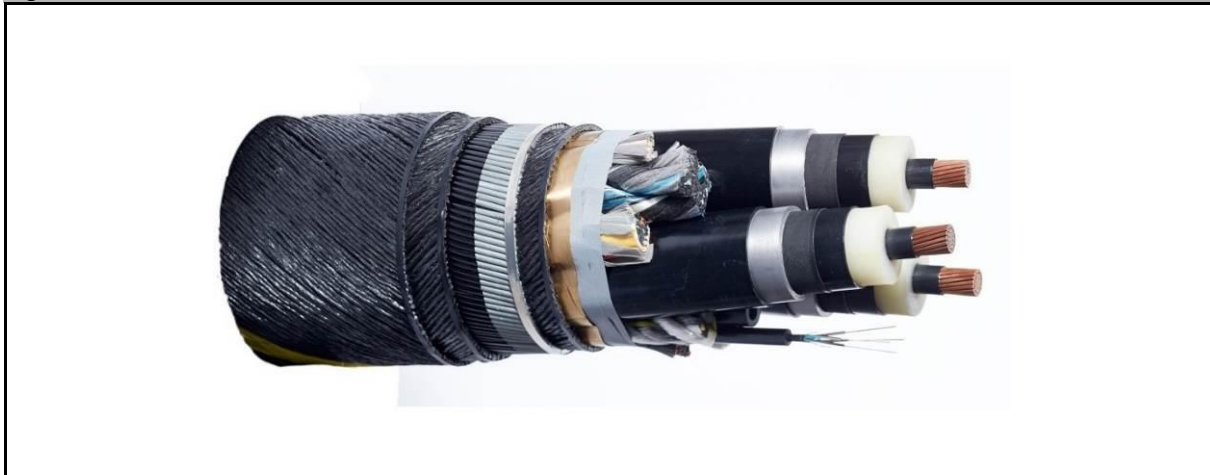
Figure 6.1: General sub-sea cable architecture

- 1) Single armour is more prone to damage over a 20 year life and provides less protection from abrasion than double armour.
- 2) Triple armour is prone to losing internal torque balance over time, is difficult to handle (stiff and heavy), and is more expensive to manufacture.
- 3) Variable armour layering (e.g. single layer in exposed area, double layer for the remainder) is often used in dynamic situations such as ROV or FPSO umbilical's, however it must be designed to length for the specific application. This means expensive bespoke manufacture rather than an off-reel 'cut and terminate' to length solution.

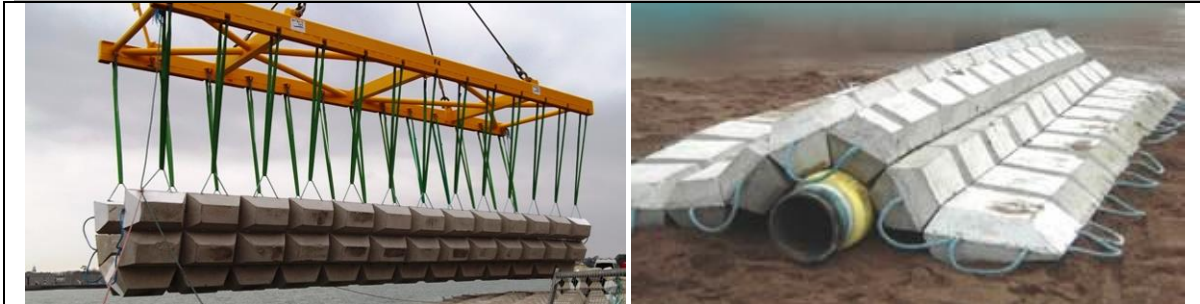
Figure 6.2: Concrete mattresses

Concrete mattresses are made up of flexible segments of concrete, typically held together by polypropylene ropes. They provide both cable protection and stabilisation and are available in a range of standard sizes or can be designed to meet specific requirements. A typical standard size is 6m x 3m x 0.15m with a submerged weight of roughly 2 tonnes. To deploy they are lowered over the cable using a lifting frame, then released automatically. Divers are typically used for accurate placement.

Two hours deployment time is typically required per mattress (largely preparation time), making the deployment cost per metre very high. Mattresses are typically used to provide protection and stability in targeted areas. Costs range from £400 per mattress upwards (excluding delivery), with additional costs for a lifting frame and divers for deployment. Deployment of such mattresses in fierce tidal streams has very seldom been practiced and would incur very significant deployment vessel and operational risks.

Due to high drag forces the mattresses cannot be laid in strong tides, with a maximum safe flow speed of approximately 0.5 m/s for safe operations, corresponding to approximately a 40 minute window in the Bluemull Sound during neap tides. Assumptions: a frame is constructed that can deploy 3 mats at a time using hydraulic shackles; sufficient accuracy can be achieved without the use of divers (but ROV required); 3 mats laid per slack tide; 12 mats per day (24 hour working); 25% contingency for weather delays (typical of summer conditions in Shetland); 20% uplift to allow for misplaced/replaced mats; capability to deploy in protected shallow waters at spring tides. Under these assumptions it would take approximately 20 days to cover a single cable. With vessel costs at tens of thousands of pounds per day (DP2 vessel; 24 hour working; including consumables; including ROV; excluding divers) and including mobilisation costs, deployment of concrete mattresses along the length of one cable would cost at least ten times as much as the cable. Note that the narrow deployment window available over slack tide significantly increases the cost of this solution at a tidal site.

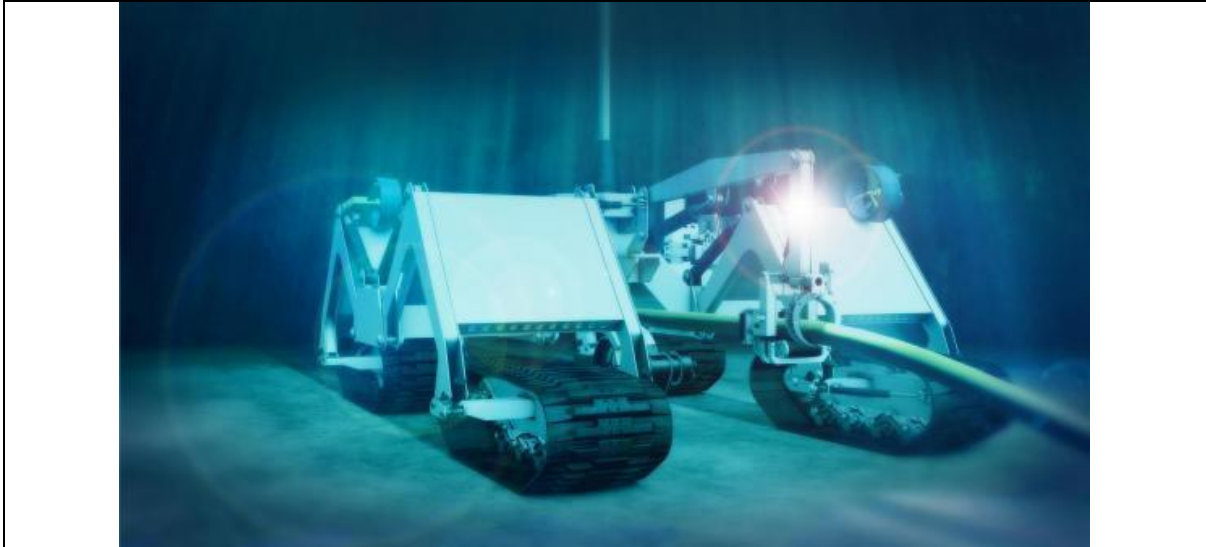
Figure 6.3: Cable trenching plough

This technique is appropriate for sites consisting of sand or clay. However, it is not suitable for tidal sites like the Bluemull Sound which largely consists of hard rock.

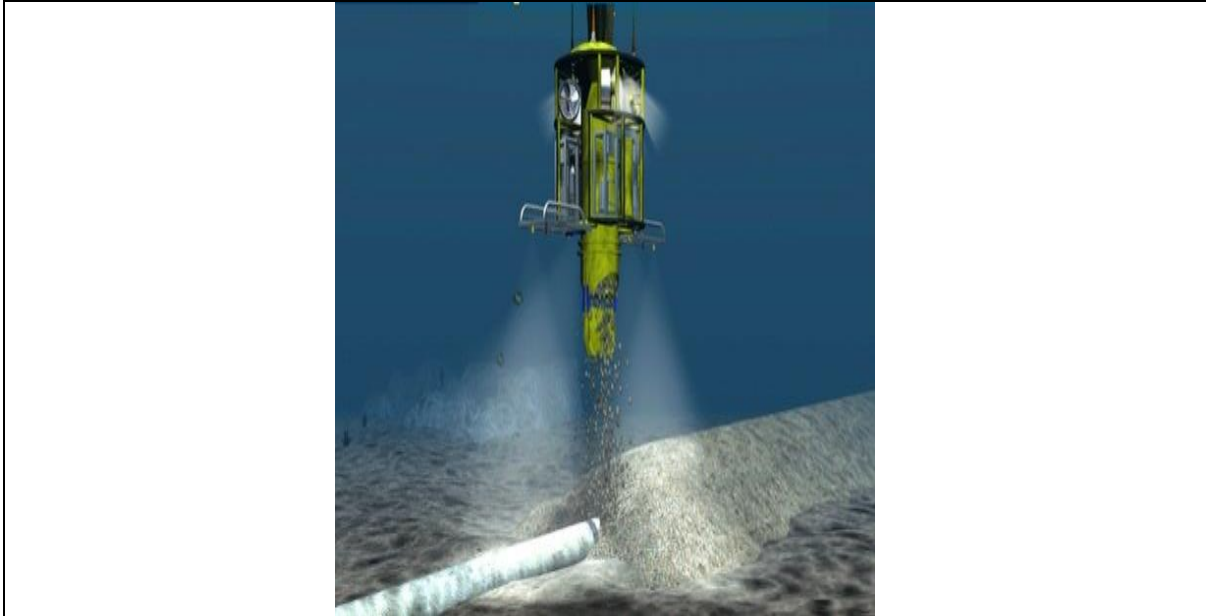
Figure 6.4: Rock dumping via a fall pipe

However, the fact that the Bluemull Sound is largely swept clean of boulders makes clear that berm stability would be an issue, risking cable integrity and ongoing significant annual maintenance costs. Rock dumping remains a snagging risk for fishermen and anchors.

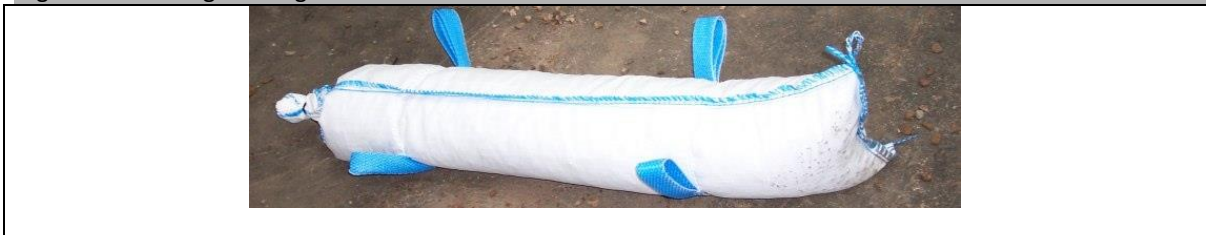
Figure 6.5: Small grout bag

Grout or rock bags are available in an assortment of standard and bespoke shapes, sizes, densities and filling material. Weights range from 25 kg to 1.5 tonnes. To deploy, they are lowered over the cable and released either remotely or by a diver/ROV. Grout bags cure after installation to increase stabilisation. Larger bags are also available as 'drop bags' with an underside release mechanism which can be operated by a diver or ROV to release the loose rocks over the cable protection area. Typical capital costs for grout and rock bags range from £200/tonne upwards (excluding delivery), with lifting gear and an ROV or diver potentially required for deployment.

This type of protection could potentially be used to protect the cable; however, as with the analysis for concrete mattresses in Section 4.7, the bag would need to be carefully designed to ensure this solution would provide any more hydrodynamic stability than a bare cable). In addition, as with concrete mattresses (a) it is not this stabilisation method would not have any positive impact on navigational safety and (b) it would be extremely expensive to use this solution to protect the entire length of cable.
