R100 Scottish Isles Fibre-optic Project

Technical Appendix A - Survey Reports (Benthic and intertidal)

A.1 INTERTIDAL SURVEY REPORT FOR CABLE CORRIDOR 2.5 EDAY TO WESTRAY: EDAY LANDING POINT

Phase 1 Intertidal Survey Report for Cusbay, Eday, Orkney (Route 2.5)

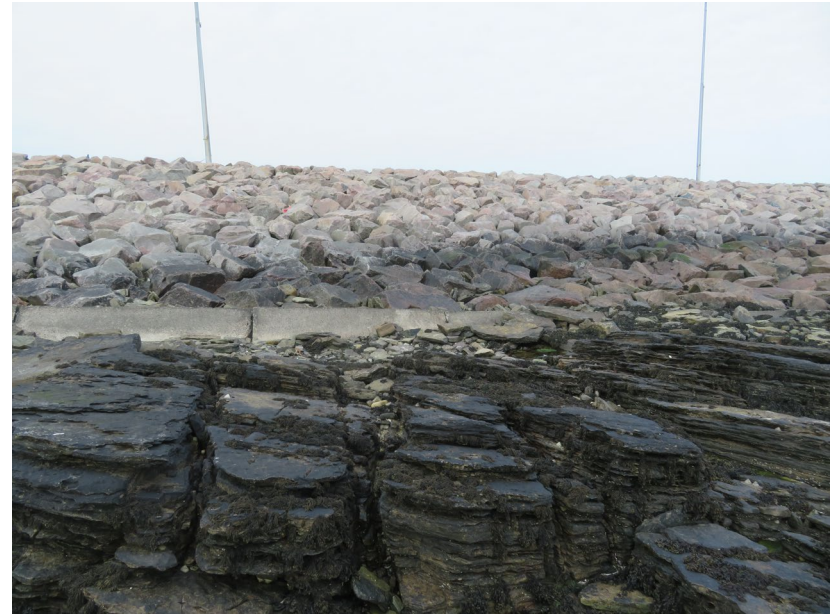
Photo 8 Artificial sea-wall around pier car park

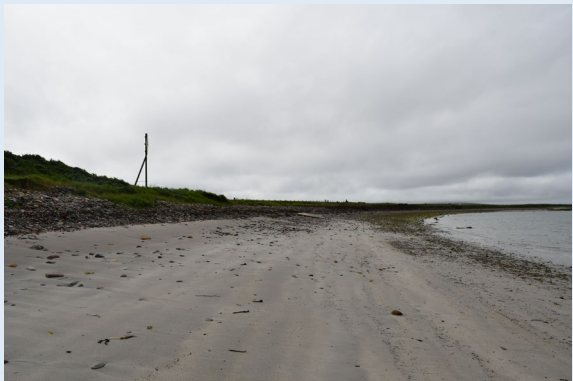
T11	Cable landing marker
