Purpose: To indicate how the defences will look when complete

The following photographs are from work completed at Benbecula Airport, delivered in four phases over the last circa 20 years

The proposals for Stornoway Airport are very similar.

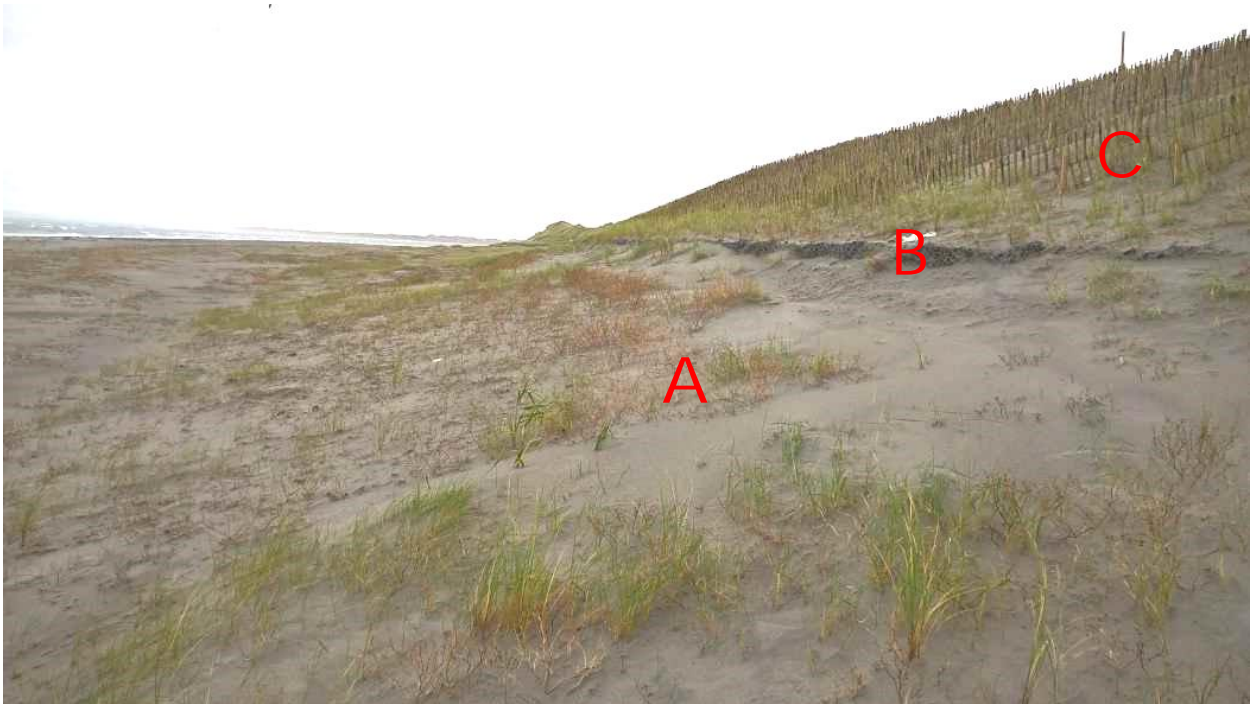
Taken 1 year after construction (Sept 2019)

A = Reno Mattress naturally covered by beach sand

B = Top Edge of mattress just visible in places

C = Dunes behind Defence reinstated with picket fencing to encourage sand deposit and Marram Grass growth

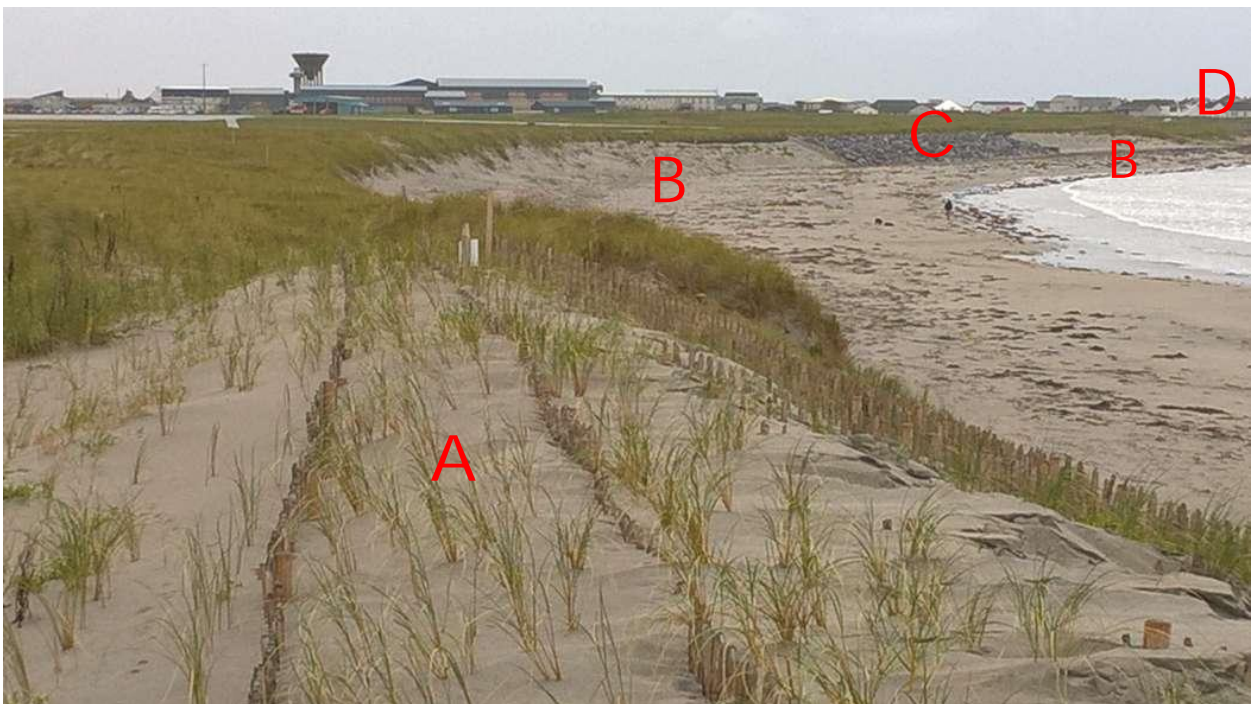
A = Top of dunes above defence – picket fence just visible

B = Distant view of the previous construction Phase 2, which was completed circa 2008

C = Distant view of a section of rock armour – necessary because local concentration of storm effects meant the mattress was unable to cope (installed circa 2012)

D = Very distant view of Phase 1 (which extends beyond end of photo)

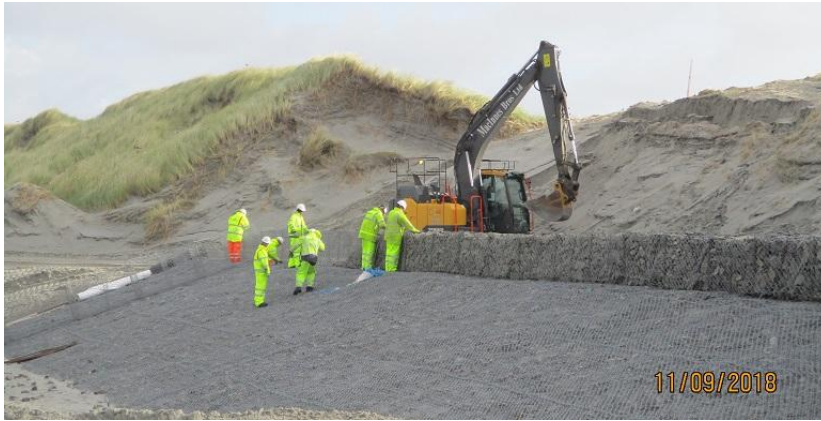
View from beach  
Sloping mattress and top edge basket just complete, before beach sand naturally washes back over

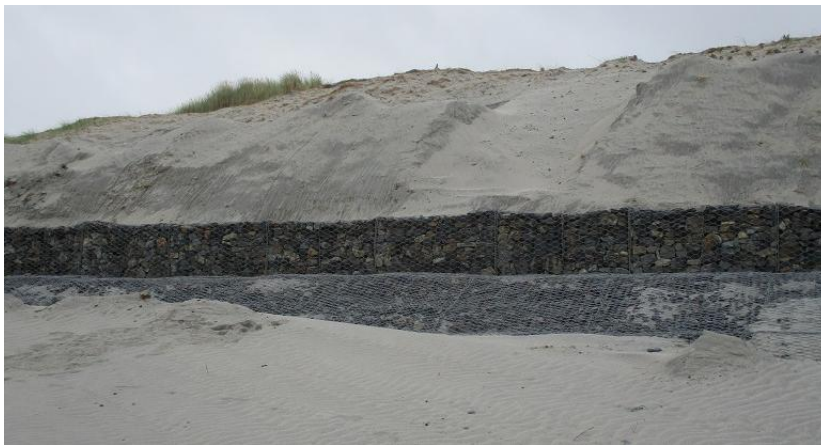
View from beach  
Beach starts to wash back over mattress  
Dune face above, just before reinstatement and placing of picket fencing

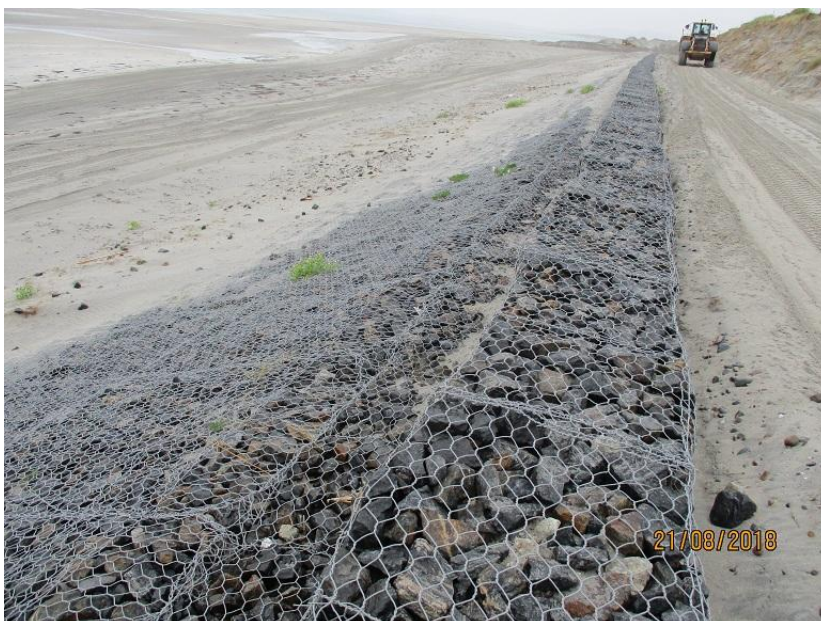
View top of defence  
Mattress and Basket complete. Shows construction strip behind the defence prior to dune face being reinstated  
Dune face reinstatement comprises returning sand to reform face to natural lines, insertion of picket fencing to stabilise and the planting of marram grass tufts saved in the original excavation
