DCP/NW/12758-NC

Extent of masonry repairs

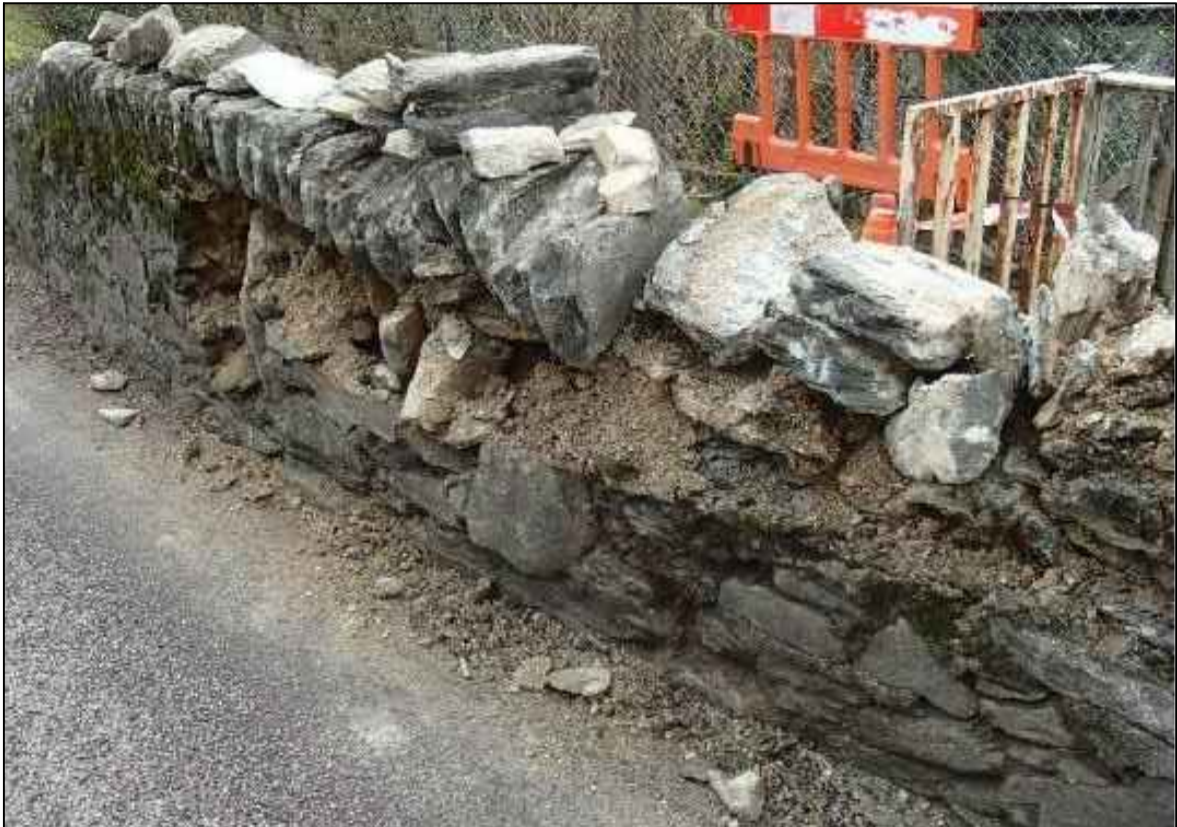
Image 1: Trunk road bridge downstream parapet

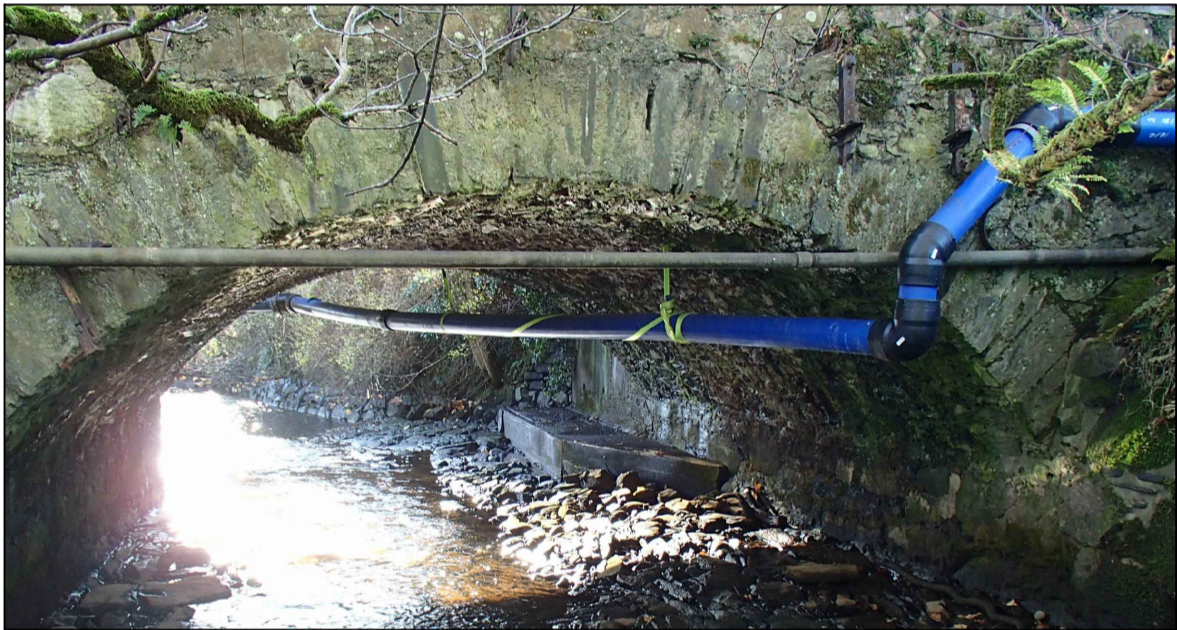
Image 2: Upstream masonry arch

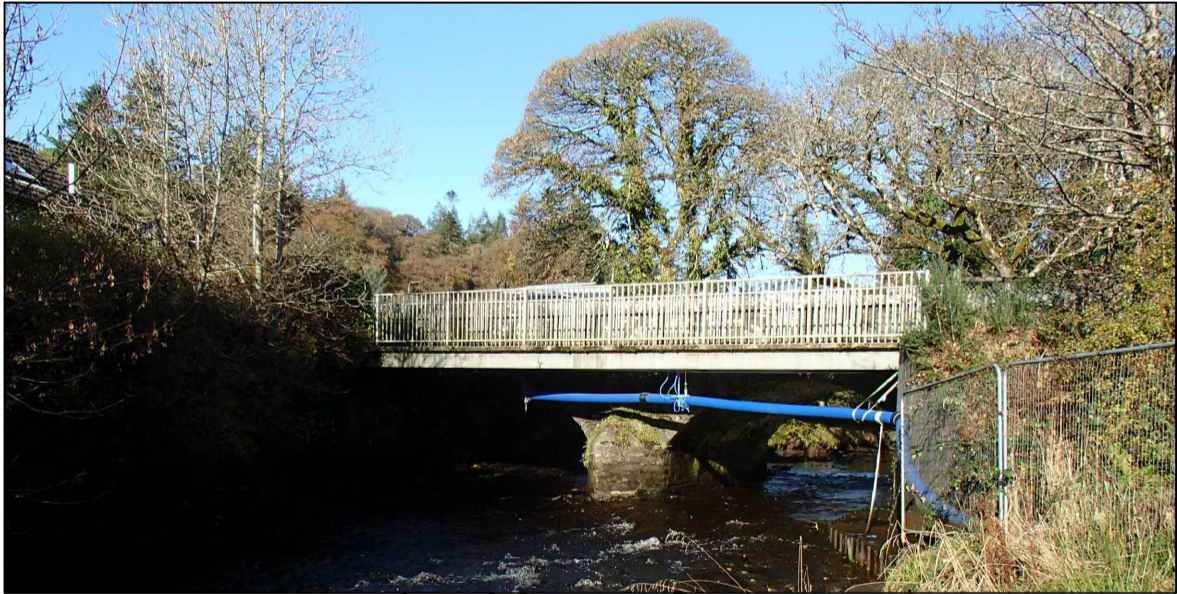
Image 3: Downstream Elevation

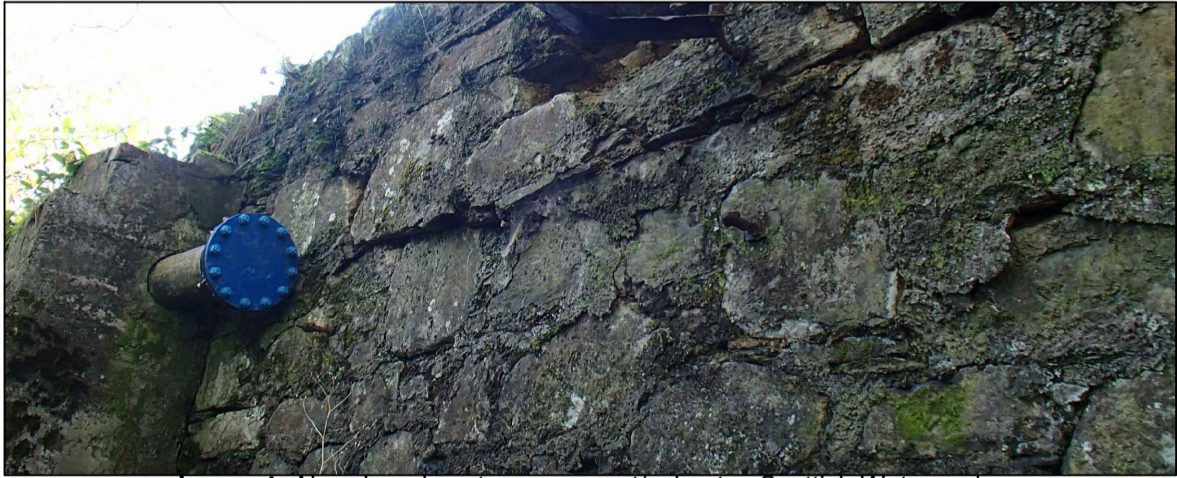
Image 4: Abandoned upstream cement/asbestos Scottish Water main.

5. Subcontractor to ensure the private scottish water utility services are not damaged or disturbed throughout the duration of the works.
