River Avon South Bank Remediation

Prepared by: IKM Consulting Ltd.

Document Ref: 20266 PEA

PRELIMINARY ECOLOGICAL APPRAISAL

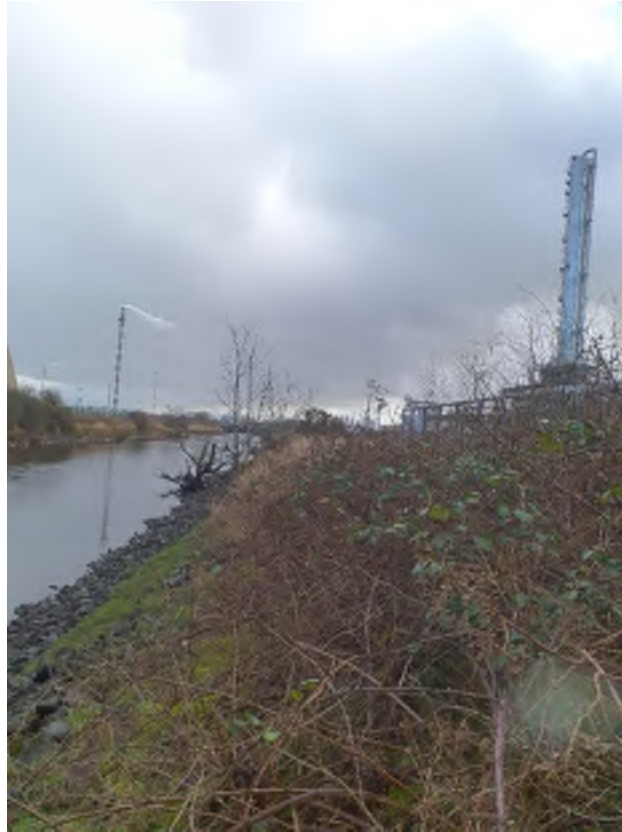
Photograph 1: Dense bramble scrub along riverbank

The riverbank fauna was composed of scattered broadleaved trees including hawthorn (*Crataegus monogyna*), dense scrub, mainly bramble (*Rubus fruticosus*) and gorse (*Ulex europaeus*) with a strip of inundation vegetation dominated by common reed (*Phragmites* sp.), as shown in **Photographs 1 and 2** below. Beyond this is an area of disturbed ground utilised as a rough access track with areas of bare ground and low growing ephemeral species bordered by dense bramble scrub, as shown in **Photograph 3** below.

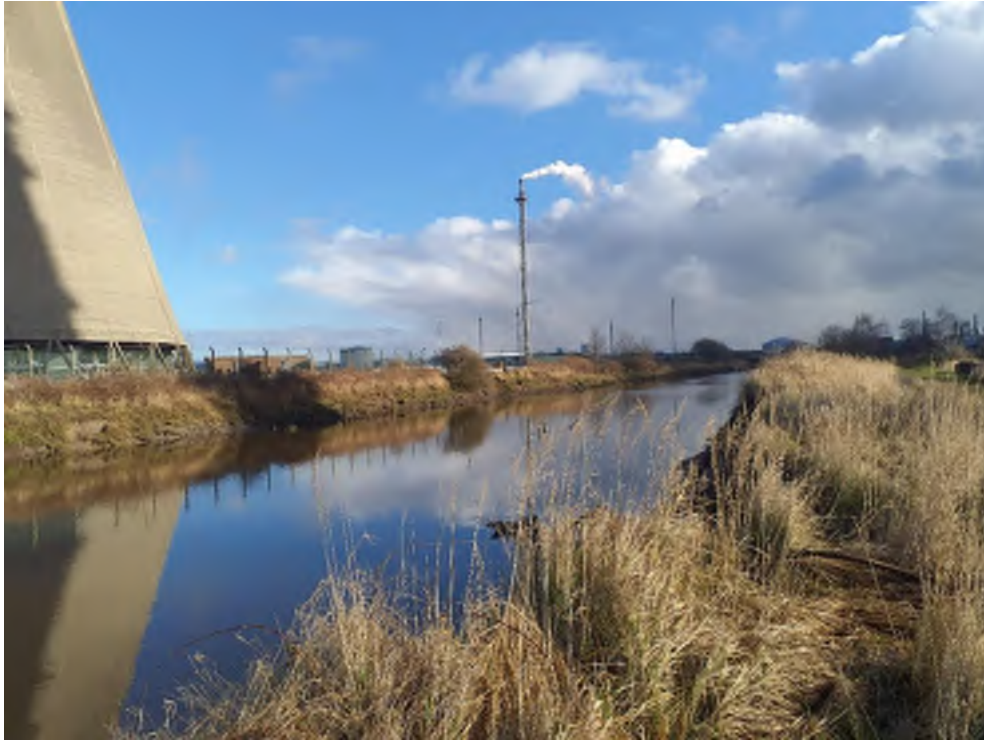
Photograph 2: View of River Avon looking downstream, with bankside vegetation

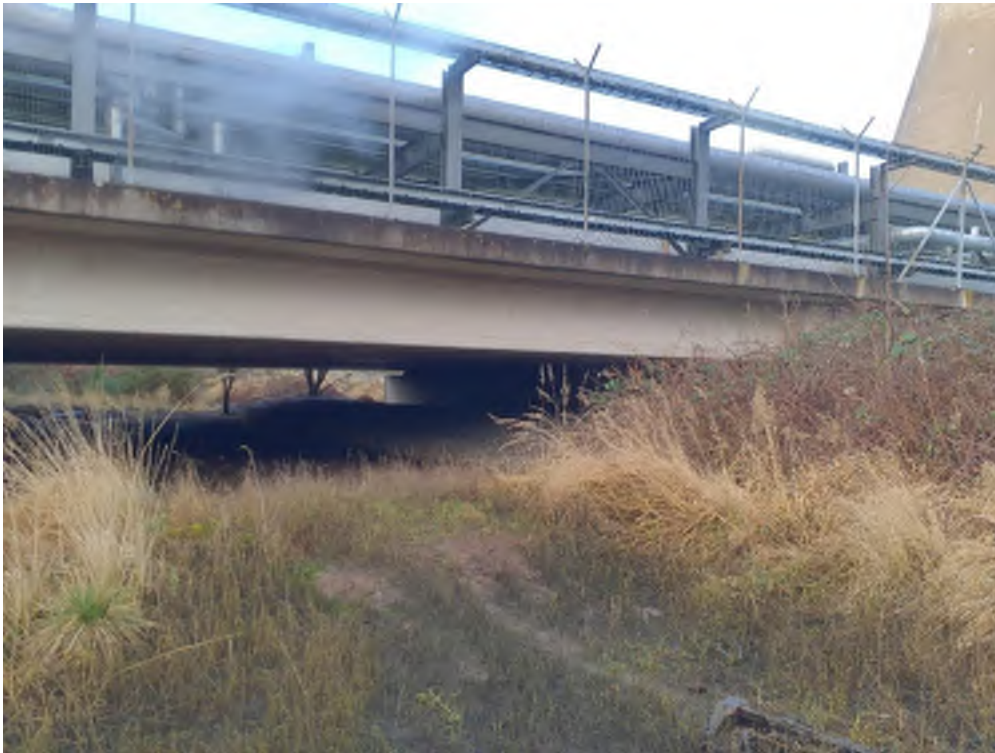
Photograph 4: View of Road 33 Bridge

Road 33 Overbridge was located to the west of the Study Area. This structure comprised a large concrete precast structure which carried a road over the River Avon, as shown in **Photograph 4** below and as Target Note B01 on Figure 2 below. In general, the southern abutment of the bridge, which could be inspected during this survey, appeared to be in a well-sealed condition, where the potential for roosting bats was limited to expansion gaps underneath the deck of the structure. The structure is however, surrounded by heavily modified, constantly lit and disturbed industrial areas, which will likely limit its suitability to support roosting bats. This structure was assessed as supporting **Negligible** bat roost potential for both active season roosting and hibernation.

The Road Bridge 33 structure located within the Study Area was assessed as supporting **Negligible** BRP, as such in accordance with best practice, no further survey effort is required for the proposed riverbank remediation works.

If in the case that the SI/GI works have not commenced within 12 months of this survey (i.e. by February 2025) then a further survey will be required to ensure baseline conditions have not changed.

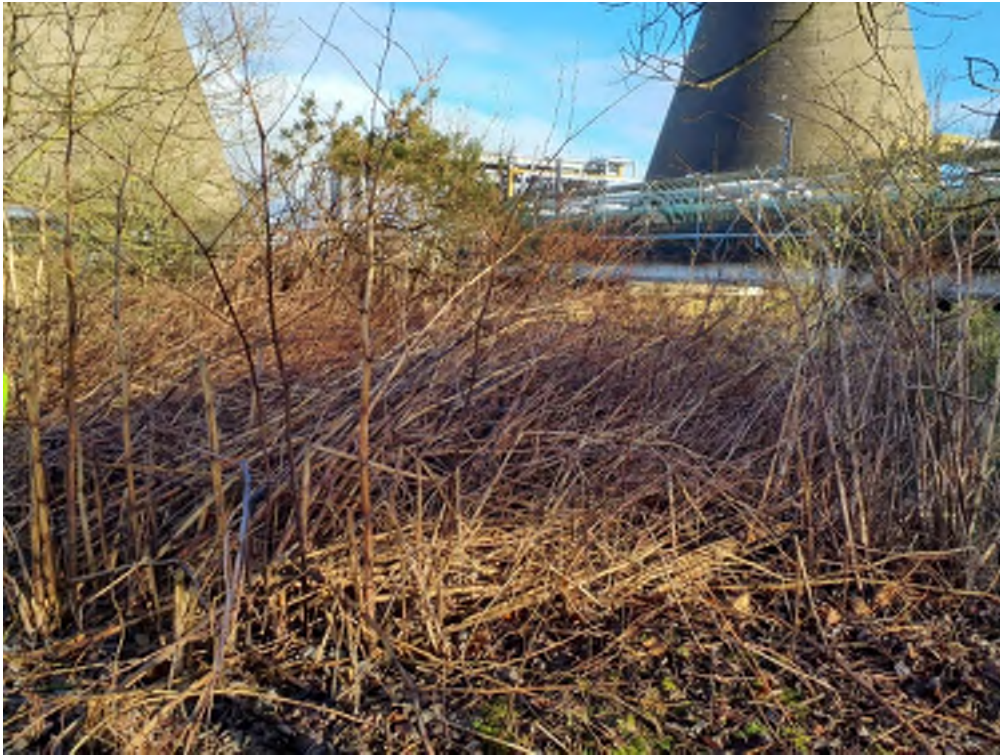
Photograph 5: Stand of Japanese knotweed within Study Area

A large stand of Japanese knotweed was recorded to the west of the Road 33 Bridge, out with the repair area. This stand was approximately 5x5m in size, and located at **Target Note 04, on Figure 2**, and shown in **Photograph 5**, but the full extent of the stand could not be determined at the time of the survey.

It is recommended that an invasive species survey is undertaken during the growing season (between May and August) to determine the full extent of all invasive species within the Study Area.

Where INNS are present within the proposed works areas, a 7m exclusion zone from all stands should be marked out and no works, storage or passing through should take place within these zones.

Where works within these exclusion zones are required, it is recommended that an invasive species specialist contractor is contacted to develop an invasive non-native species management plan for the proposed remediation works. This may include the removal or treatment of the species.
