UB 240-131 VIADUCT

PRELIMINARY ECOLOGICAL APPRAISAL

FEBRUARY 2023

PROJECT TITLE:	Story Y5 development	PARENT:	19702
	UB 240/131 - Viaduct- Condition led Repairs and Painting	PROJECT NO:	19752

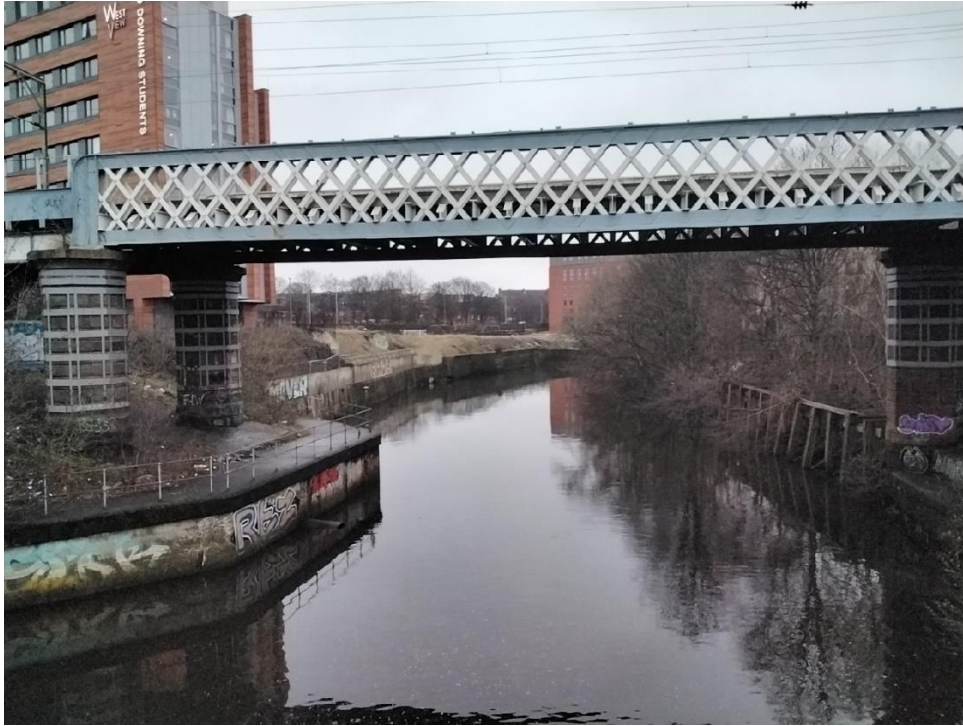
UB 240/131 was a sandstone single span viaduct with a metal deck, which carries the NEM3 railway line over the River Kelvin, as shown in **Photographs 1 and 2**. The structure adjoins UB240/130A Yorkhill Viaduct to the east and UB240/130 Ferry Road beyond this.

Photograph 1: Southern face of UB240/131

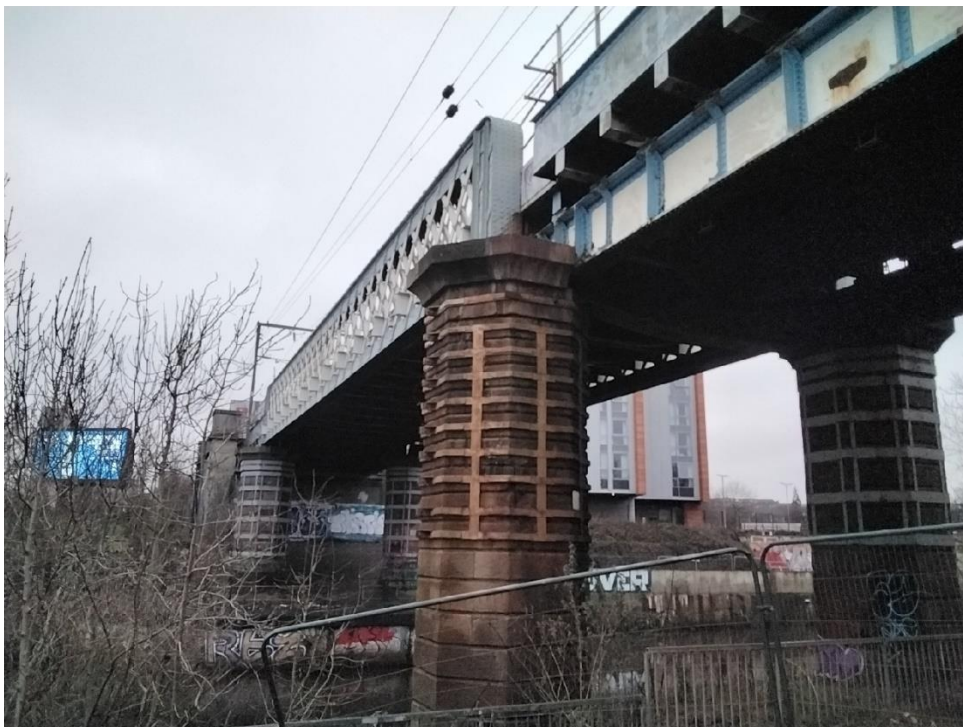
Photograph 2: View of UB240/131

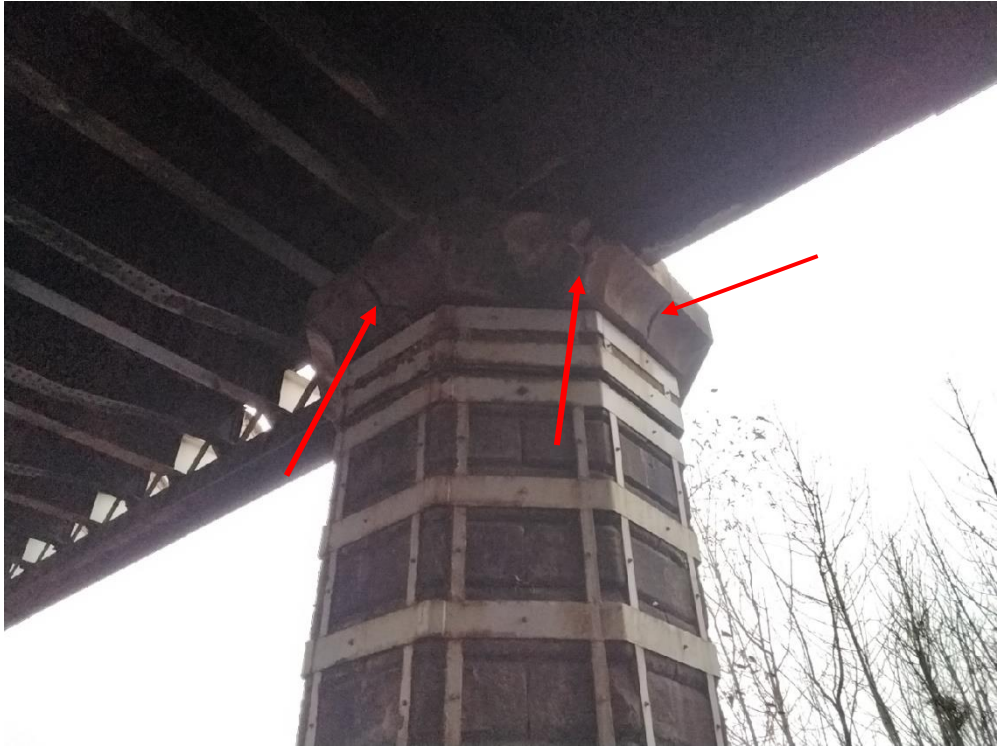
UB240/131 is shown as **Target Note B01 on Figure 1**. This structure had four sandstone column piers supporting a metal deck. No obvious suitable features were noted on the deck of the structure, but small gaps were noted in between the sandstone brickwork at the top of both western-most piers, which may be suitable for single or small numbers of roosting bats. Examples of these potential roost features are shown in **Photographs 3 and 4** below.

This structure was assessed as supporting **Low** potential for active season roosting and **Negligible** potential for winter hibernation.

Photograph 3: Example of potential roost features on piers (red arrows)

The UB240/131 structure (**Target Note B03, Figure 1**) was assessed as supporting **Low** bat roost potential and as such, further survey is required at this structure to determine presence or likely absence of evidence of roosting bats. A single activity survey should be undertaken in accordance with current best practice guidelines (Collins, 2016) for structures assessed as supporting **Low** bat roost potential. A minimum of one activity survey is required to be completed between May and August, inclusive, during suitable weather conditions.

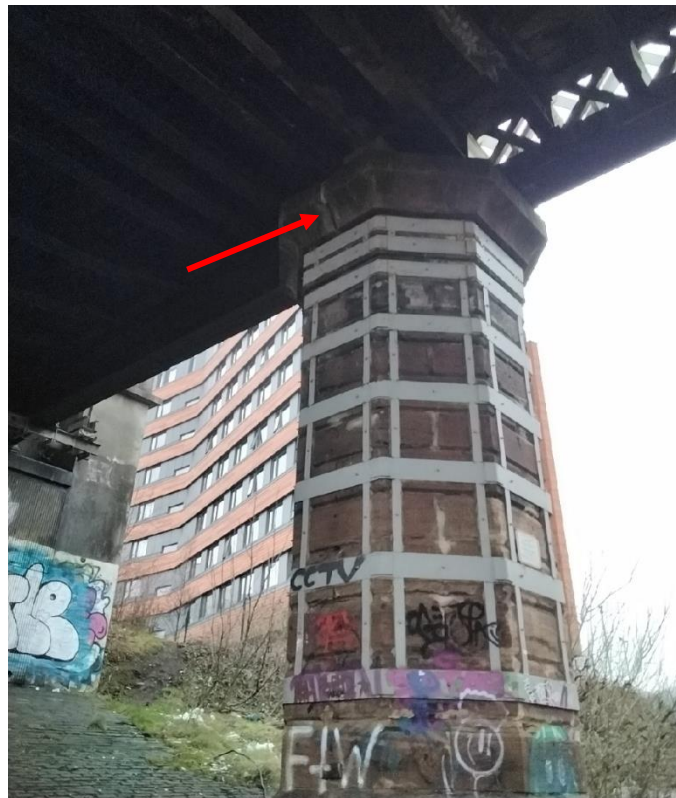
Photograph 4: Example of potential roost feature on pier (red arrow)

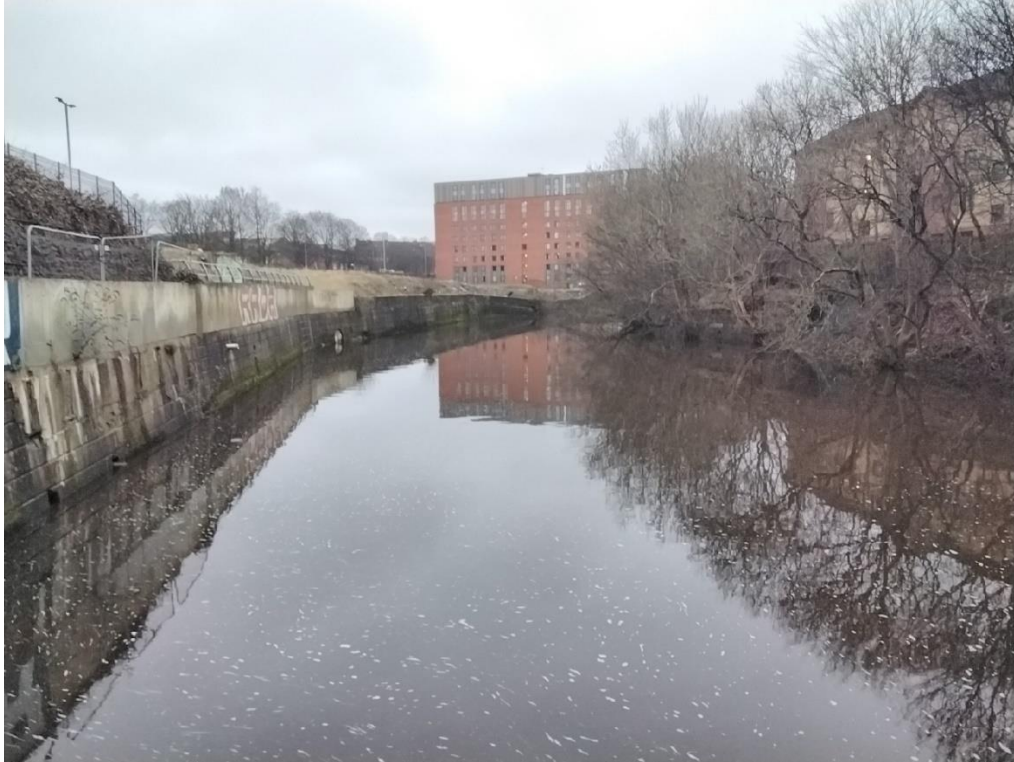
Photograph 5: View of the River Kelvin looking upstream

No evidence of otter was identified within the Survey Area. The banks of the River Kelvin, although vegetated in places were also highly engineered and modified with metal and concrete retaining walls/flood protection walls, an example of which is shown in **Photograph 5**. These areas were considered to support no suitability for otter resting sites, and therefore, lowered the Survey Areas potential to support otter. The Kelvin may, however, offer some suitable otter foraging or commuting habitat within the wider landscape, and occasional use of the Survey Area by otter cannot be ruled out from this survey alone.

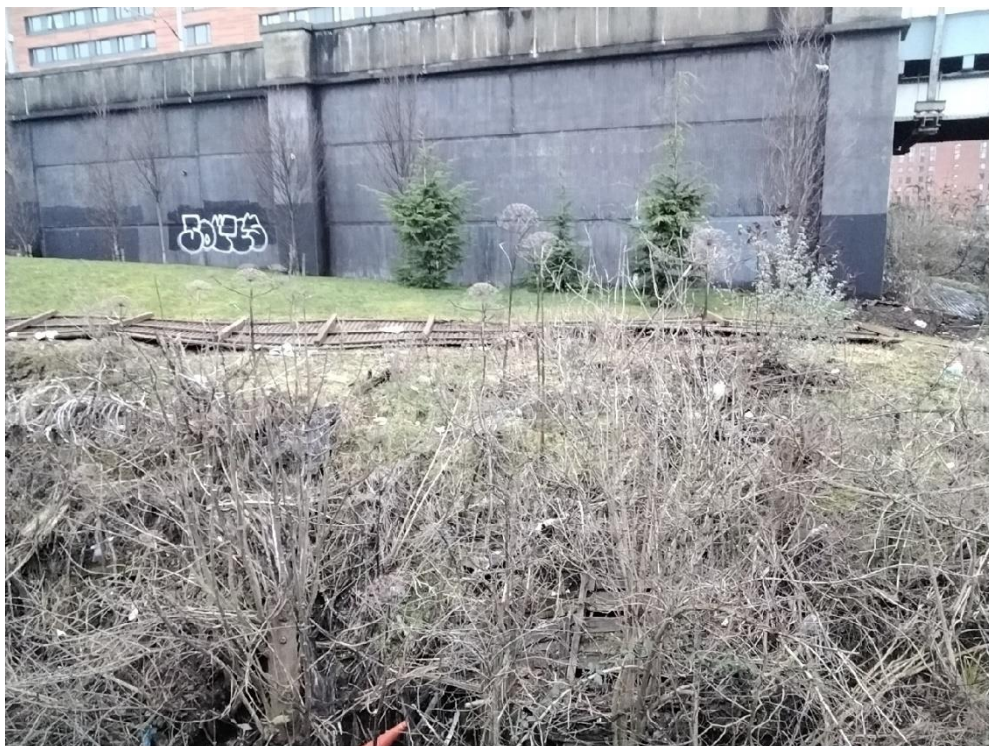
Dead stems of giant hogweed were noted on the eastern bank of the River Kelvin. Although the full extent of the infestation could not be established during this survey, the dead stems extended along a 15-20m stretch of the bank, the central location of which is shown as **Target Note 04, on Figure 1**, and in **Photograph 6** below.

**Photograph 6: Giant hogweed stems noted along banks of River Kelvin
(Target Note 04 Figure 1)**

In the first instance, it is recommended that this area is resurveyed during the growing season (from May onwards) to determine the extent of the infestation.

In the first instance, areas where giant hogweed has been identified (central location around Target Note 04 and 05 on Figure 1) should be avoided, and alternative work methodologies considered.

If the areas of giant hogweed cannot be avoided to accommodate the works at the structure, a minimum 4m exclusion zone around all plants should be marked and no works, storage or passing through should take place within the exclusion zones.

Where works within these exclusion zones are required, it is recommended that an invasive species specialist contractor is contacted to develop an invasive non-native species management plan. This may include the removal or treatment of the species.

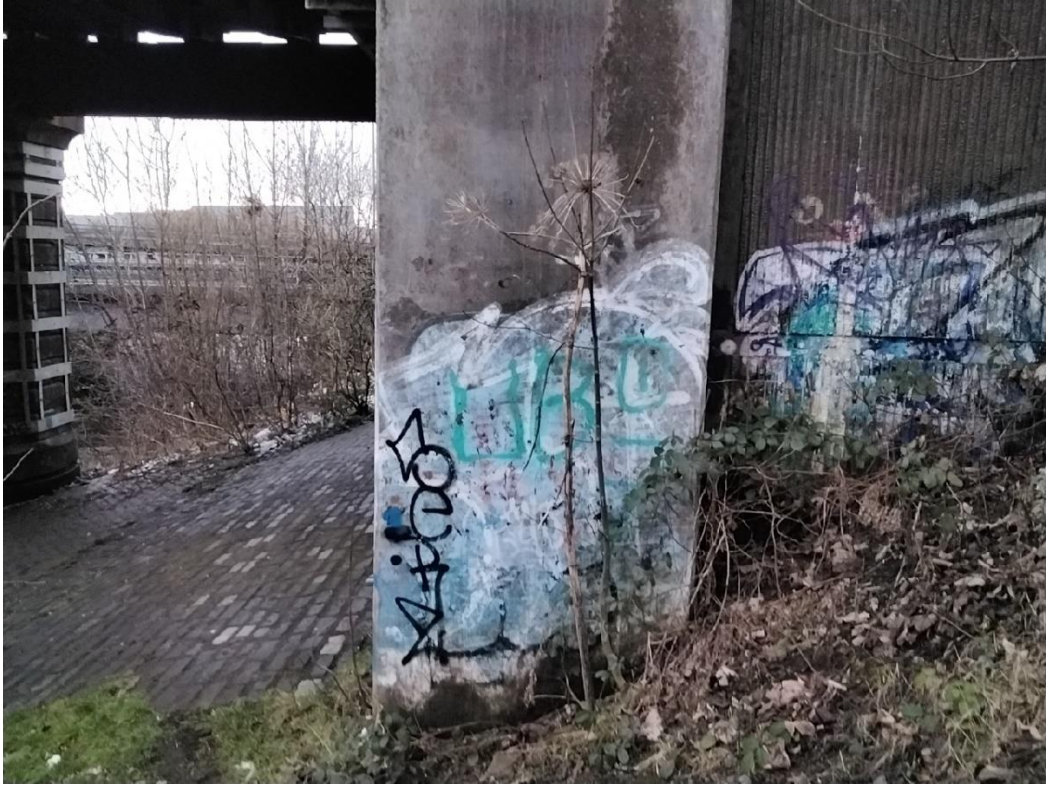
Dead stems of giant hogweed were also noted at the northwest corner of the structure, as shown as **Target Note 05 on Figure 1**, and in **Photograph 7** below. The full extent of this infestation could not be determined as the dead stems appeared to have been flattened/disturbed on the ground.

**Photograph 7: Giant hogweed stems at edge of structure
(Target Note 05, Figure 1)**
