5. Project Details

5.1 Brief Description of the Project

In 2024, temporary remediation works were undertaken along a 100-metre section of the southern bank of the River Avon, within the KG Plant in Grangemouth (NGR: NS 94971 80419). These works were necessitated by localised bank failure and erosion, which had exposed critical infrastructure, including two 33kV electricity supply cables, one of which serves the Kinnel Plant. The erosion posed a significant risk to the integrity of the riverbank, adjacent land, and buried utilities.

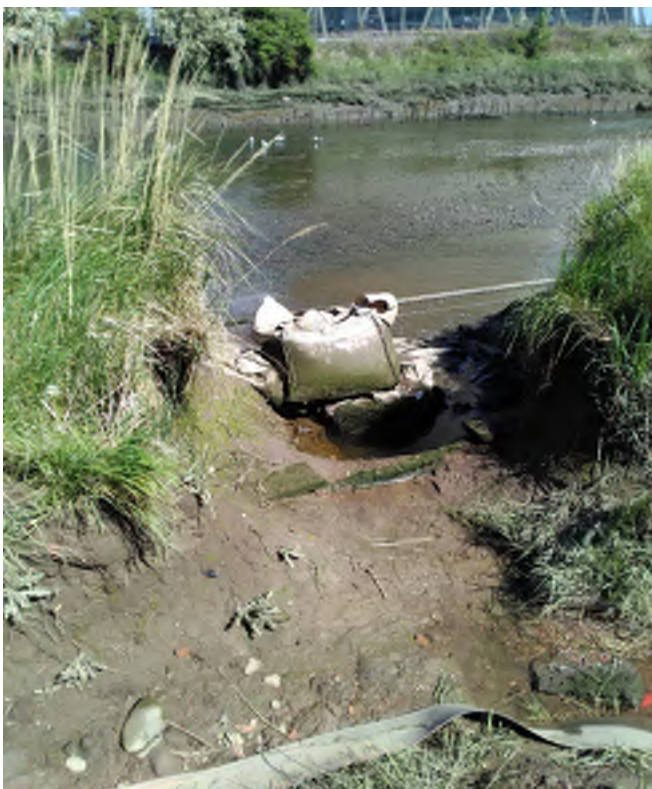
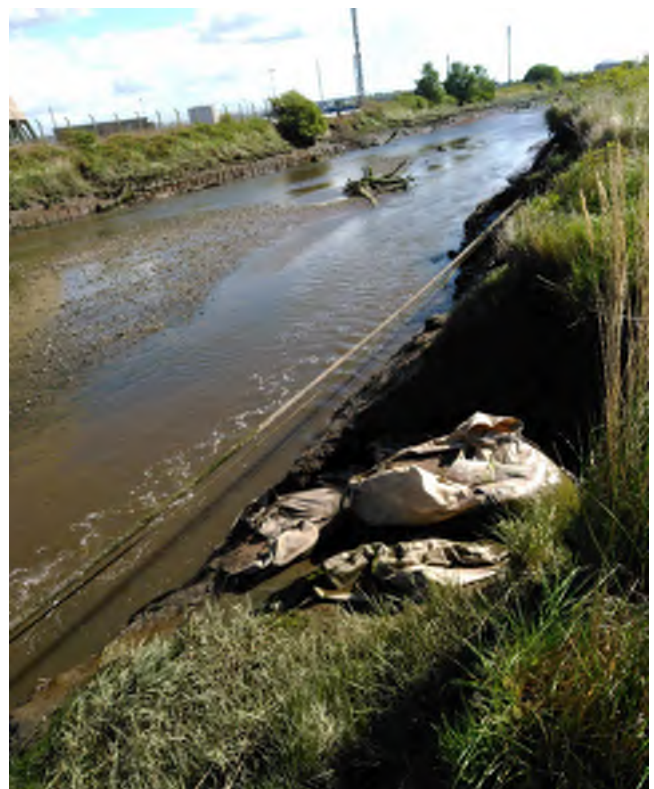
Figure 2: Photographs showing deterioration of the site – cable significantly exposed and no longer buried in the riverbank prior to the remediation in 2024 (before Marine Licence Number: MS-00010836)

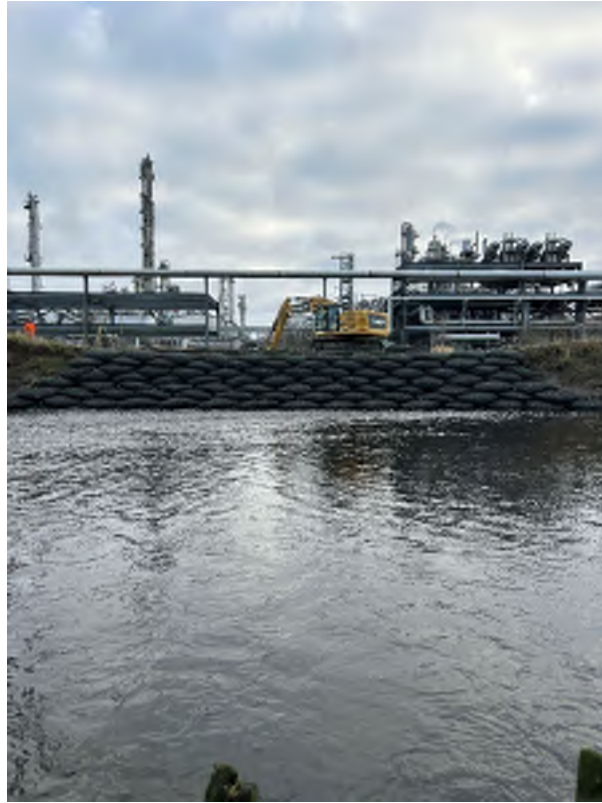
Figure 3: Completed rock bag installation.

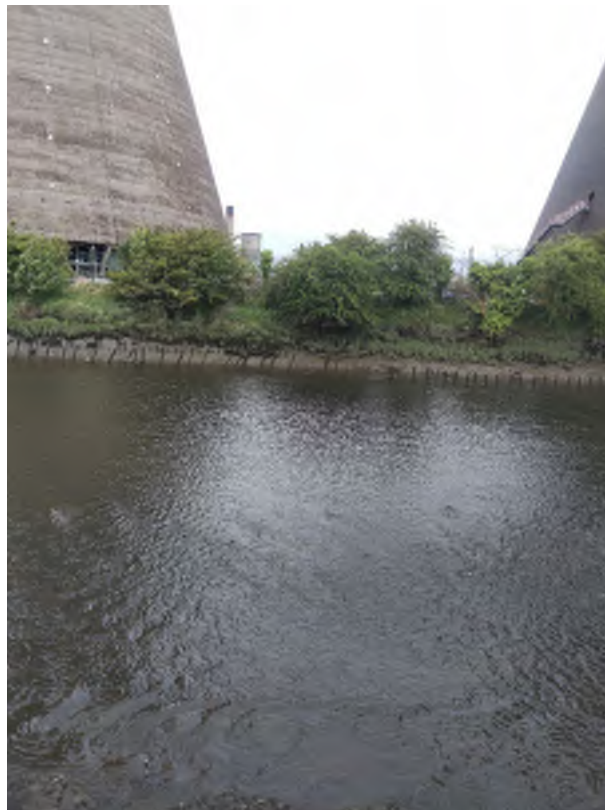
Figure 4: Adjacent Riverbank May 2025 – indicating no erosion

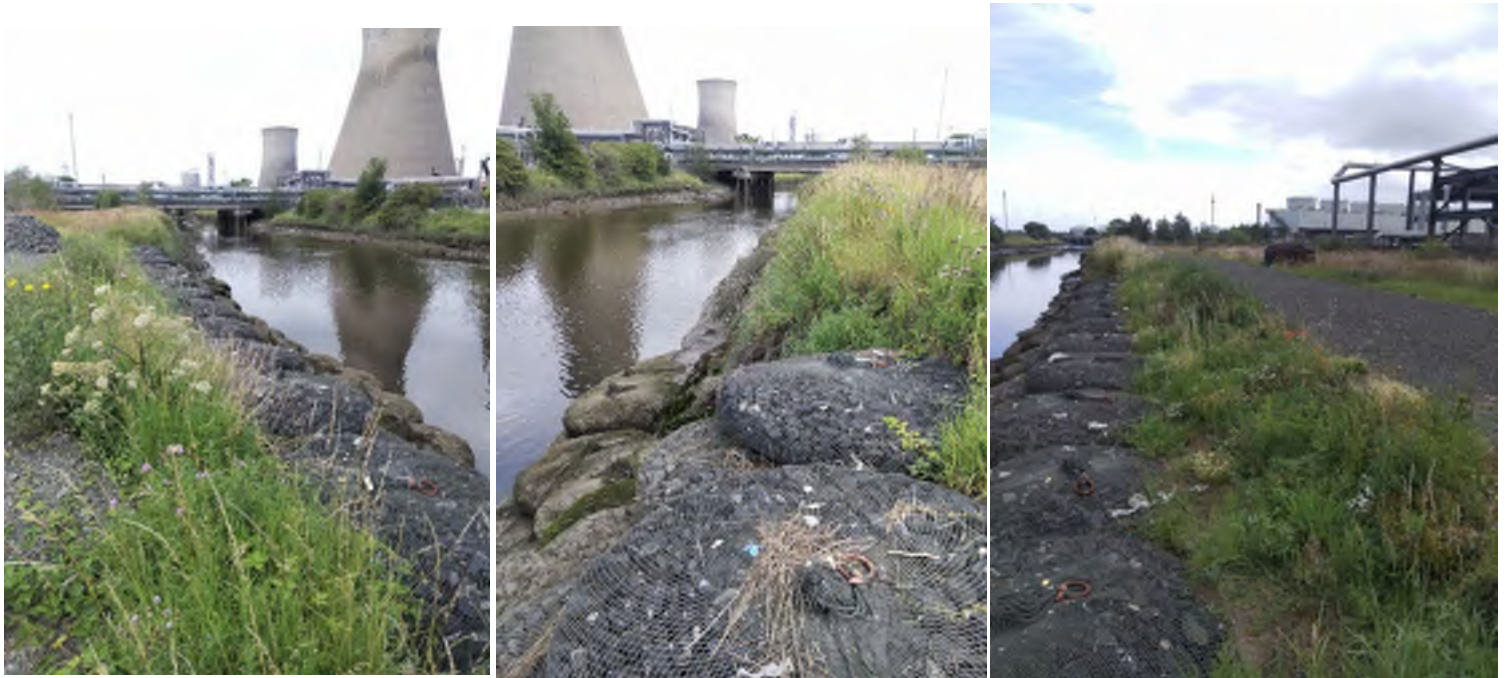
Figure 5: Regeneration of the Riverbank

These temporary measures have proven effective, with recent site inspections indicating early signs of natural bank regeneration.

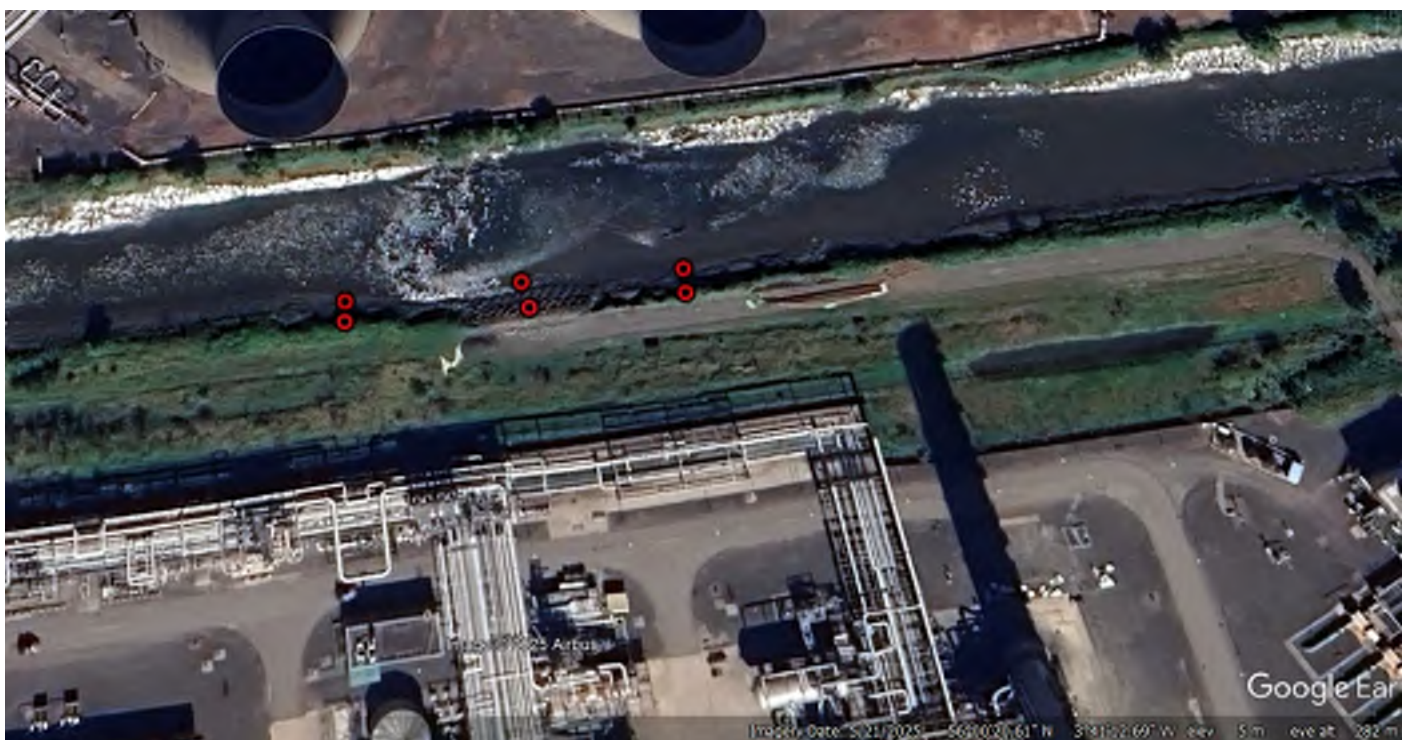
Figure 6: Activity - Rockbag installation with Brushwood Fencing(approximate) (red points).
