# Beatrice Offshore Windfarm Seabed Change and Scour Monitoring

## Technical Scour Assessment: Turbine Foundations

Document permissions	Unrestricted
Project number	DER6409
Project name	Beatrice Offshore Windfarm Seabed Change and Scour Monitoring
Report title	Technical Scour Assessment: Turbine Foundations
Report number	RT006
Release number	01-00
Report date	21 March 2023
Client	Beatrice Offshore Windfarm Ltd

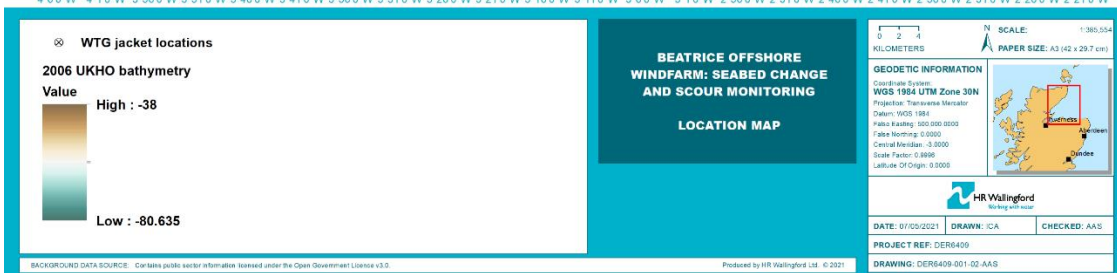
Figure 2.2: Jacket leg ID

<sup>1</sup> Each jacket has four piles with labelling A1, A2, B1, B2, therefore there are up to four local scour holes per jacket. Jacket leg IDs are shown in Figure 2.2.

Figure 2.1 shows the boundaries of the wind farm lease site and the location of the 84 Wind Turbine Generators (WTGs). Each WTG is installed on a steel jacket substructure connected by four piled foundations driven into the seabed. The piles are identified in Figure 2.2 for reference. The WTGs are connected at a voltage of 33 kilovolts by a network of inter-array cables (IACs). There are a total of 91 IACs arranged in fourteen circuits (also referred to as strings) and six WTGs per string. The first WTG in a string is connected by an IAC to an Offshore Transmission Module (OTM). The circuits are cross-connected at the ends in pairs. The two OTMs in the centre of the array and their associated IAC form part of the Offshore Transmission Assets and are not included within this study.

It should be noted that because of the differing rotations of the jackets the leg naming is such that each label does not correspond to the same compass direction relative to the centre of the pile. For this reason it is not meaningful to compare each leg ID between locations. For reference the pile identifications are shown in Figure 2.2.

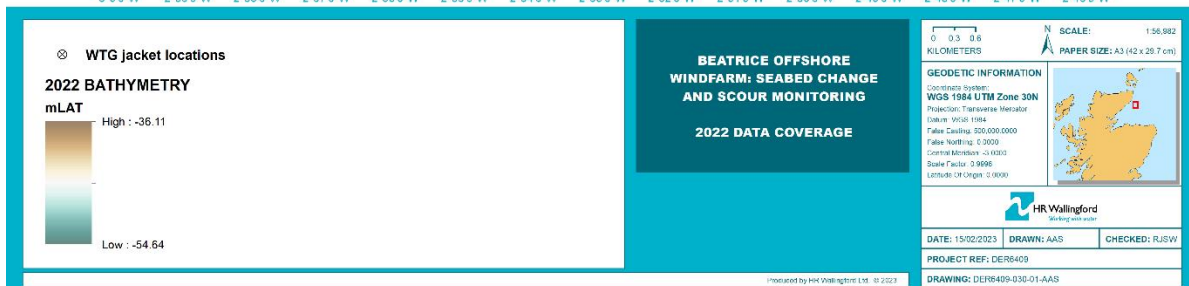
Figure 4.1: 2022 bathymetric data coverage

The spatial coverage of the 2022 bathymetric survey is shown in Figure 4.1, providing inputs to both the analysis of scour at WTG foundations and also for bed level change analysis along IACs

Figure 4.1 details the coverage at each foundation for the post-installation 2019, 2020, 2021 and 2022 surveys.

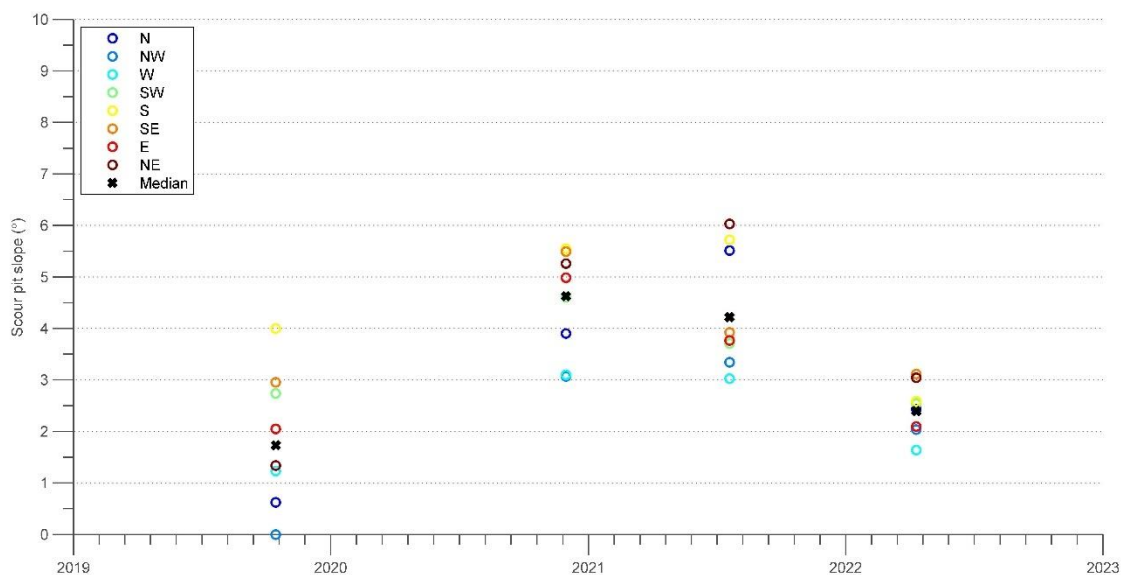
In sandy sediments under unidirectional flow conditions the upstream slope of a scour hole can be approximated by the angle of repose (Harris and Whitehouse, 2015), whilst the downstream slope is about half this angle  $\pm 2^\circ$ , approximately. Typical values for the angle of repose in sands are in the range of  $26^\circ$  to  $45^\circ$  (Hoffmans and Verheij, 1997). From the monitoring data obtained from built offshore wind farms, the scour extents for foundation structures placed in morphologically dynamic tidal areas within predominantly sandy environments indicate slope angles lower than those based on sediment angle of repose. This is not unexpected as under reversing tidal conditions the downstream / upstream positions will reverse and, therefore, the lower slope angles associated with the wake vortices are likely to prevail over the longer-term.

In our experience, the slope angles observed at BOWF are much less steep than observed at other wind farm sites where there are strong tidal currents. This may be partially due to the scour development still being ongoing, but also the generally weak tidal currents and potentially the periodic effect of wave action acting to (transiently) infill the scour.

Figure 6.10: Average scour slopes for each compass direction for the 2019, 2020, 2021 and 2022 surveys
