Nigg East Quay Construction Works Screening Request

Client: Global Energy Nigg Ltd.

Document number: 9793
Project number: 673123j
Status: Final

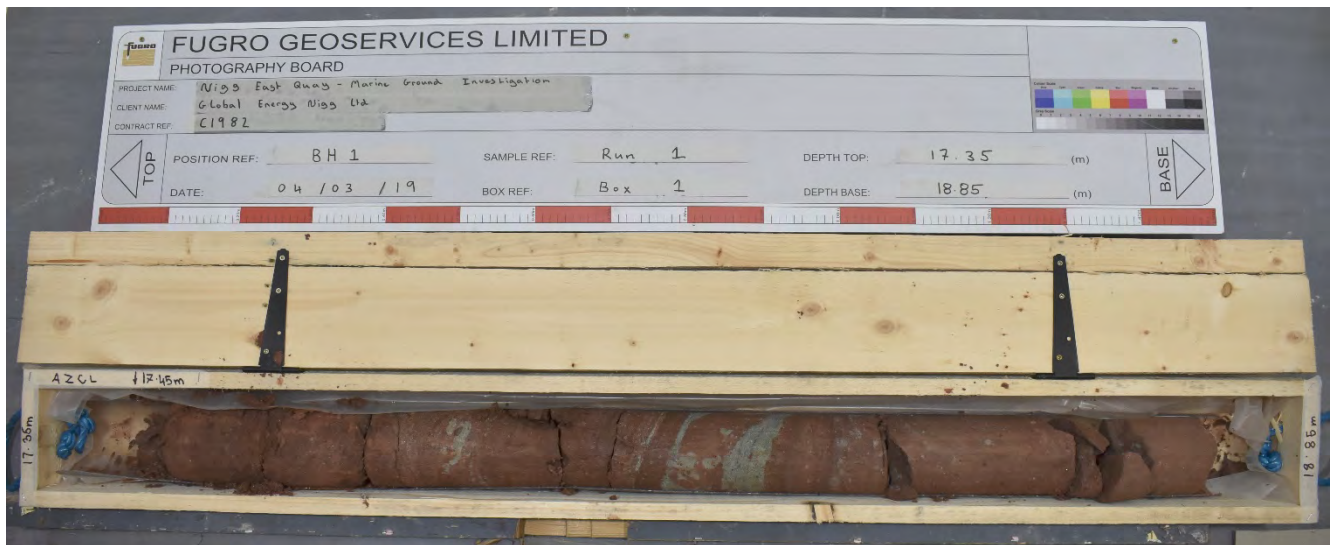
BH01; 17.35m to 18.85m

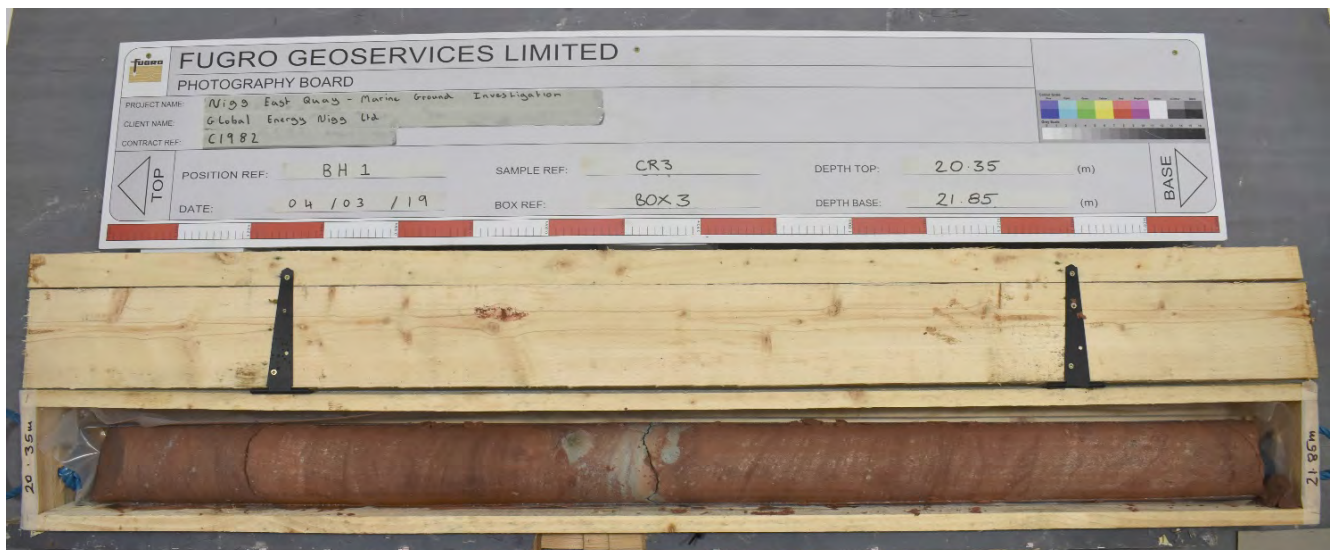
BH01; 20.35m to 21.85m

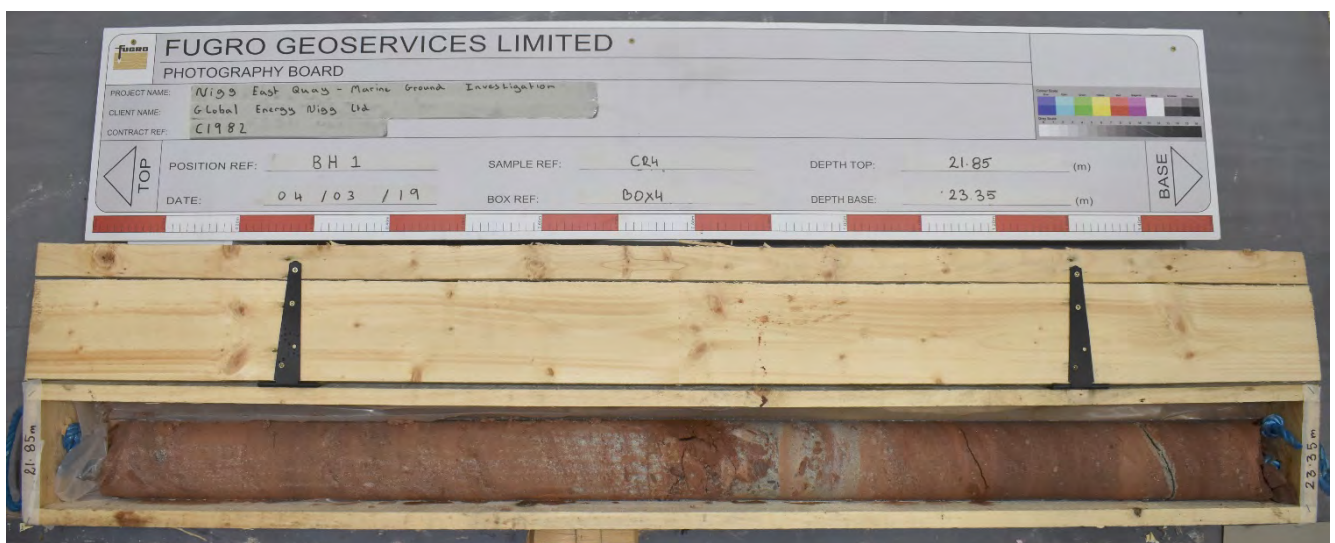
BH01; 21.85m to 23.35m

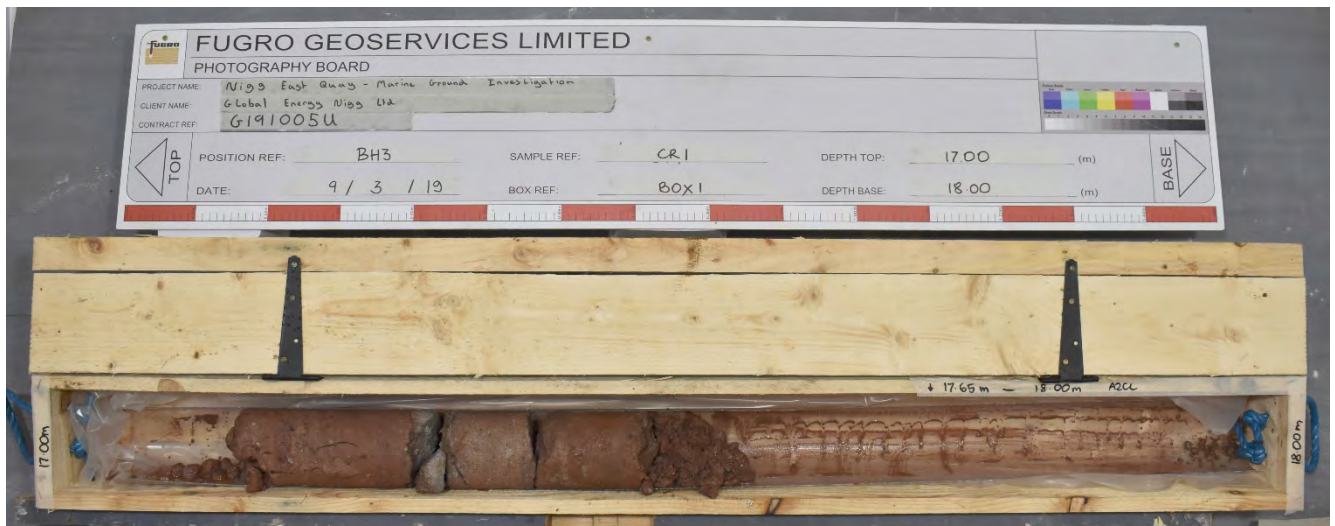
BH03; 17.00m to 18.00m

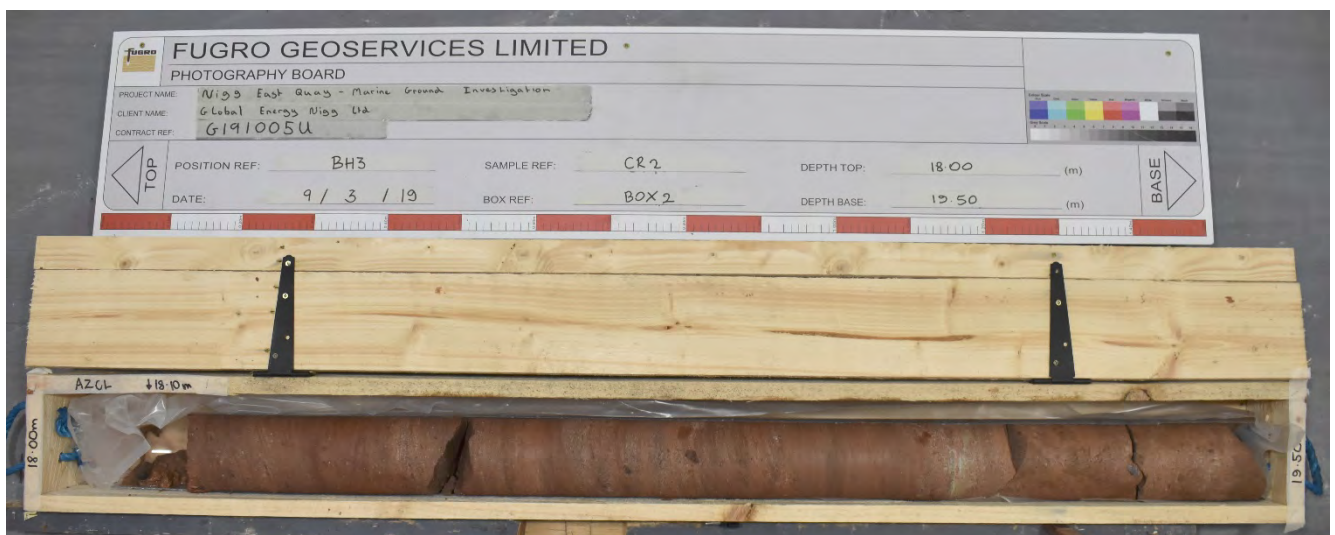
BH03; 18.00m to 19.50m

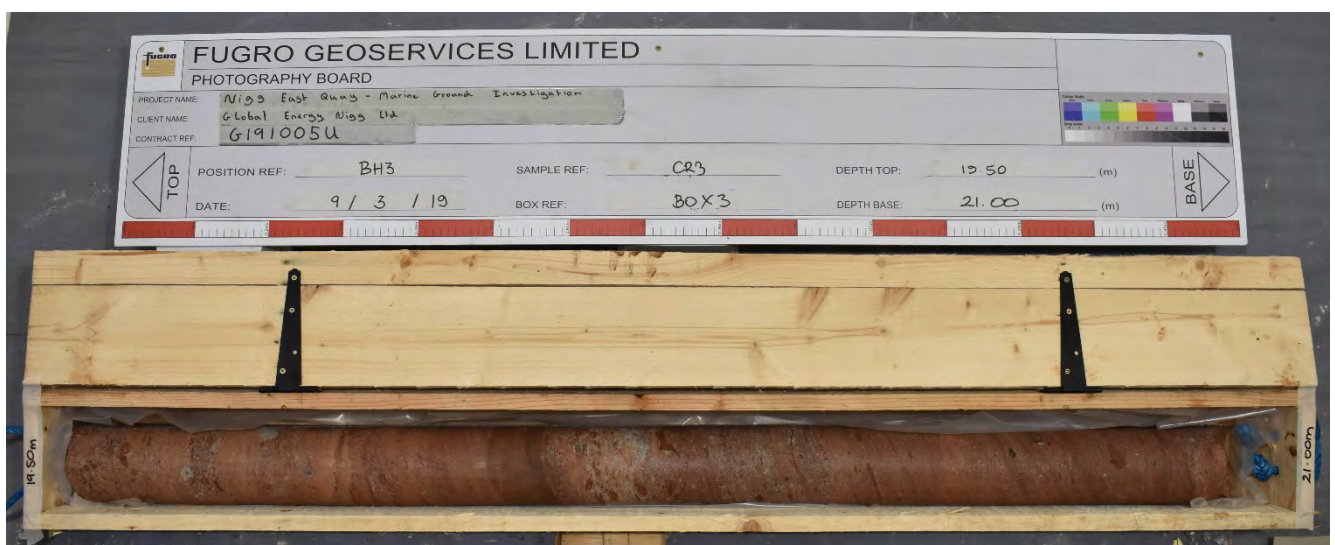
BH03; 19.50m to 21.00m

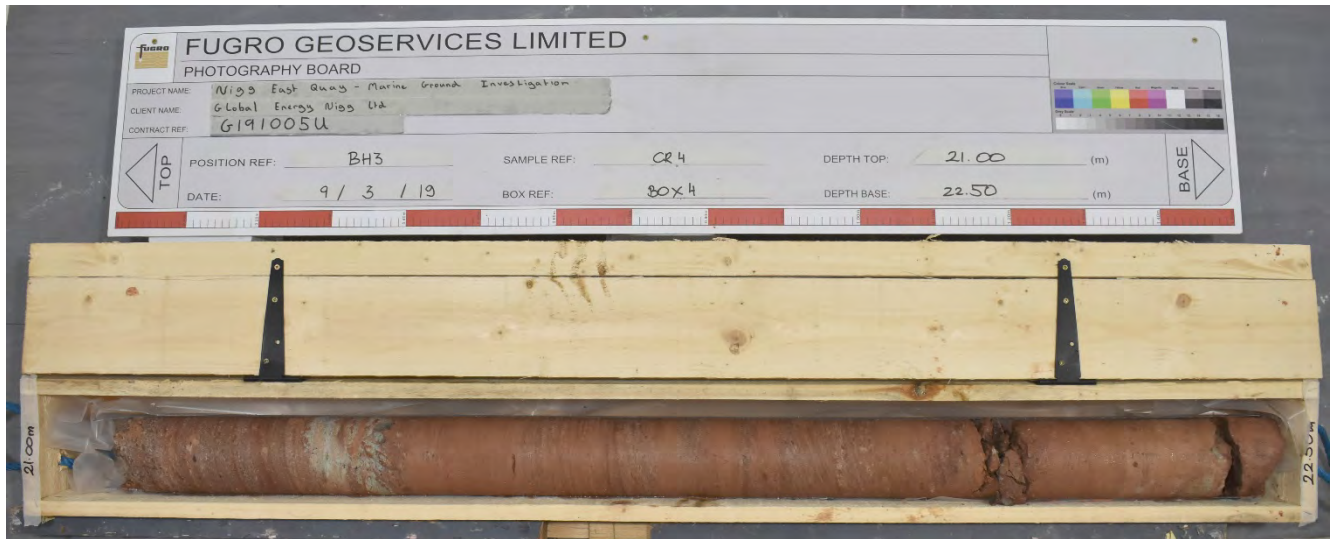
BH03; 21.00m to 22.50

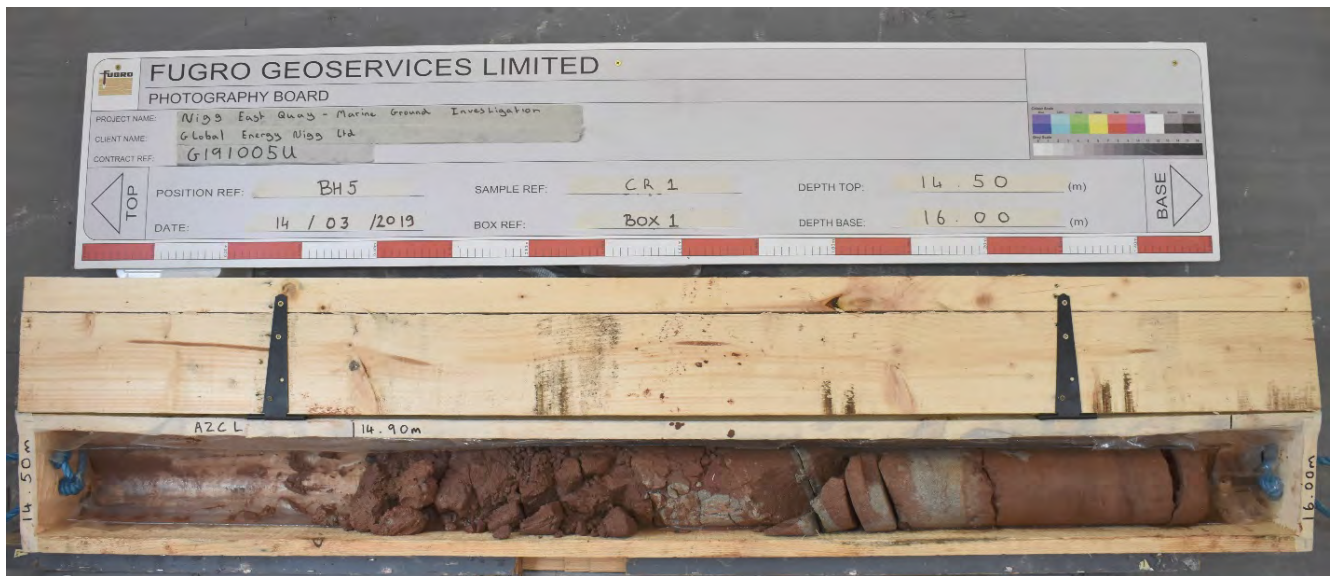
BH05; 14.50m to 16.00m

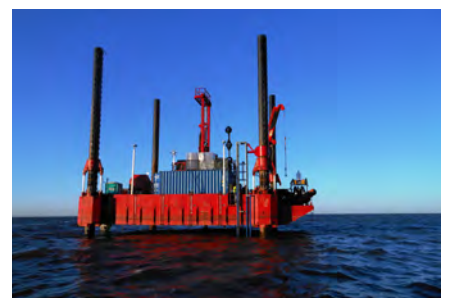
Skate 3 on site in Uruguay.

Max. separation:	32 m
Working draft:	0.985 m
No. of containers:	7
Deck area:	238.1 m ²
Leg size:	762 mm diameter
Elevating system:	Hydraulic ram & duo pin rack
Accommodation:	Workshop/canteen container

The Skate 3 range consists of medium sized, high payload, container transportable jack-up platforms. These platforms have low international transport cost coupled with high performance capabilities.

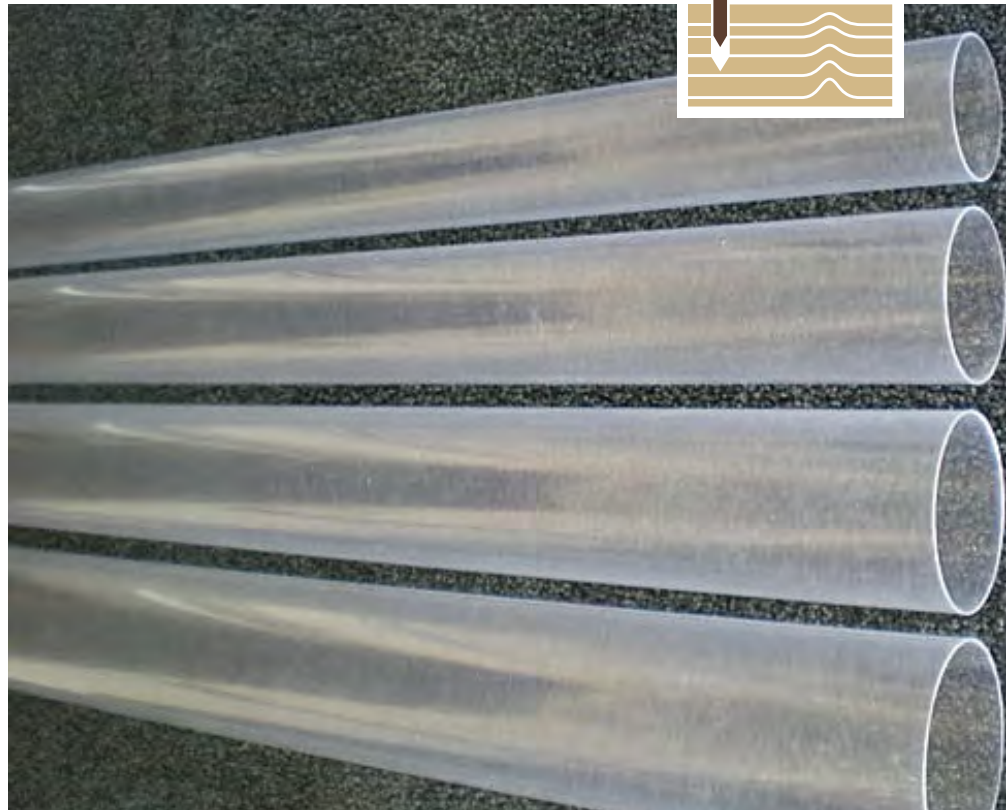
Geobor-S Core Liner.

Technical Specifications	Metric	Imperial
Hole diameter, method 1 & 4:	146.0 mm	5.75 in
Hole diameter, method 2 & 3:	150.0 mm	5.90 in
Drill bit outer diameter:	145.6 / 149.6 mm	5.73 / 5.90 in
Drill rod outer diameter:	139.7 mm	5.58 in
Bit kerf, method 1:	21.8 mm	0.86 in
Bit kerf, method 2 & 3:	23.8 mm	0.94 in
Core diameter:	102.0 mm	4.05 in
Hole area (od 146/150):	167.3 / 176.7 cm ²	26.0 / 27.4 in ²
Core area:	81.7 cm ²	12.7 in ²
Cutting area in % of hole area:	51.7 %	51.7 %

The core barrel itself is designed for flushing with water, mud or air, and can easily be adapted for most soil and rock conditions by the use of an appropriate core bit or non-coring device.
