# Uig Harbour Redevelopment

Sediment Disposal Site Seabed Survey Report

The Highland Council

Project number: 60536743  
UHRD-ACM-XX-DG-RP-EG-00001

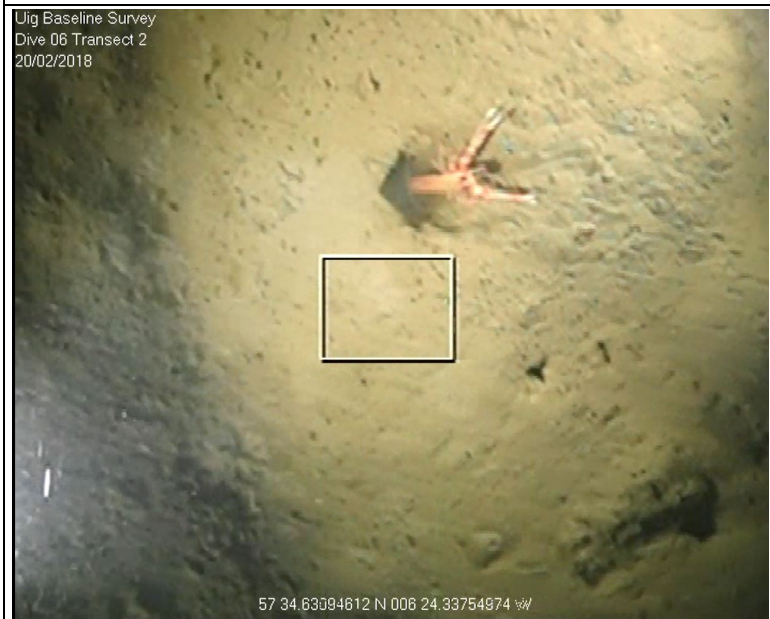
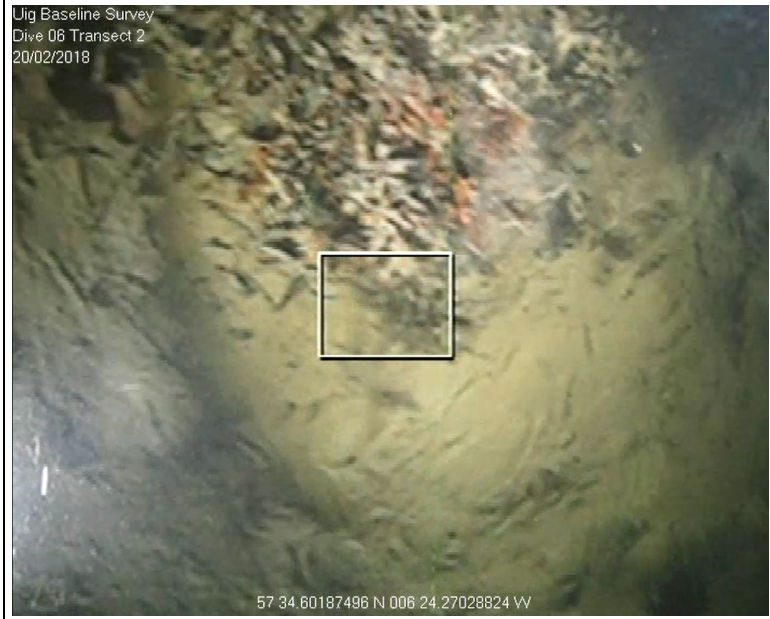
| Transect ID: TR02 | Survey Date: 20 <sup>th</sup> February 2018 |
|---|---|
| <div data-bbox="181 241 954 857"> <p>Uig Baseline Survey<br/>Dive 06 Transect 2<br/>20/02/2018</p> <p>57 34.63594612 N 006 24.33754974 W</p> </div> <p data-bbox="325 880 813 913">Figure 3-5: <i>Nephrops norvegicus</i> (langoustine)</p> <div data-bbox="181 981 954 1597"> <p>Uig Baseline Survey<br/>Dive 08 Transect 2<br/>20/02/2018</p> <p>57 34.60187496 N 006 24.27028824 W</p> </div> <p data-bbox="389 1617 748 1650">Figure 3-6: Bryozoan, <i>Flustra</i> spp.</p> | |

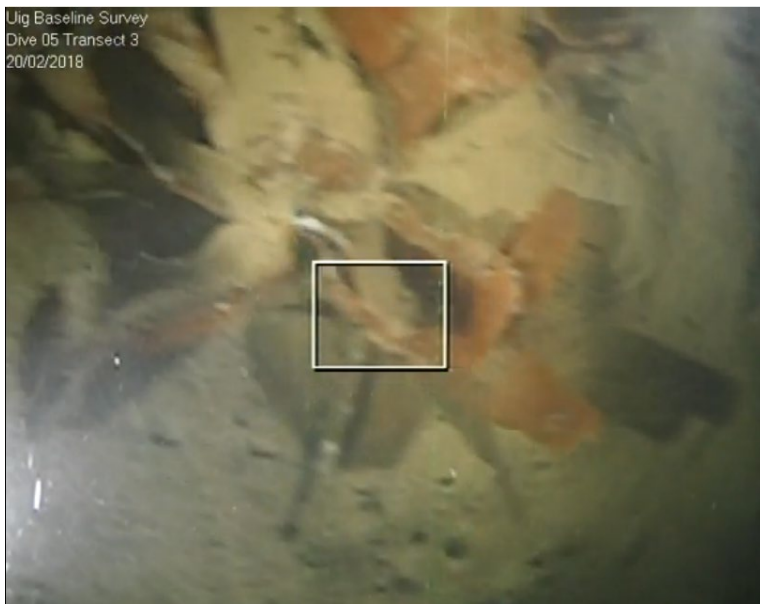
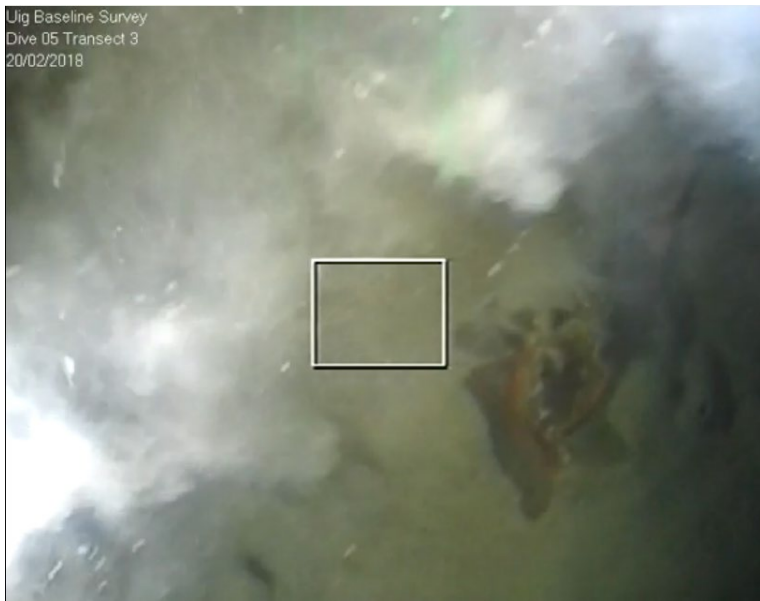
| <p><b>Representative still image of transect features:</b></p> <p>Uig Baseline Survey<br/>Dive 05 Transect 3<br/>20/02/2018</p> <p><b>Figure 3-7: Kelp debris</b></p> <p>Uig Baseline Survey<br/>Dive 05 Transect 3<br/>20/02/2018</p> <p><b>Figure 3-8: Kelp debris</b></p> | <p><b>Video Limitations:</b> The rapidly moving ROV collides intermittently with the seabed, suspending sediment.</p> <p><b>Biological Summary:</b> When the light is sufficient, it is possible to see burrows within the soft sediment on the seabed. Some debris was also recorded along the transect including detached fronds and holdfasts of kelp (<b>Figure 3-7</b> and <b>Figure 3-8</b>). Some benthic fishes were also seen within the footage, however they flee too quickly to be able to identify. A starfish was recorded in the first video (Dive 05 18-02-20 21.39.20, <b>Figure 3-9</b>).</p> <p>The second video (Dive 05 18-02-20 22.09.22) despite the same difficulties, confirmed the presence of <i>Nephrops norvegicus</i> along the transect route.</p> |

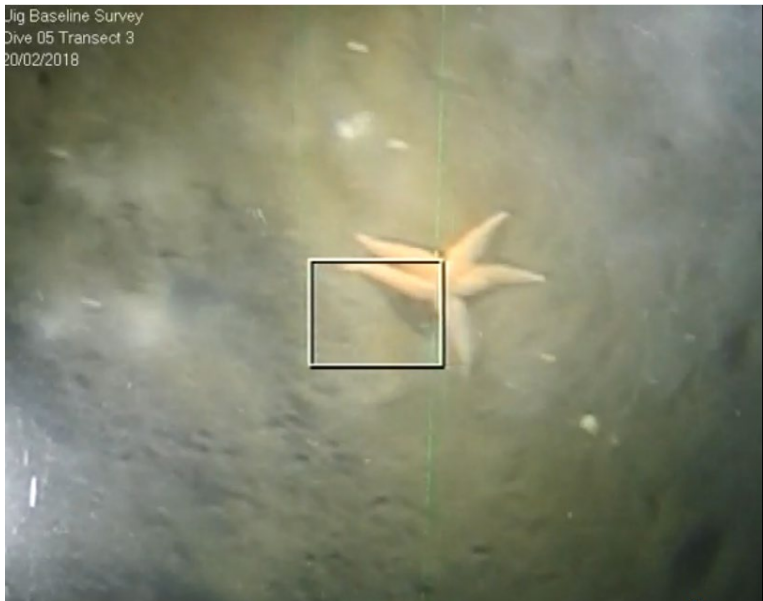
| Transect ID: TR03 | Survey Date: 20 <sup>th</sup> February 2018 |
|---|---|
| <div data-bbox="188 302 335 369"> <p>Jig Baseline Survey<br/>Dive 05 Transect 3<br/>20/02/2018</p> </div> <p data-bbox="379 929 762 958">Figure 3-9: Starfish - <i>Asterias rubens</i></p> <p data-bbox="320 1619 821 1648">Figure 3-10: Transect 3 IMG_1074 <i>P. phosphorea</i></p> | |

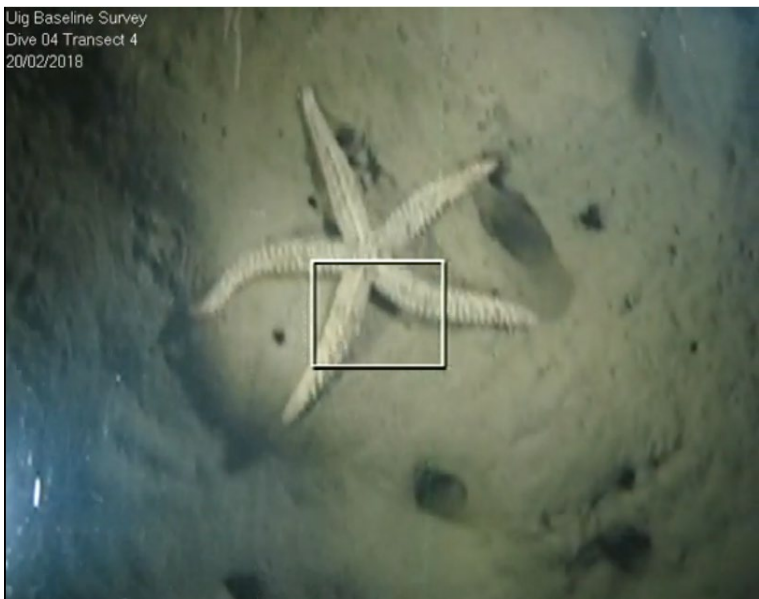
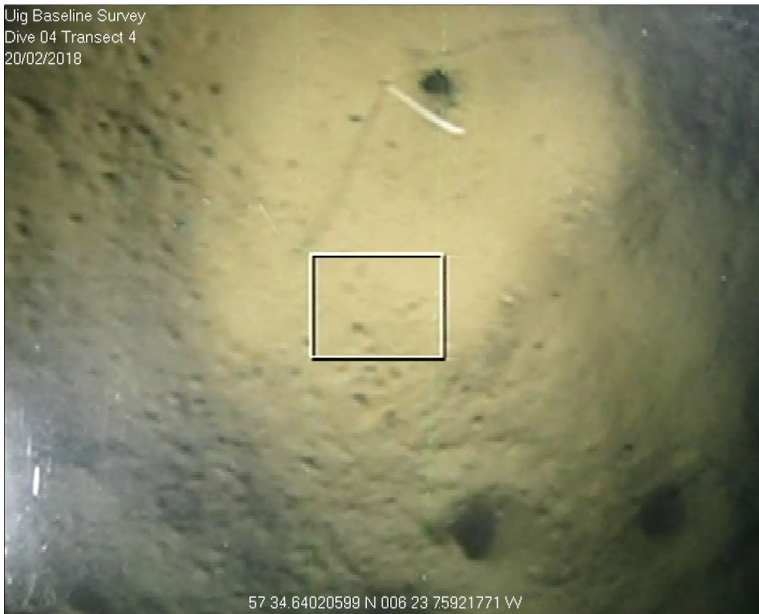
| <b>Representative still image of transect features:</b><br> <p><b>Figure 3-11: Starfish - <i>Marthasterias glacialis</i></b></p> <p><b>Figure 3-12: Seapen - <i>Virgularia mirabilis</i> and <i>Nephrops</i> burrow holes</b></p> | <b>Video Limitations:</b> The first video, recorded from dive 04 18-02-20 20.41.04 was the least limited by the speed of the ROV and suspended sediment issues.<br><br>The second video (Dive 04 18-02-20 21.11.05) was dark and had little clear content of the seabed.<br><br><b>Biological Summary:</b> The first video (Dive 04 18-02-20 20.41.04) documented the most biological evidence for the transect, capturing footage of starfish ( <b>Figure 3-11</b> ), seapens ( <b>Figure 3-12</b> ) and <i>Nephrops norvegicus</i> ( <b>Figure 3-13</b> ). Dive 04 18-02-20 21.11.05 recorded seapens amongst the burrow holes within the fine soft sediments. |

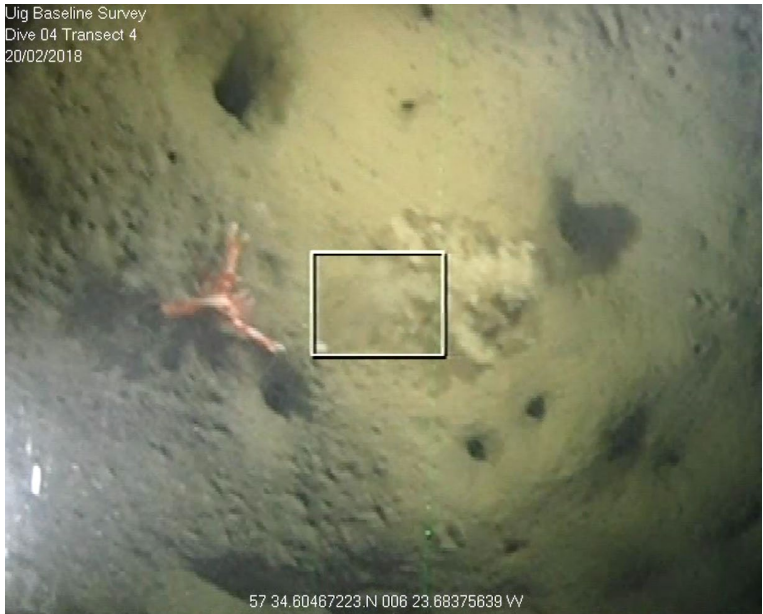
| <p>Uig Baseline Survey<br/>Dive 04 Transect 4<br/>20/02/2018</p> <p>57 34.60467223.N 006 23.66375639.W</p> <p><b>Figure 3-13: <i>Nephrops norvegicus</i> and burrow holes</b></p> | |

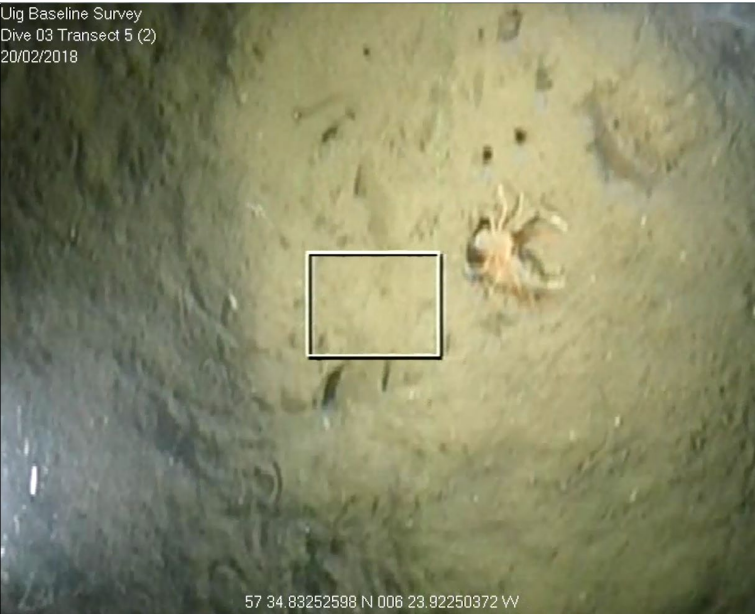
| <b>Representative still image of transect features:</b> | <p><b>Video Limitations:</b> As with all other transects, the ROV collided with the seabed frequently, suspending soft sediments.</p> <p><b>Biological Summary:</b> Some rocks and boulders were seen to be present on the soft sediment seabed. Burrows within the soft sediment were visible when the footage was clear. Species present included <i>Nephrops</i>, benthic fishes (which dispersed rapidly with the presence of the ROV) and squat lobster (Figure 3-14).</p> |

| Transect ID: TR05(3) | Survey Date: 20 <sup>th</sup> February 2018 |
|---|---|
| <p>Uig Baseline Survey<br/>Dive 03 Transect 5 (2)<br/>20/02/2018</p> <p>57 34.83252598 N 006 23.92250372 W</p> <p>Figure 3-14: Squat lobster - <i>Galathea Squamifera</i></p> | |
