A.7 INTERTIDAL SURVEY REPORT FOR CABLE CORRIDOR 2.4 FAIR ISLE TO BU: FAIR ISLE LANDING POINT

A.8 INTERTIDAL SURVEY REPORT FOR CABLE CORRIDOR 2.8 SHETLAND TO WHALSAY: SHETLAND LANDING POINT

A.9 INTERTIDAL SURVEY REPORT FOR CABLE CORRIDOR 2.8 SHETLAND TO WHALSAY: WHALSAY LANDING POINT

A.10 BENTHIC SURVEY REPORT FOR CABLE CORRIDOR 2.1 YELL TO UNST

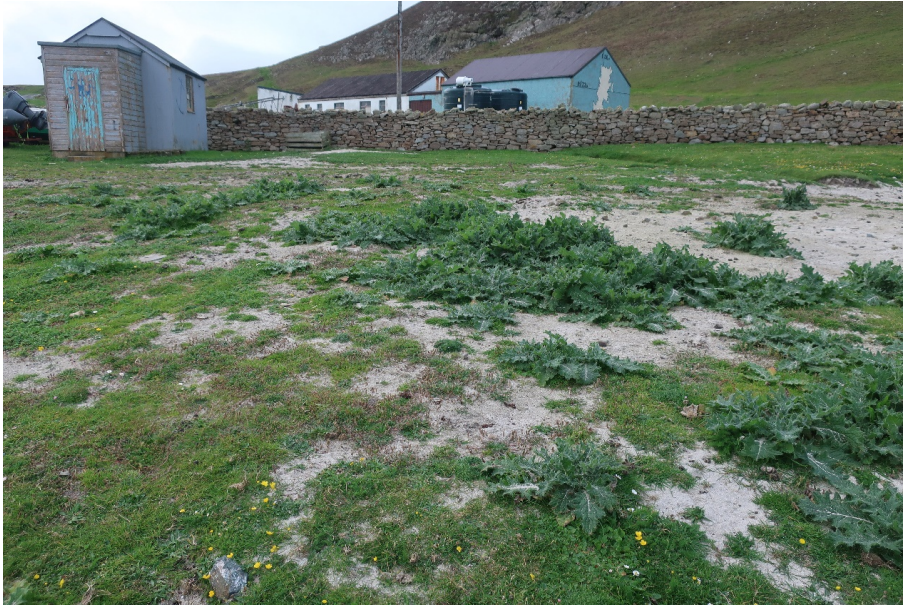
Target Note No.	Location and Description	Photograph
T1	Unconsolidated fore dune, established from North Haven dredging maintenance, August 2020. Bare patches with scattered patches of pioneer colonists, <i>Poa annua</i> , <i>Plantago coronopus</i> , <i>Plantago lanceolata</i> coastal form and <i>Cirsium vulgare</i> .

Photo 1 **Unconsolidated dune (Target Note 1, Figure 2.3)**

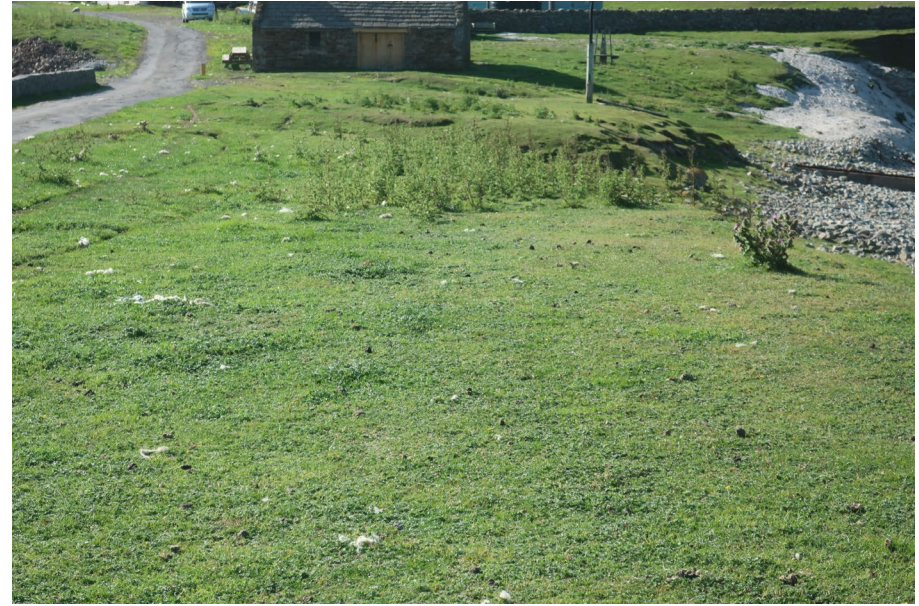
T2	Heavily disturbed area of degraded grey dune, densely vegetated and in most parts dominated by <i>Potentilla anserina</i> with frequent <i>Lolium perenne</i> , <i>Festuca rubra</i> , <i>Agrostis stolonifera</i> and <i>Cirsium arvense</i> .

Photo 2 **Degraded grey dune (Target Note 2, Figure 2.3)**

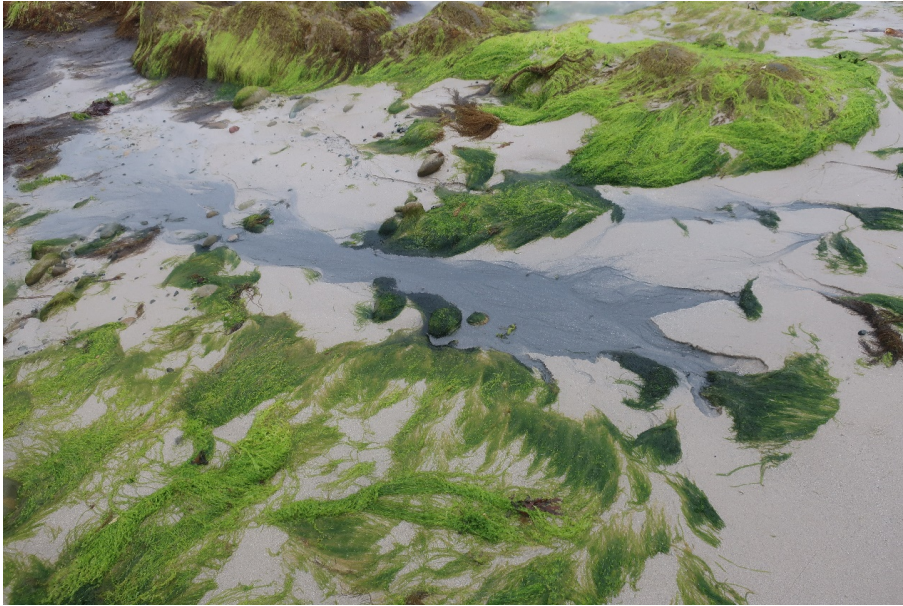
T17	Beach west of old slip: fine sand to c5 cm depth, dark brown (oily) mud-rich sand below and bedrock in places beneath that. Beach surface generally free of material. Lower portion, the first 5m landward from low tide mark, with worm casts (at c25 per square metre). Interstitial fauna of diverse polychaetes including very abundant <i>Capitella capitata</i> and frequent <i>Malacoceros fuliginosus</i> .

Photo 17 Beach west of Old Slipway – note oily substance (Target Note 17, Figure 2.2)

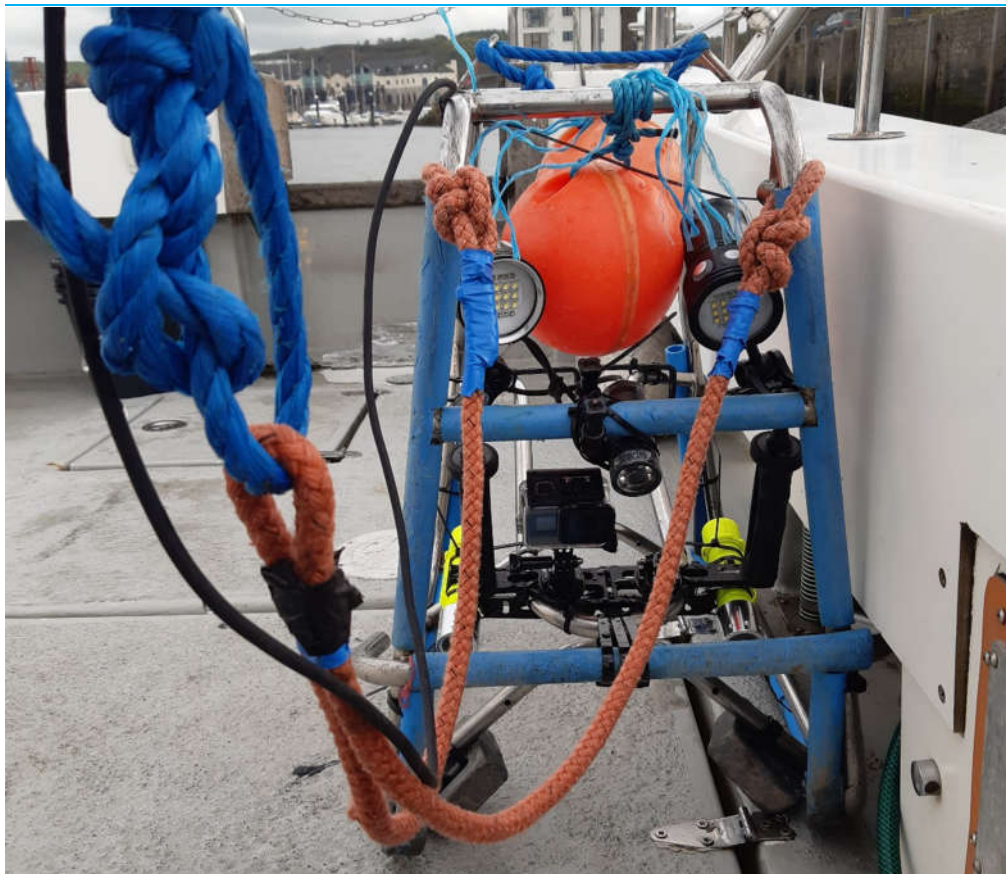
A DDV camera was deployed to collect information on the biology of the seabed and to verify the physical and biological nature of the seabed. ENVISION designs, builds and operates a range of camera systems tailored to the local environmental conditions within the proposed survey areas. The system used on this survey was built specifically for benthic survey in rugged environments and is shown in Figure 3. Its robust structure was designed to enable it to maintain position in strong current as well as to glide easily over a variety of substrates without snagging.

The camera system designed by ENVISION for benthic survey

The system comprised two video cameras: a high-resolution CCTV camera connected to the surface via an umbilical and a high definition (HD) camera. The CCTV camera was connected to a screen and a digital capture device and was used primarily for real-time viewing, allowing the operator of the camera frame to view its progress and adjust height and speed over the seabed as required. Figure 4 shows an example of the topside equipment.

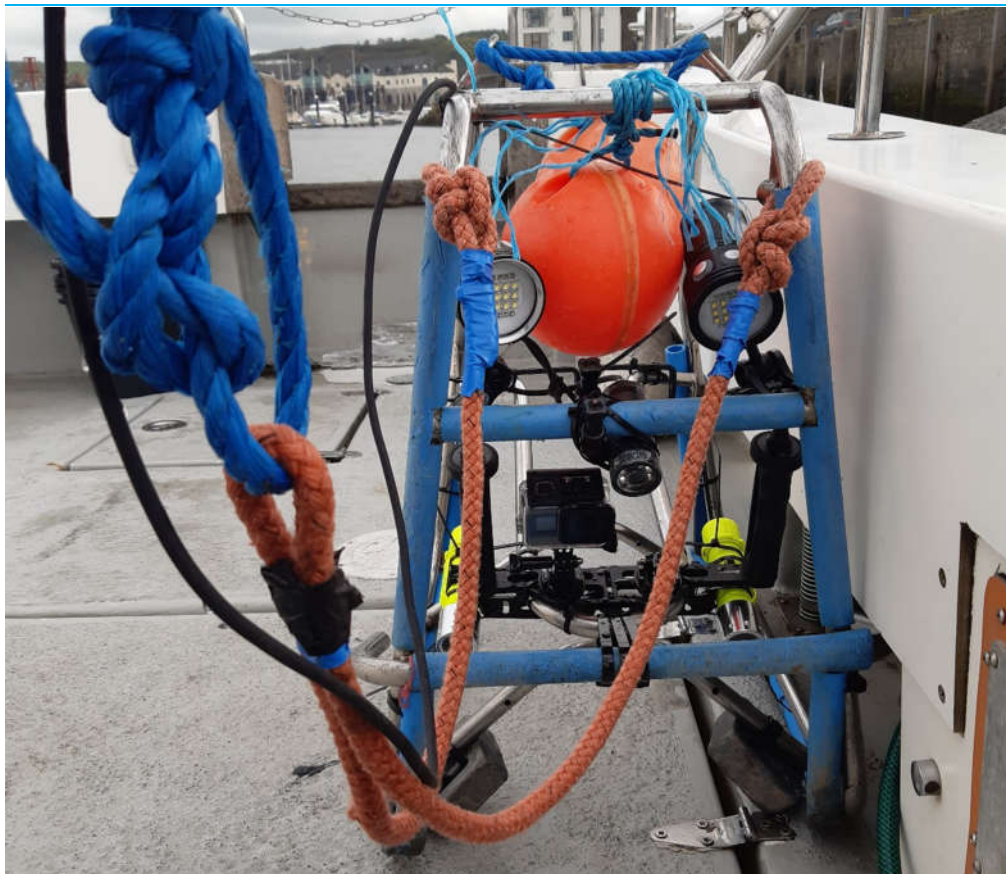
A DDV camera was deployed to collect information on the biology of the seabed and to verify the physical and biological nature of the seabed. ENVISION designs, builds and operates a range of camera systems tailored to the local environmental conditions within the proposed survey areas. The system used on this survey was built specifically for benthic survey in rugged environments and is shown in Figure 3. Its robust structure was designed to enable it to maintain position in strong current as well as to glide easily over a variety of substrates without snagging.
