# BRITISH TELECOMMUNICATIONS PLC

## R100 Shetland Isles Fibre-optic Project

### Technical Appendix D - Navigation Risk Assessment

R100 Shetland Isles Fibre-optic Project

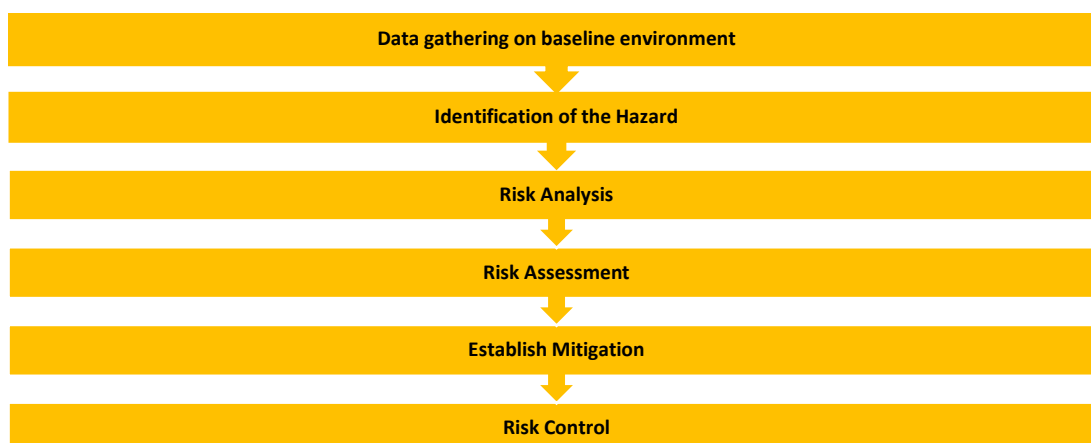
**Figure 1-2 Assessment Steps**

The assessment has been informed by the above guidance which states that the assessment stage should follow a clear progression; from the characterisation of the hazard, the risk that hazard has on, in the case of this assessment, the existing shipping baseline and the steps & risk controls that are in place to reduce the overall impact of the hazard to As Low As Reasonably Practicable (ALARP).

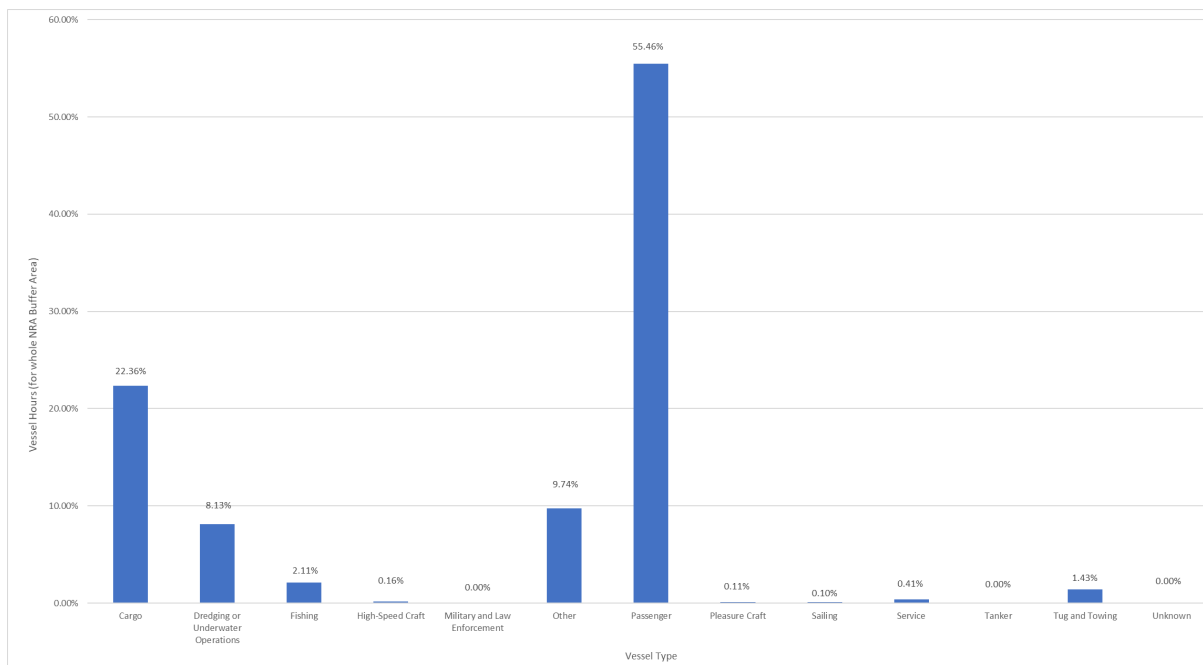
**Figure 3-3 Vessel Distribution Across the 2.1 Yell – Unst Study Area**

A total vessel density of 8547 hours per month were recorded across the study area in 2019. The percentages of the vessel categories are presented in **Figure 3-3**. Passenger vessels make up a large portion of the data (55%).

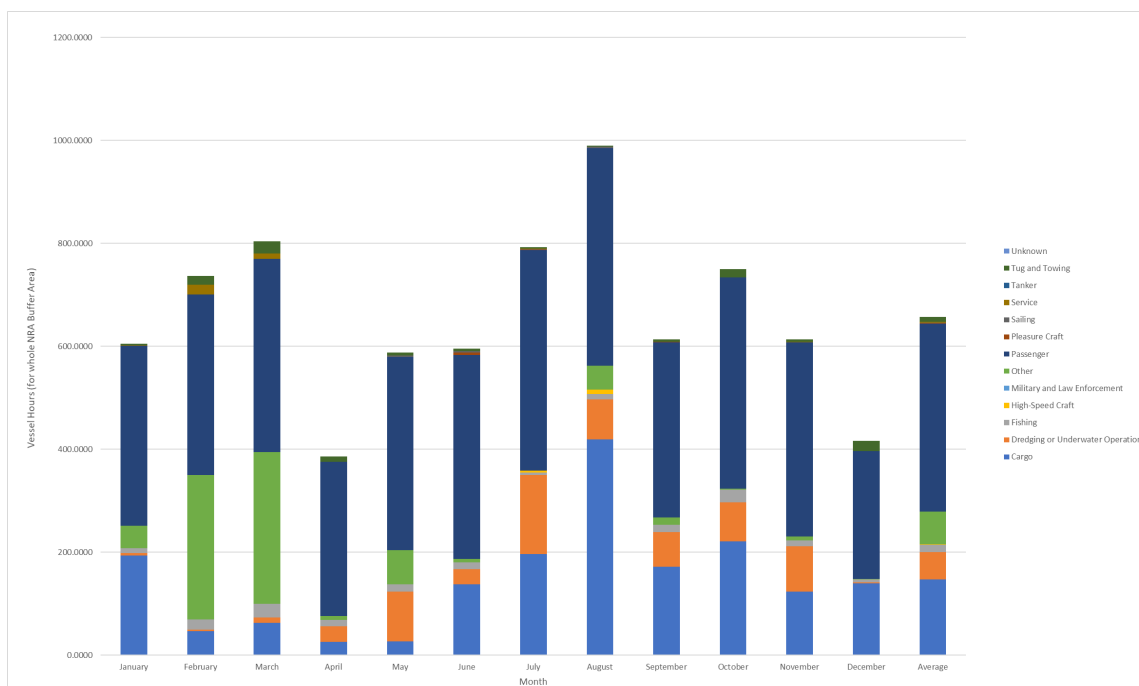
**Figure 3-4 Seasonality Changes in Vessel Traffic Across the 2.1 Yell – Unst Study Area**

Seasonal distribution of the vessel traffic has been analysed across the study area and the busiest months are observed in August. **Figure 3-4** highlights the seasonal changes.

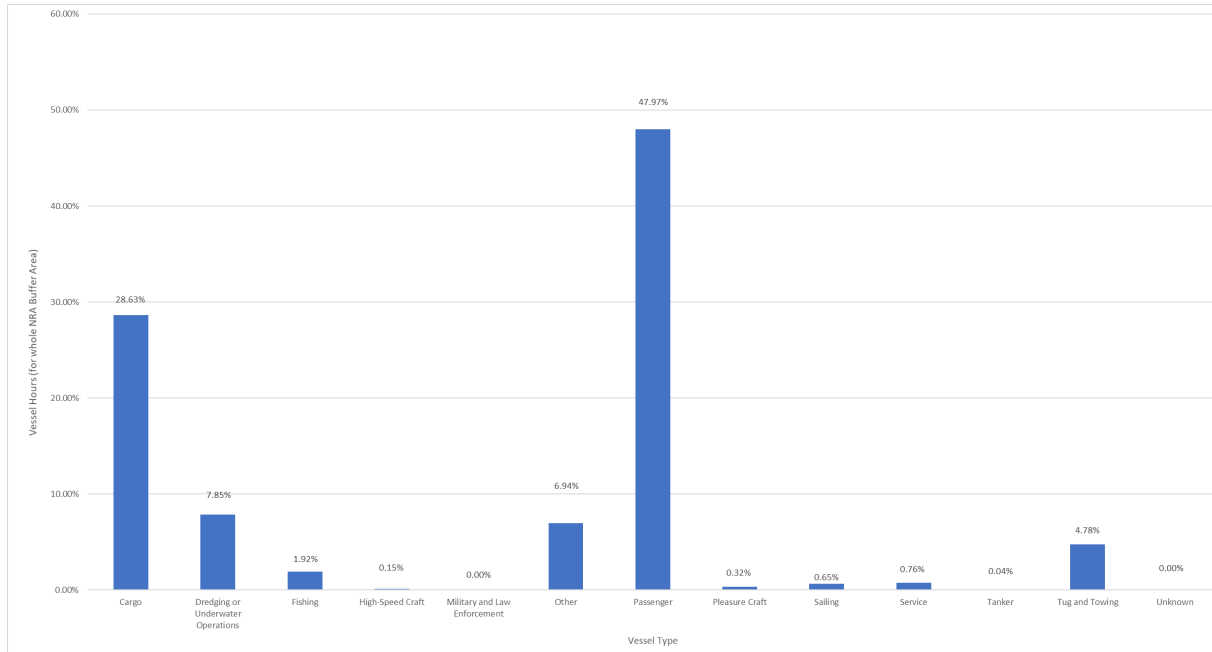
**Figure 3-7 Vessel Distribution Across the 2.2 Shetland – Yell Study Area**

A total vessel density of 4940 hours per month were recorded across the study area in 2019. The percentages of the vessel categories are presented in **Figure 3-7**. The data is generally split between Cargo and Passenger Vessels, with each making up approximately 28% and 48% of the data respectively.

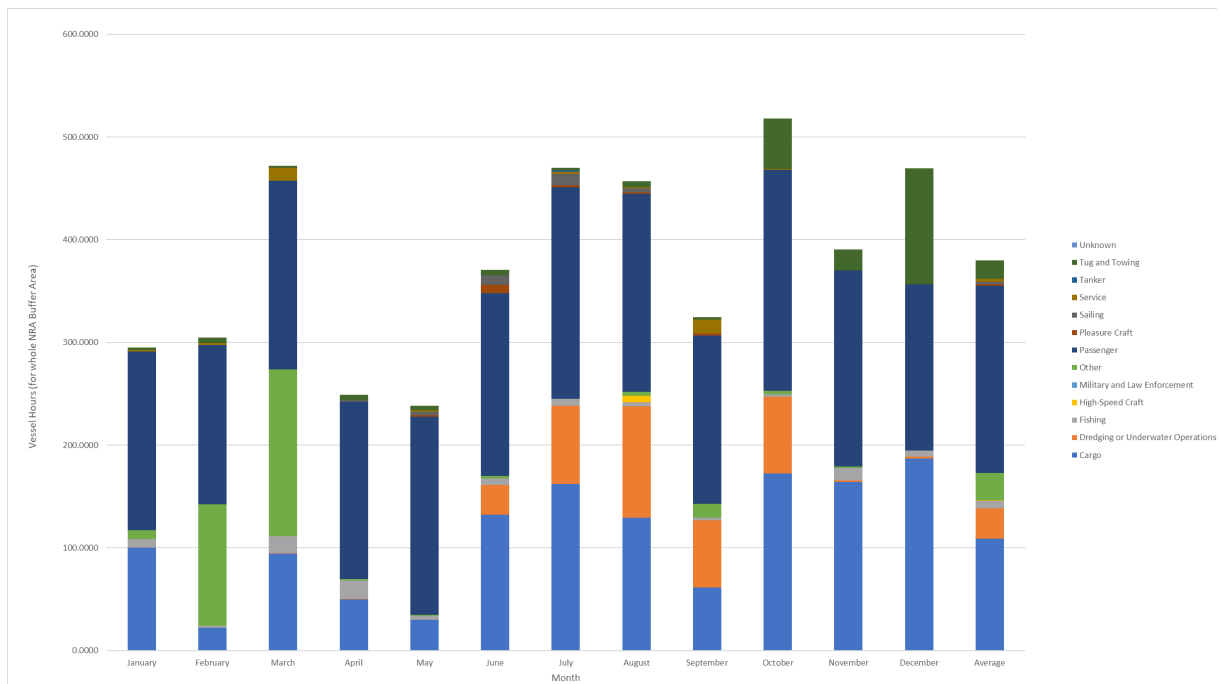
**Figure 3-8 Seasonality Changes in Vessel Traffic Across the 2.2 Shetland – Yell Study Area**

Seasonal distribution of the vessel traffic has been analysed in across the cable corridor and is highlighted in **Figure 3-8**. It is hard to discern any seasonal pattern across the study area with the quietest months being January, February, April and May.

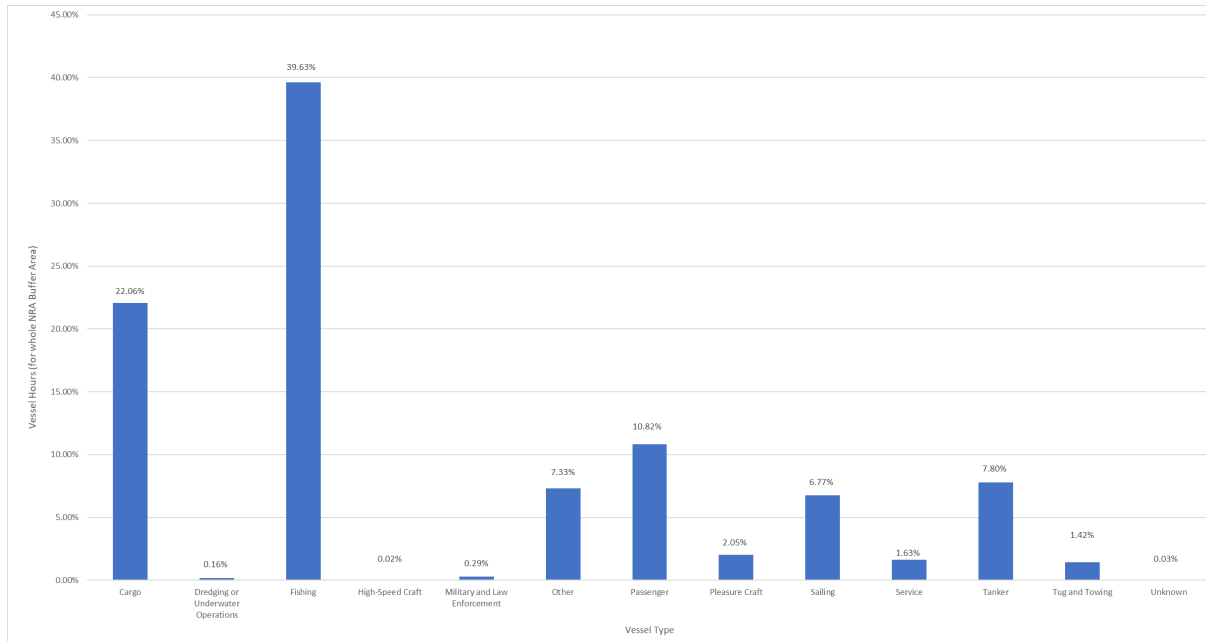
**Figure 3-11 Vessel Distribution Across the 2.3 Shetland – Sanday Study Area**

A total vessel density of 11324 hours per month were recorded across the study area in 2019. The percentages of the vessel categories are presented in **Figure 3-11**. Fishing, Cargo and Passenger make up the majority of the data (39%, 22% & 10% respectively).

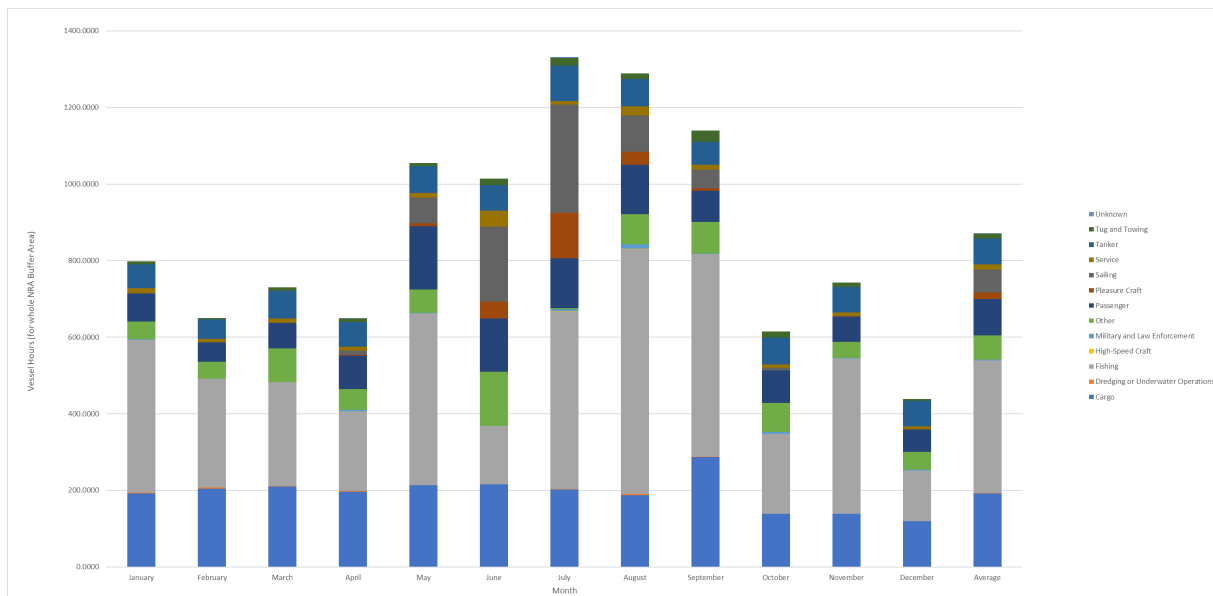
**Figure 3-12 Seasonality Changes in Vessel Traffic Across the 2.3 Shetland – Sanday Study Area**

Seasonal distribution of the vessel traffic has been analysed in across the cable corridor and the busiest months are observed between May to September. **Figure 3-12** highlights the seasonal changes.

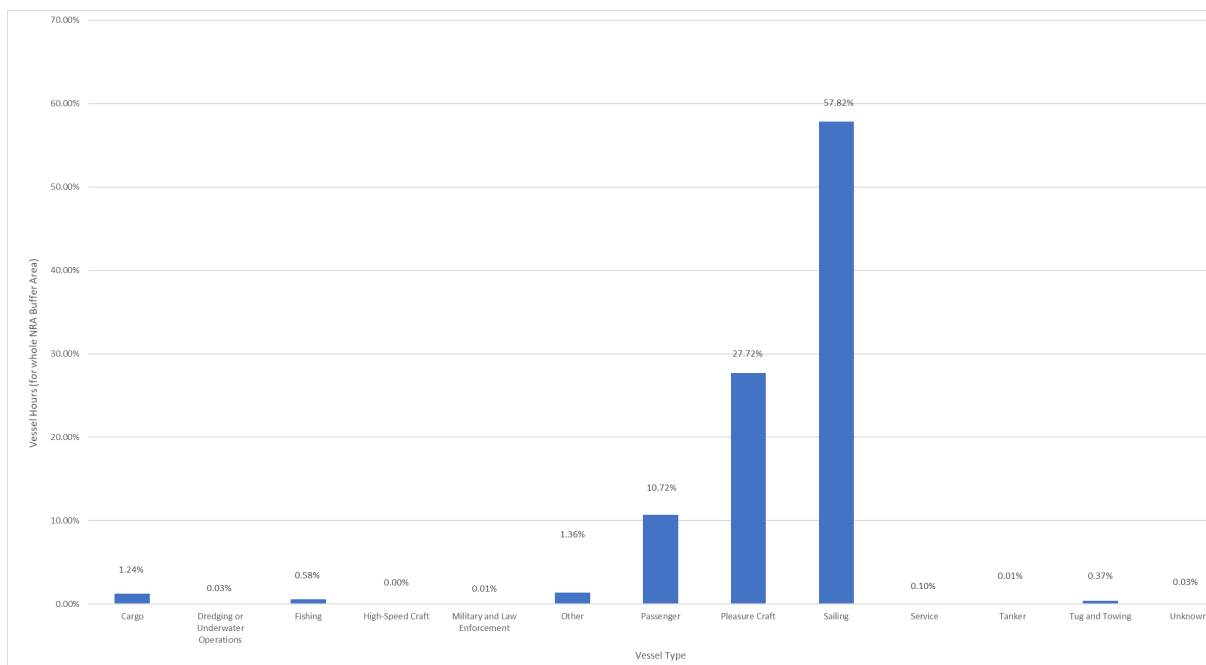
**Figure 3-15 Vessel Distribution Across the 2.4 Fair Isle – BU Study Area**

A total vessel density of 2434 hours per month were recorded across the study area in 2019. The percentages of the vessel categories are presented in **Figure 3-15**. Sailing vessels make up over half of the data (57%) and pleasure craft 27%. Passenger vessels make up just over 10% indicating that this area is predominantly used for leisure activities.

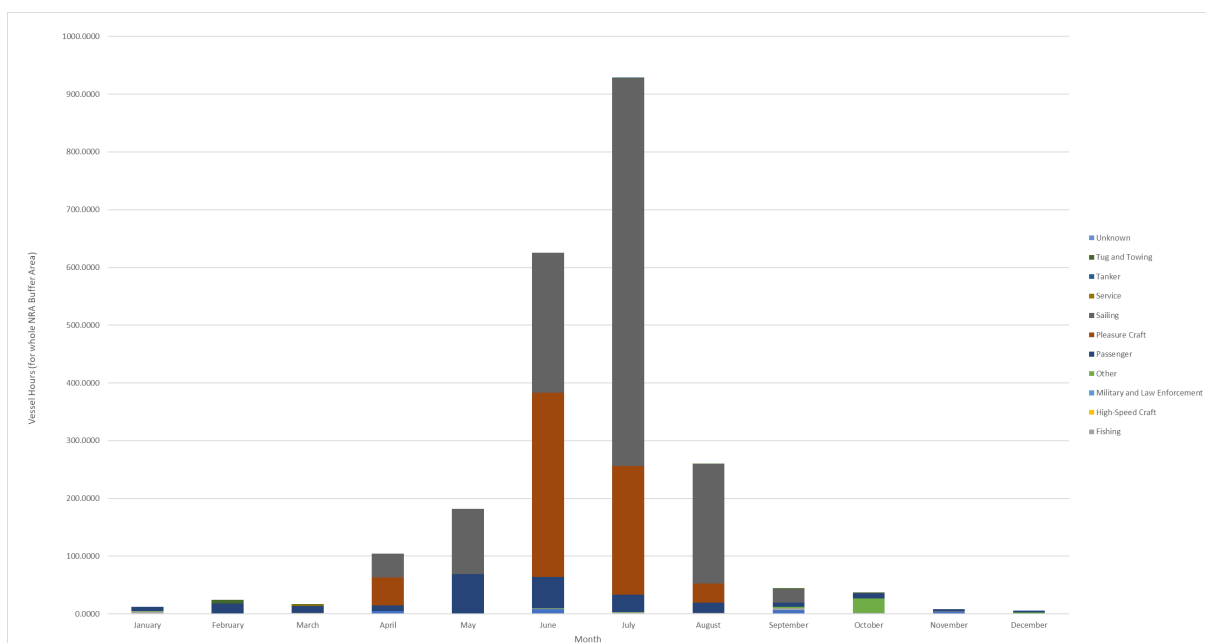
**Figure 3-16 Seasonality Changes in Vessel Traffic Across the 2.4 Fair Isle – BU Study Area**

Seasonal distribution of the vessel traffic has been analysed in across the cable corridor and the busiest months are observed between June and July. **Figure 3-16** highlights the seasonal changes.

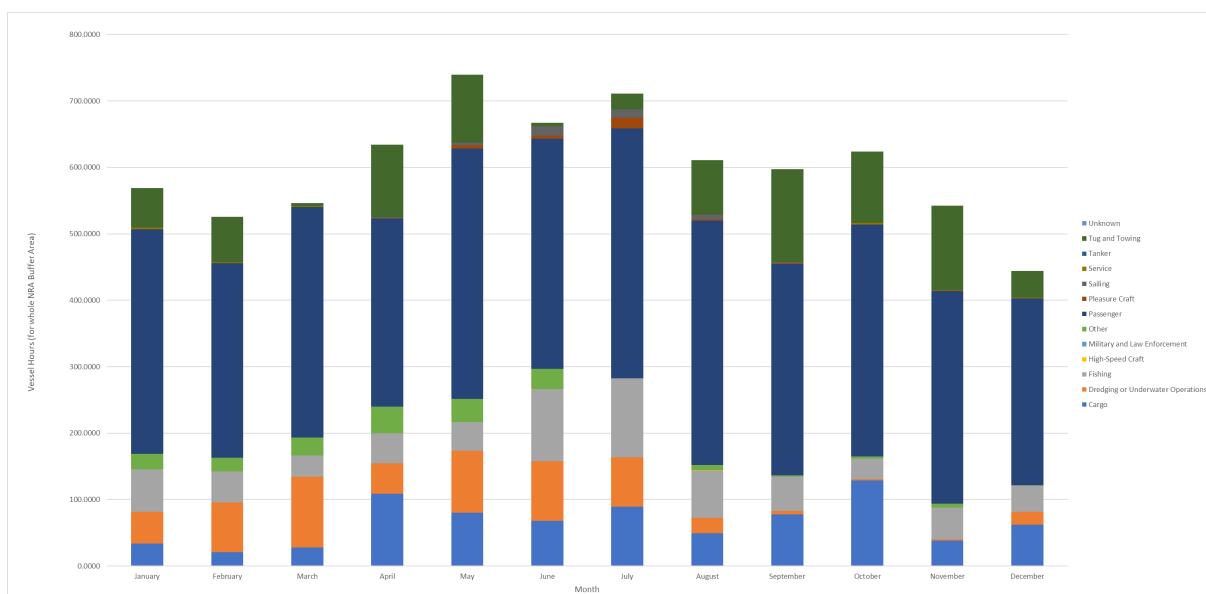
**Figure 3-19 Seasonality Changes in Vessel Traffic Across the 2.8 Shetland – Whalsay Study Area**

Seasonal distribution of the vessel traffic has been analysed in across the cable corridor. **Figure 3-19** highlights the seasonal changes noting that there are no real discernible seasonality changes with the exception of the quietest month in December. It can also be observed that the intensity of passenger vessel is similar all year round.

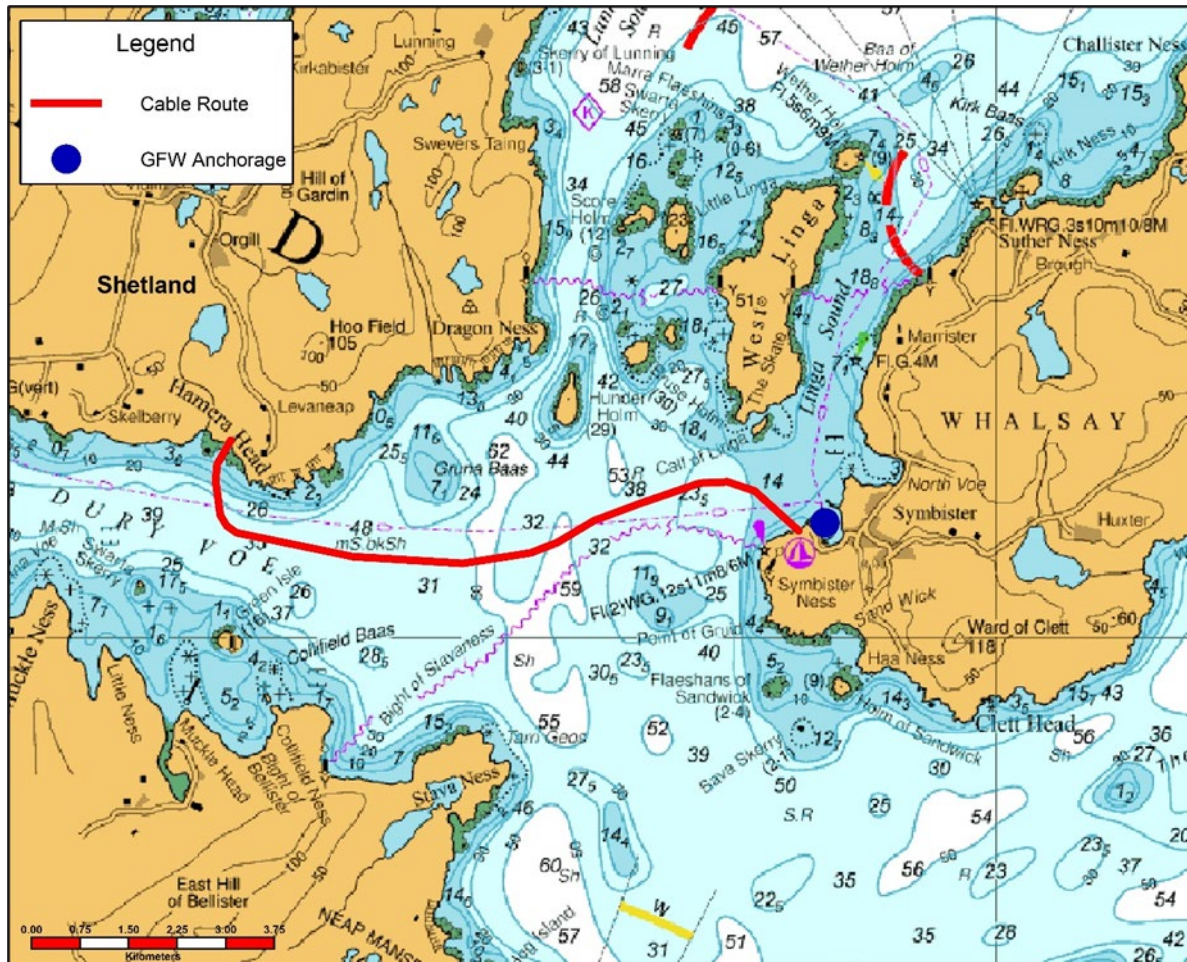
**Figure 3-23 Designated Anchorage near Cable corridor 2.8 Shetland - Whalsay (ref 8)**

An undesignated anchorage is present within port limits of Symbister Bay, as well as a designated and uncharted anchorage nearby in North Voe. The latter anchorage is for buoyed anchors only, since the seabed is foul with old moorings. **Figure 3-23** highlights the anchorage in this area and the cable corridor avoids this to the southwest.

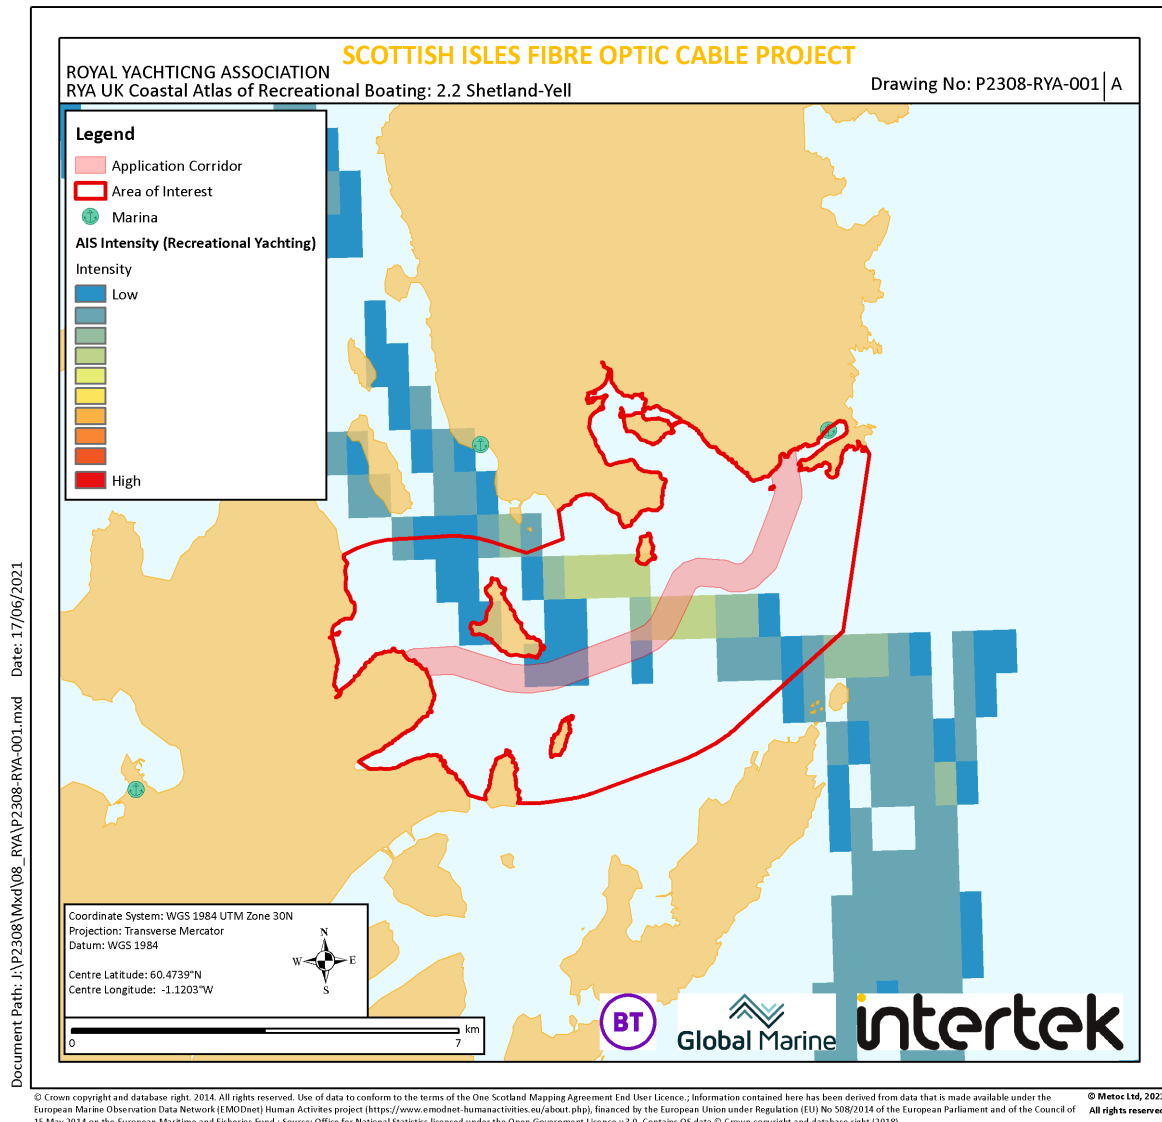
Figure 3-25 RYA Data Across the 2.2 Shetland – Yell Study Area

The recreational vessel density across the study area is generally Low. There are no general boating areas or clubs in the area. There are two mariners present which may indicate that smaller recreational vessels that do not transmit AIS are low in number.

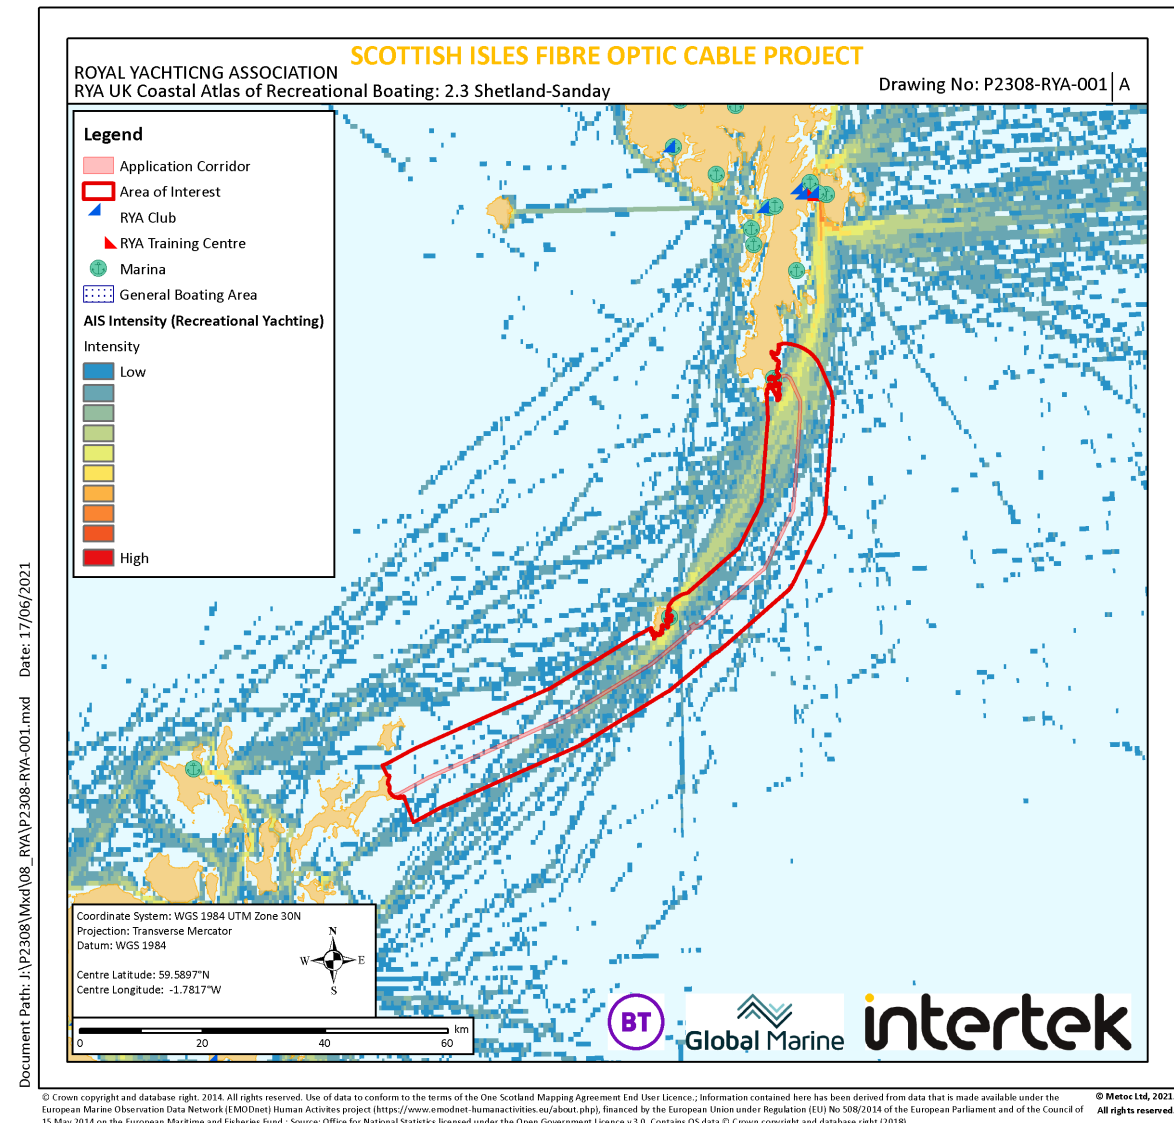
Figure 3-26 RYA Data Across the 2.3 Shetland – Sanday Study Area

The recreational vessel density across the study area is generally Low with Medium density in the northern part of the study area. There are no general boating areas or clubs. There is one mariner on Fair Isle and one mariner in Shetland, which may indicate that smaller recreational vessels that do not transmit AIS are low in number.

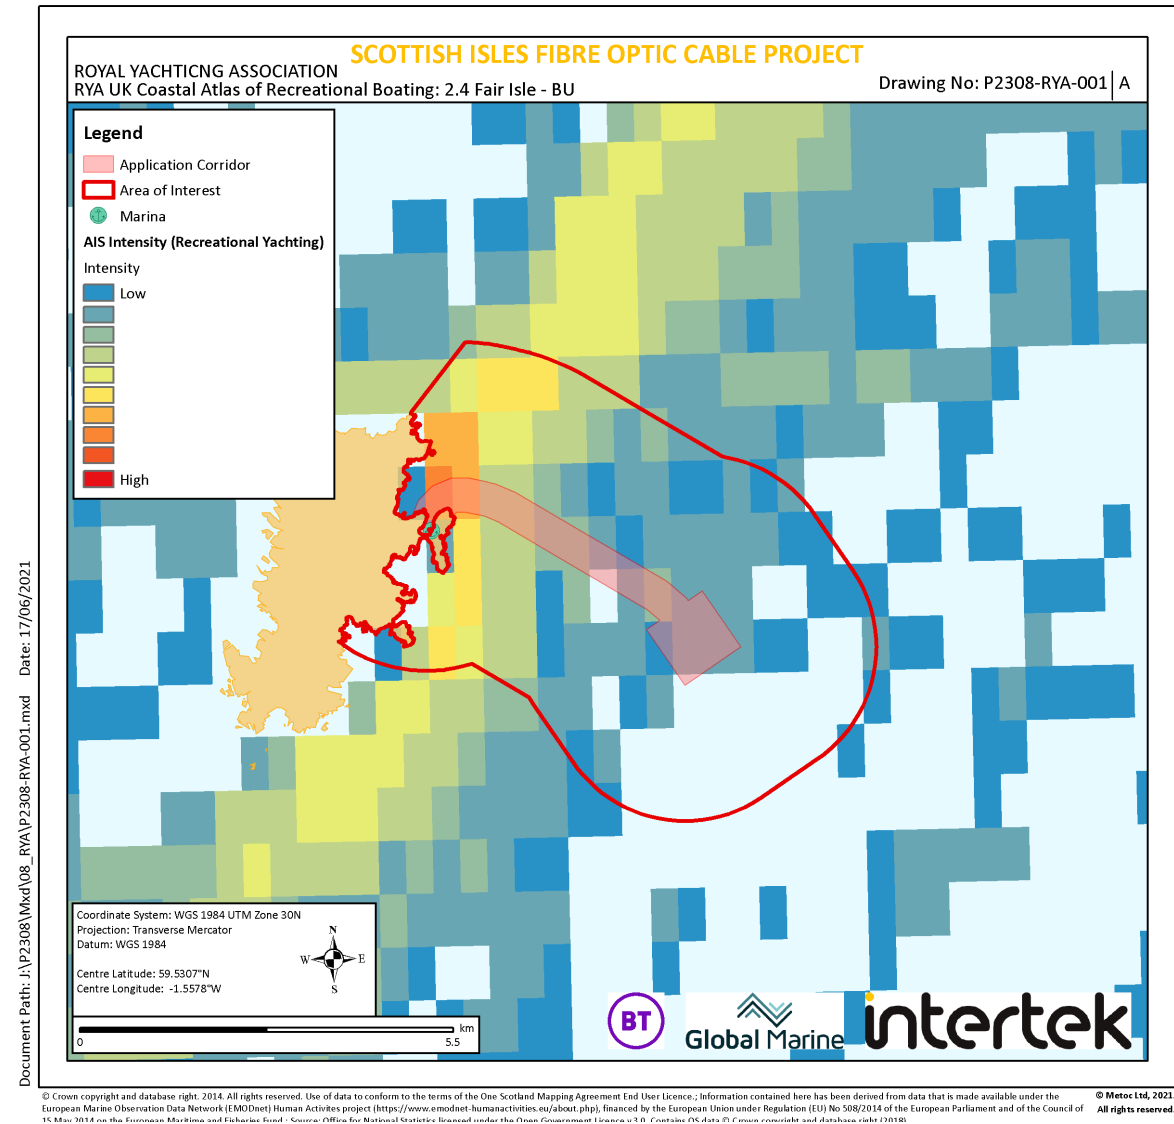
Figure 3-27 RYA Data Across the 2.4 Fair Isle – BU Study Area

The recreational vessel density across the study area is generally Low with one route of medium density transecting the study area. There are no general boating areas or clubs and in the area. One mariner is present which may indicate that smaller recreational vessels that do not transmit AIS are low in number.

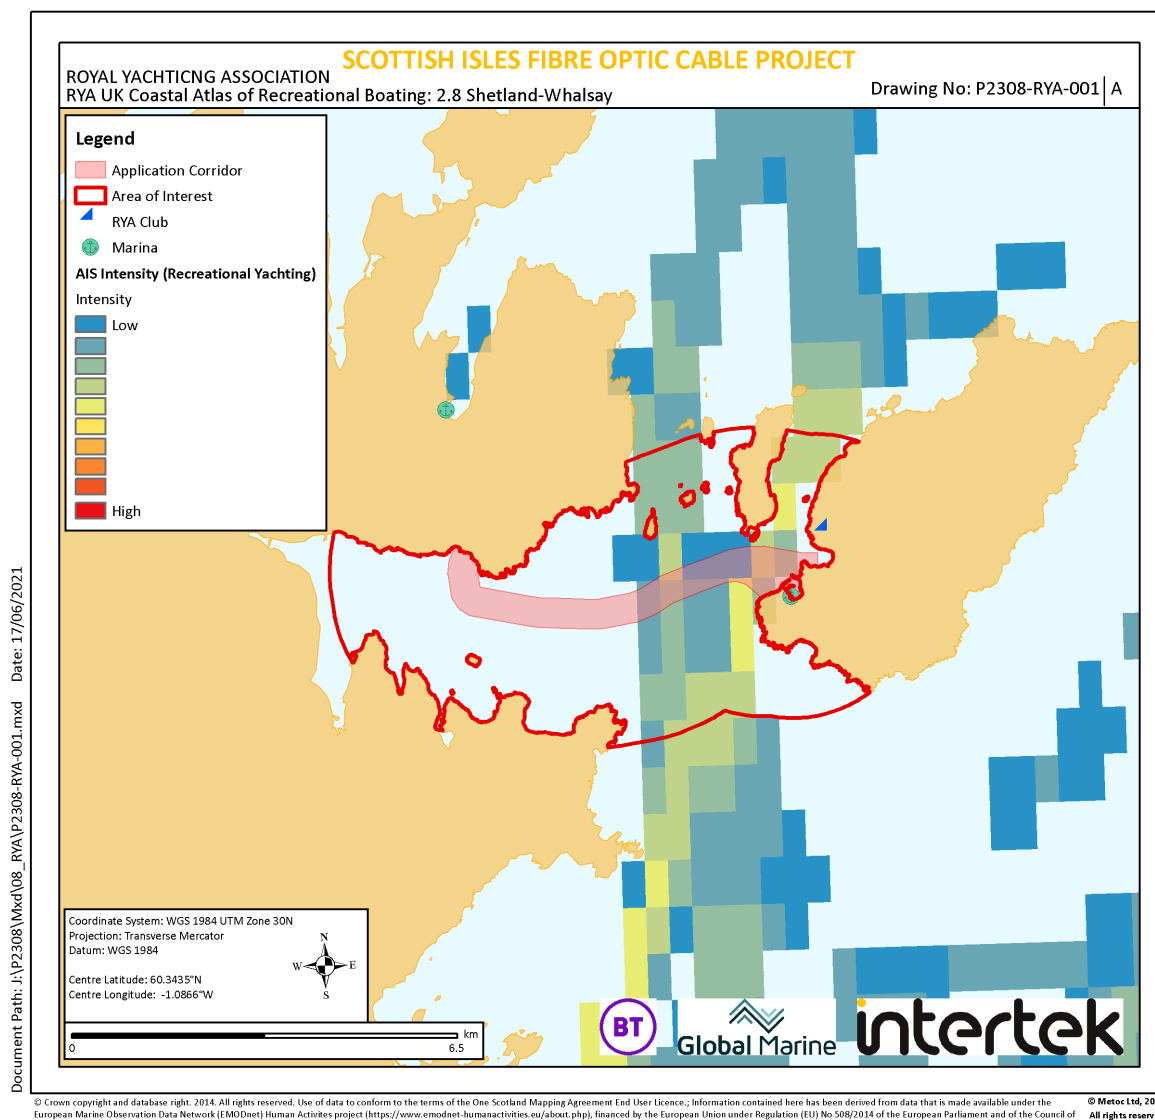
Figure 3-28 RYA Data Across the 2.8 Shetland – Whalsay Study Area

The recreational vessel density across the study area is generally Low with one route of medium density transecting the study area. There are no general boating areas or clubs and in the area. One mariner is present which may indicate that smaller recreational vessels that do not transmit AIS are low in number.

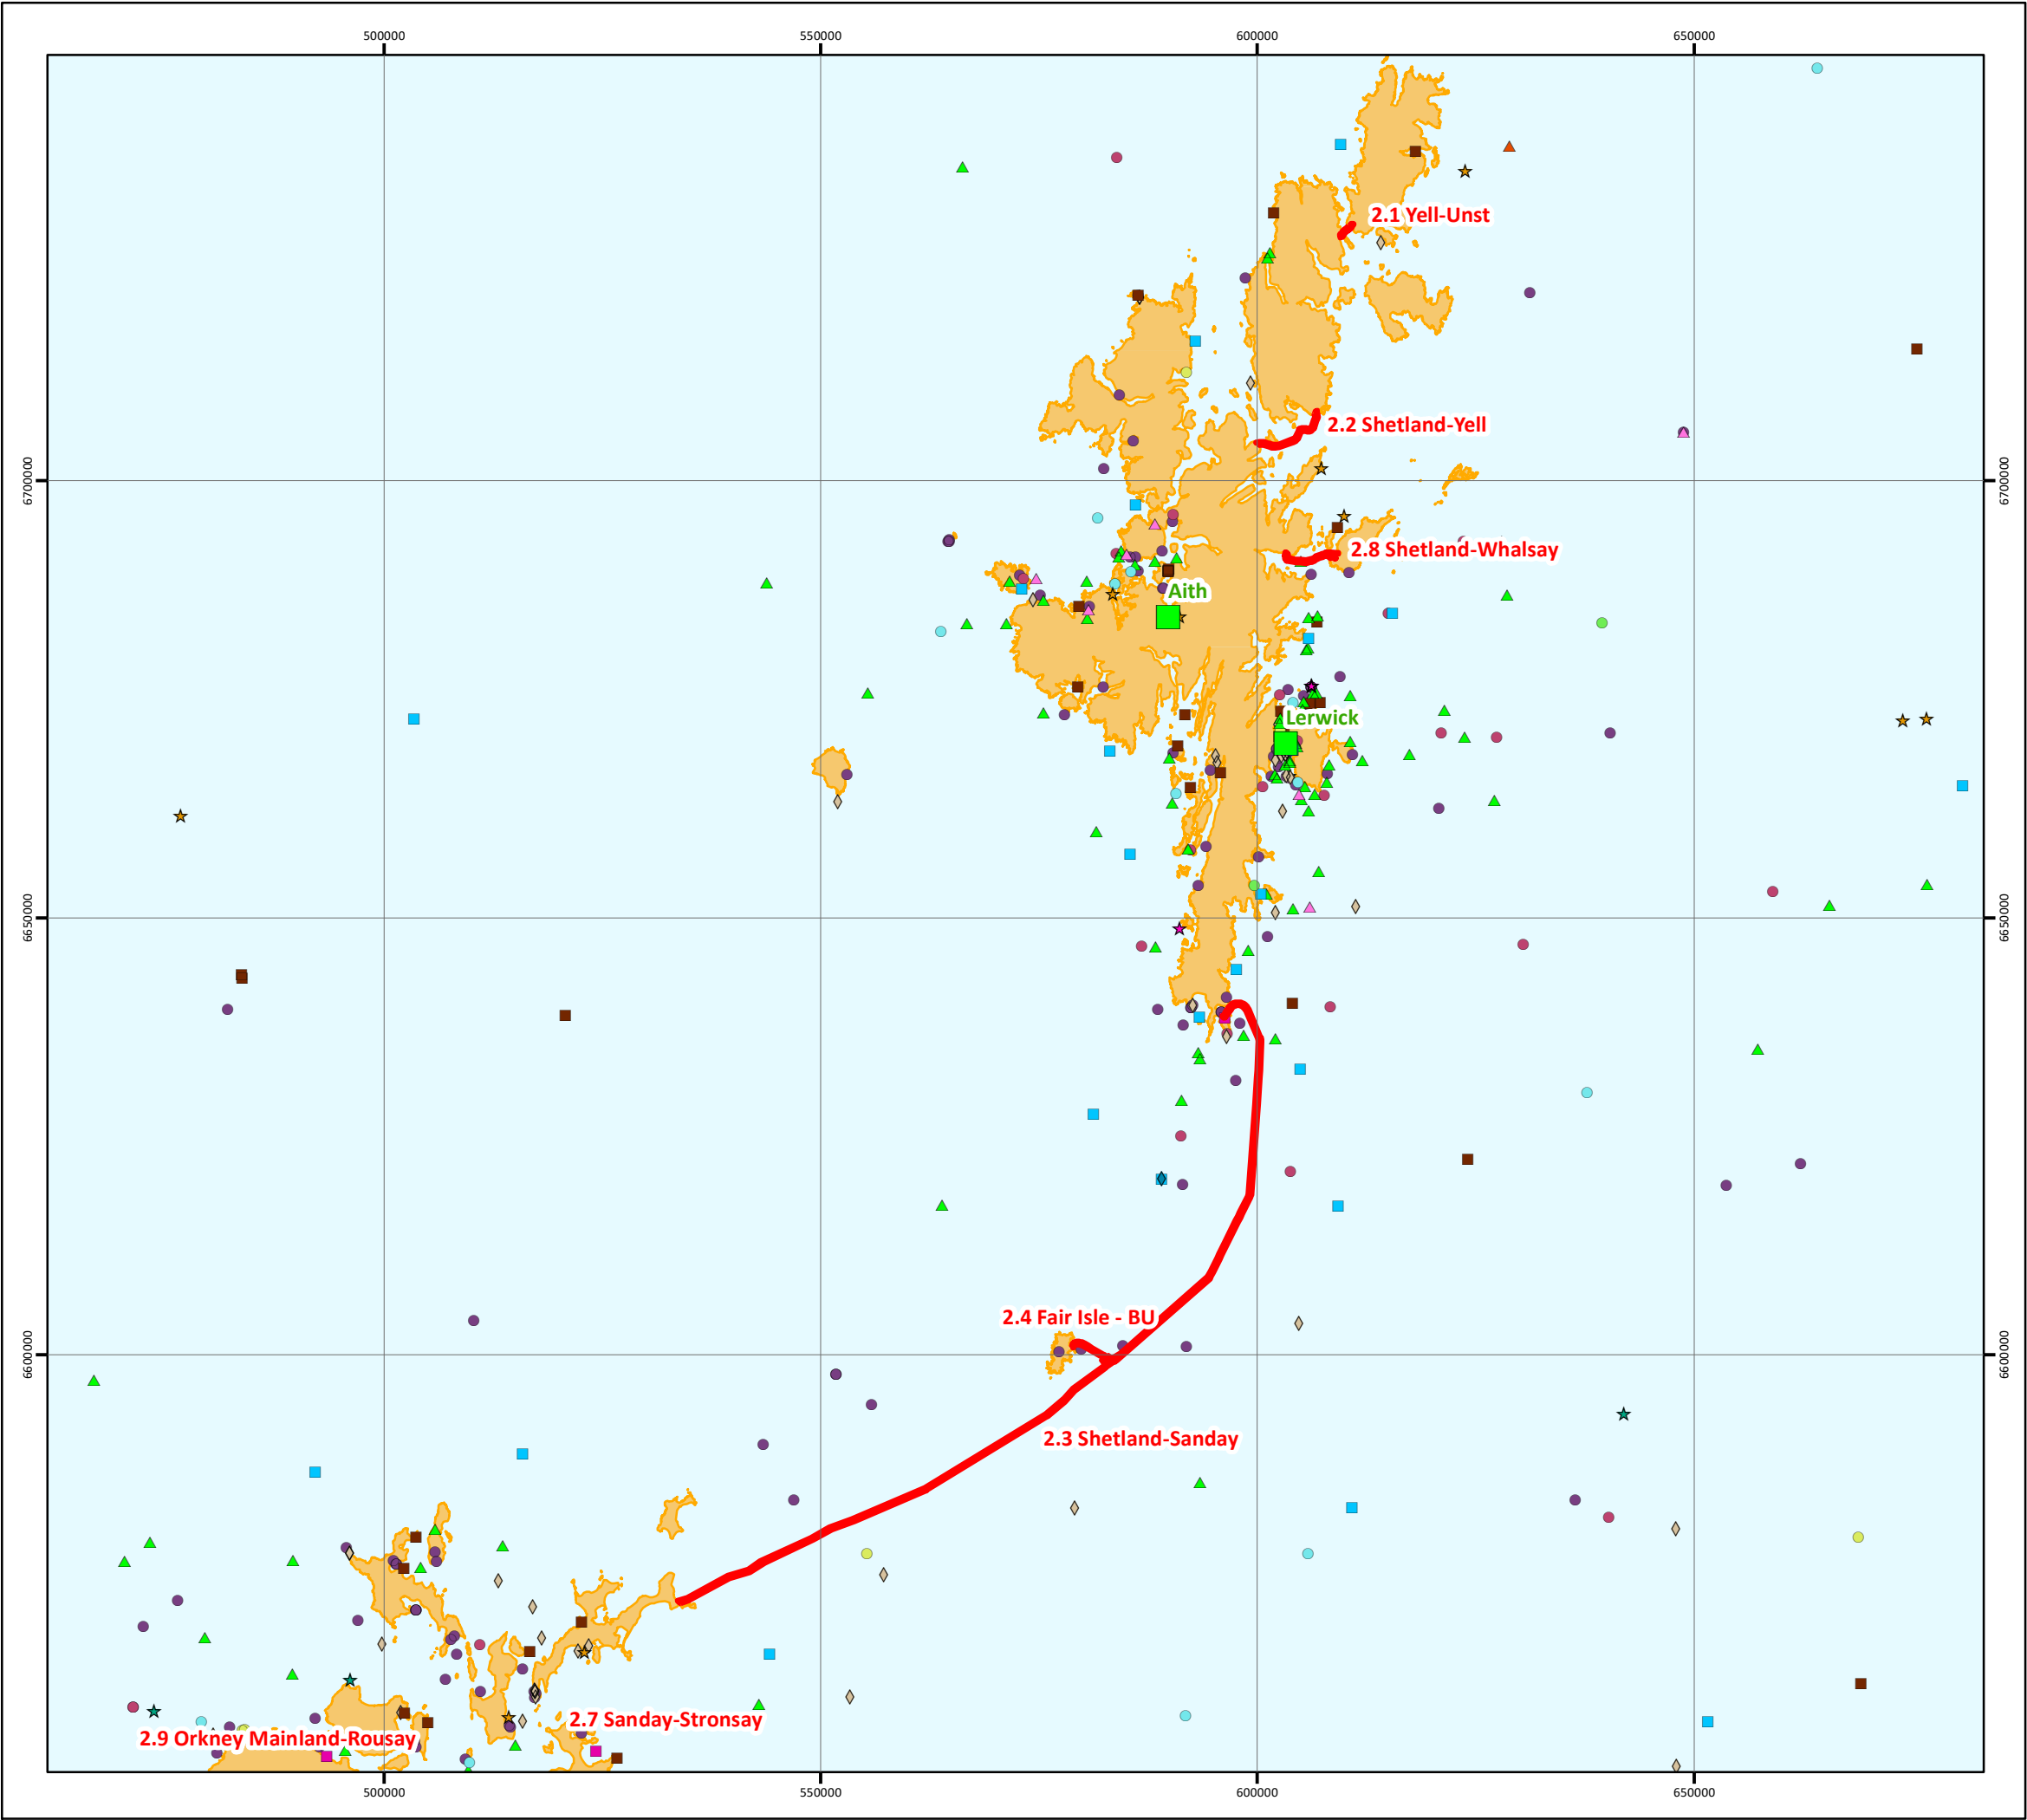
**Figure 3-31** (P2308-RNLI-001\_SH) presents the locations of incidences recorded by the RNLI.

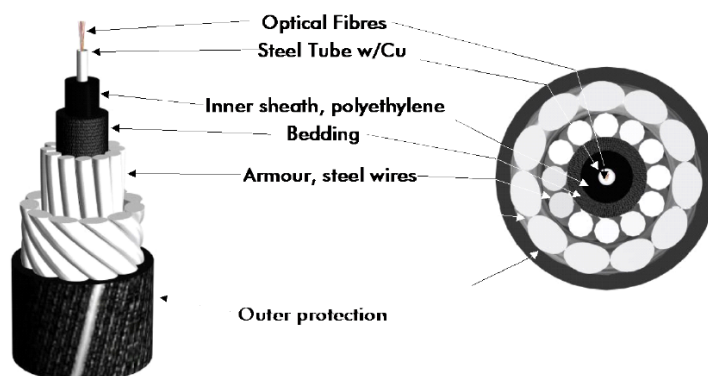
**Figure 2-1 Cross section of URC-1 fibre optic cable (rock armour variant)**

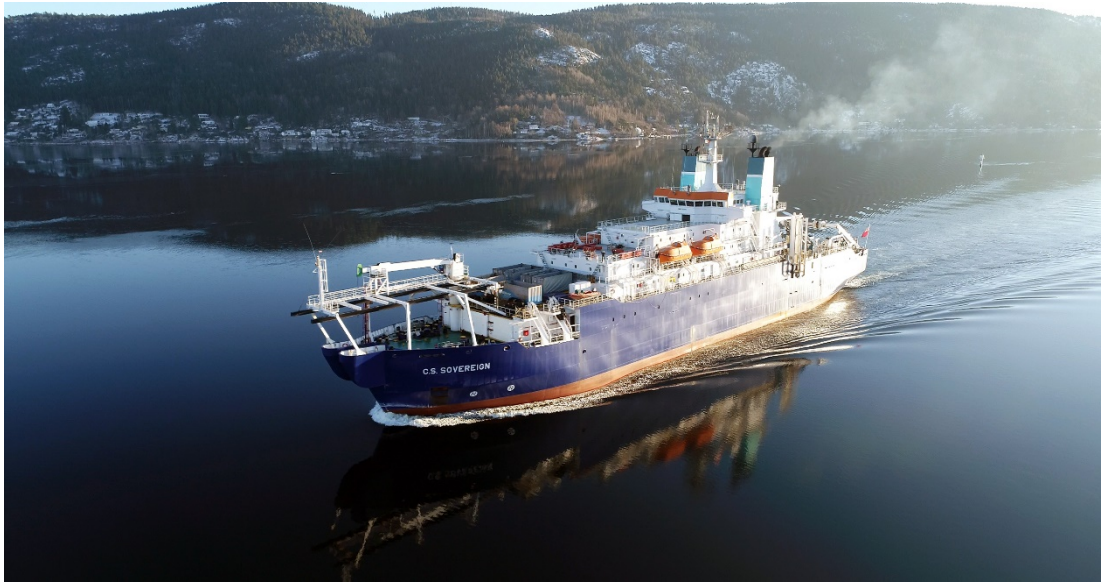
**Figure 2-4 Typical MLV**

The MLV is a specialist ship equipped with dynamic positioning systems, designed specifically to carry and handle long lengths of armoured fibre-optic cable (Figure 2-4). A plough and ROV will be mobilised to the vessel for cable laying activities. Following mobilisation, the cable will be loaded onto the ship at the cable factory and then transit to the worksite.

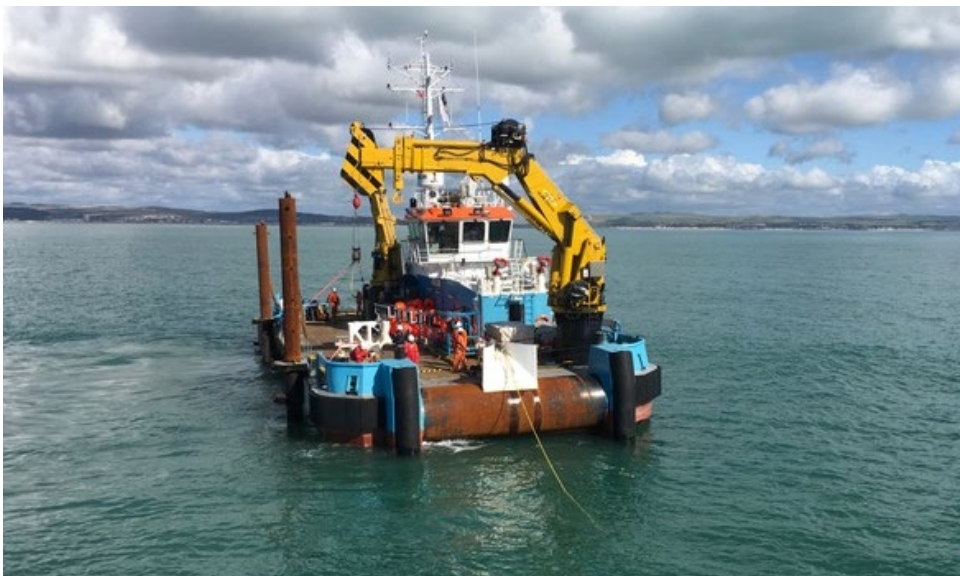
**Figure 2-5 Typical multicat**

A multicat (Figure 2-5) can be mobilised to support either cable installation or cable burial operations in shallow water areas where the main lay vessel cannot access. The vessel would be mobilised with a small deck spread to support cable storage and installation equipment as cable engine and cable chute, along with a burial tool and support equipment.

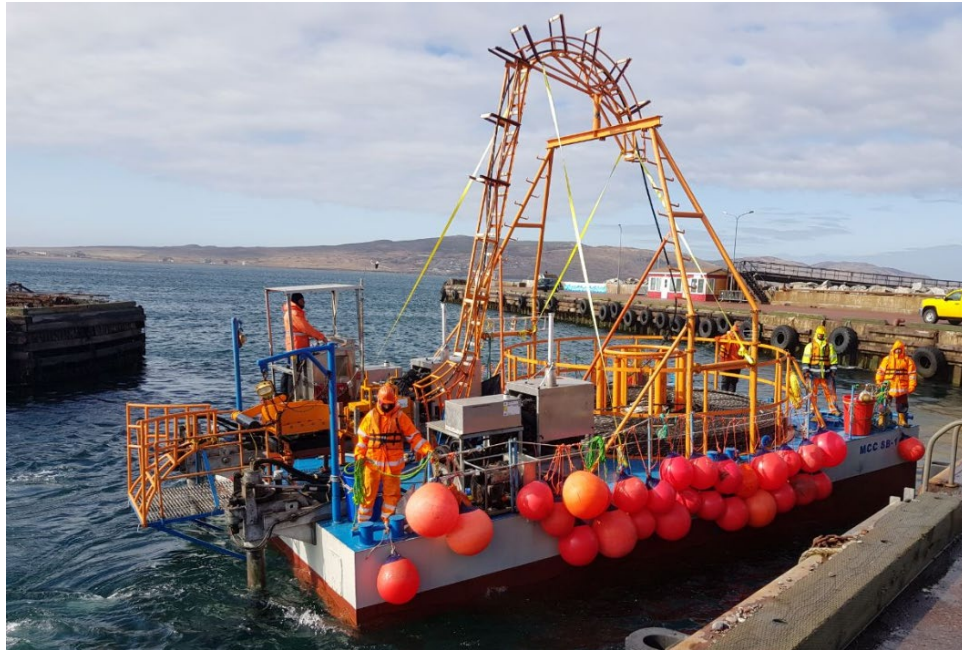
**Figure 2-6 Barge**

A self-propelled barge can be mobilised to support either cable installation or cable burial operations in shallow water areas where the main lay vessels or multicats cannot access. The vessel would be mobilised with a small deck spread to support cable storage and installation equipment as cable engine and cable chute, along with a burial tool and support equipment. Anchor/clump weights will be deployed from a support vessel or from the barge in advance of the works.

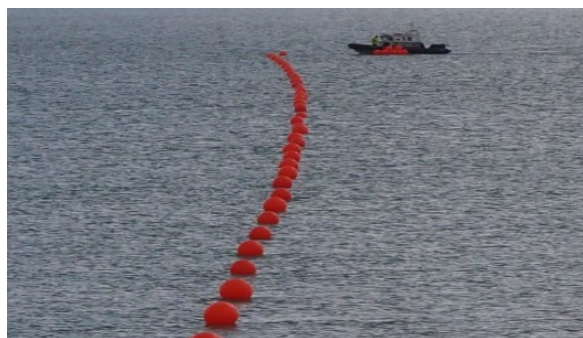
**Figure 2-7 Typical shallow water vessel**

For all shore end and shallow water operations, multiple small inshore vessels (such as RIBs) will be used to support the cable pull in, the lowering of the cable onto the seabed and any burial of the cable in waters depths less than 15m (Figure 2-7).

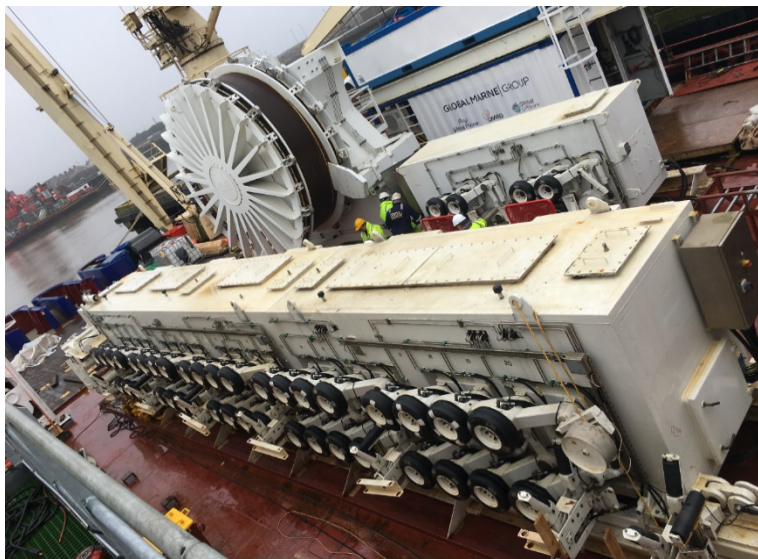
**Figure 2-8 Typical Cable Engine**

The MLV installs the cable by passing it through the on-board cable engine (Figure 2-8) which assists in moving the cable to the stern sheaves where the cable is over boarded and deployed to the seabed.

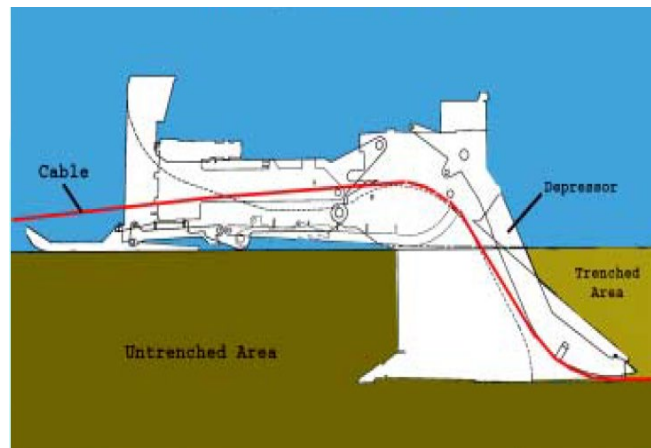
**Figure 2-9 Plough schematic**

The MLV will lay away from the first shore end and bury the cable via the plough as described in Section 2.5.2.2 below. There will be certain sections (such as in areas of hard ground and at crossings (if any)) where the cable will be laid on the surface of the seabed and will not be ploughed (Section 2.5.3).
