# BRITISH TELECOMMUNICATIONS PLC

## R100 Shetland Isles Fibre-optic Project

### Technical Appendix D - Navigation Risk Assessment

R100 Shetland Isles Fibre-optic Project

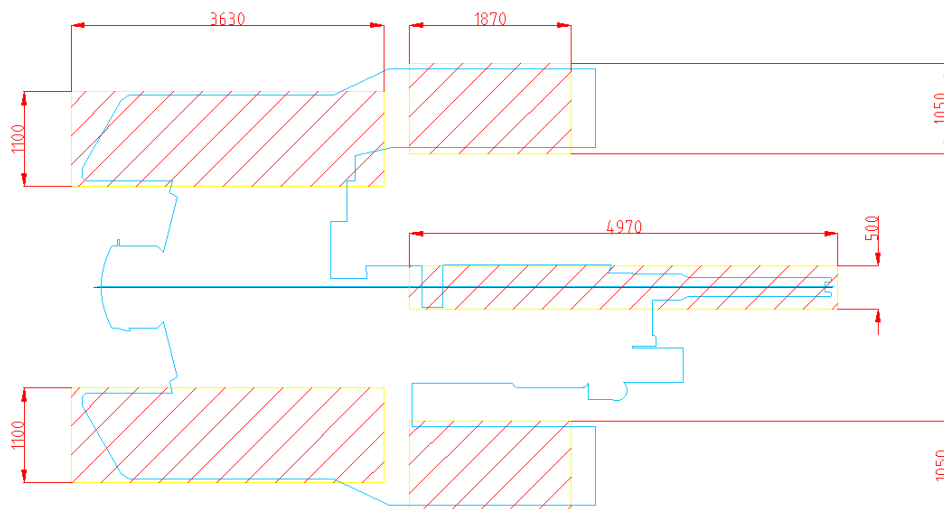
The skids have an approximate footprint of 7m<sup>2</sup> per skid and the share footprint is approximately 2.45m<sup>2</sup>. The plough share width is approximately 0.5m. The sections of the plough in contact with the seabed is outlined in Figure 2-10 and demonstrated by the hatched areas. The plough dimensions are indicative of the size of equipment to be used. Burial by plough will be carried out at a rate of approximately 600m/ hour (depending on sediment type).

**Figure 2-10 Plough footprint**

Note: measurements are in millimetres (mm)

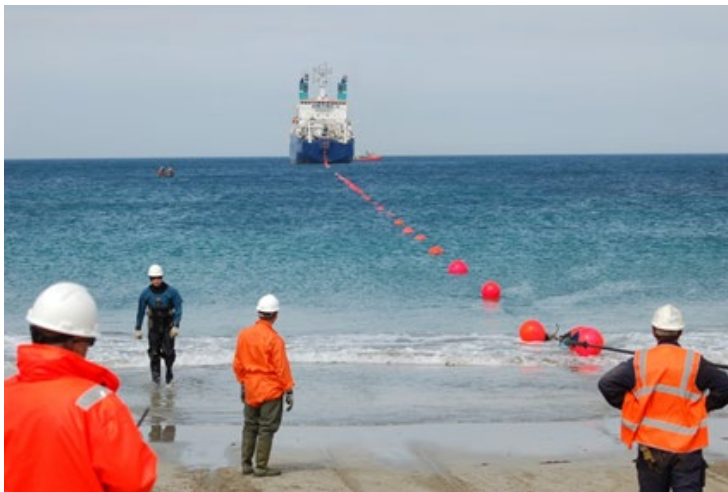
**Figure 2-11 Typical DSE landing from MLV**

Under the control of the Beach Master, the second excavator will commence the pull in of the cable ashore which will be supported in the water by buoys attached to the cable on the MLV/PLSE as it is paid out (Figure 2-11). The excavator will slowly move along the beach while monitoring the cable tension under the control of the Beach Master.

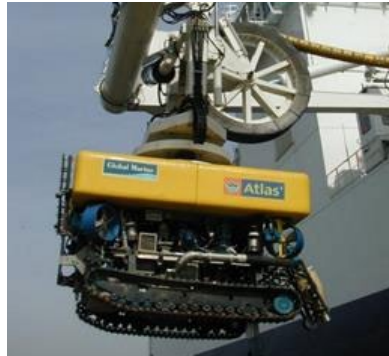
**Figure 2-12 Typical ROV jetting trencher**

On completion of cable laying and plough burial operations there will be areas along the route where it has not been possible to utilise the plough such as In-Service cable crossings where the cable has been surface laid over the third-party cable. These areas of cable will be buried by means of a jetting ROV (Figure 2-12). This operation is referred to as PLIB. The jetting ROV is tracked to allow it to sit on the seabed and follow the cable whilst employing water pumps to inject seawater either side of the cable. This fluidises the seabed and allows the cable to sink below the surface. A typical jetting trencher ROV is shown in Figure 2-12 and Figure 2-13 with two 500mm wide tracks each with a seabed contact length of 2,500mm; the target burial depth is 1m. It should be noted that the seabed will naturally reinstate to its original profile shortly after completion of the works.

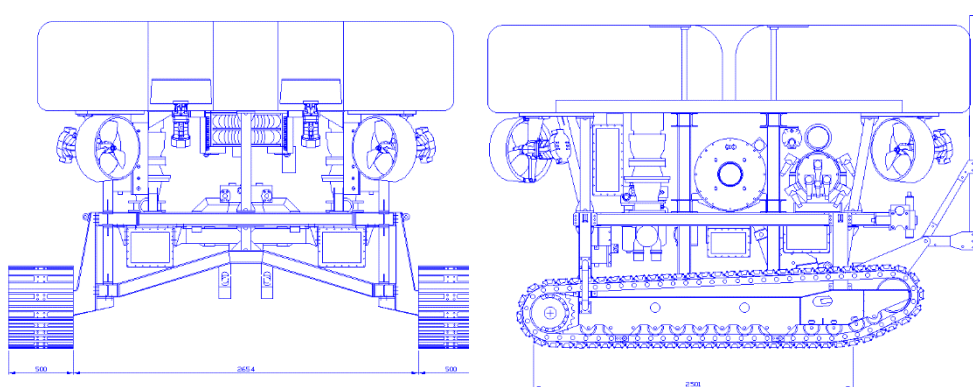
**Figure 2-13 Typical ROV Schematic**

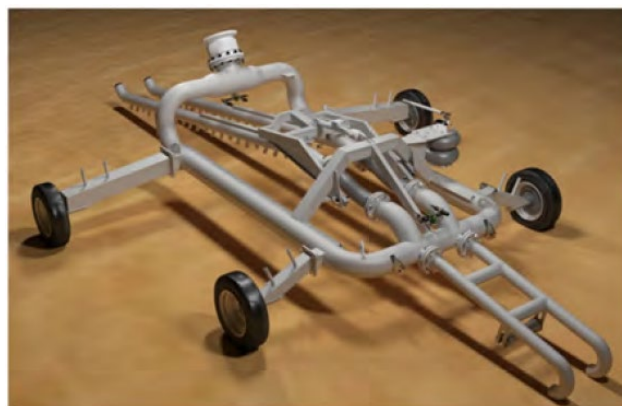
**Figure 2-14 Typical diver assisted jet burial tool**

An ancillary support vessel will set up close to the landfall and the burial tool will be deployed to the beach where the cable will be loaded into the tool. Having run up the water pump, the jet legs will then be lowered to the required PLB depth as it is slowly commencing burial. This operation will

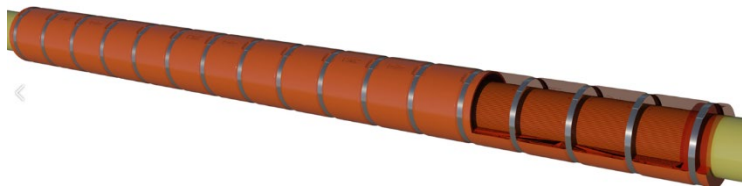
**Figure 2-15 Typical High-Density Polyethylene Protection (HDPE) cable protection**

High Density Polyethylene (HDPE) Protection, Uraduct ® (or similar), is currently the only planned cable protection method for all of R100 cable crossings (Figure 2-15). Uraduct® (or similar) is a well-established anti-abrasive method of cable protection which may be applied 50m either side of the cable crossing (100m in total per crossing). This will provide separation between the installed cable and existing asset. Once installed the Uraduct ® (or similar) is approximately 94mm in diameter. Post lay burial (Section 2.7) will be undertaken to bury the cable to a target depth of 1m if possible following surface lay, subject to the burial status of the crossed assets.

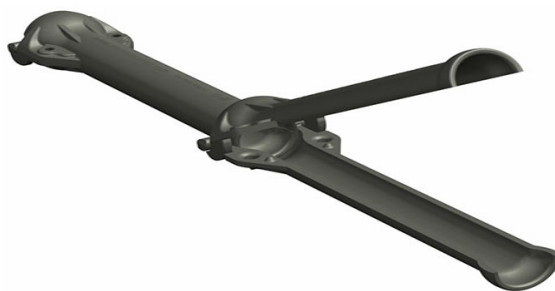
**Figure 2-16 Articulated pipe**

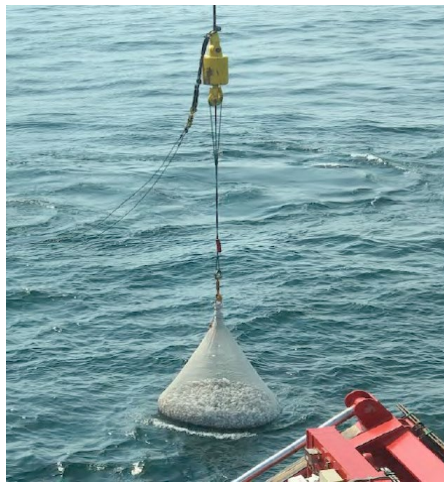
**Figure 2-19 Rock bag deployment**

Rock bags are typically installed on top of the cable and are sized to suit each scenario dependant on current speeds and environmental conditions (Figure 2-19). The size and weight of the rock bags to be used will ultimately be dependent on the findings of the Cable Burial Assessment (CBA) and post installation survey results. The exact number will not be known until after the cable has been installed. A contingency number of rock bags has been provided per cable route (see Table 2-5 below). Typical dimensions of the rock bags likely to be used for R100 are shown in Table 2-4 below.
