## Western Isles Subsea Cable Link

Report identifying additional studies required as part of the Western Isles Subsea Cable Marine Licence Application  
Scottish Hydro Electric Transmission plc

**Document Number:** A-100336-S00-REPT-003

**Document Type:** Technical Note

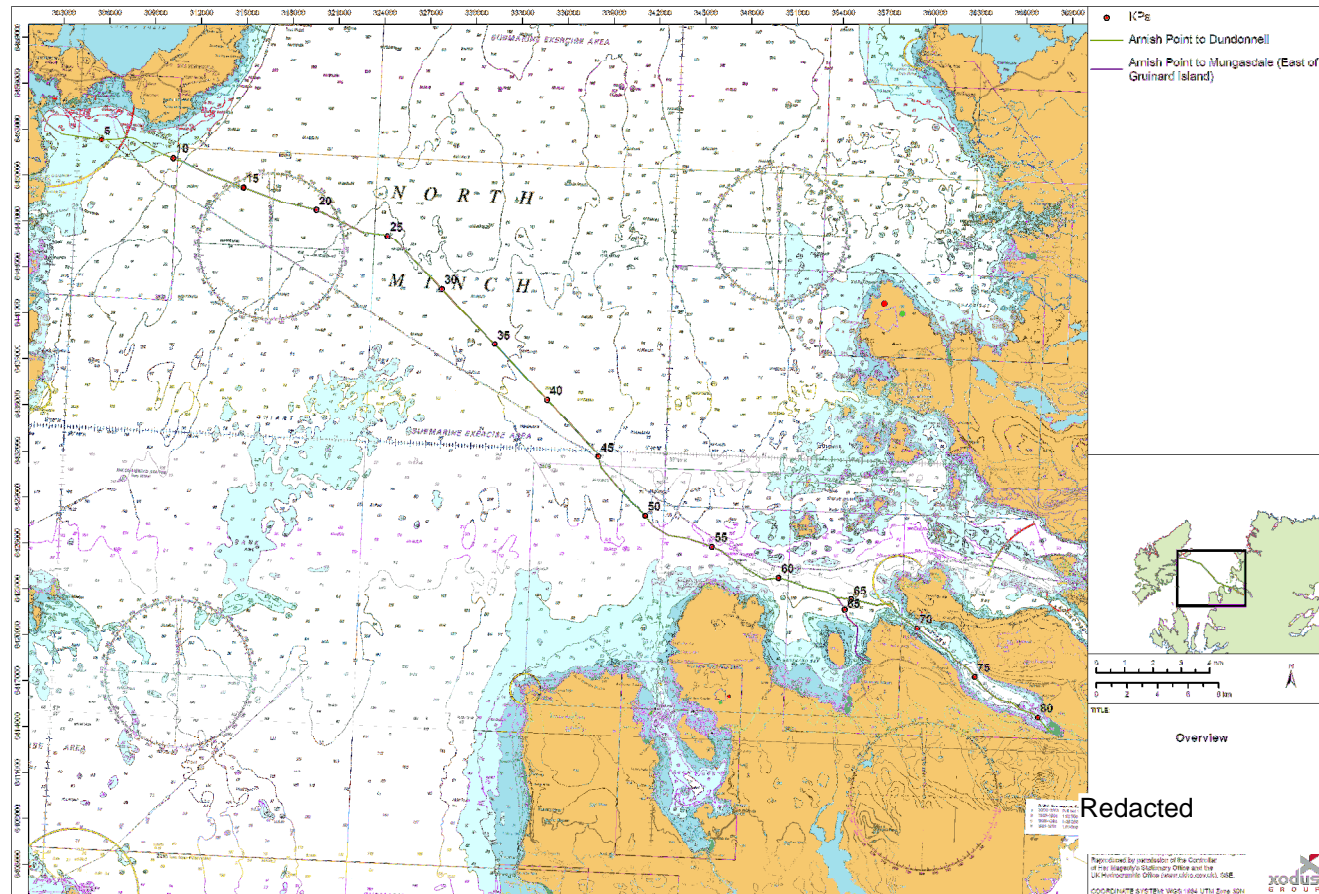
Figure 1.1 Preferred subsea cable route options (Note: KPs are route markers)

The total length of the preferred cable route between Arnish Point and a landfall at Dundonnell, at the end of Little Loch Broom is 82 km.

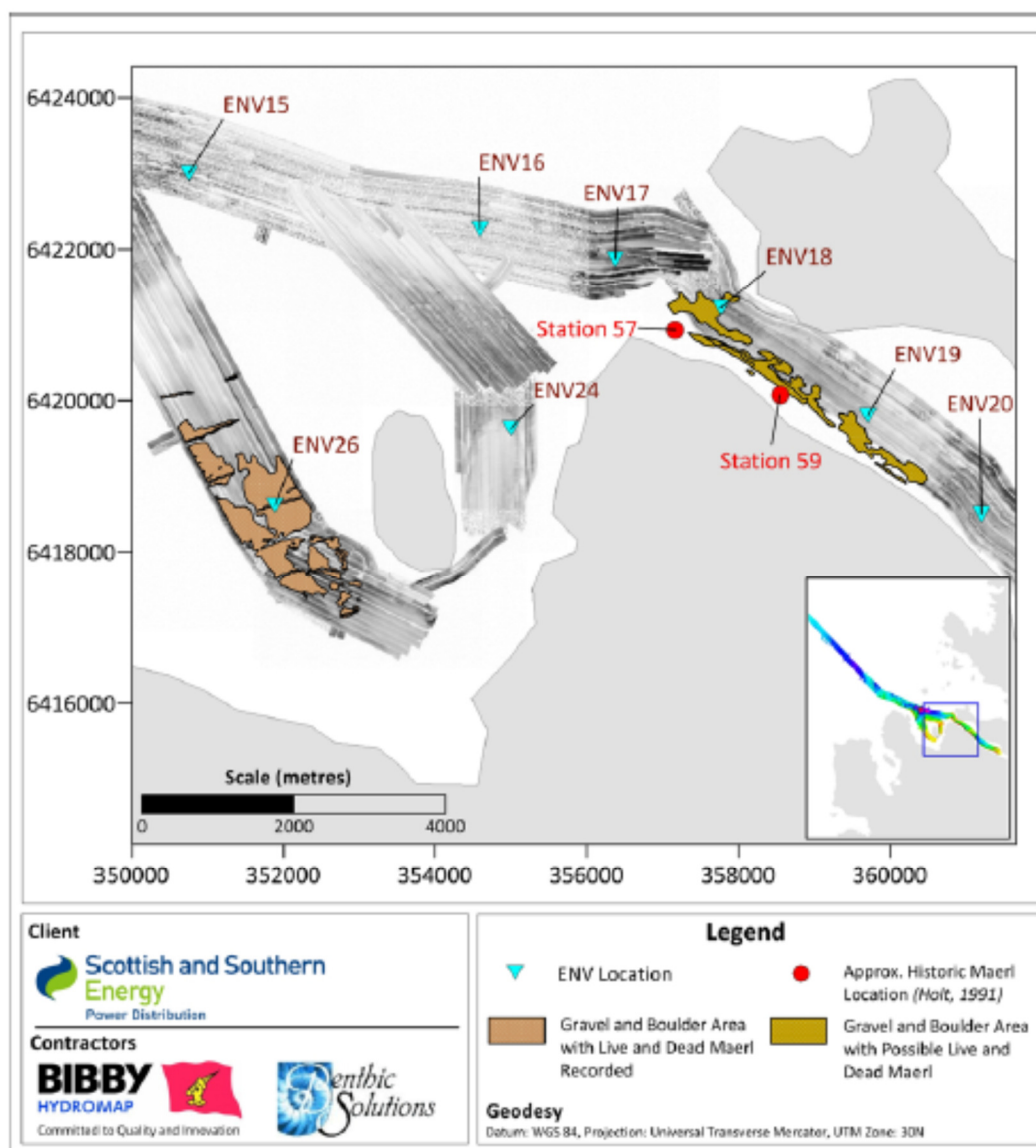
Figure 2.3 Extract from Bibby HydroMap Report (2016a) showing location of maerl identified during marine survey

The results from the survey (Bibby Hydromap, 2017) confirm that both live and dead maerl is present along the proposed route as it passes to the east of Gruinard Island. Further information on the results from the Bibby Hydromap survey is presented in Section 2.4.1. A copy of the survey report is included in Appendix A.

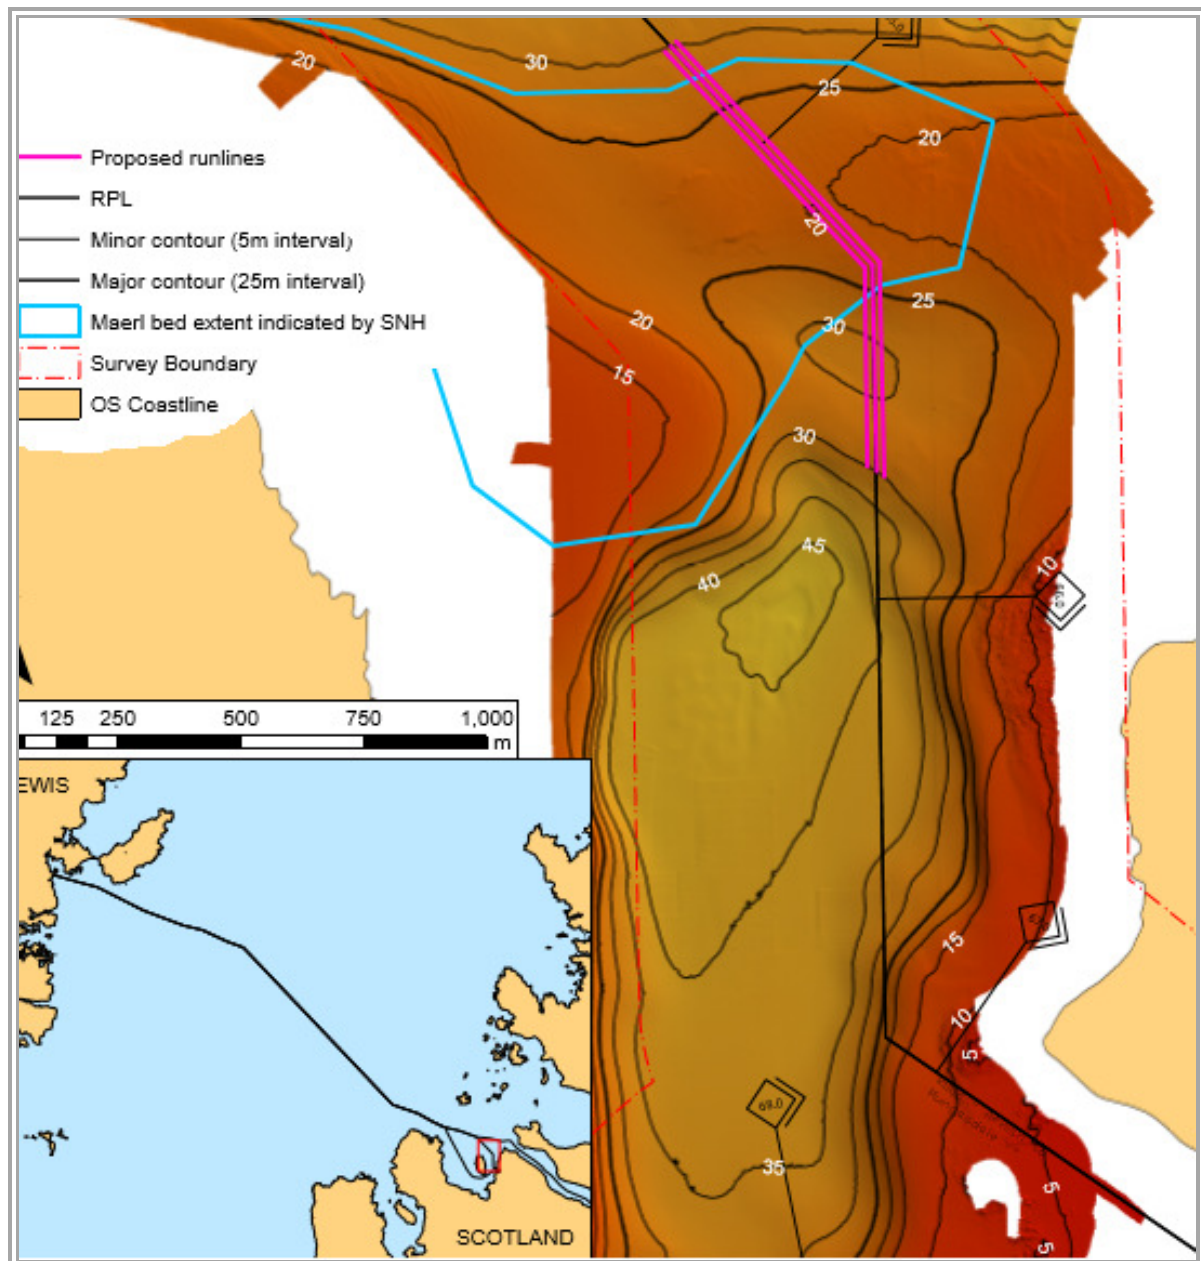
Figure 1: Site Location Plan

Bibby HydroMap were commissioned by SSE in March 2017 to carry out a drop-down camera survey to the north-east of Gruinard Island. The survey was completed under Bibby HydroMap's Terms and Conditions. The survey was carried out by Benthic Solutions and Bibby HydroMap teams on 27/03/2017.

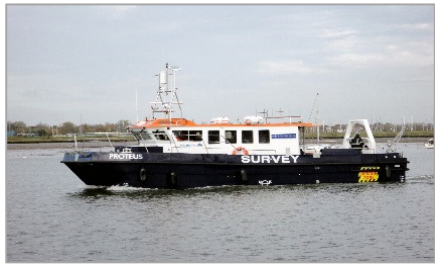
Table 4: MV Proteus Information

Launched in 2013 from Essex, UK, Proteus is a 14m purpose built day running survey vessel.  She has a maximum speed of 24 knots and a draft of 1.1m allowing her to work in a minimum safe working water depth of 3m.

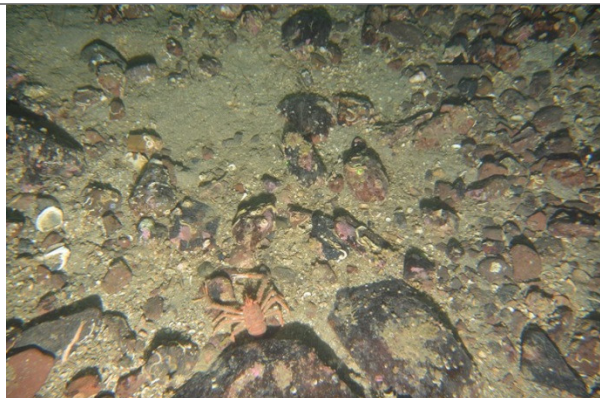
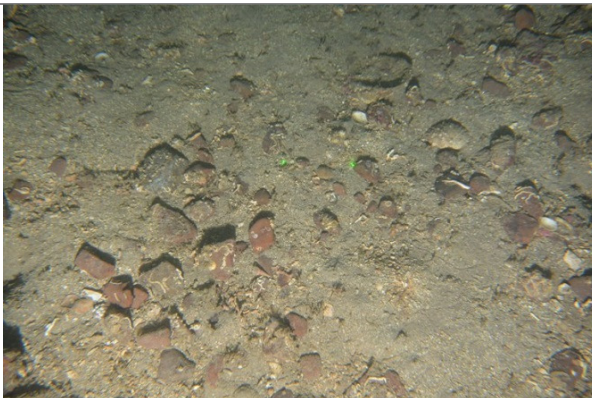
- Nil (maerl absent);
- <5% (occasional branches recorded);
- <25% (maerl aggregations are noted as distinct patches, usually associated with sediment hollows, ripple troughs or sheltered parts of the seabed);
- <50% (maerl recorded in foliose form and covering a larger area);
- >50% (significant coverage by foliose form sometimes in multiple layers with notable low level relief above the natural sediment level); and
- Dead (where dead maerl debris/gravels are recorded), the same scoring system has been applied (between <5% to >50%).

<p>Line - STBD 15m - DSC_0124</p> <p>No live or dead maerl (Nil)</p>	<p>Line - STBD 15m - DSC_109</p> <p>No live maerl, &lt;5% dead maerl</p>

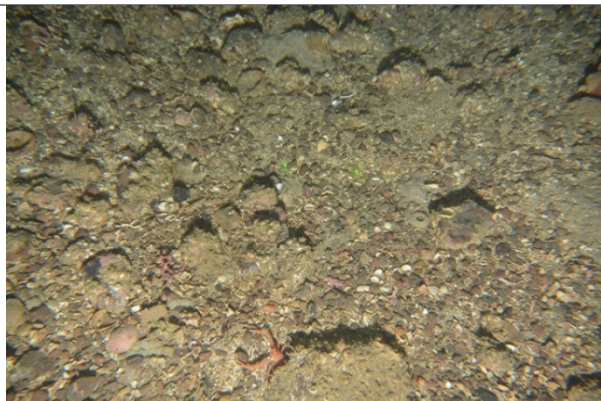
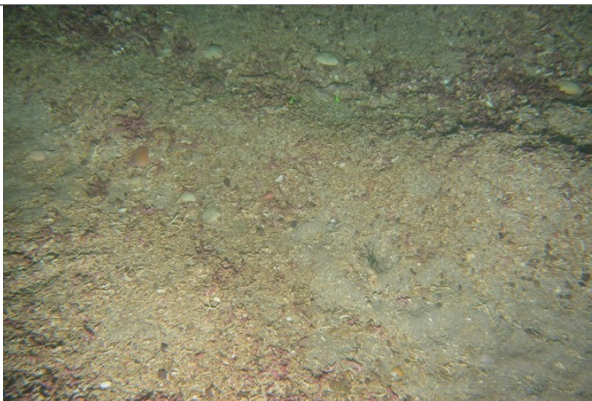
Line - Port 15m - DSC_0213 5% live maerl, no dead maerl	Line - RPL - DSC_105 <25% live maerl, >50% dead maerl

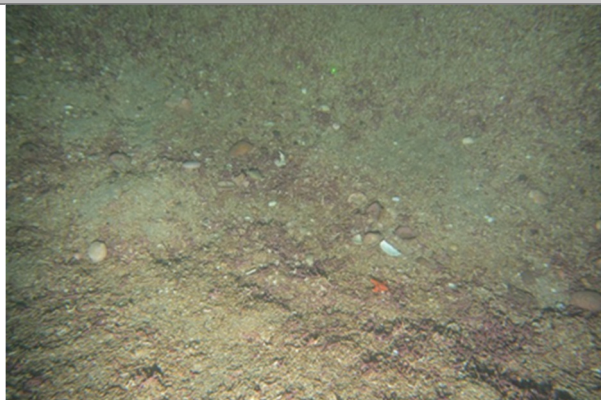
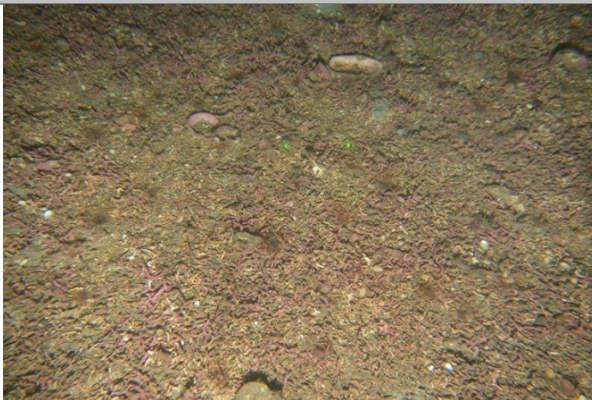
Line - RPL B - DSC_0019 <50% live maerl, >50% dead maerl	Line - Port 15m - DSC_0264 >50% live maerl, <50% dead maerl

\* Lasers are positioned 9cm apart

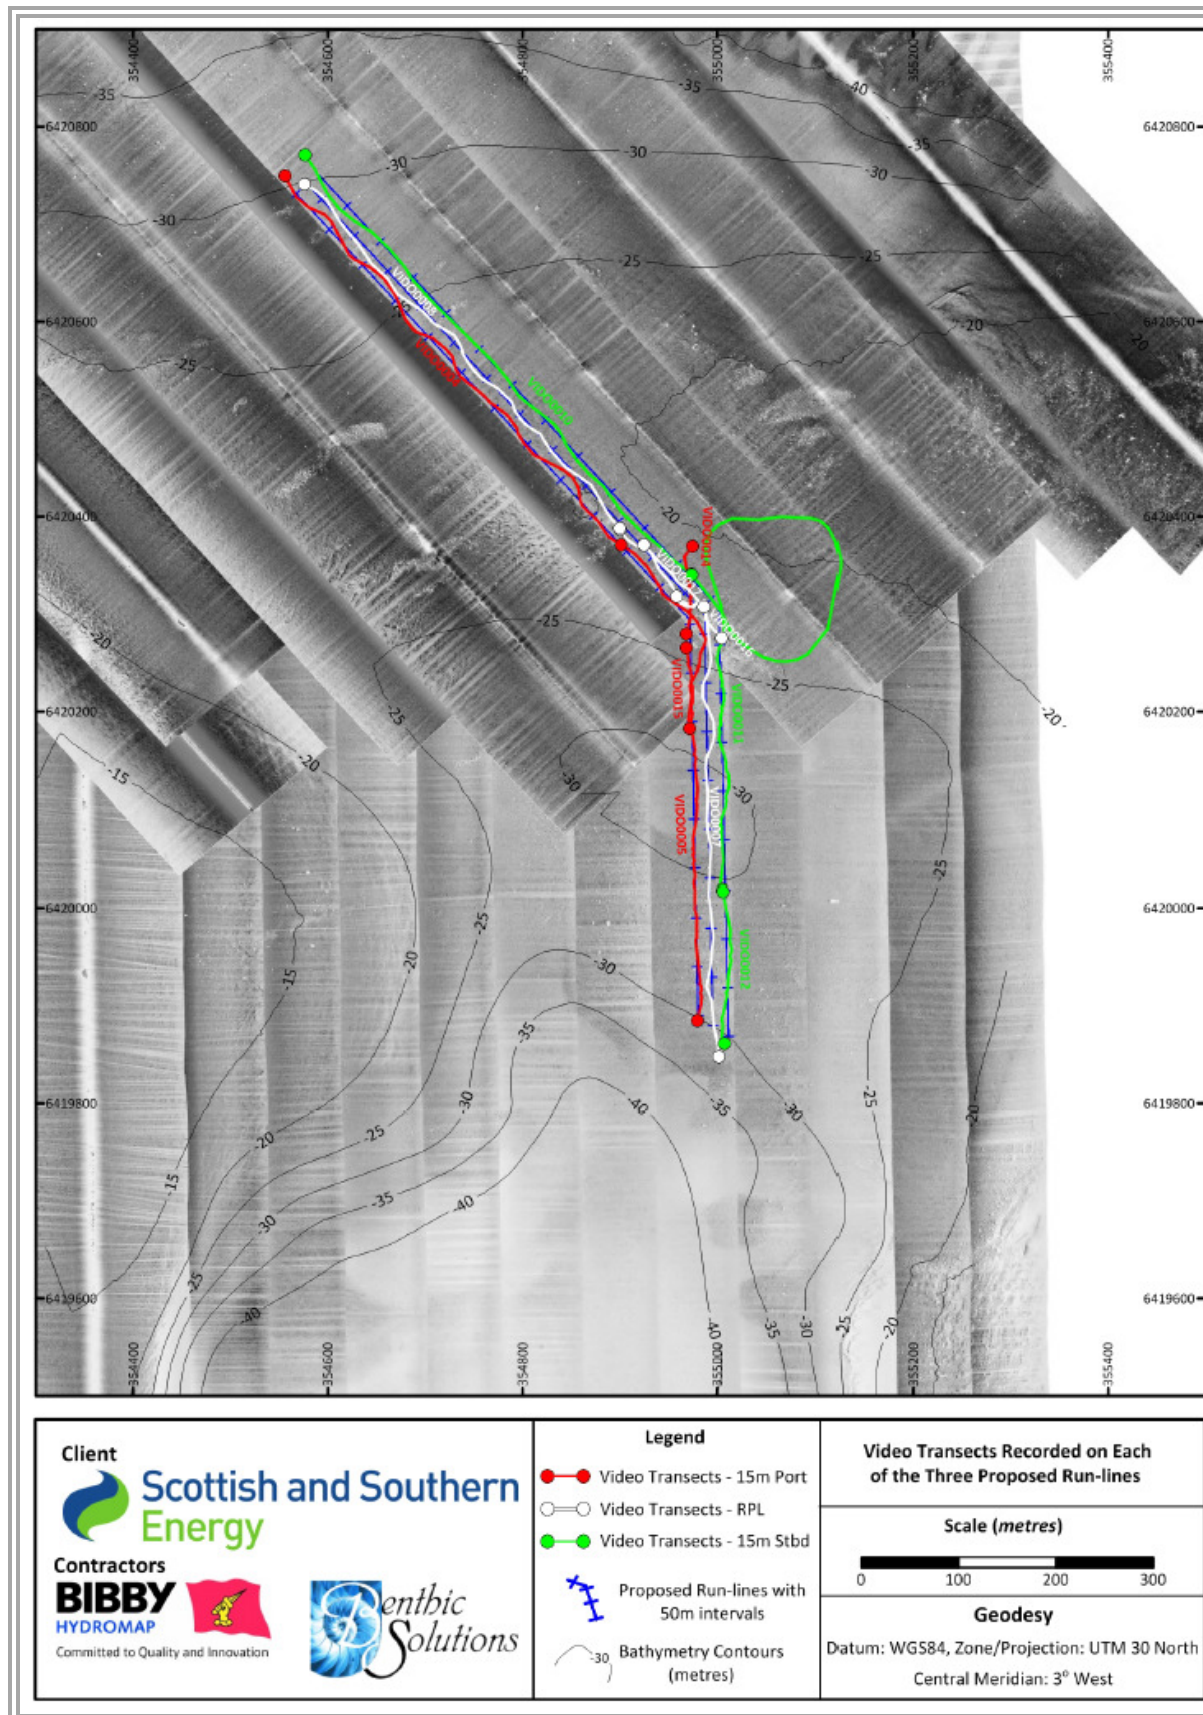
**Figure 3: Video Transects Recorded along Run-lines**

As per scope of work the camera was towed along each of the proposed transects at approximately 0.5 knots with the camera system lowered towards the seabed at 50m intervals in order to obtain a minimum of 5 high quality photos, along with recording HD and surface-streamed video footage. A total of 550 high quality images were acquired over the three run-lines, with approximately 3 hours 14 minutes of HD video footage recorded. The location of each seabed image is presented in Figure 4.1. These data were then analysed to assess the percentage cover of both dead and living maerl, following the scoring criteria listed below in Table 4.1, with the full percentage cover matrix presented in Appendix 3.

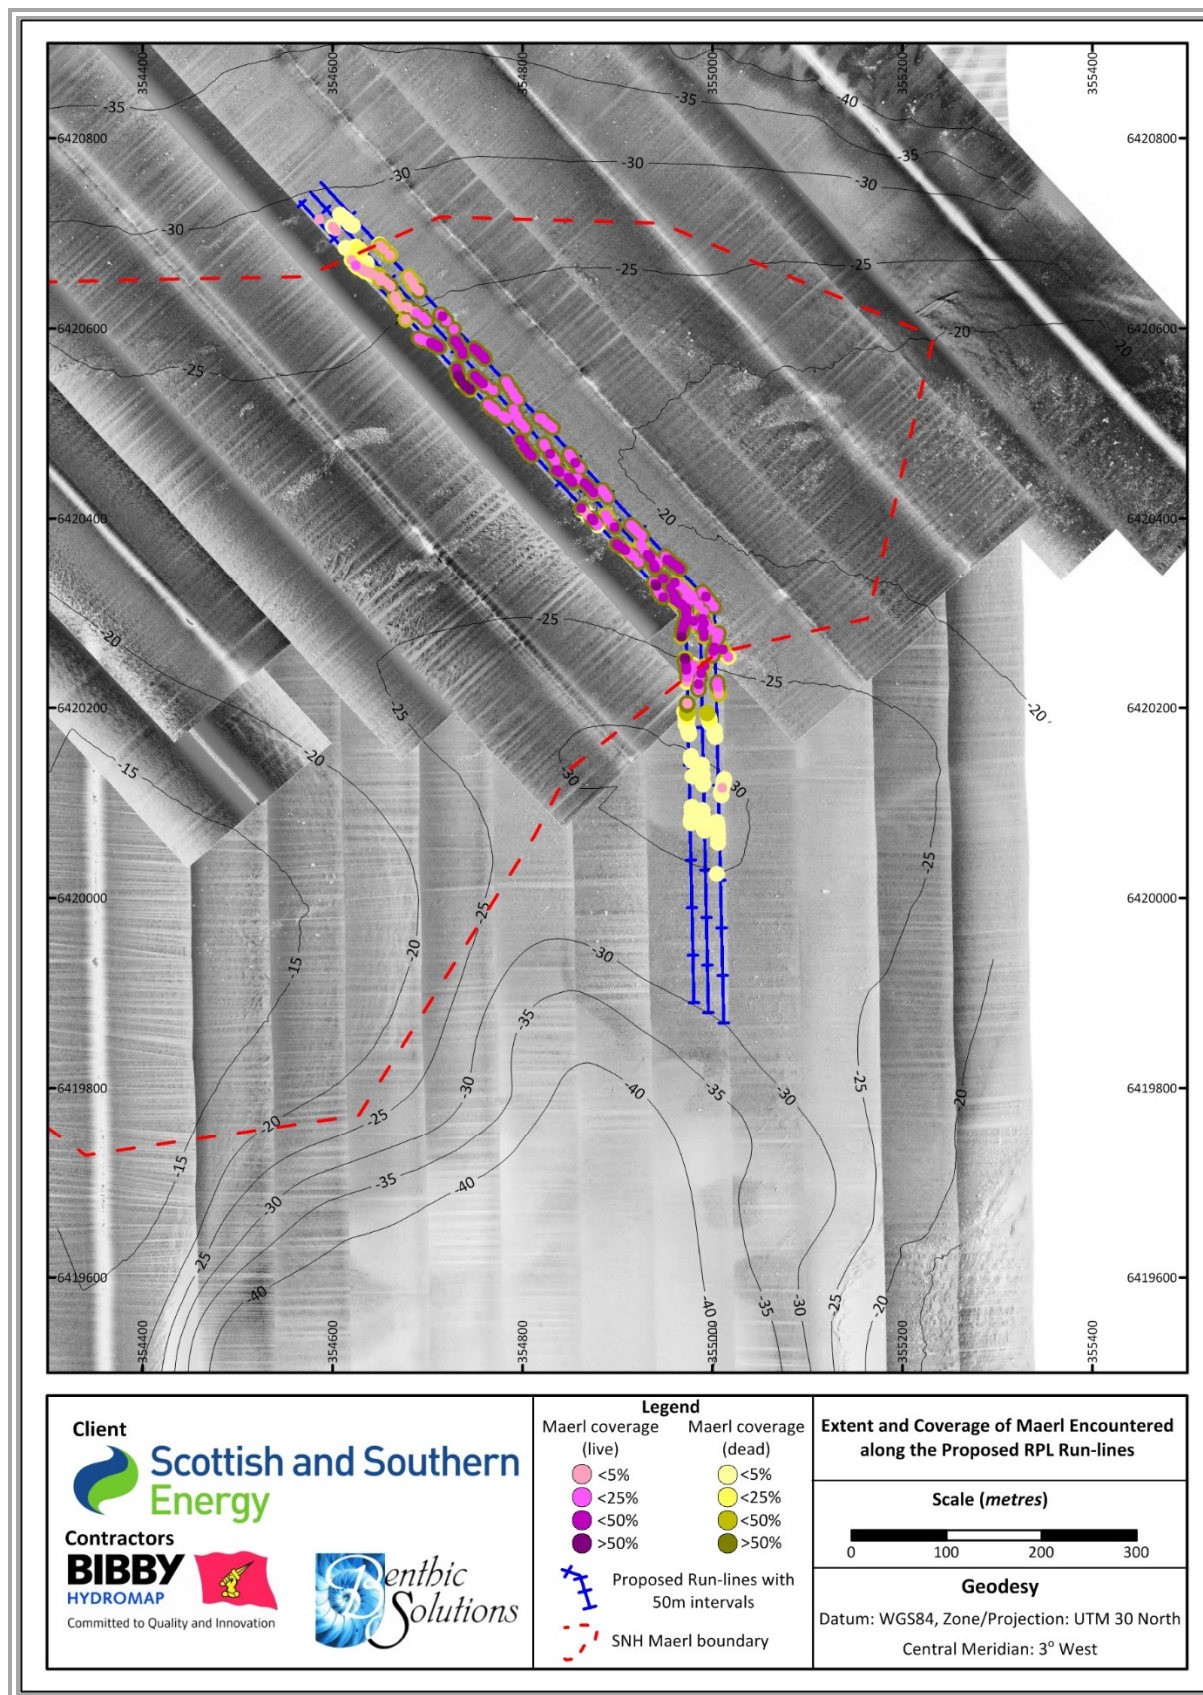
**Figure 4: Maerl Distribution Recorded on Run-lines**

The occurrence of maerl was generally uniform between the three lines and the occurrence of live maerl is generally consistent with the SHN boundary (see Figure 4 below). Neither living nor dead maerl were encountered at the start or end of each line. Where live maerl was recorded it was usually present amongst dead maerl. The highest percentage cover of live maerl was located above the 25m contour and was generally observed as biogenic megaripples, typically with a higher percentage of live maerl in the troughs of such features. The megaripples encountered between KP65.0 and KP65.4 are orientated between north-east to south-west and east-northeast to west-southwest with wavelengths of 1-2m.

Further away from the 25m contour, live maerl was mostly recorded as singular or several maerl thalli on cobbly sandy gravel substrate, often amongst dead maerl thalli (Figure 4.2). Maerl observed in the seabed photography most likely belonged to the species *Phymatolithon calcareum* as identified during a previous survey around this area (Bibby HydroMap, 2016), although *Lithothamnion corallioides* and *Lithothamnion glaciale* forms may also be present as they are typically found together with *P. calcareum* around the British Isles (MarLIN, 2017).
