SEAGREEN OFFSHORE WINDFARM

PRE-CONSTRUCTION SITE SURVEY

PUXO IDENTIFICATION AND DISPOSAL

OPERATIONS AND RESULTS

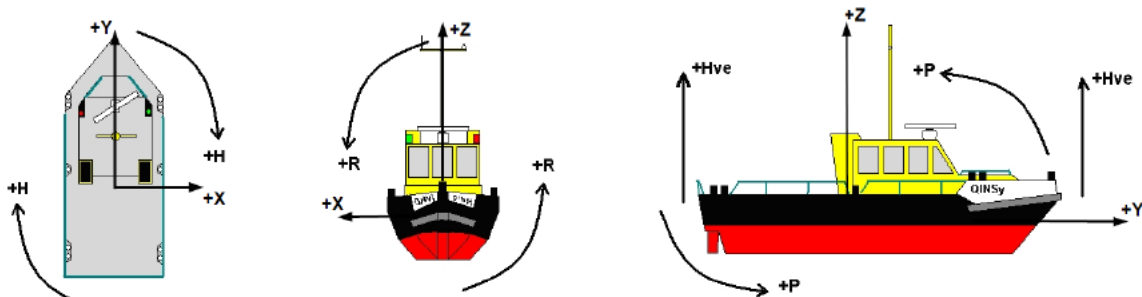
Figure 3-1: Angular and axis sign conventions (source: QINSy documentation)

Offset sign convention	
The X axis runs laterally from port to starboard	
The Y axis runs longitudinally, from stern to bow	
The Z axis runs vertically upwards

Rotation sign convention	
Pitch, bow up (P)	+ (positive)
Roll, starboard down (R)	+ (positive)
Yaw, heading starboard (H)	+ (positive)
Heave, up (Hve)	+ (positive)

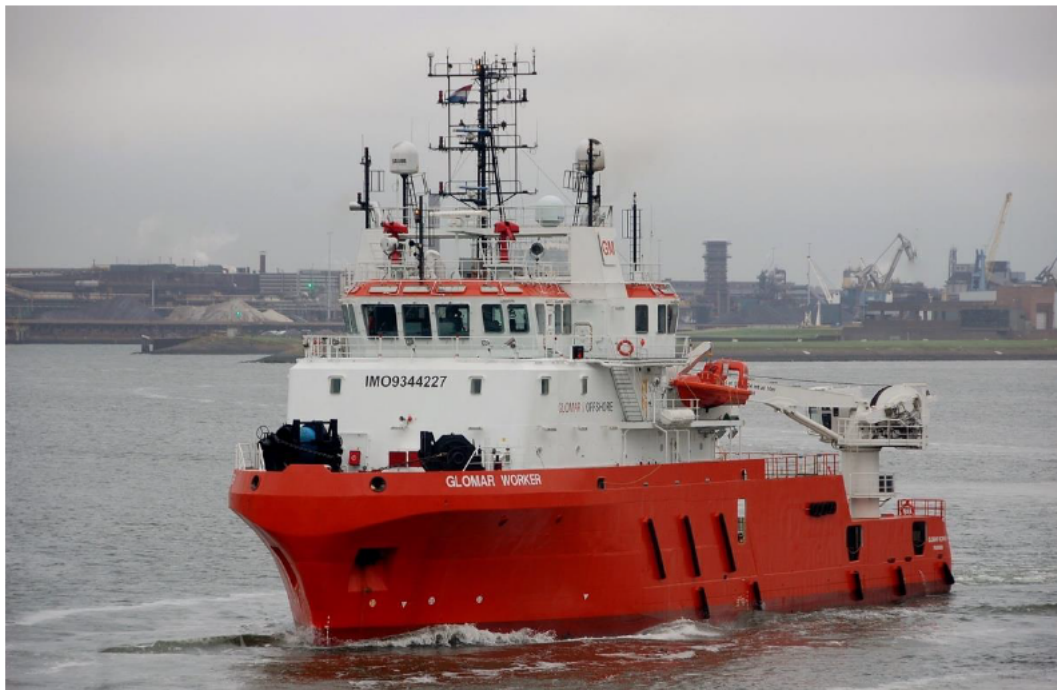
Figure 5-1: Glomar Worker

Glomar Worker (Figure 5-1) is a 60 m multipurpose offshore vessel. Completed in 2008 (rebuilt in 2020) and equipped with a grade 2 dynamic positioning system (DP2), a diesel electric drive system, Dual USBL subsea positioning and a 24t heave compensated offshore crane. A survey/ROV spread is permanently mobilised on board.

The *Glomar Worker* has accommodation for 44 persons, together with dedicated office and recreation spaces for marine and charterer's personnel. The vessel has an economical speed of 10 knots and a service speed of 13 knots.

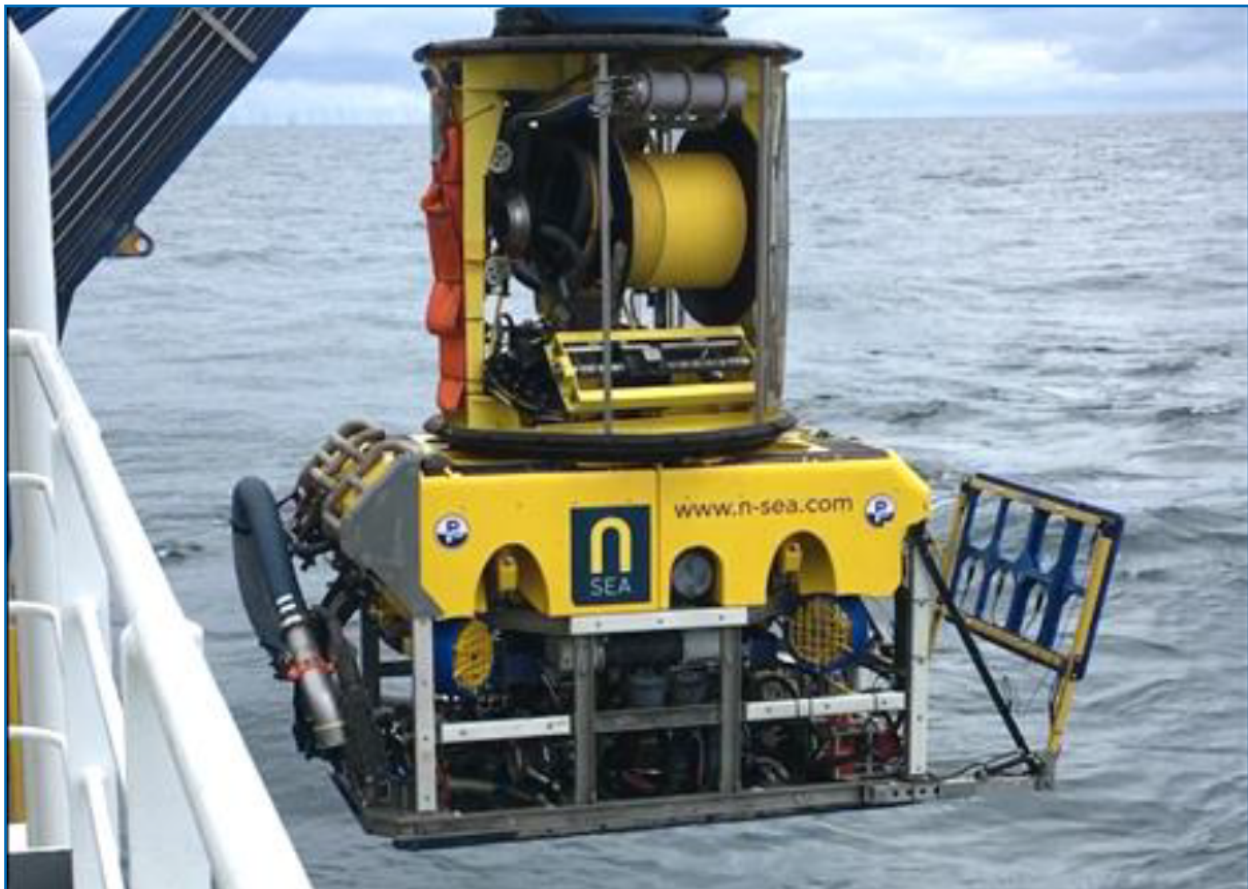
Figure 5-2: Triton XLX WROV with TSS440 and dredge pump

A Perry Slingsby Triton XLX 150 HP work-class remotely operated vehicle (WROV) (Figure 5-2) was mobilised on the *Glomar Worker*. The system offers a comprehensive combination of thrust, payload, through frame lift and sensor interface. The vehicle has a combined thruster output of 150 HP, a subsea payload capacity of 250 kg for transporting or recovering materials, has a through frame lift capacity of 3000 kg and can operate up to 3050 m of water depth and/or current speeds up to 1.6 kn. The vehicle has an in-air weight of 4800 kg and is equipped with a top hat tether management system (TMS) and launch and recovery system (LARS).

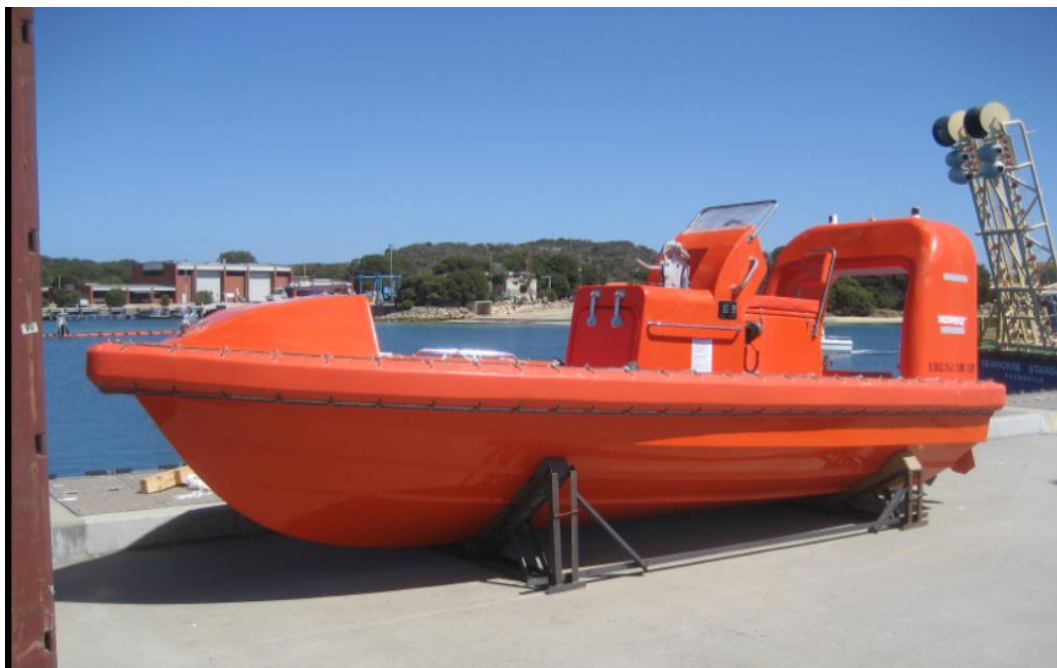
Figure 5-4: Noreq - FRB 650

Noreq – FRB 650 (Figure 5-4) was used during this ID and Disposal campaign. This EOD FRC was mobilised permanently on the *Glomar Worker*. It was equipped with Inboard Marine Diesel Waterjet as the main engine and has 30 knots speed.

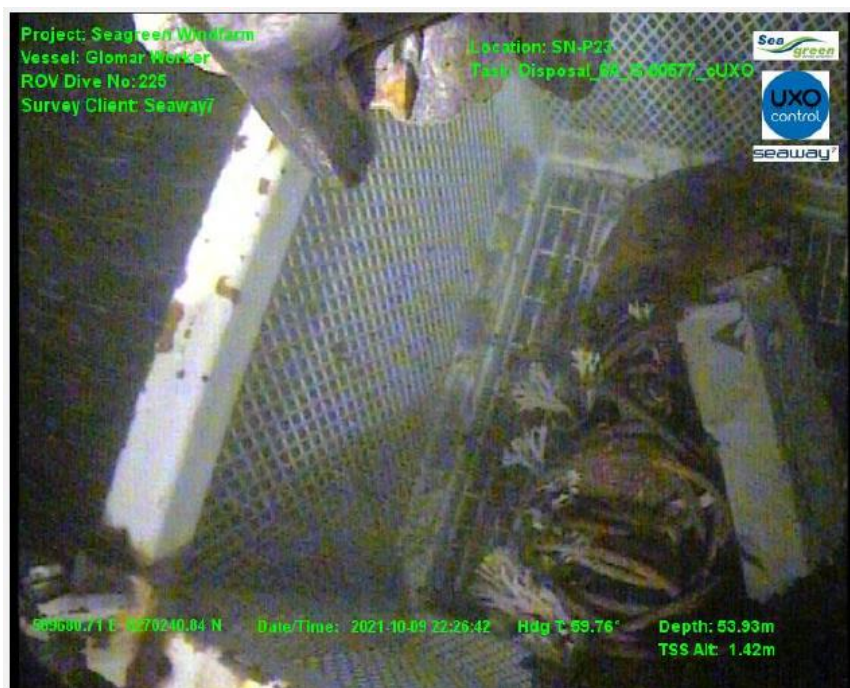
Figure 8-1: Related debris target 6A_G-00577 loaded to basket

The crater of 1.6 m x 1 m x 0.3 m was caused by detonation. The concrete and metallic parts of HYDRA placement unit coiled mooring wire and mooring plate were found visually in the crater and were temporary relocated to the wet store: 589677.4 mE 6270248.4 mN.

On 09 of October, a visual and TSS440 post detonation survey was completed over an area of 20 x 20 m as per MOC [Ref. 26]. A TSS440 reading of 918 μ V was recorded in the crater. The dredging was conducted by ROV, but no significant targets were found. A second TSS440 as left survey showed that maximum reading was reduced to 70 μ V after two hours of dredging, and target was considered clear by EOD client.

The ROV basket was used to recover all the UXO related debris to deck as seen in Table 8-1.

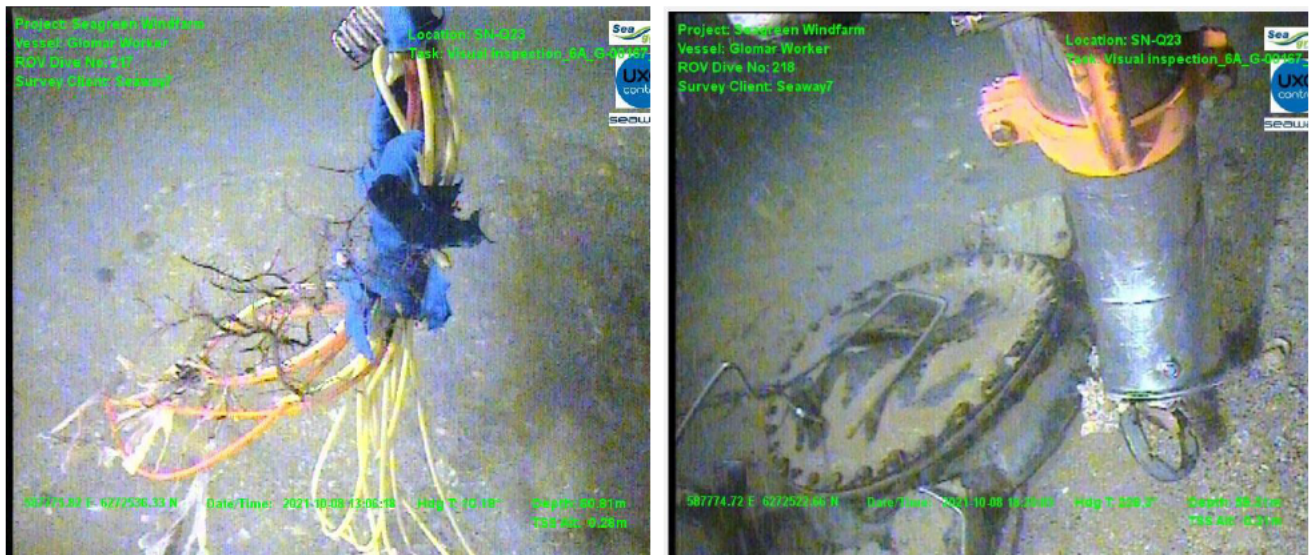
Figure 8-2: Piece of shot line and top cover plate as part of target 6A_G-00167 debris

The crater of 2.18 m x 1.7 m x 0.5 m was induced by detonation. A visual and TSS440 post detonation survey was completed over an area of 20 x 20 m as per MOC [Ref. 26]. No UXO related objects were observed on the surface. A piece of shot line, concrete and metallic parts of HYDRA placement unit as well as the mine top cover plate were found in the crater as seen in Figure 8-2.

All UXO related debris were recovered to deck by subsea ROV Basket. An TSS440 reading of 983 μV was observed during the as left survey. After 10 hours of dredging Client UXO supervisor cleared the target location, as no significant objects had been found.

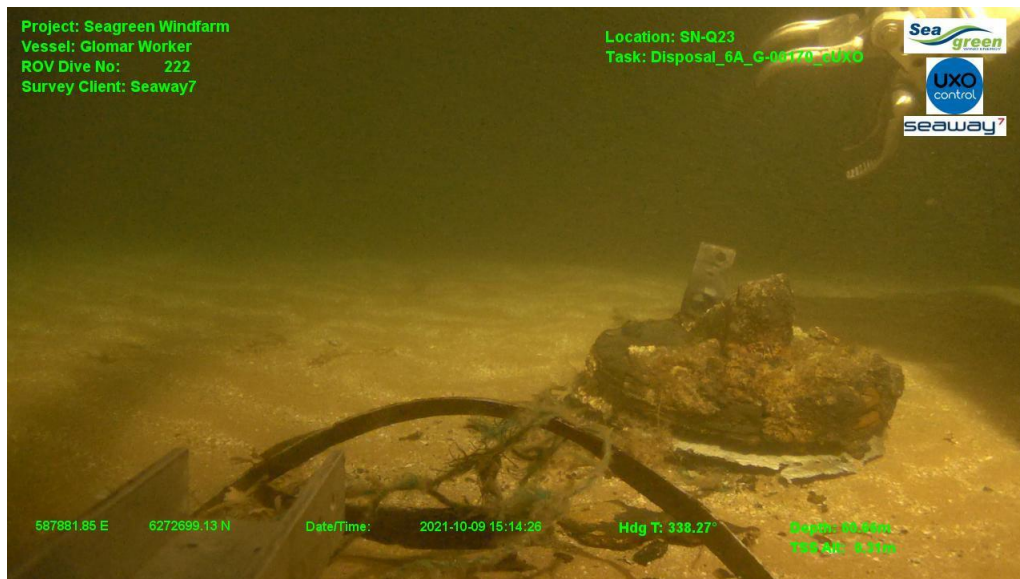
Figure 8-3: Debris recovered from crater of disposed target 6A_G-00170

The 20 minutes post-detonation MMO watch was conducted. A crater of 2.28 m x 1.6 m x 0.5 m was caused by detonation. The mines mooring plate was found visually in the crater. As per MOC [Ref. 26], a visual and TSS440 post detonation survey was completed over an area of 20 x 20 m. A TSS440 reading of 1978 μV was recorded in the crater and a second debris was recovered after an hour of dredging. The 5m x 5m as left survey over the crater was conducted after all UXO related objects were recovered to deck. The maximum TSS440 reading recorded during the second survey was 31 μV .
