**Staffin Community Harbour Development  
Environmental Impact Assessment Report  
Volume 3: Appendices  
September 2021**

# **Appendix A1: The Environmental Impact Assessment Team**

## **Staffin Community Harbour Development**

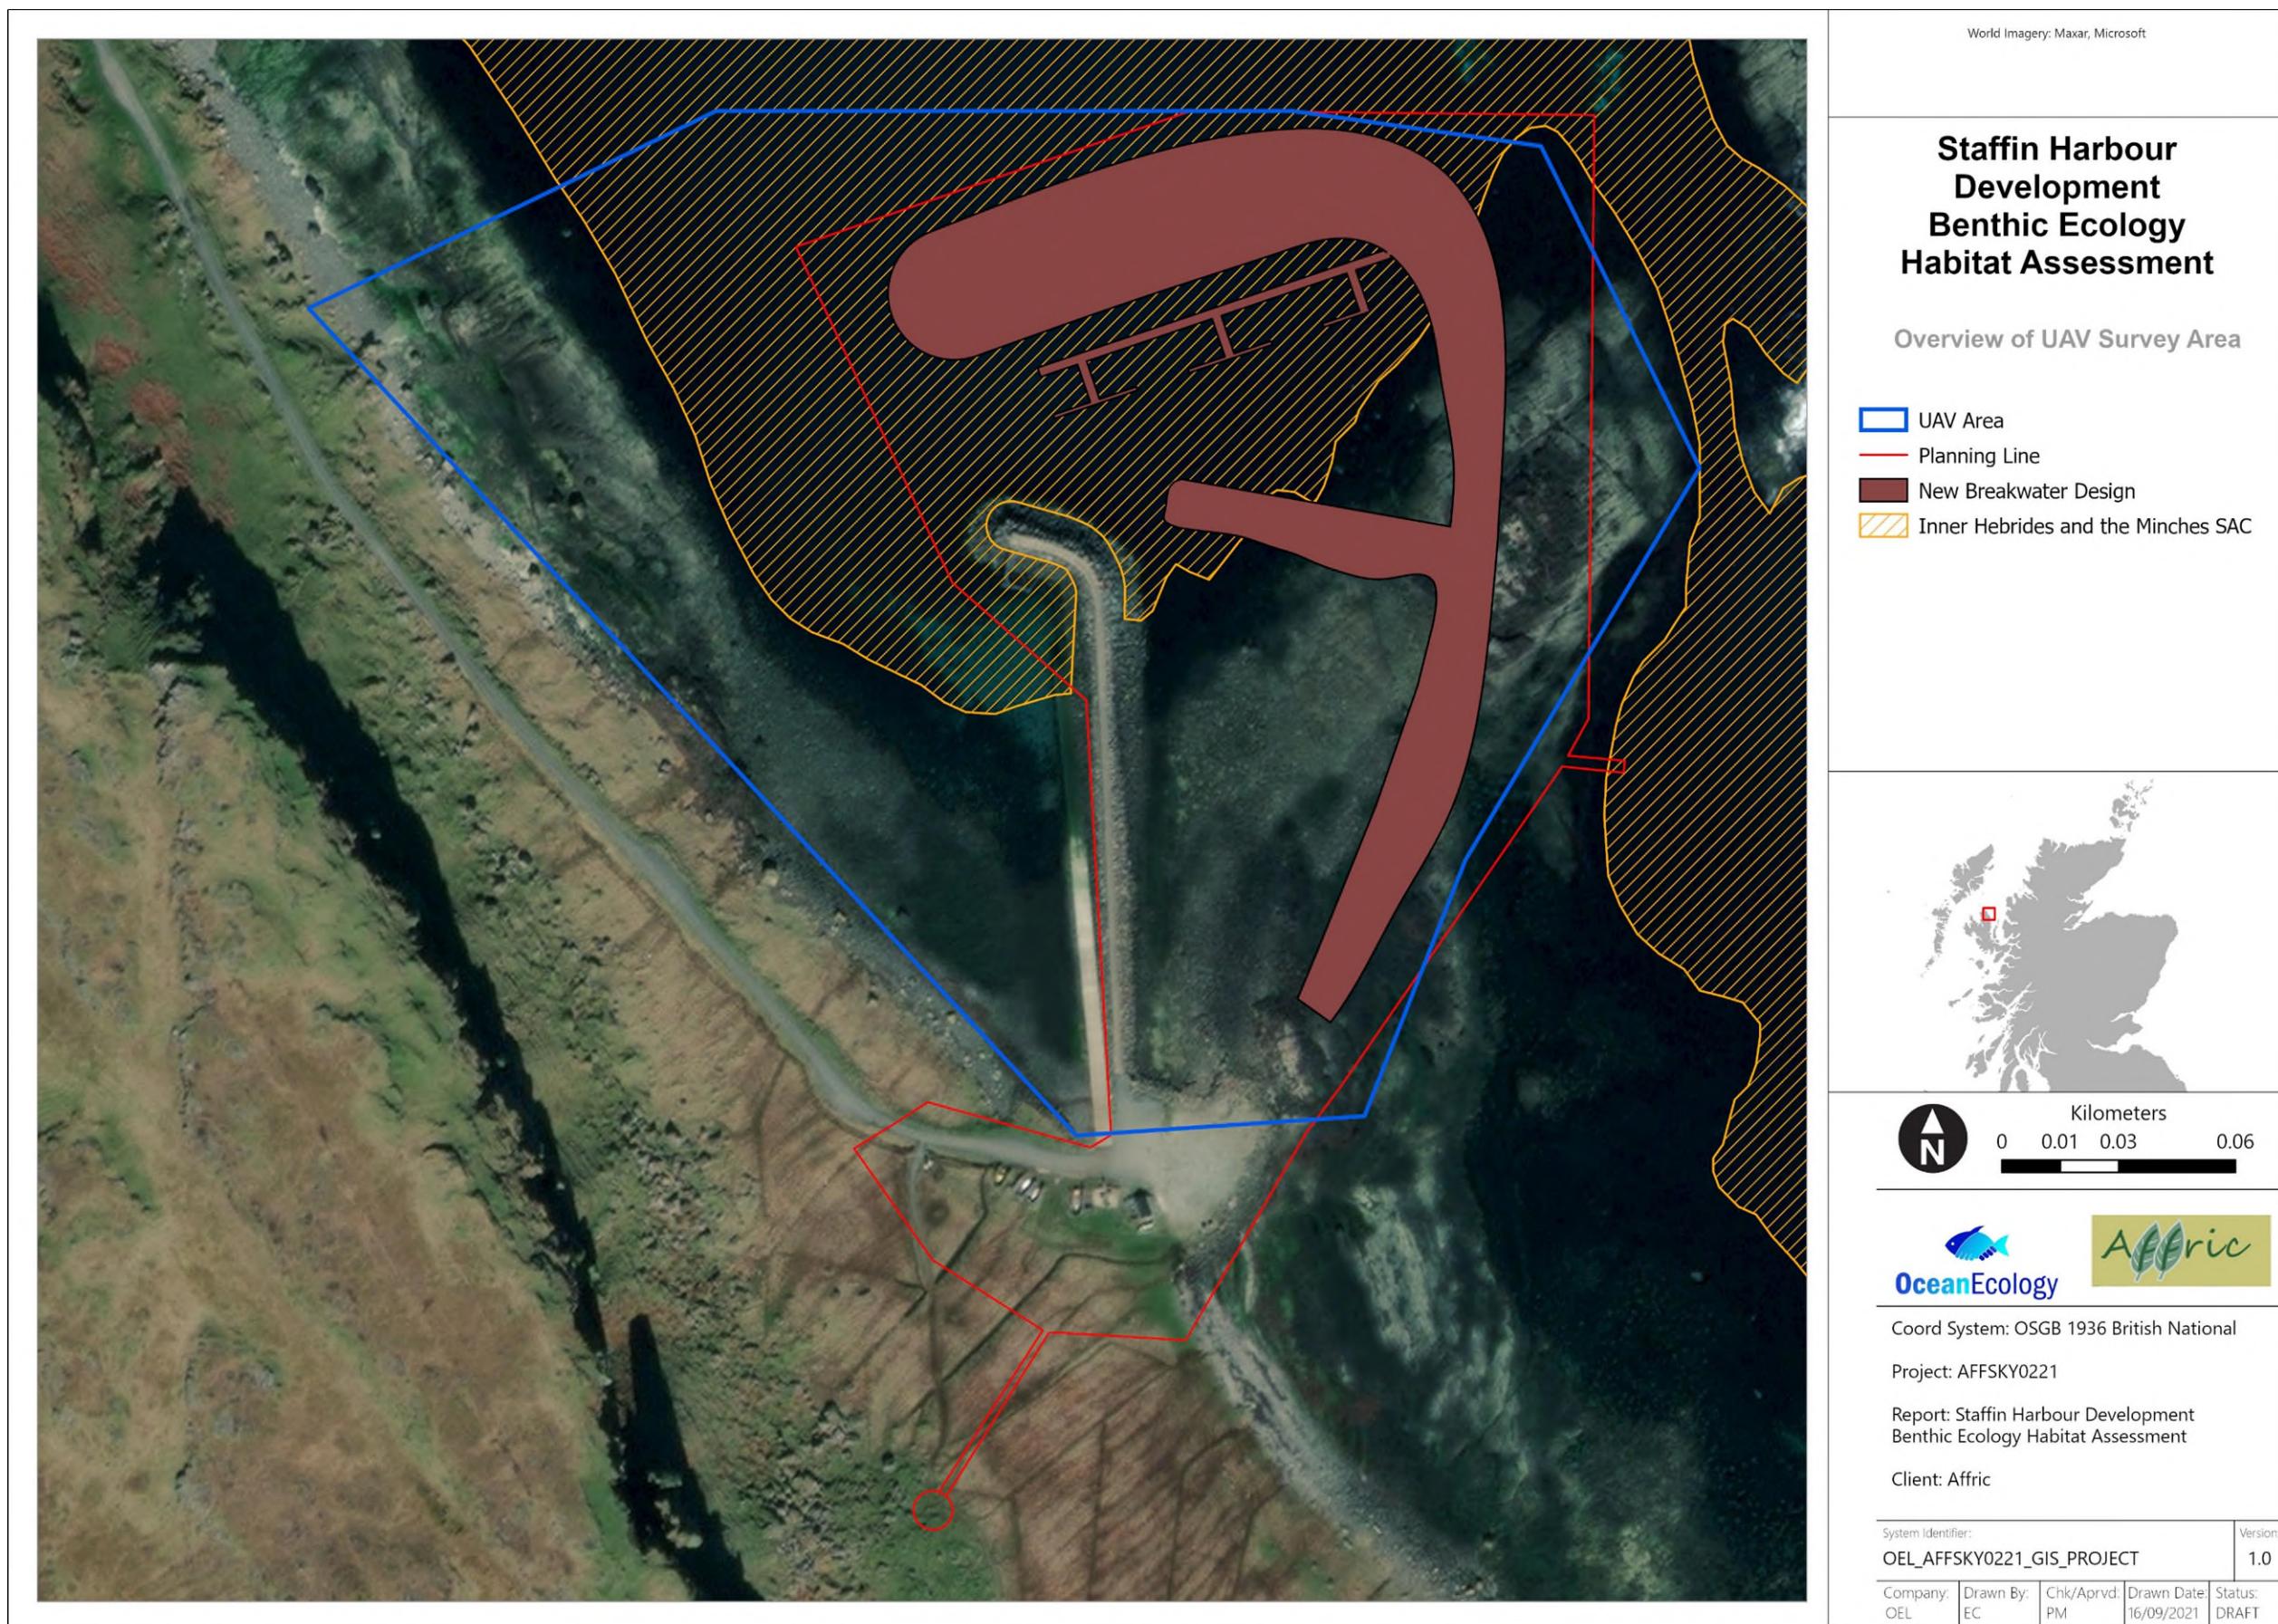
**Figure 2** Overview of the Staffin Harbour survey area covered by the UAV flight and new slipway and breakwater designs.

The UAV mapping was by Tracks Ecology Ltd in accordance with the Civil Aviation Authority (CAA) regulations. Tracks Ecology Ltd holds a Certificate of Competency for flights within the A2 subcategory and a General Visual Line of Sight Certificate. The UAV used was a DJI Phantom 4 Professional. Two flights were necessary to adequately cover the survey area to the appropriate resolution and were pre-planned using the Pix4DmapperPro software to achieve an orthomosaic Ground-Sampling Distance (GSD) of 1-5 cm/px. Appendix II includes the full UAV survey report.

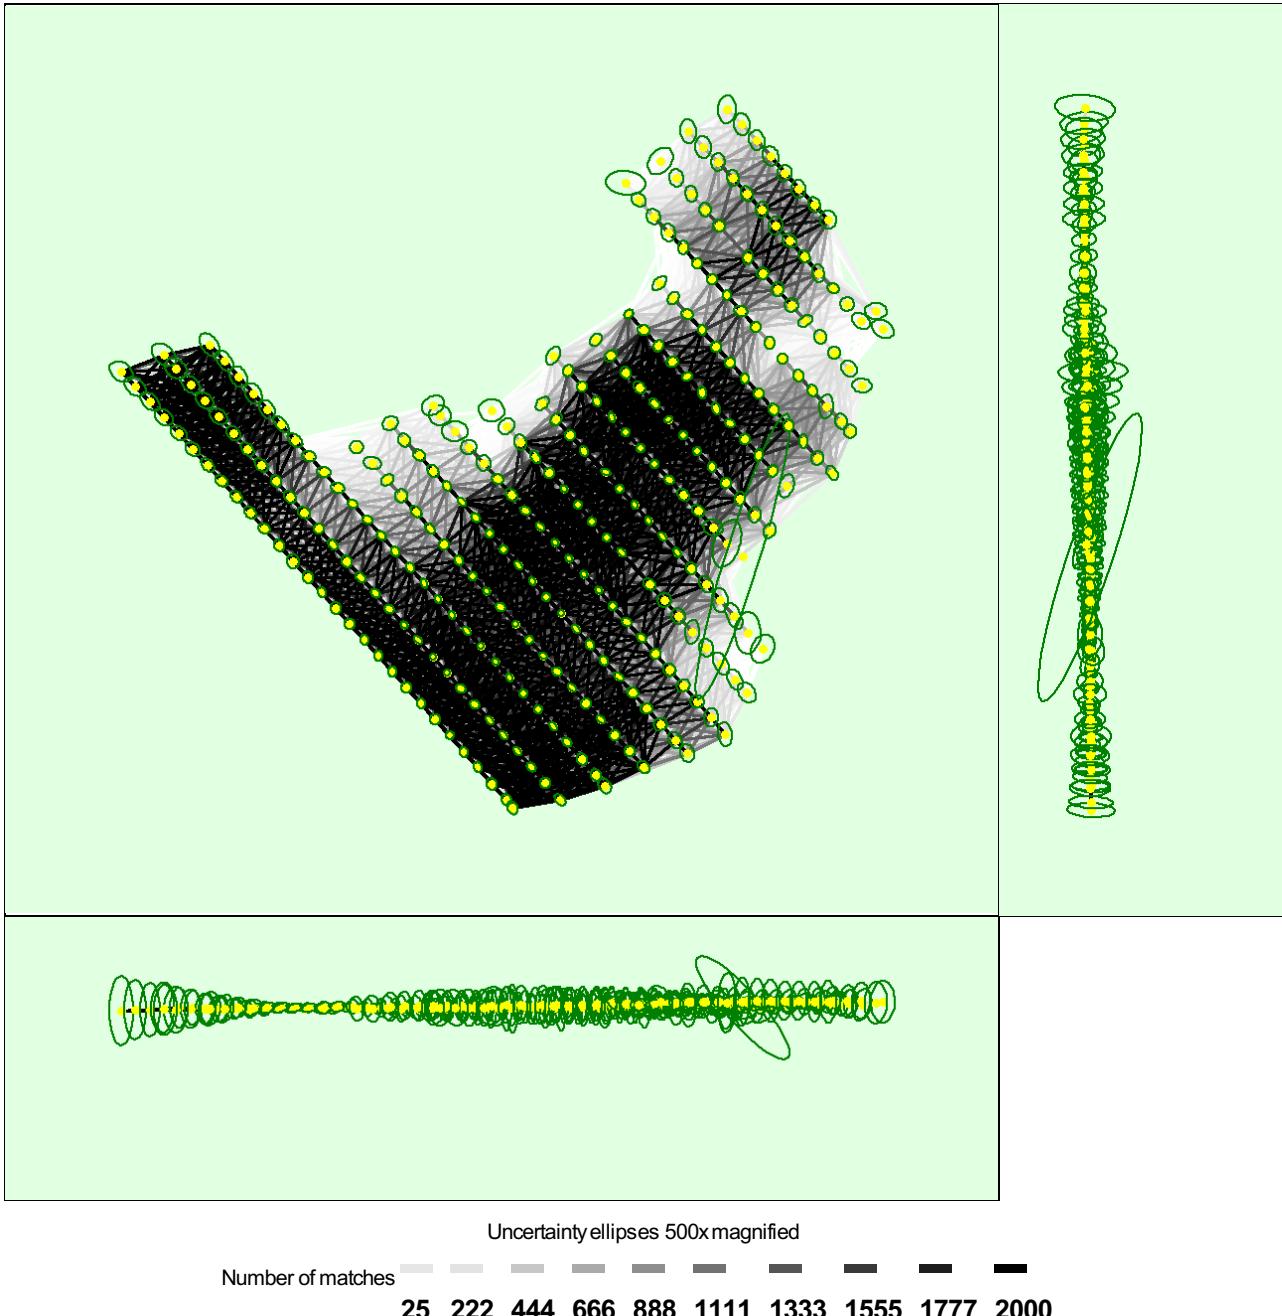
Figure 5: Computed image positions with links between matched images. The darkness of the links indicates the number of matched 2D keypoints between the images. Bright links indicate weak links and require manual tie points or more images. Dark green ellipses indicate the relative camera position uncertainty of the bundle block adjustment result.

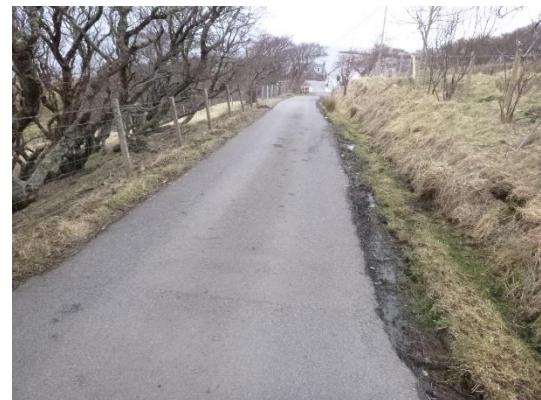
Road narrow (min 2.45m), soft verge and ditch to right.

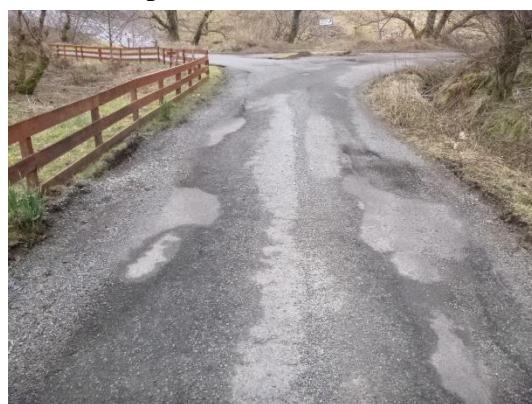
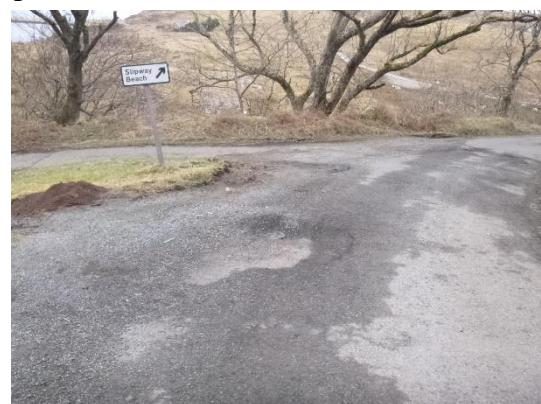
### 4.2 Ch 250 and bend

Surface in poor condition, some holes and patches.

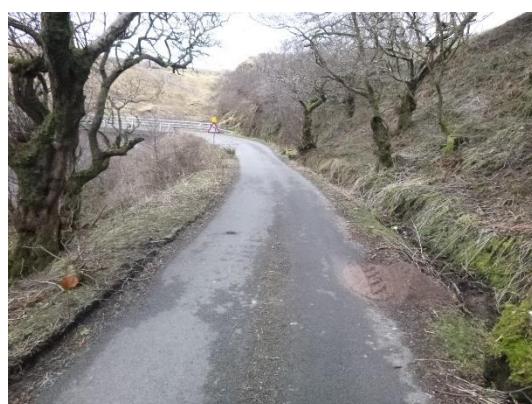
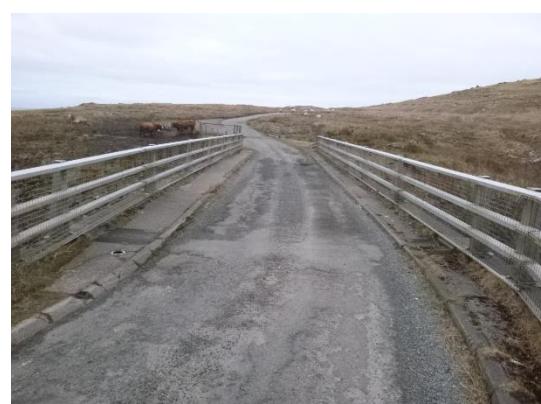
### 4.3 Ch 300-392

Good condition, narrow soft verge and ditch to right, trees close on right. Widening at bend leading on to bridge ch 376-392. Bridge 3.3m clear between kerbs, with 1.0m footpath left and 0.6m edge strip right. One hole in bridge surfacing, through to waterproofing. *Fill hole approx. 0.8x0.5m*

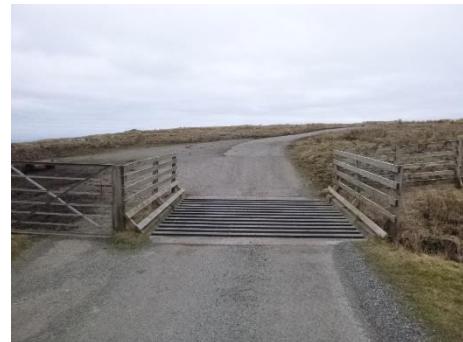
#### 4.4 Ch 410

Cattle grid 3.3m clear between kerbs, good condition. Hard area (unsurfaced) just beyond to ch 430 – allows for passing.

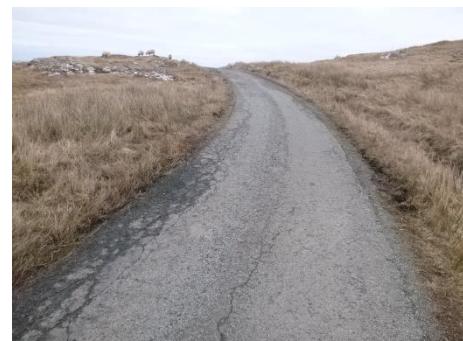
#### 4.5 Ch 490-505

Cracking to left edge, although bedrock outcrops close by. Possible settlement. *Edge strengthening 15m long.*

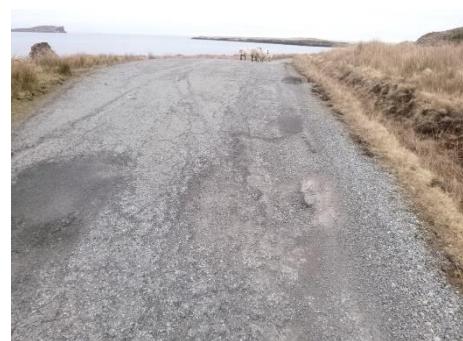
#### 4.6 Passing place ch 533

Cracking and patches.  
*Resurface/reconstruct R edge 10m*

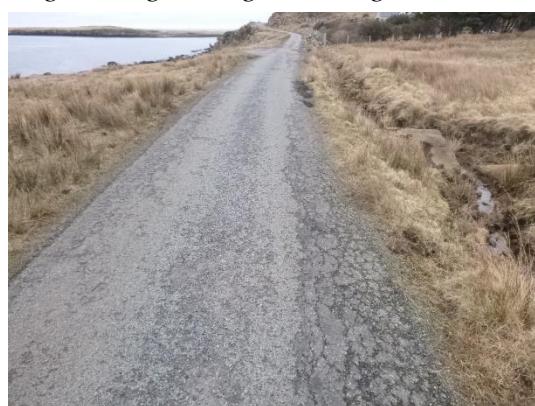
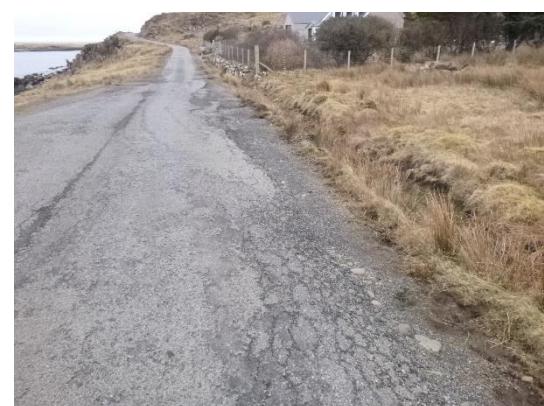
#### 4.7 Ch 615 – 633 passing place

Cracking along right edge, some settlement. Ditch close on right.  
*Edge strengthening 25m long*

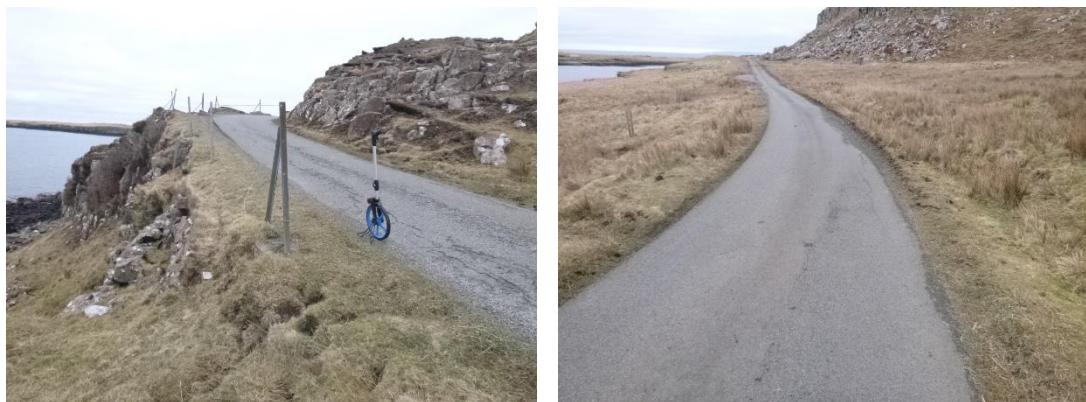
#### 4.9 Ch 740 – 800

Patchy, wider round bend. Rock outcrops close to right side; steep drop on left side. From ch 800 generally good condition but narrow.

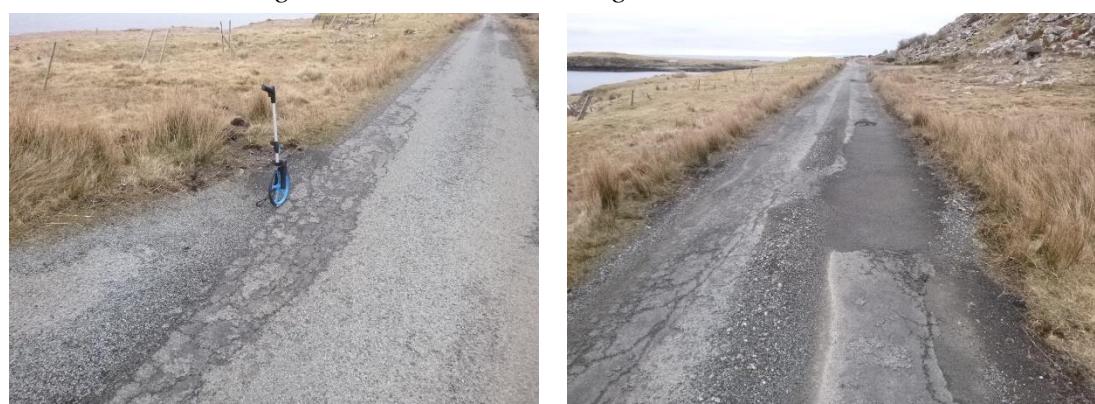
#### 4.10 Ch 845 – 930

Cracking to right edge. Soft verges, some patches and holes towards parking area at ch 935 to 955. *Edge reconstruction 85m long.*

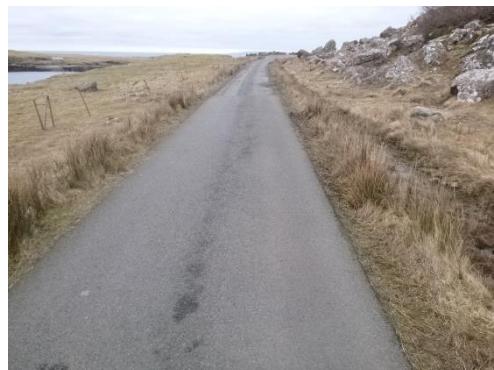
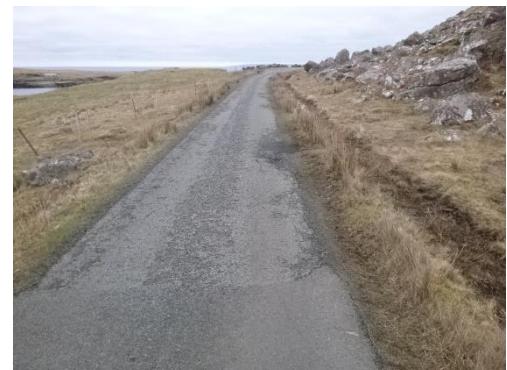
**4.11 Ch 960 – 1030**

Generally in good condition, narrow but straight.

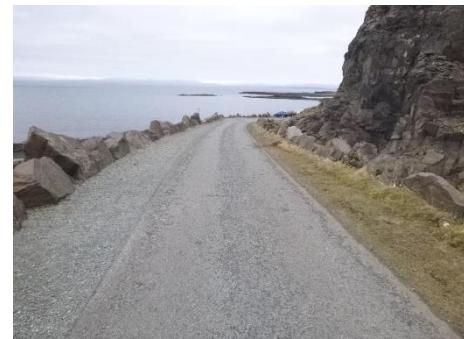
**4.12 Ch 1040 – 1190**

Widens to left, gravel strip on left edge, line of stones both sides. Adequate width.

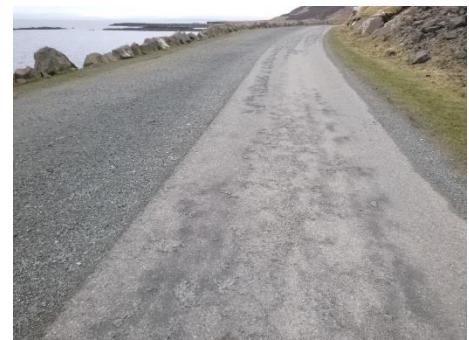
**4.13 Ch 1190 – 1300**

Fair condition, patchy. Gravel parking area left, stone edge left.

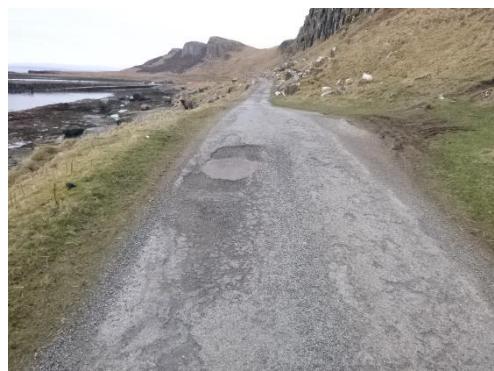
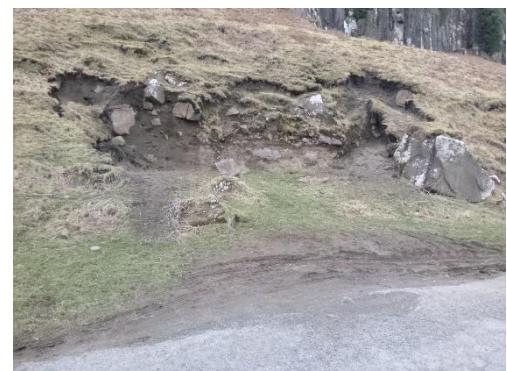
**4.14 Ch 1340 – 1350**

Holes and patch including in passing place. Slip to bank above but not close enough to encroach onto road. *Reconstruct 6 sq.m*

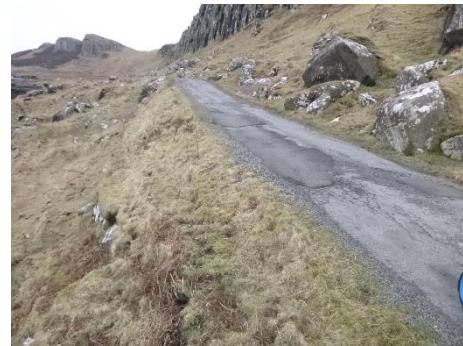
#### 4.15 Ch 1380 – 1390

Patch to left edge, steep bank to left. *Repair 10m x 1.5m*

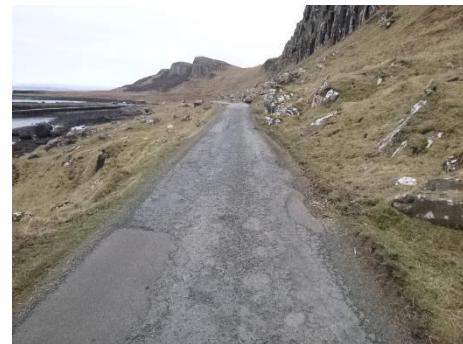
#### 4.16 Ch 1390 – 1450

Right edge collapsed and cracked, verge?  
*Edge reconstruction 60m long*

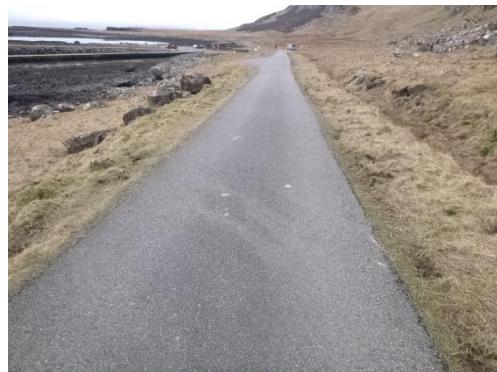
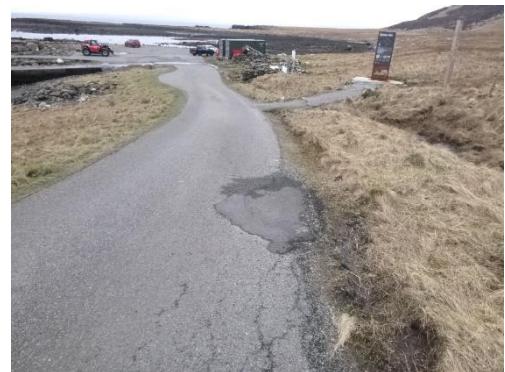
#### 4.17 Ch 1450 – 1740

Generally in good condition, recent surface with no defects. Patch and edge cracking around ch 1690.

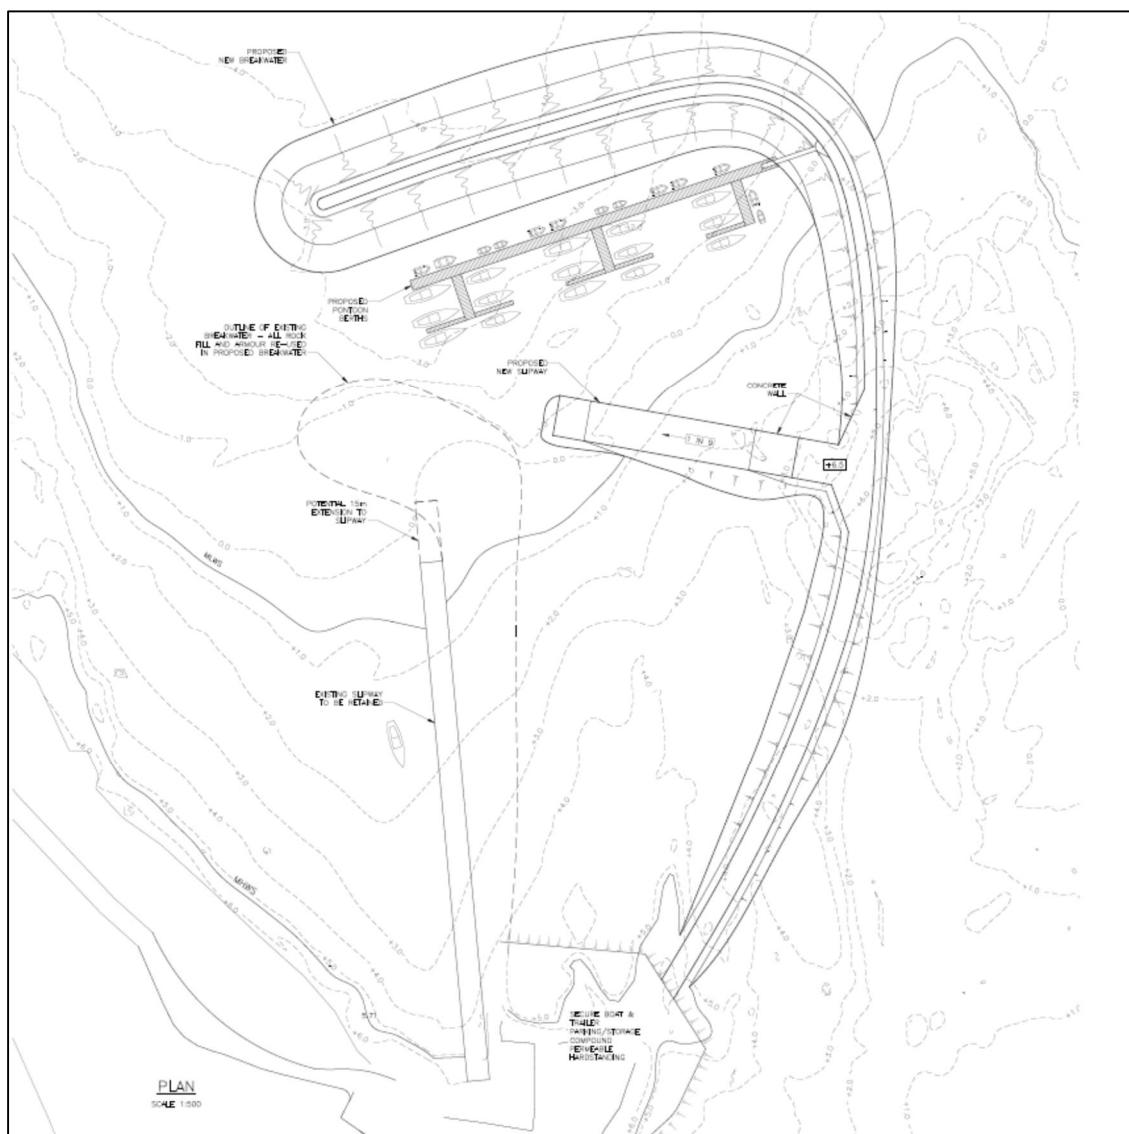
**Figure 1** Radical East Option for Staffin Harbour with marina berths and slipway

A revised layout for the Radical East Option (REO) harbour layout and marina has been proposed as shown on the Wallace Stone drawing in Figure 1. RPS were requested to undertake hydraulic modelling for this layout to predict the wave climate around the proposed marina berths and slipway to be located behind this revised breakwater arrangement and to examine the impact on the sediment transport regime.

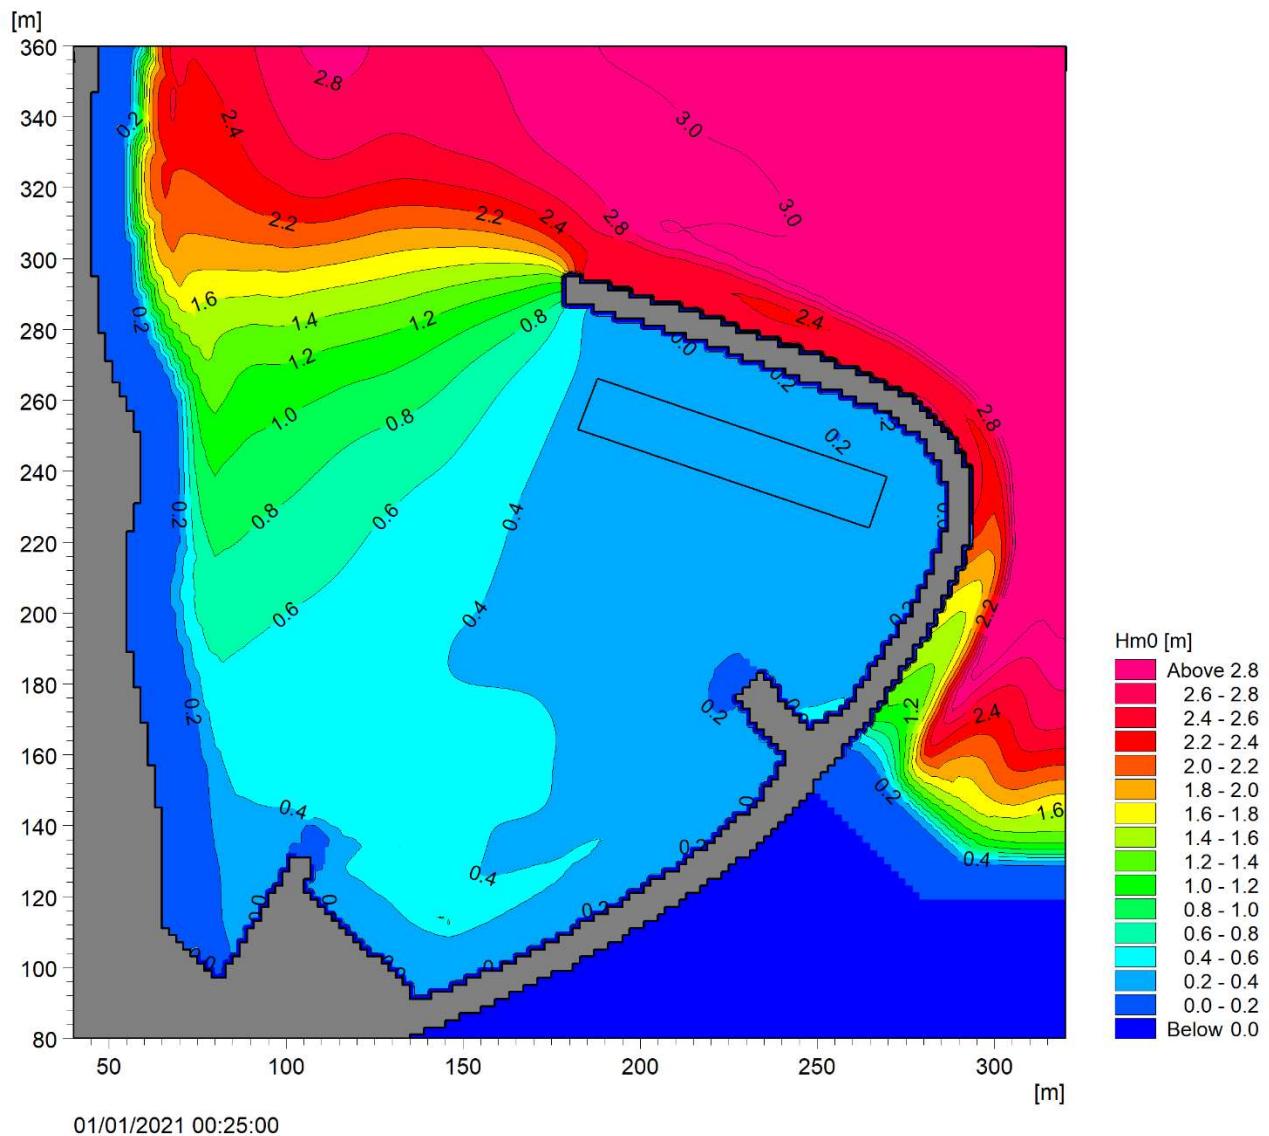
**Figure 7 Significant wave heights – 1 in 50 year return period storm from the north with swell**

The significant wave heights behind the breakwater during this 1 in 50 year return period storm at HW are shown in Figure 7. The extent of the marina area is shown by the black rectangular line. It will be seen that the significant wave heights over the entire marina area are predicted to be below 0.4m with the wave heights ranging from 0.34m to 0.21m. The significant wave height at the existing slipway will be about 0.47m but only 0.28m at the new slipway. The wave period will be relatively long at about 15.73 seconds

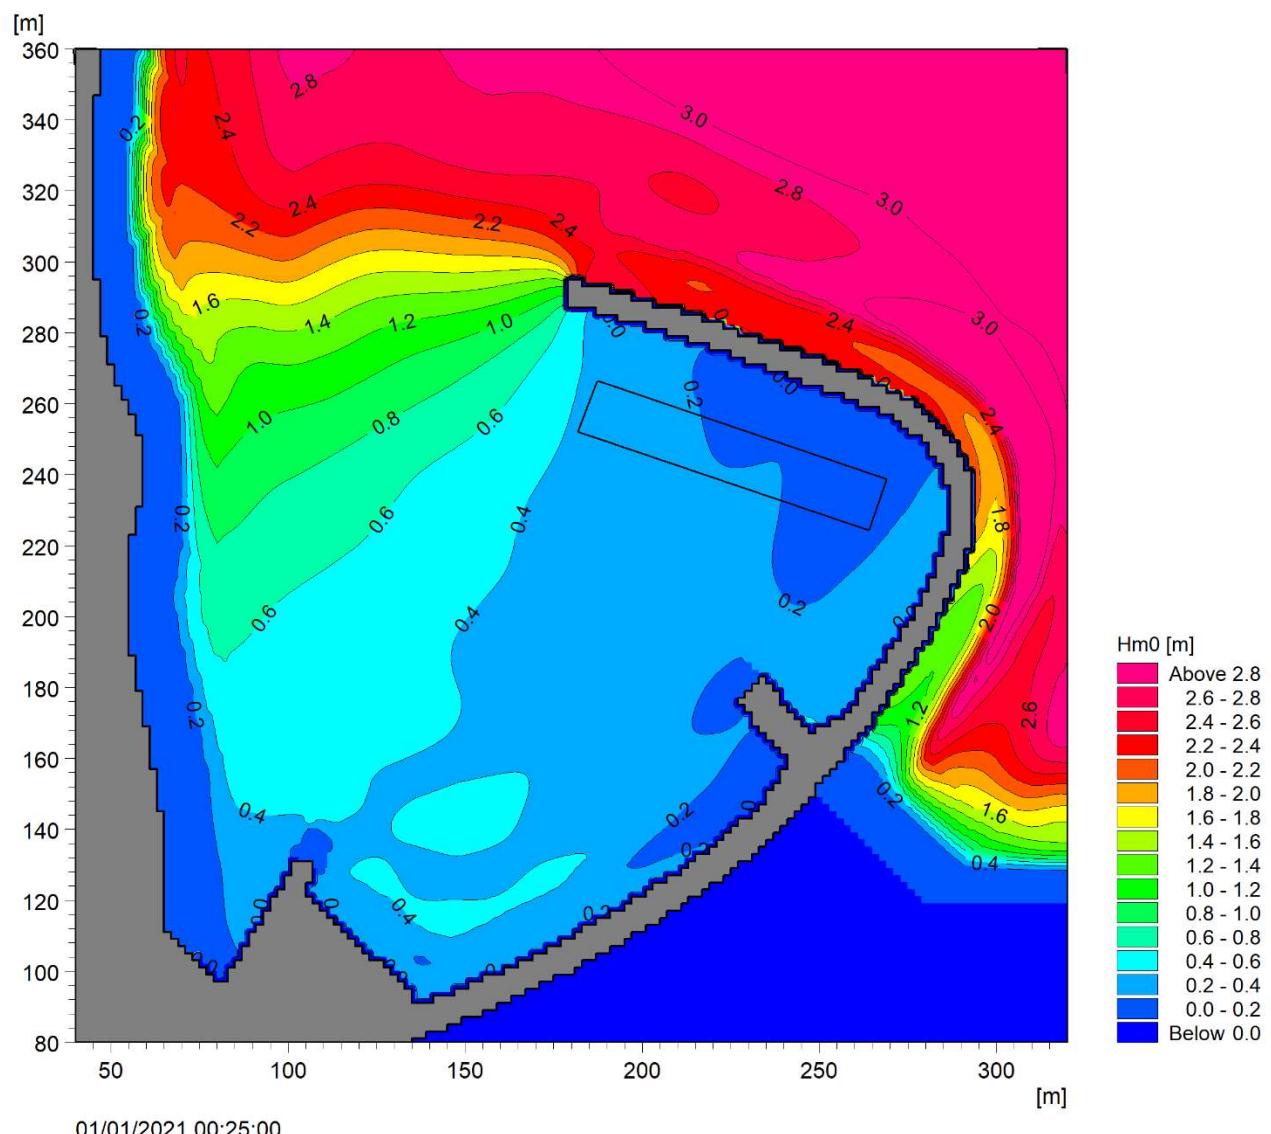
**Figure 8 Significant wave heights – 1 in 50 year return period storm from the north with wave generation cross the North Minch**

The significant wave heights behind the breakwater during this 1 in 50 year return period storm generating waves across the fetches in the North Minch at HW are shown in Figure 8. The extent of the marina area is shown by the black rectangular line. It will be seen that the significant wave heights over the entire marina area is predicted to be less than 0.4m with the heights ranging from 0.38m to 0.17m. The significant wave heights at the existing slipway will be about 0.42m while the significant wave height at the new slipway will be up to 0.3m. The spectral peak wave period of the waves will be about 11.5s.

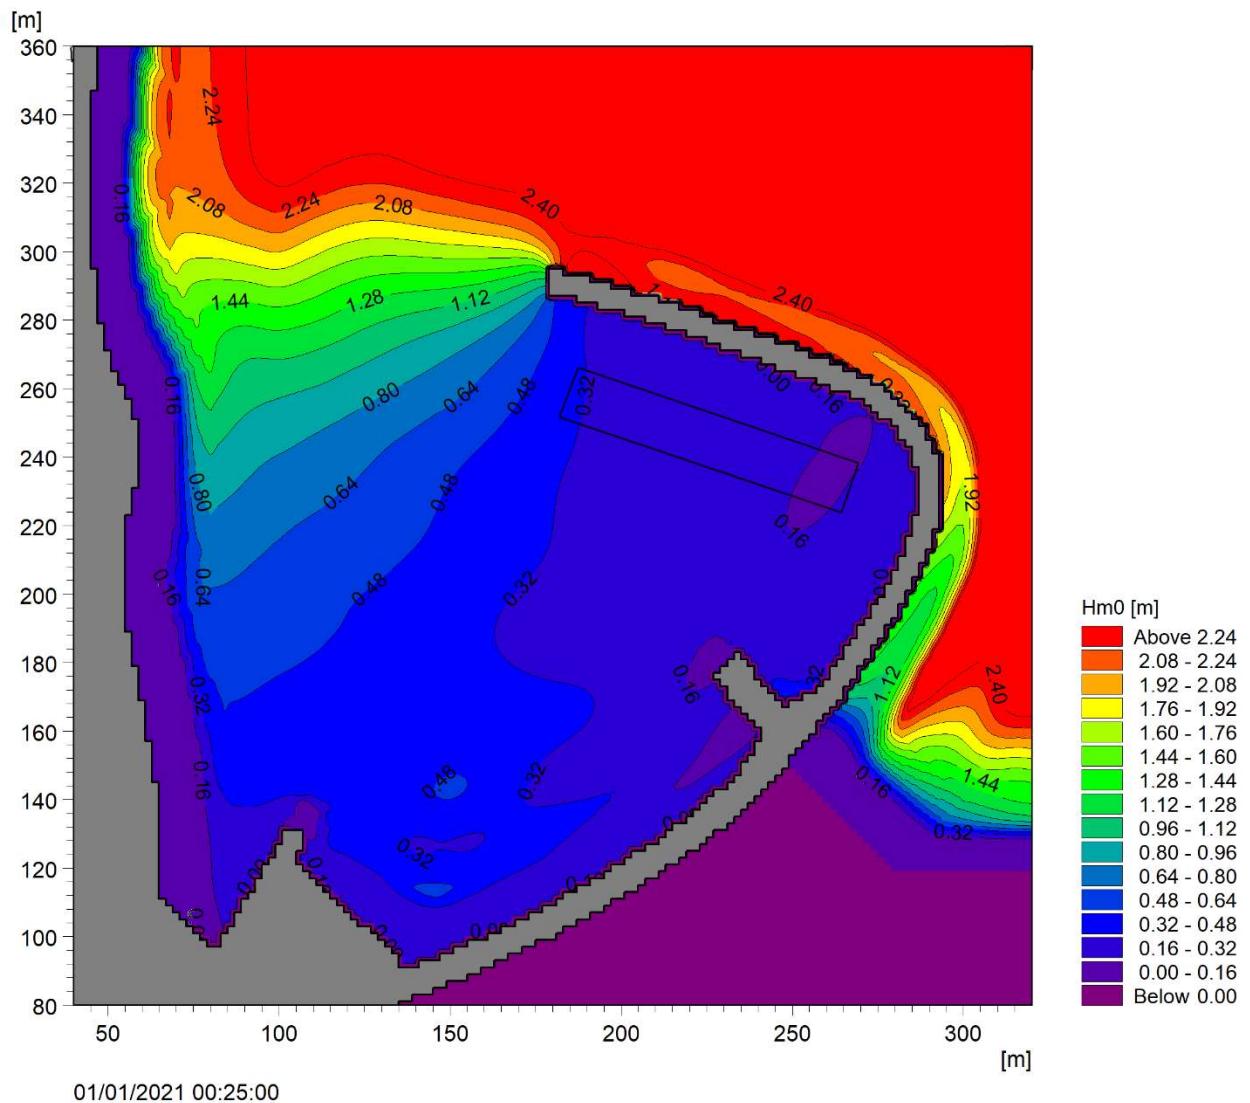
**Figure 9 Significant wave heights – 1 in 1 year return period storm from the north with swell**

The significant wave heights behind the breakwater during this 1 in 1 year return period storm at HW are shown in Figure 9. The extent of the marina area is shown by the black rectangular line. It will be seen that the significant wave heights over the marina area are expected to vary between about 0.33m to 0.16m. The significant wave height at the existing slipway is predicted to be up to 0.32m, while the significant wave heights at the new slipway are expected to be about 0.16 to 0.22 metres. The wave period during this 1 in 1 year return period event is about 11.96 seconds.
