## Structure C 302/127A

Location: Between Tain and Ardgay Stations

ELR: WCK 54.1035

## Inspection

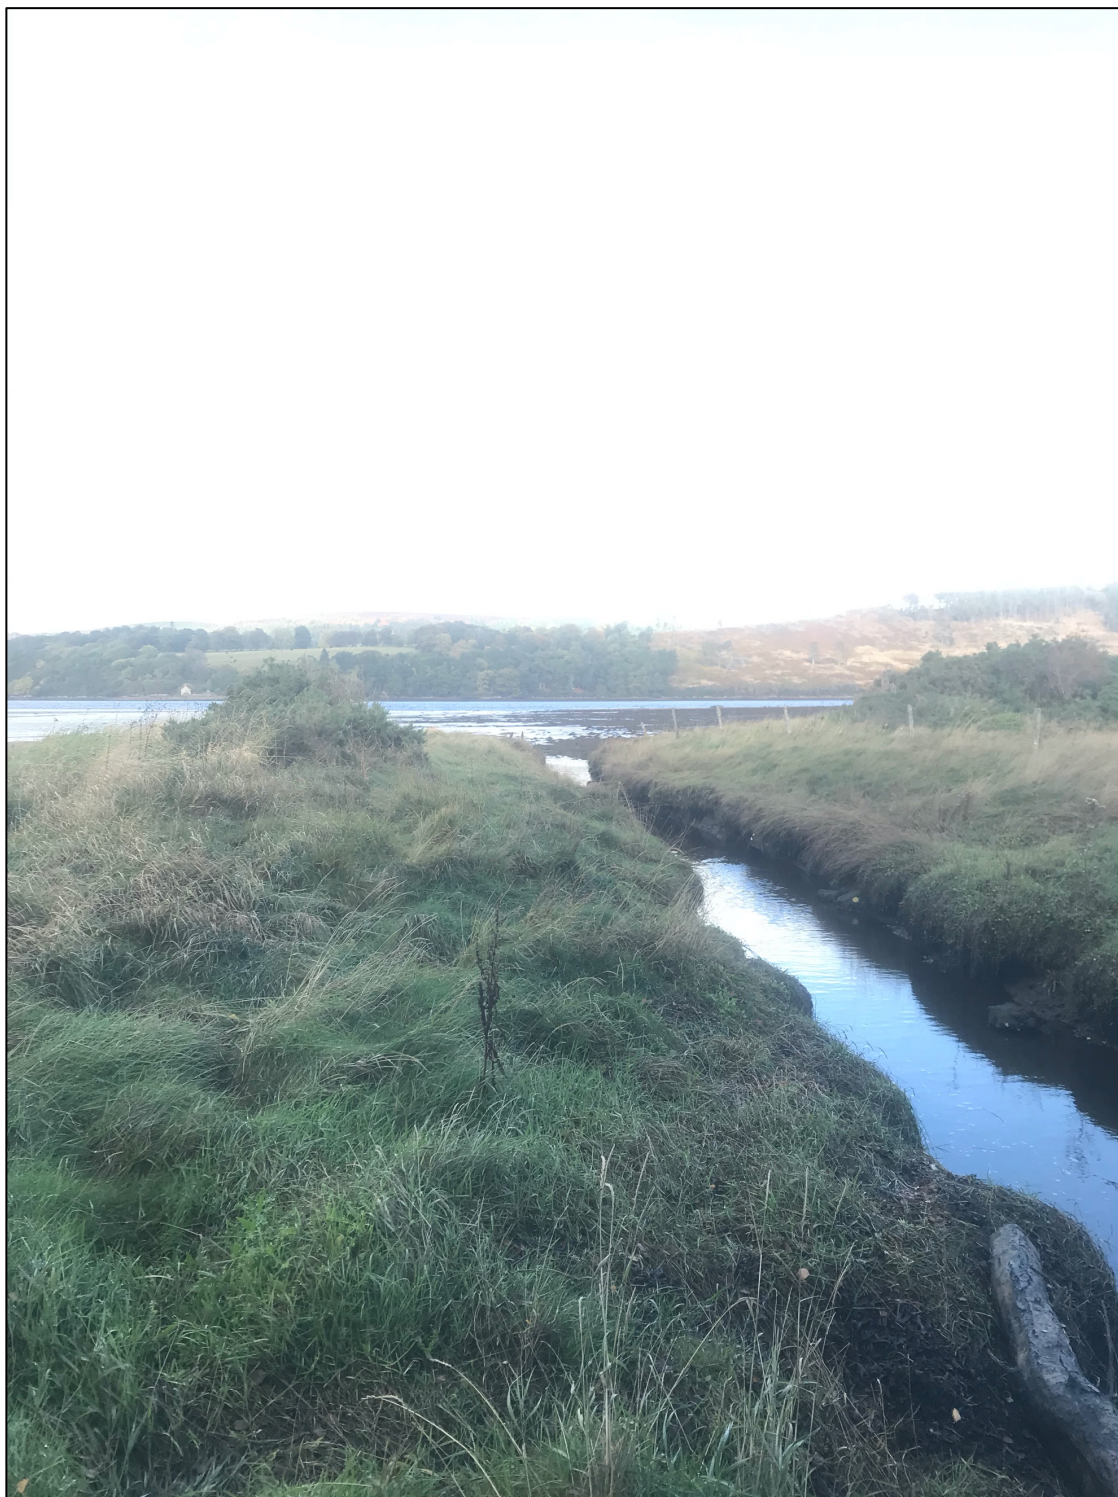
Figure 3 – View Downstream to Dornoch Firth

Timber bank protection is situated along both of the outlet banks. The wood is deteriorated although in fair condition for its suspected age and the material behind the retention is stable.
