## Retaining Wall Detailed Examination Report

ELR: KNE1

Struc. Ref: 200/561

ELR: KNE1		Contract Mileage: 004m 0240yds 10.91chs			Struc. Ref: 200/561	
Struc. Type	WCE RD	NR ID	11009030	Rpt ID	8909	OS Ref NS92858723
		Exam ID	2940107			
Dimensions	Max Height 4.00m Max Length 2500.00m					Exam Date 19/04/19
Side of Line						Last Detailed 17/05/18
Min dist. from Track	2.30					Last Visual
Line	Kincardine Power Stn - Charlestown Jn (Goods Line)					
Name:	Kincardine on Forth

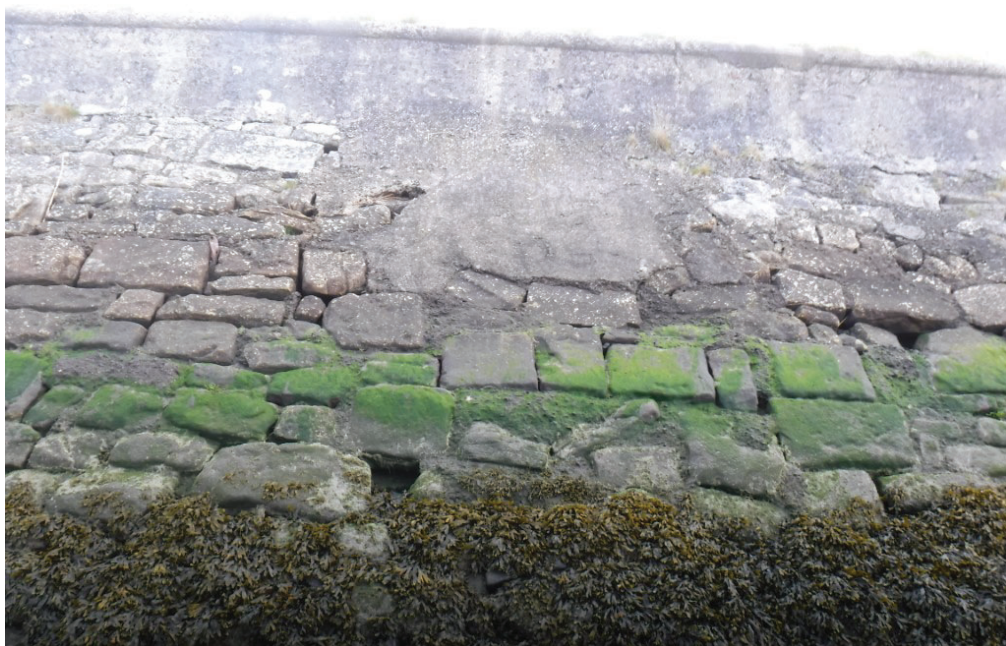
Areas of washout noted at 4M 260Y and 4M 280Y, between the revetment and the wave return wall do not appear to have deteriorated since last year's examination (see Photographs 4 and 5 respectively).

Photograph 4 - Section 1- 4M 260Y- View of washout -19.04.19

- a – Repair all voids noted throughout section.
- b – Repair all washed out areas noted throughout section.
- c – Repair eroded coping stone at the crest of the wave return wall at 4M 0295Y.
- d – Repair washout at 4M 280Y

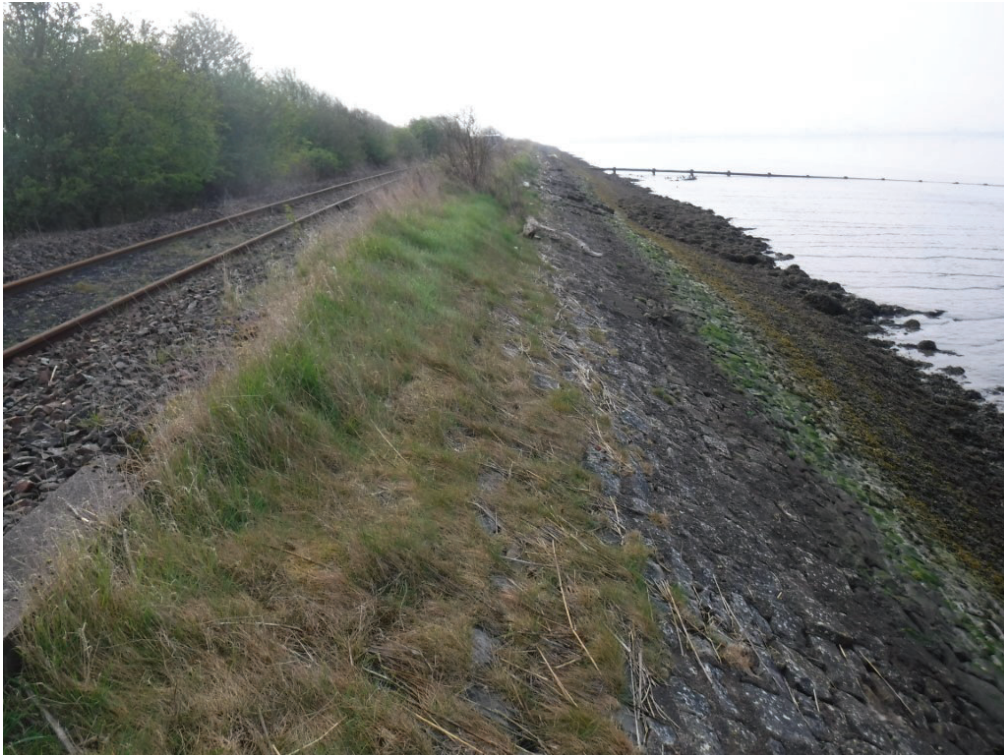
This section comprises a stone revetment approximately 3m in height with a vegetated earth crest. Along the toe of the defence at low tide there is a tidal mudflat, meaning much of the toe is difficult to inspect. The view from the start of the section, looking to high mileage, can be seen in Photograph 11.

Photograph 11 - Section 2- Start of section to high miles -19.04.19

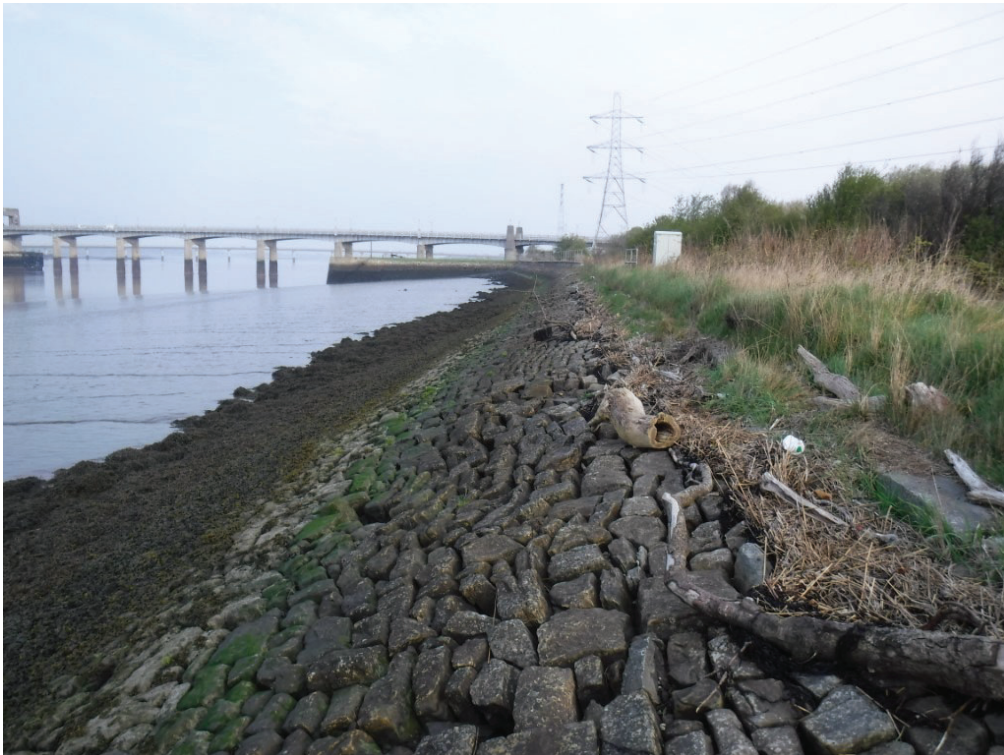
Photograph 16 - Section 2- 4M 490Y-Low mileage of condition of revetment low miles -19.04.19

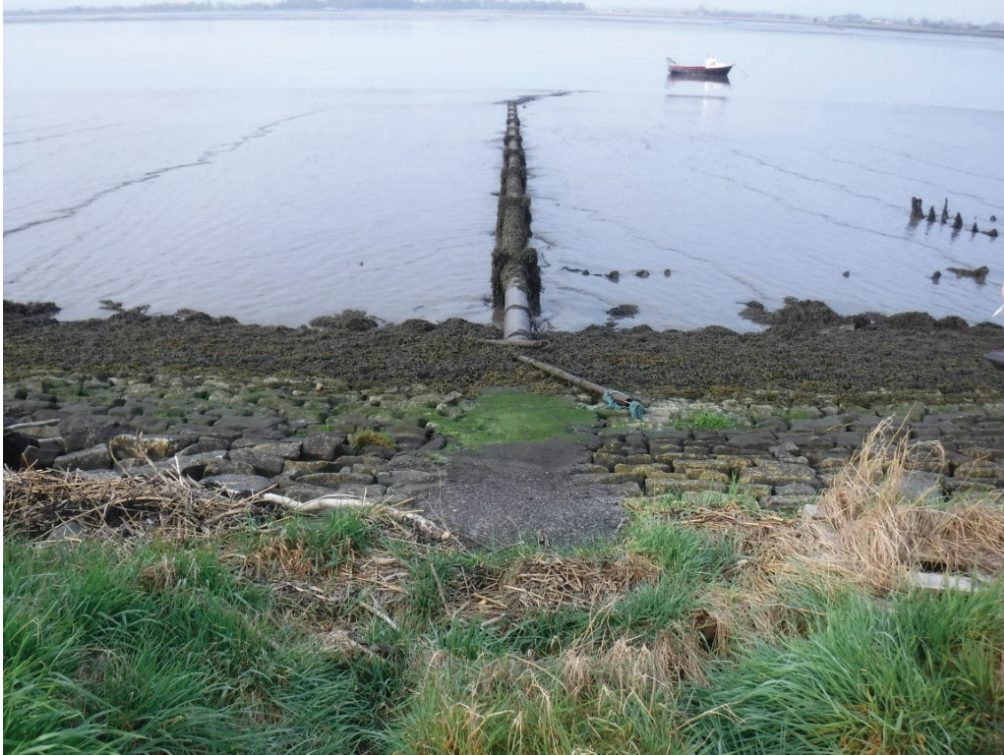
A view of the outlet pipe at 4M 490Y can be seen in Photograph 17.

Photograph 17 - Section 2- 4M 490Y- Outlet pipe -19.04.19

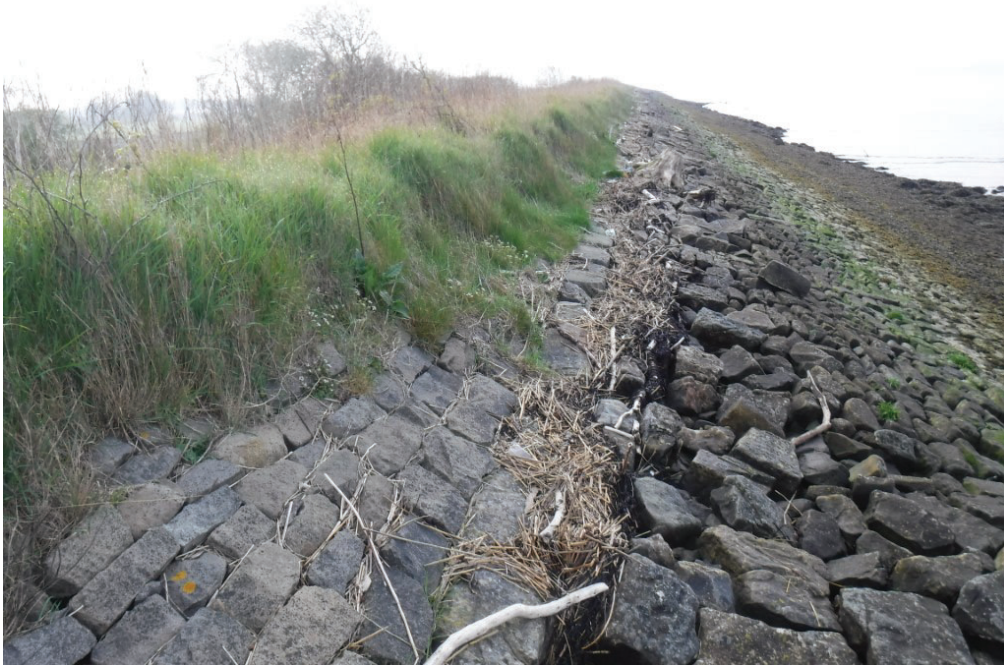
The revetment was in poor condition along the crest at 4M 570Y as shown in Photograph 21 and 22. A general view to high mileage of erosion at the crest of the revetment can be seen in Photograph 23.

Photograph 23 - Section 2- 4M 570Y- Erosion, now vegetated -19.04.19

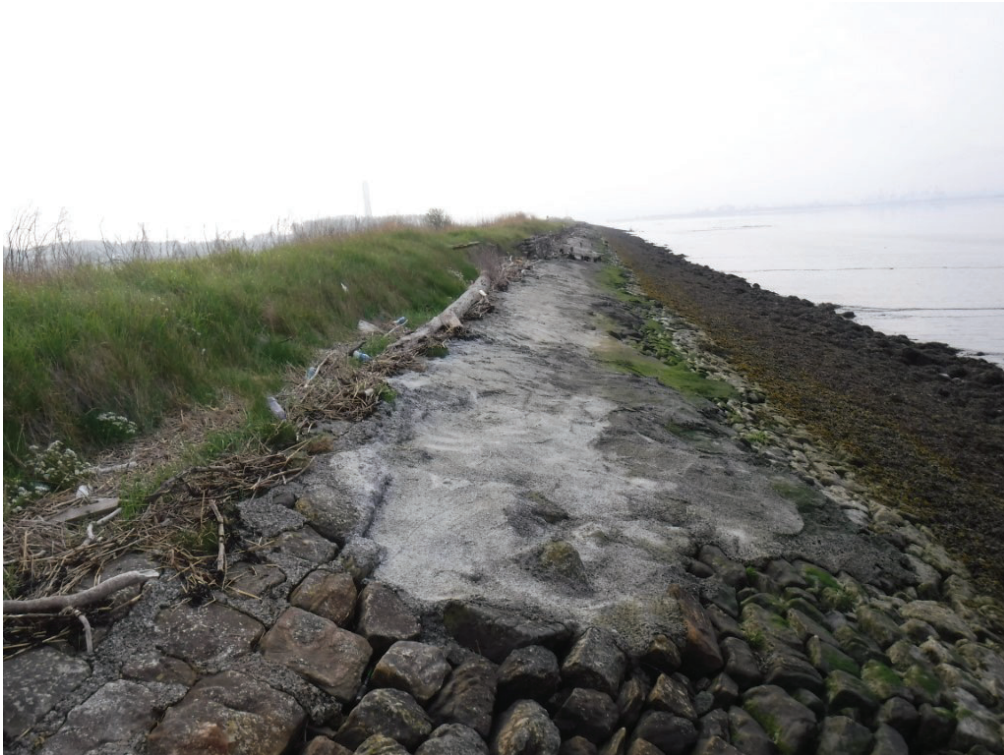
Photograph 27 - Section 2- 4M 760Y- High miles of concrete repair & exposed crest-19.04.19

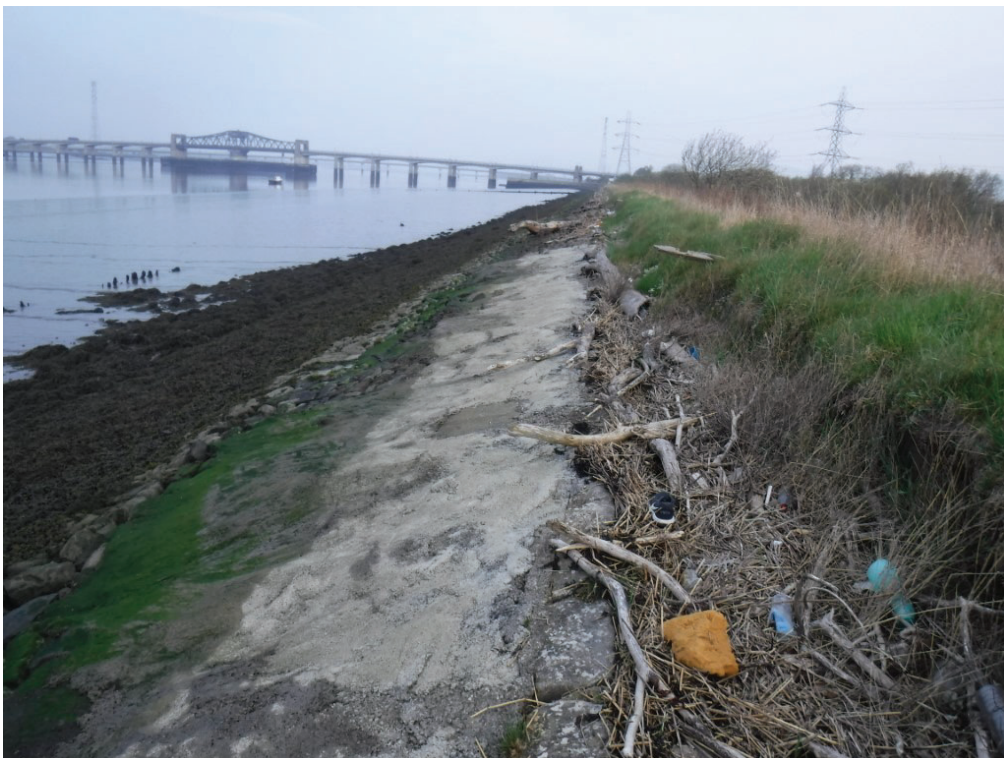
Photograph 28 - Section 2- End of section to low miles -19.04.19

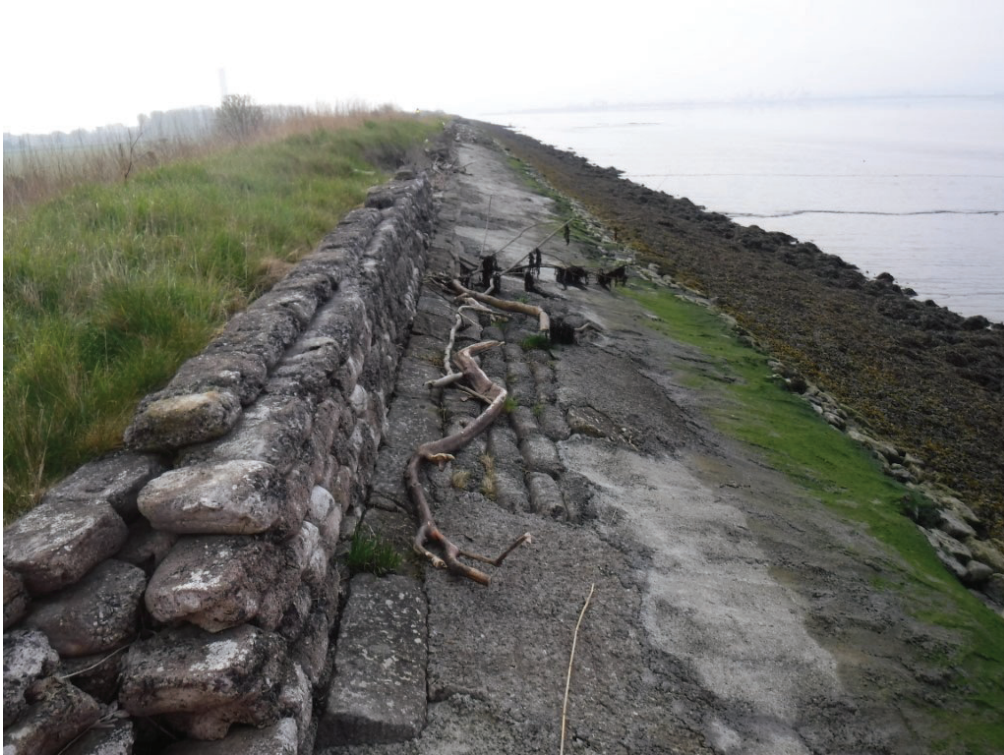
The view looking to high mileage can be seen in Photograph 29.

Photograph 29 - Section 3- Start of section to high miles -19.04.19

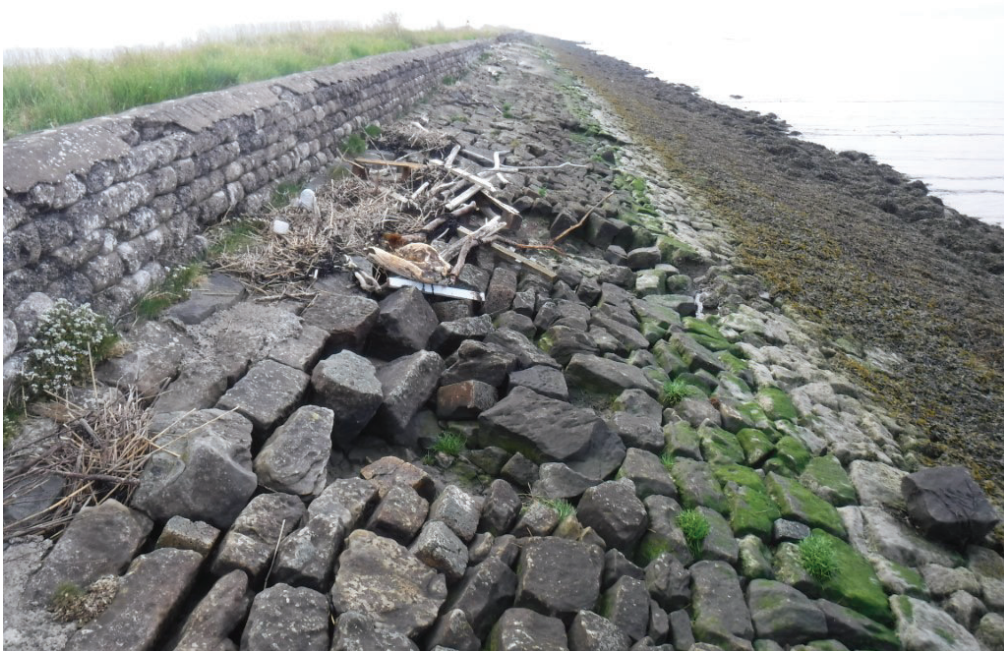
A general view of large voids in the revetment from 4M 930Y and 940Y can be seen in Photographs 31 and 32.

Photograph 31- Section 3- 4M 930Y- Void at mid revetment -19.04.19

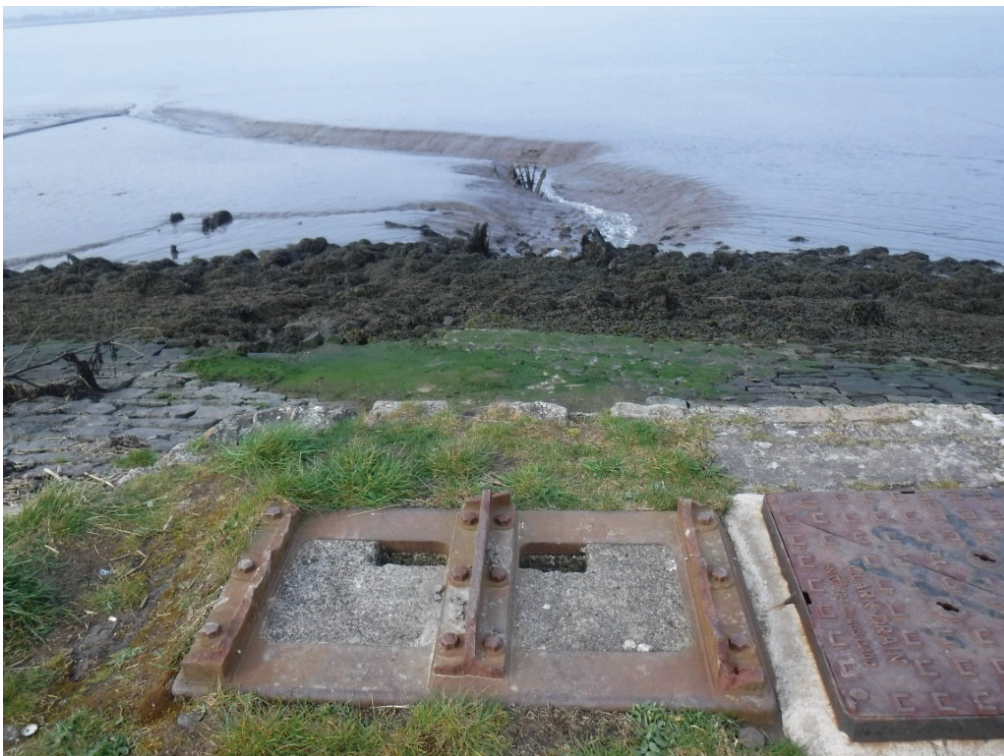
Photograph 38 - Section 3- 4M 1075Y- Culvert -19.04.19

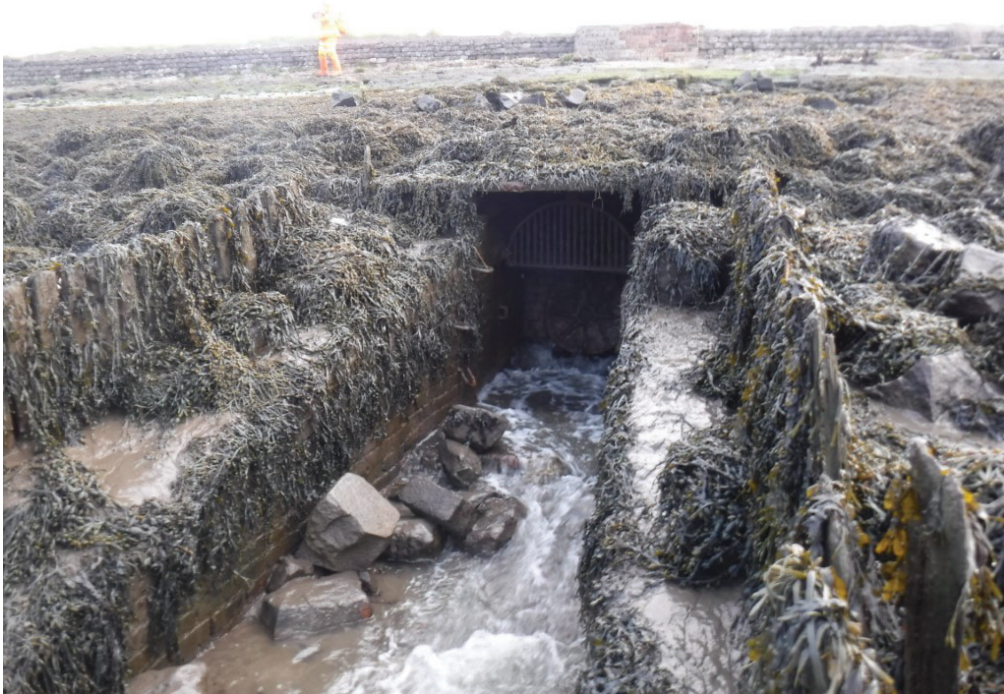
Photograph 39 - Section 3- 4M 1075Y- View of culvert outlet -19.04.19

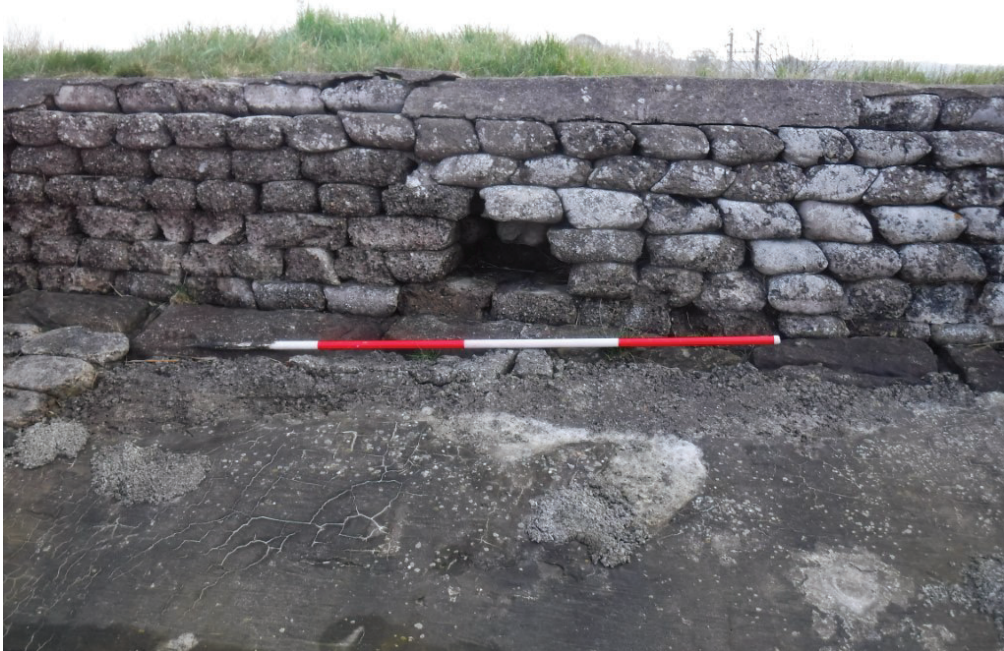
Another culvert was noted at 4M 1114Y. The wave return valve was found to be in good condition as seen in Photograph 40. There is also a large void in the revetment at this mileage (Photograph 41). The void has not deteriorated since last year's examination and the manhole cover is now repaired.

Photograph 41 - Section 3- 4M 1114Y- Washout above wave return outlet 0.6x0.5 -19.04.19

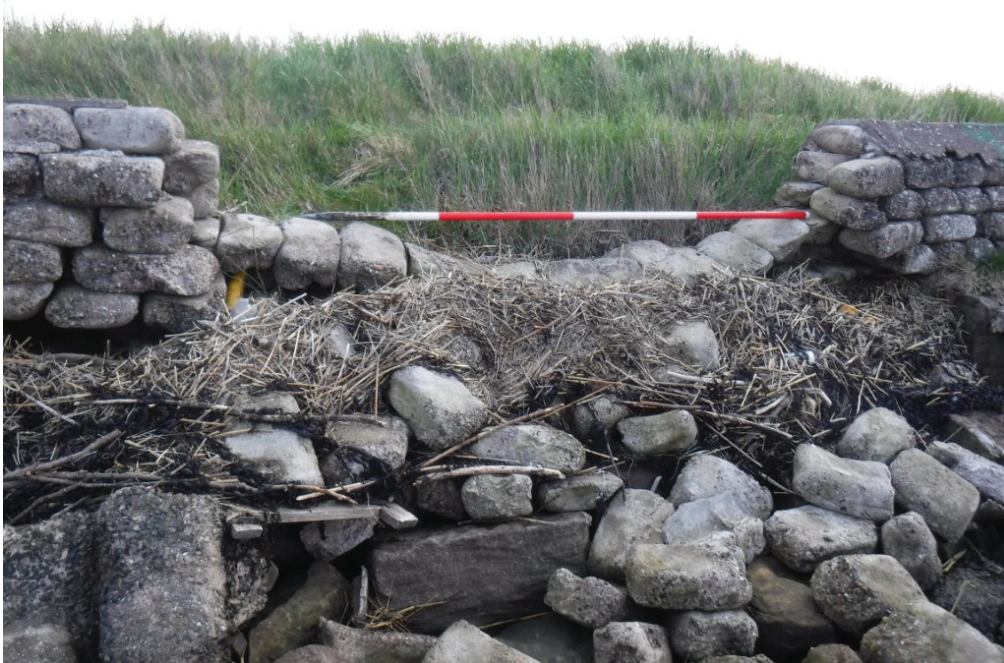
A large void (20m x 3m x 0.6m) was noted at 4M 1200Y. No deterioration was noted in the current examination (Photograph 43).

Photograph 43 - Section 3 - 4M 1200Y - Collapsed wave return wall -19.04.19

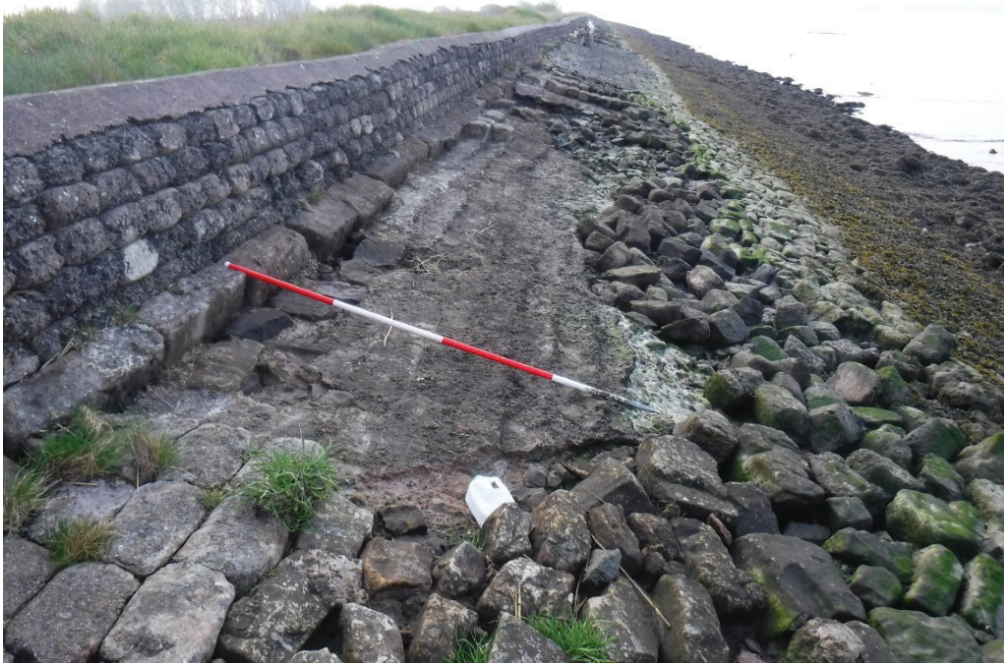
Photograph 47 - Section 3- 4M 1260Y - Loss of concrete bag work -19.04.19

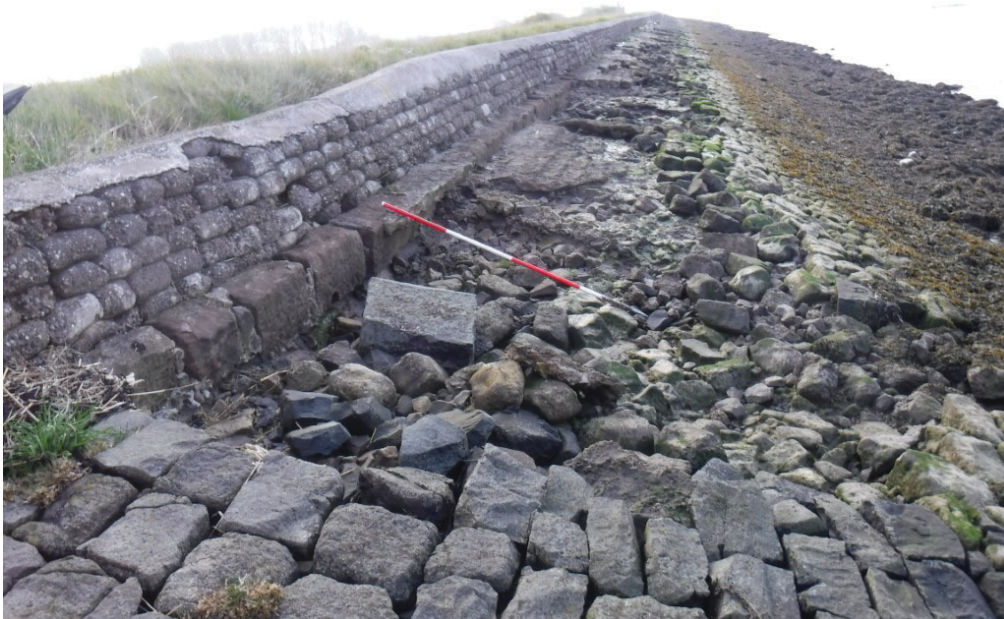
Photograph 48 - Section 3 - 4M 1295Y- General view of void at crest (3) -19.04.19

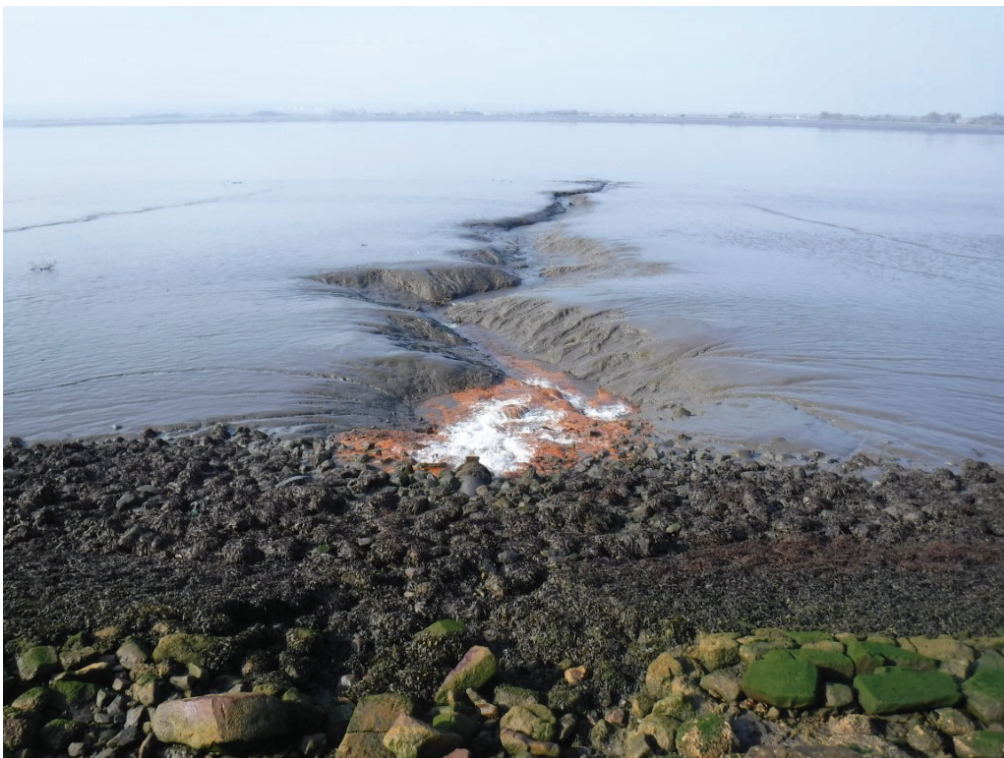
A view showing the outlet pipe from the pumping station at 5M 0060Y was flowing freely at time of inspection is shown in Photograph 60.

Photograph 60 - Section 3- 5M 60Y- Pipe outlet from power station -19.04.19

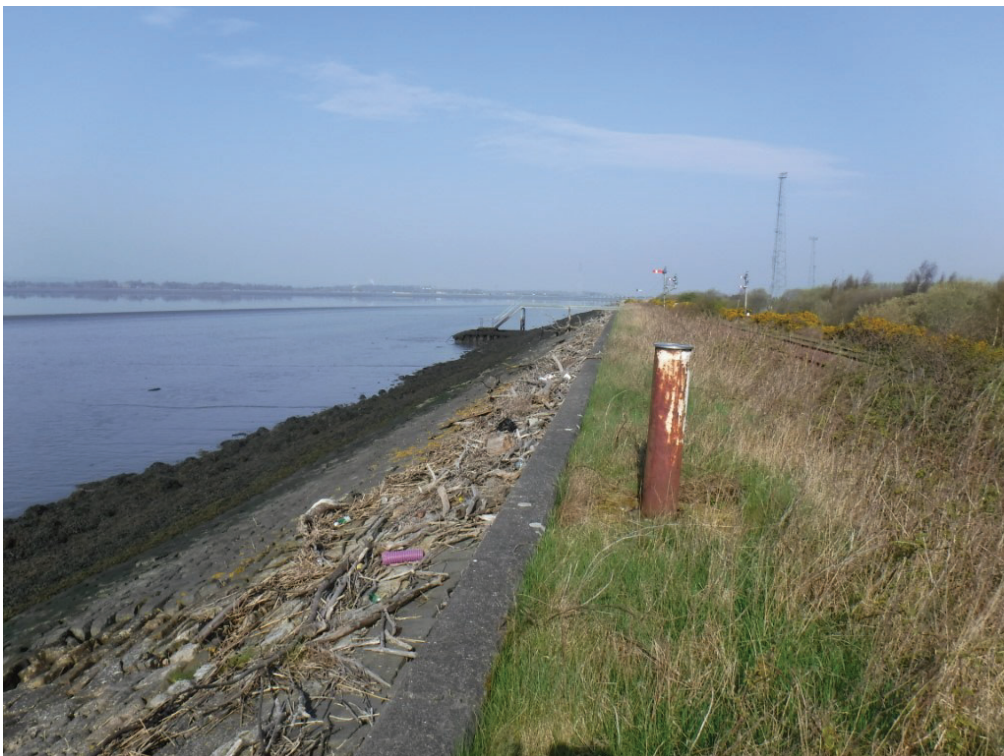
A view of the defence from the end of the defence can be seen in Photographs 74.

Photograph 74 - Section 3- End of defence to low miles -19.04.19
